**Re: Release Characterization and Closure Report  
ConocoPhillips  
Battle Axe Central Tank Battery Release  
Unit Letter A, Section 27, Township 26 South, Range 32 East  
Lea County, New Mexico  
Incident ID# NCE2002452675**

Tetra Tech, Inc. (Tetra Tech) was contacted by ConocoPhillips to assess a release that occurred from an equipment failure at the Battle Axe Central Tank Battery (CTB). The release footprint is located in Public Land Survey System (PLSS) Unit Letter A, Section 27, Township 26 South, Range 32 East, in Lea County, New Mexico (Site). The approximate release point occurred at coordinates 32.018301°, -103.656126°, as shown on Figures 1 and 2.

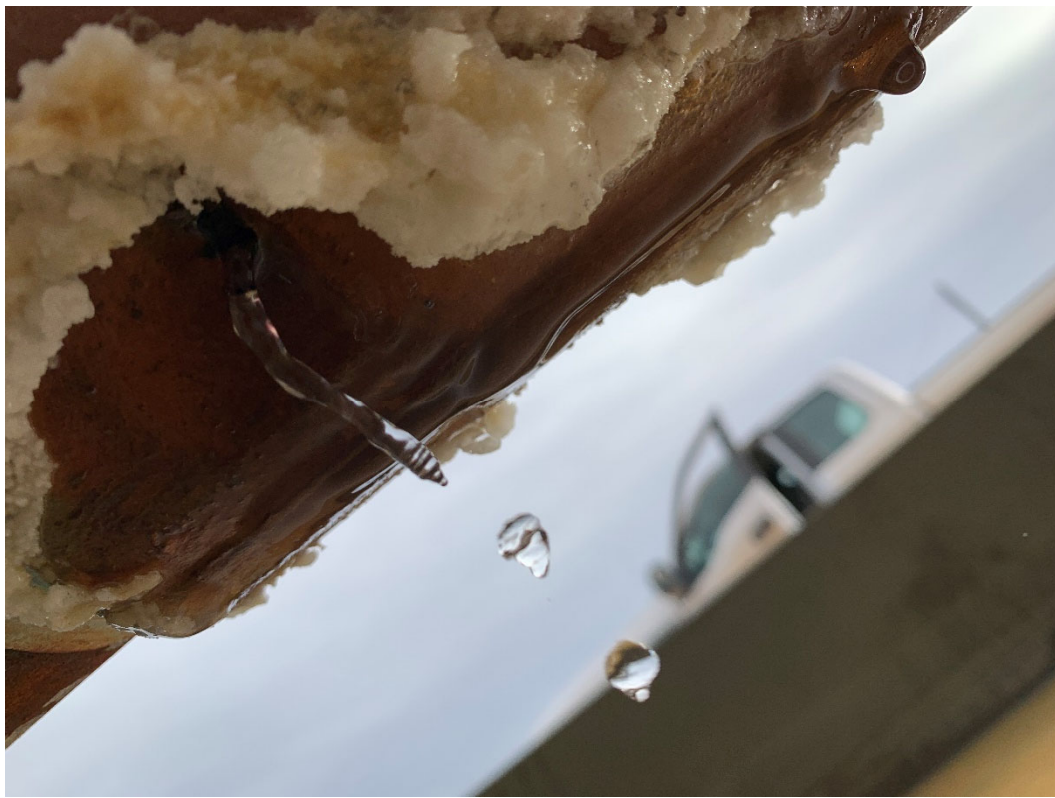
TETRA TECH, INC. PROJECT NO. 212C-MD-02796	DESCRIPTION	Fluid being released on underside of ball valve fitting.	1
	SITE NAME	COP – Battle Axe CTB Release	11/29/2019

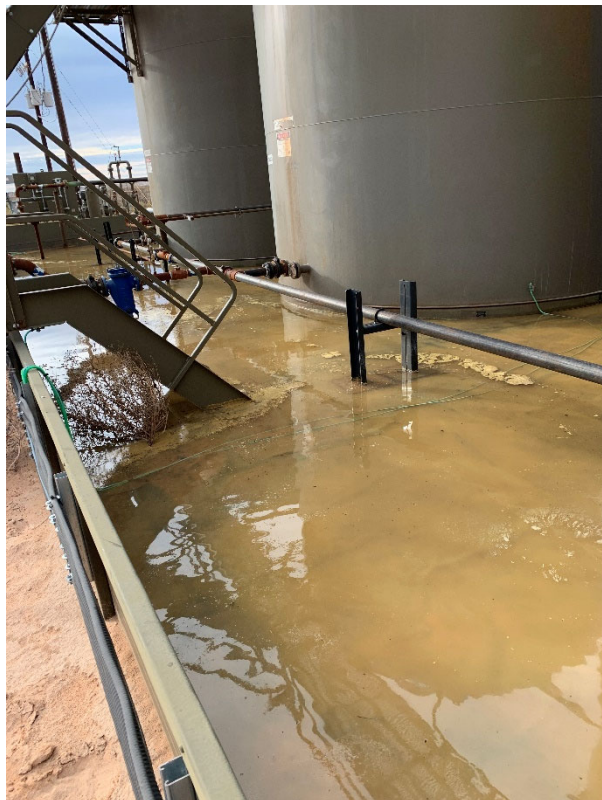
TETRA TECH, INC. PROJECT NO. 212C-MD-02796	DESCRIPTION	View south. Eastern portion of lined secondary containment immediately following discovery of release.	2
	SITE NAME	COP – Battle Axe CTB Release	11/29/2019

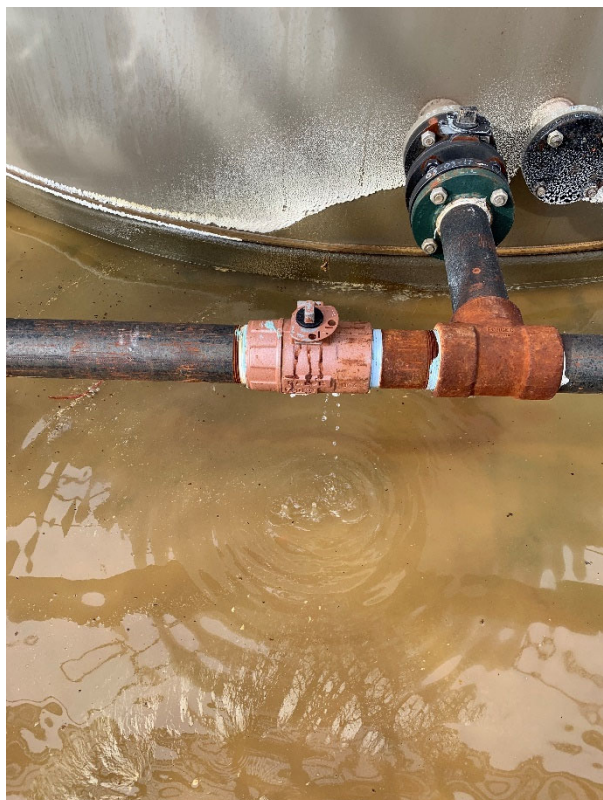
TETRA TECH, INC. PROJECT NO. 212C-MD-02796	DESCRIPTION	Failed ball valve at the time of release discovery.	3
	SITE NAME	COP – Battle Axe CTB Release	11/29/2019

*Repair made on 11/25/19, replaced ball valve*

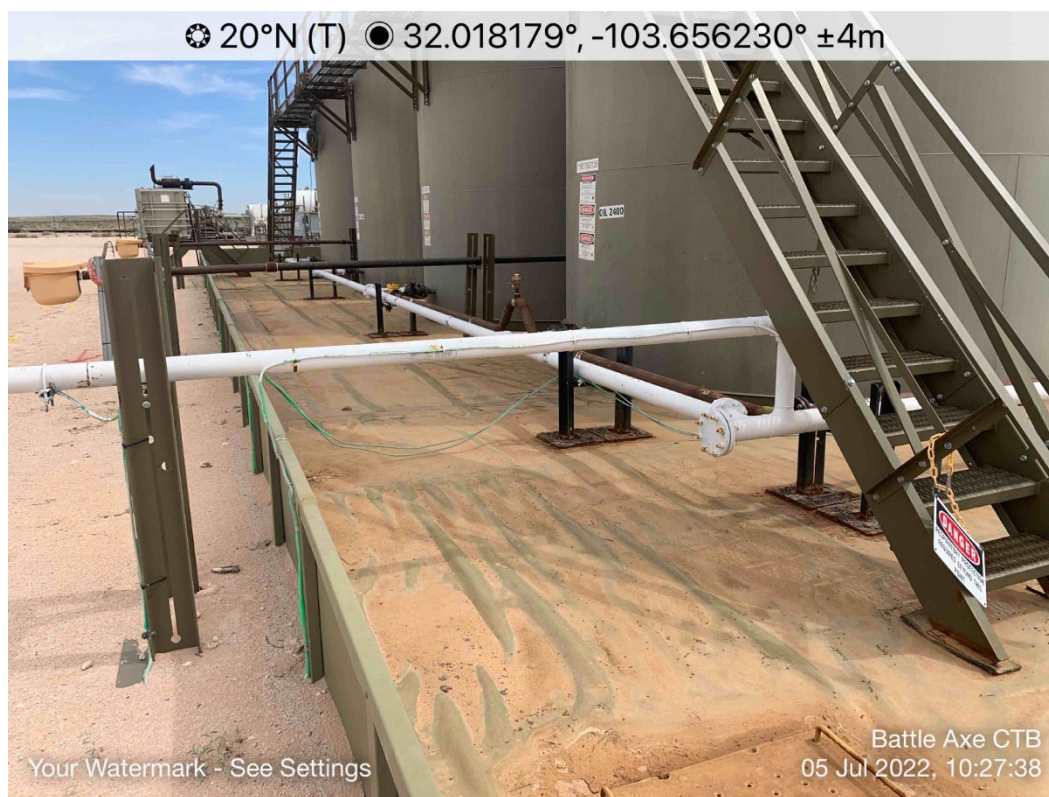
TETRA TECH, INC. PROJECT NO. 212C-MD-02796	DESCRIPTION	View north. Western portion of the lined secondary containment during liner inspection.	4
	SITE NAME	COP – Battle Axe CTB Release	7/5/2022

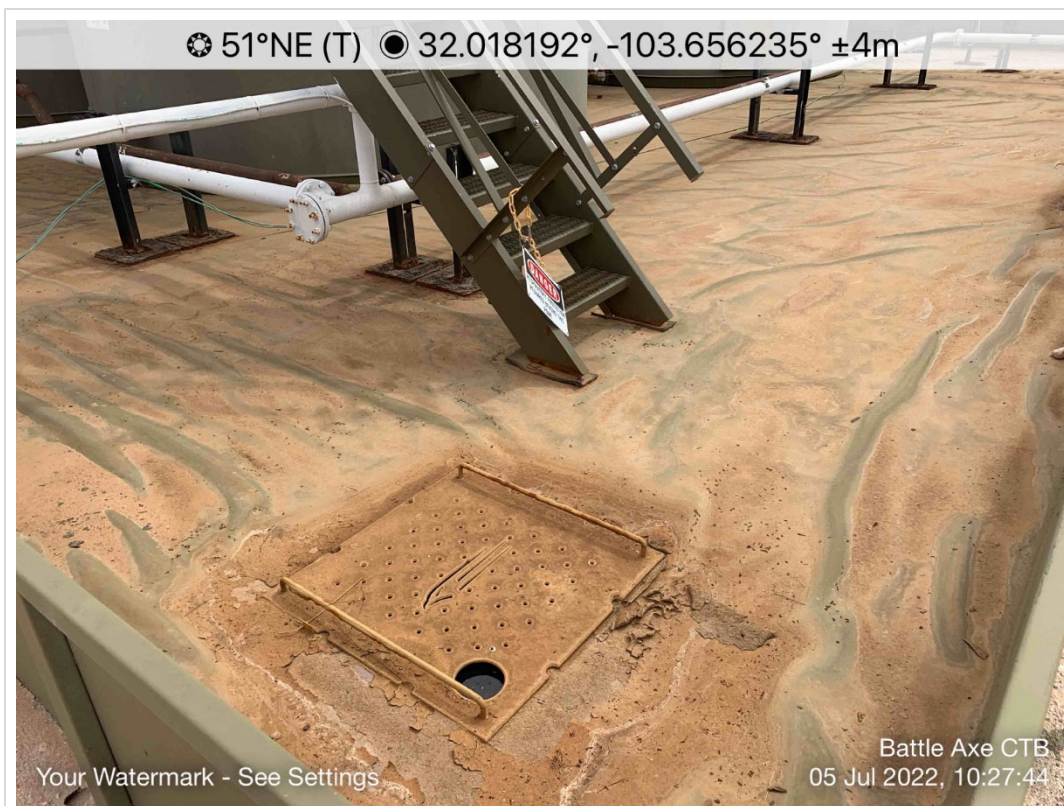
TETRA TECH, INC. PROJECT NO. 212C-MD-02796	DESCRIPTION	View northeast. Sump in the southwestern corner of the secondary containment during liner inspection.	5
	SITE NAME	COP – Battle Axe CTB Release	7/5/2022

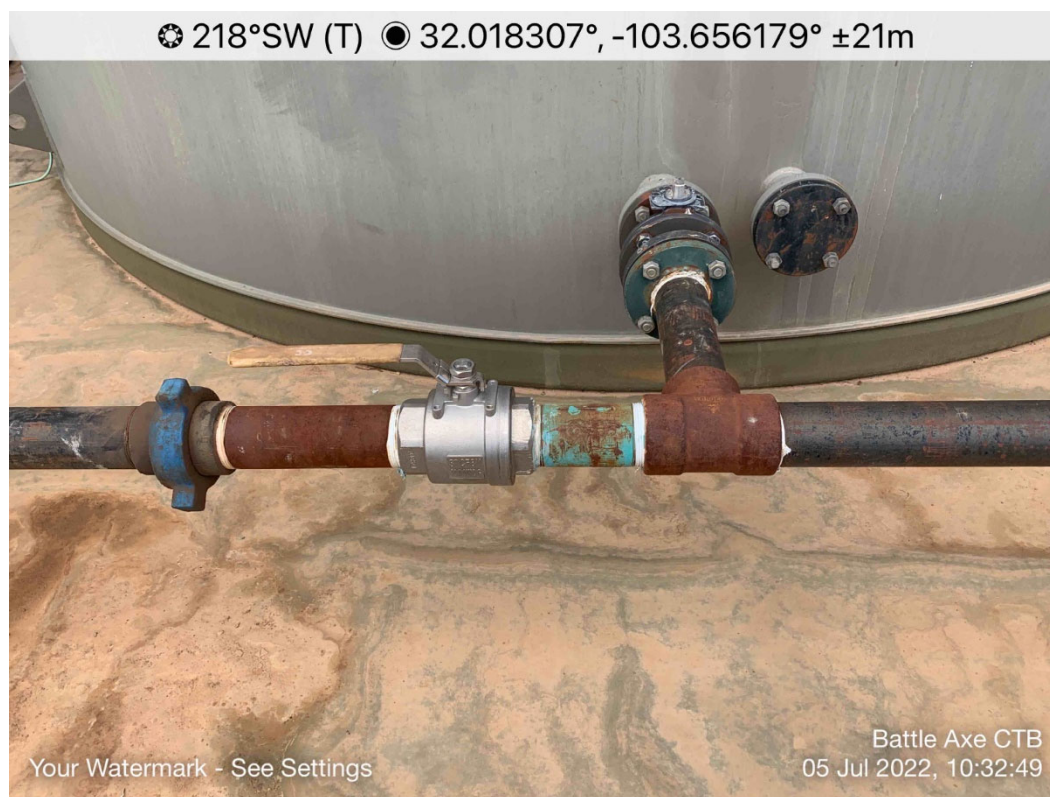
TETRA TECH, INC. PROJECT NO. 212C-MD-02796	DESCRIPTION	View west. Replaced ball valve fitting.	6
	SITE NAME	COP – Battle Axe CTB Release	7/5/2022

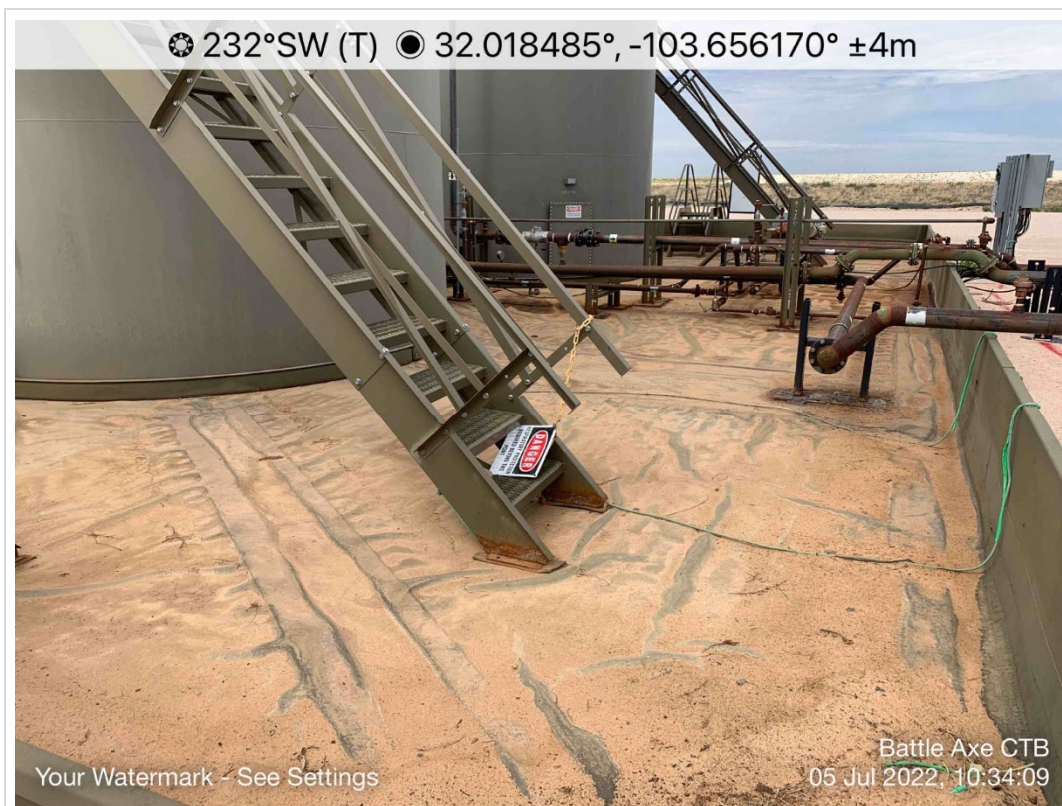
TETRA TECH, INC. PROJECT NO. 212C-MD-02796	DESCRIPTION	View west-southwest. Northern portion of lined secondary containment during liner inspection.	7
	SITE NAME	COP – Battle Axe CTB Release	7/5/2022

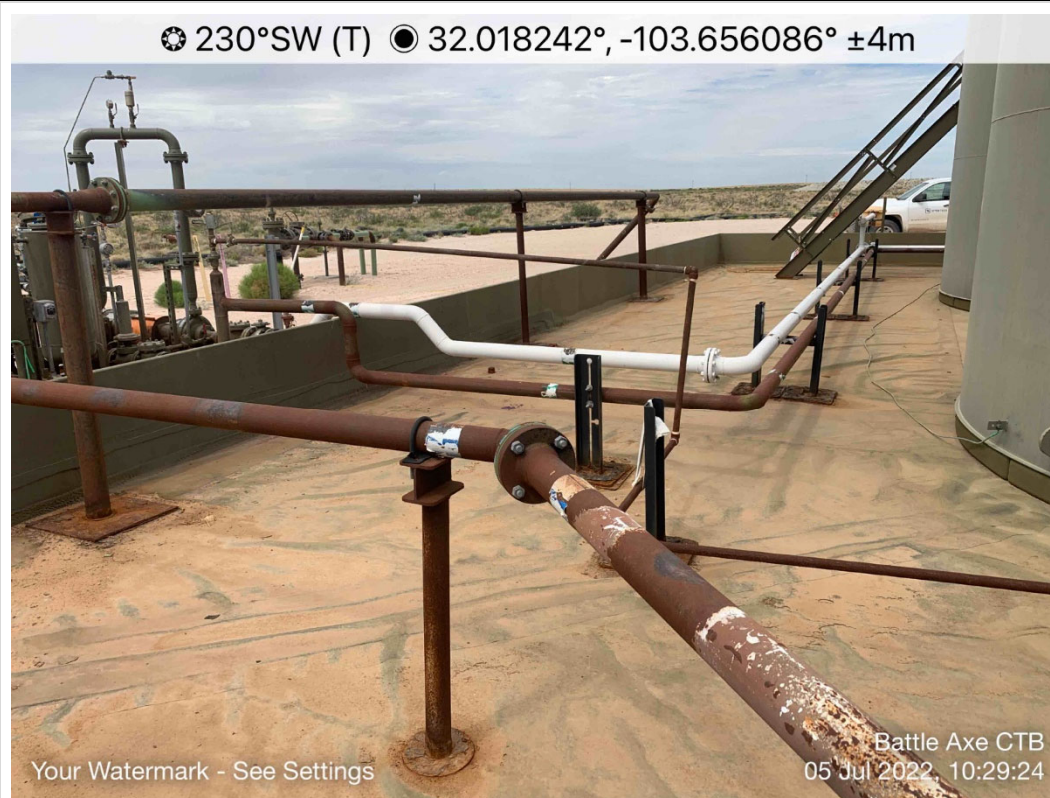
TETRA TECH, INC. PROJECT NO. 212C-MD-02796	DESCRIPTION	View southwest. Southern portion of lined secondary containment during liner inspection.	8
	SITE NAME	COP – Battle Axe CTB Release	7/5/2022

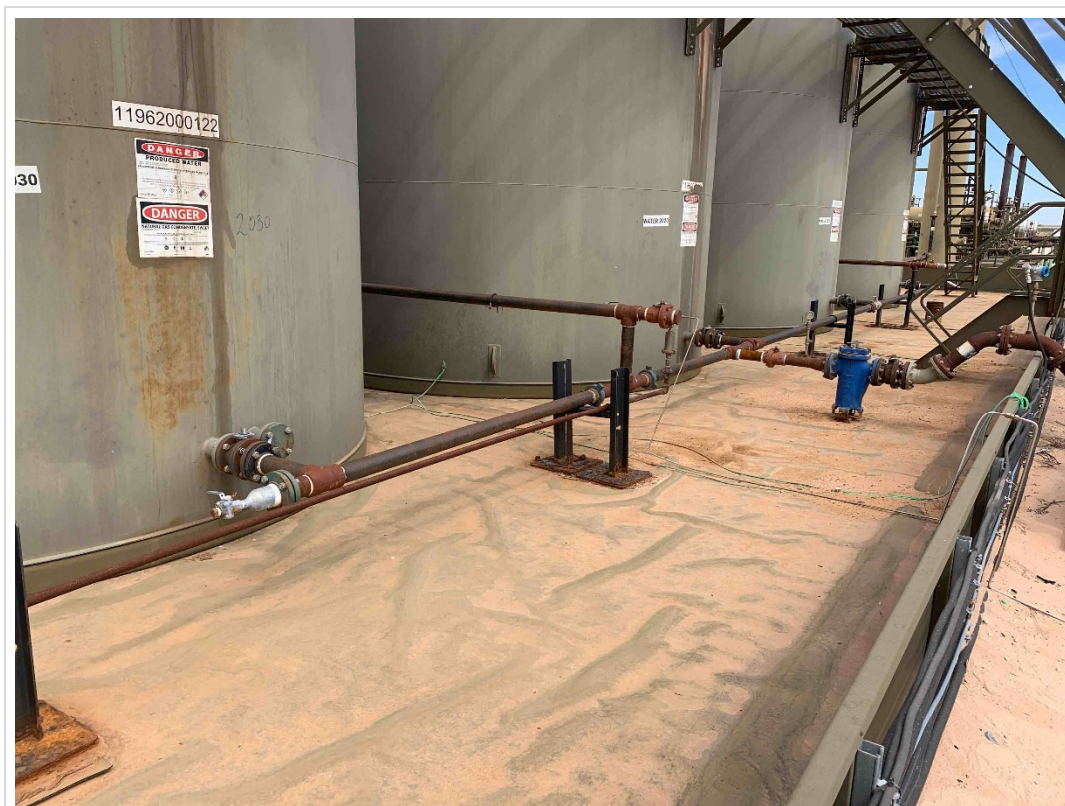
TETRA TECH, INC. PROJECT NO. 212C-MD-02796	DESCRIPTION	View northwest. Eastern portion of lined secondary containment during liner inspection.	9
	SITE NAME	COP – Battle Axe CTB Release	7/5/2022
