Re: Second Quarter 2022 – SVE System Update

San Juan 28-6 #31
Rio Arriba County, New Mexico
Hilcorp Energy Company
NMOCD Incident Number: NVF1816655680

Ensolum, LLC (Ensolum), on behalf of Hilcorp Energy Company (Hilcorp), presents this *Second Quarter 2022 – SVE System Update* report summarizing the soil vapor extraction (SVE) system performance at the San Juan 28-6 #31 natural gas production well (Site) located in Unit M, Section 28, Township 28 North, Range 6 West in Rio Arriba County, New Mexico (Figure 1). Specifically, this report summarizes Site activities performed in April, May, and June of 2022 to the New Mexico Oil Conservation Division (NMOCD).

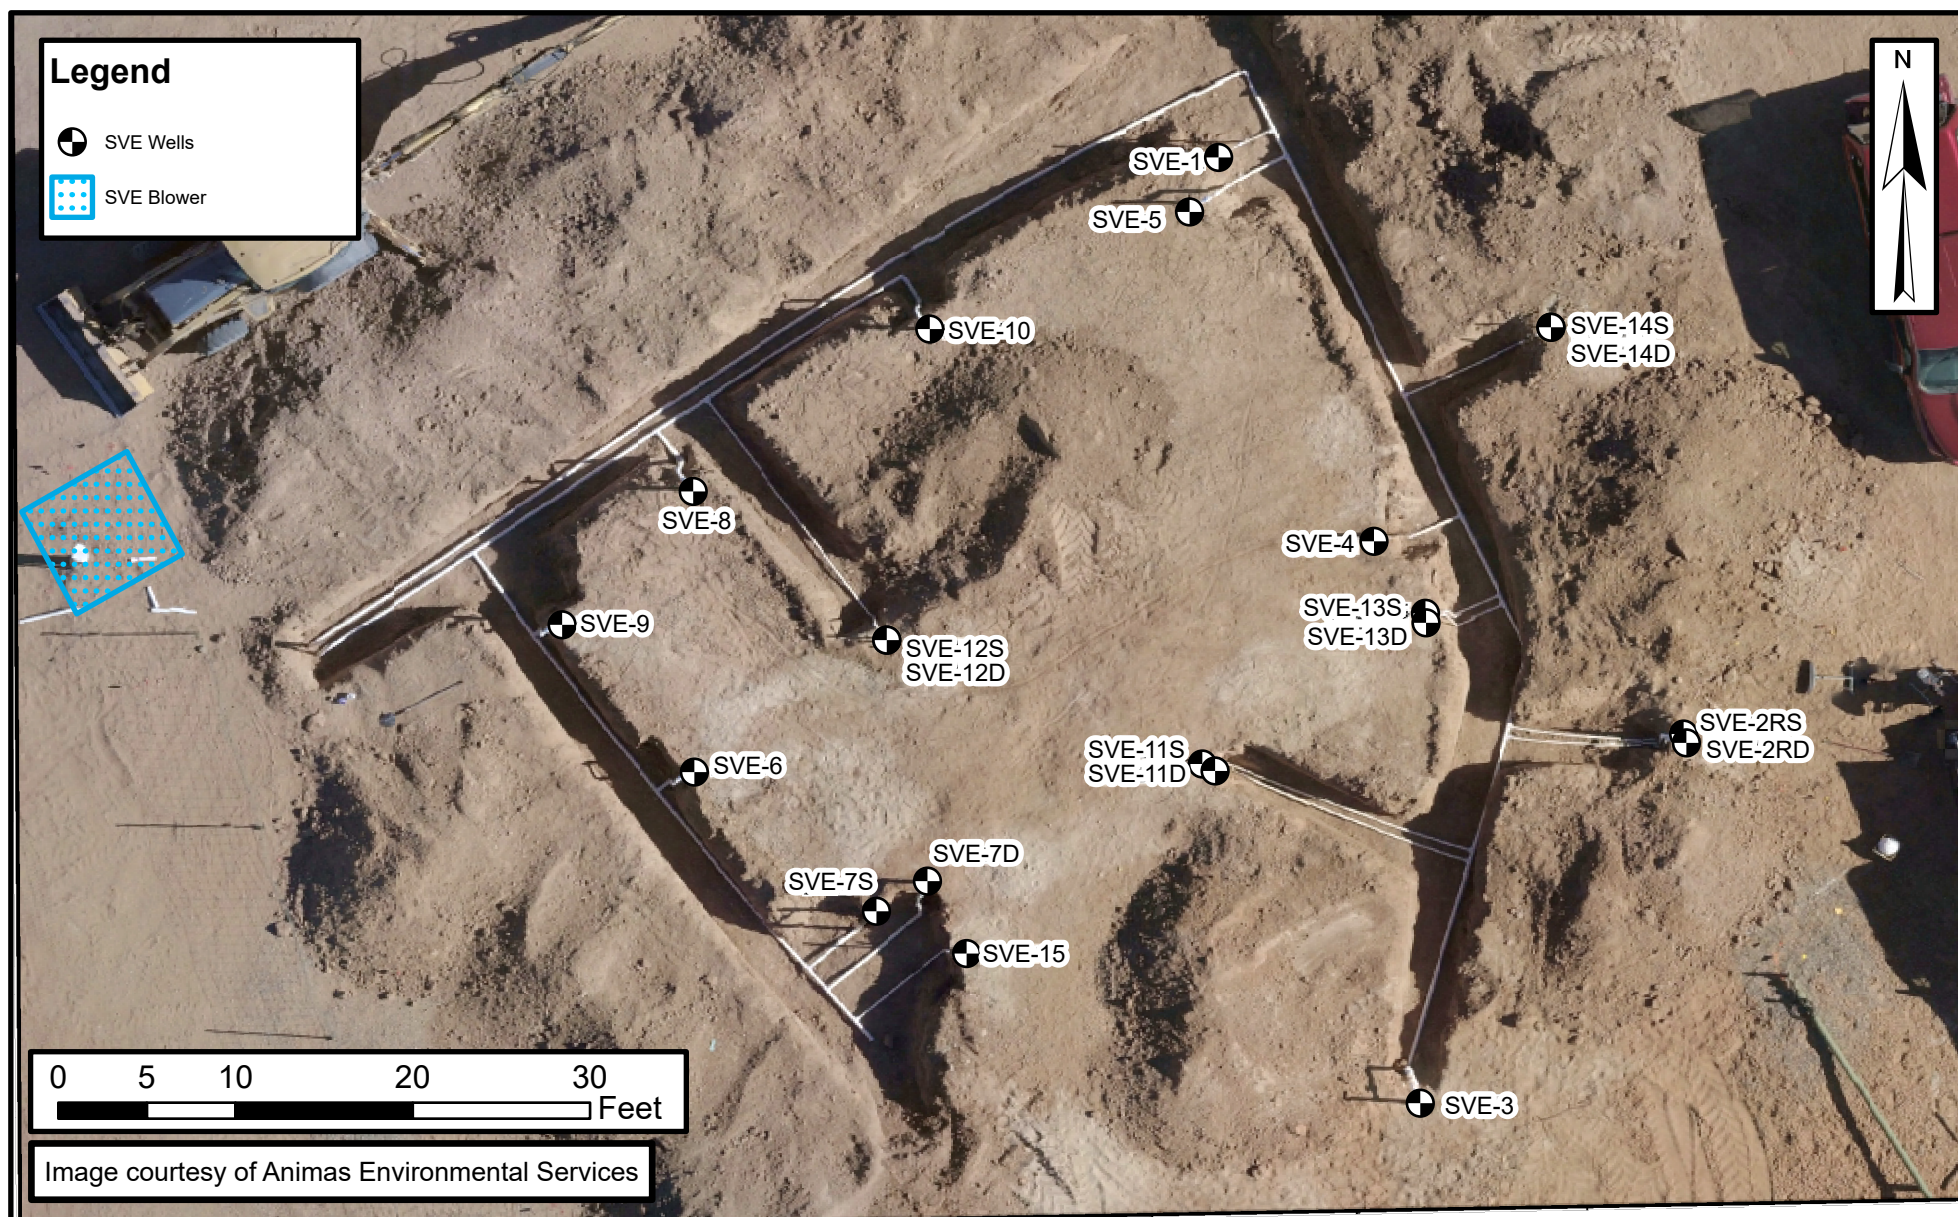
FIGURE
2

The current SVE system consists of a three-phase, 3 horsepower (HP) Ametek Rotron Model EN656 regenerative blower capable of producing 100 standard cubic feet per minute (scfm) of flow and 50 inches of water column (IWC). In total, 19 SVE wells are installed at the site at varying depth intervals in order to induce air flow through the impacted zones in the subsurface. SVE well locations are presented on Figure 2.

SVE System Configuration

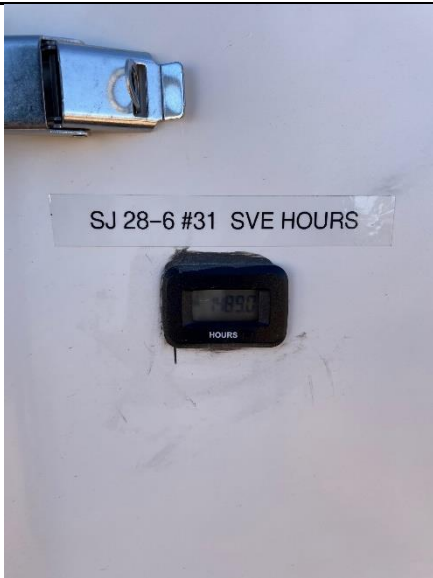
<p>Photograph 1</p> <p>Runtime meter taken on April 6, 2022 at 9:35 AM Hours = 1489.0</p>

Between April 6 and June 13 2022, the SVE system operated for 1,619 hours for a runtime efficiency of 99.2 percent (%). Table 1 presents the SVE system operational hours and percent runtime. Appendix B presents photographs of the runtime meters taken during the first and last field visits of the quarter. During the second quarter 2022, all SVE well were operating.

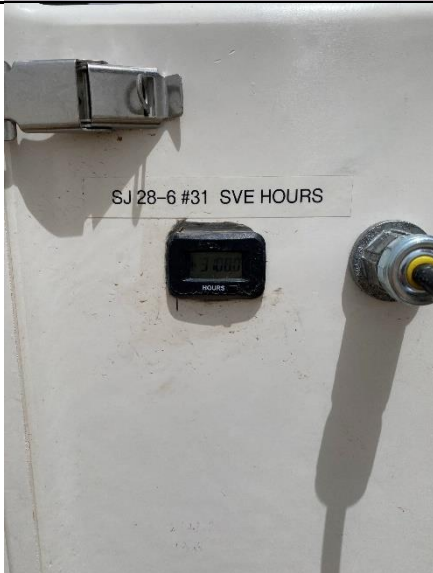
<p>Photograph 2</p> <p>Runtime meter taken on June 13, 2022 at 11:53 AM Hours = 3108.0</p>
