# Release Closure Report

## Strait BLN State Com #5

API #30-025-38169

Revised August 29, 2022

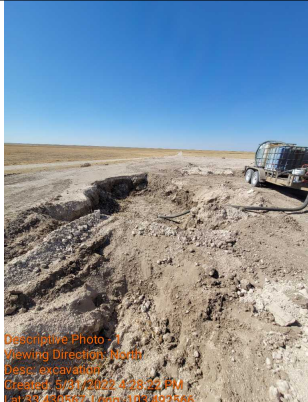
**Viewing Direction: North**

excavation

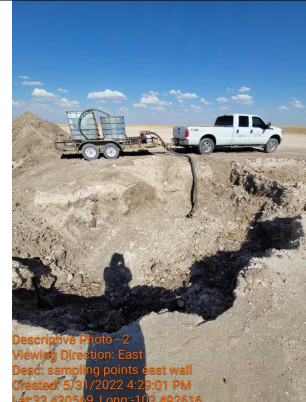
**Viewing Direction: East**

sampling points east wall

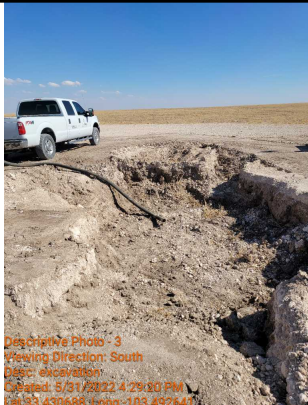
**Viewing Direction: South**

excavation

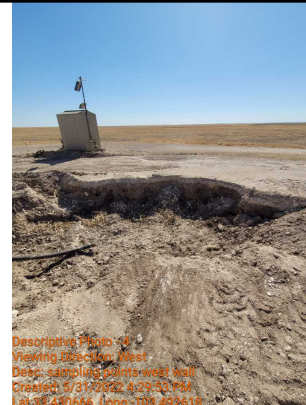
**Viewing Direction: West**

sampling points west wall

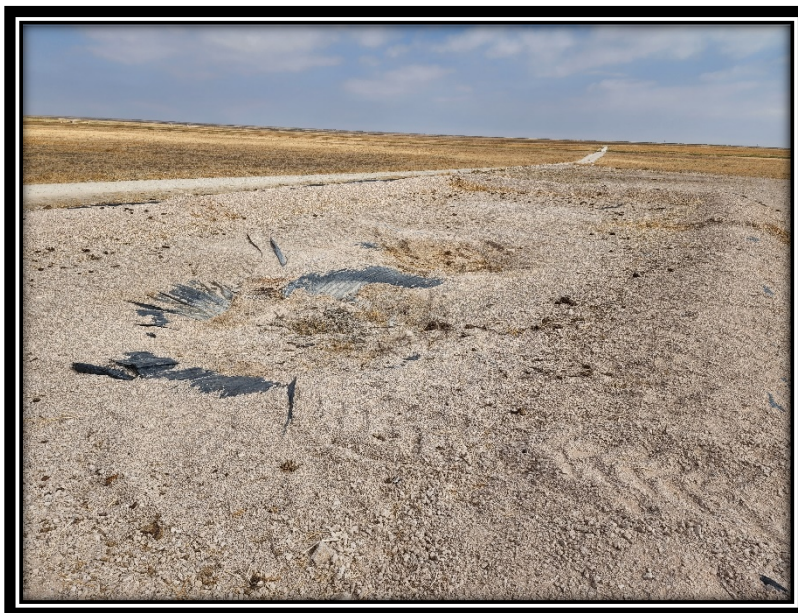
Picture 1: View of Impacted Area

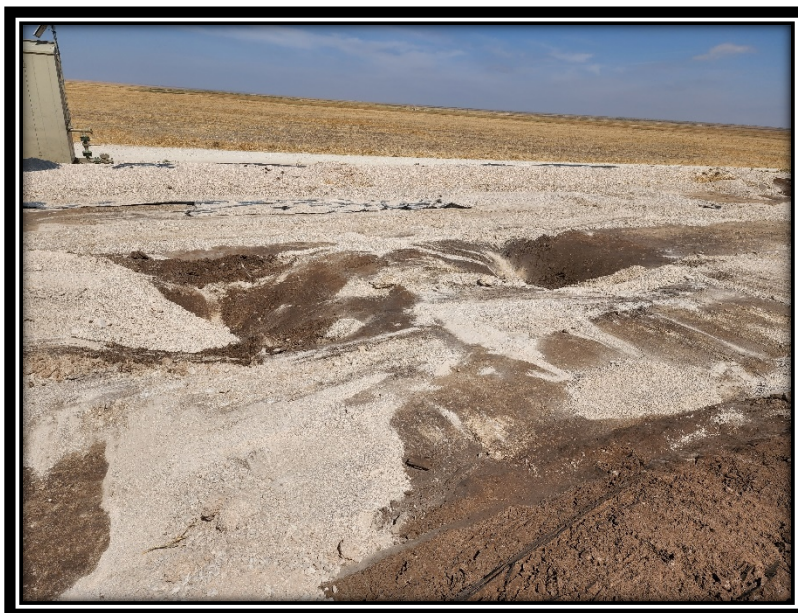
Picture 2: View of Liner Removal

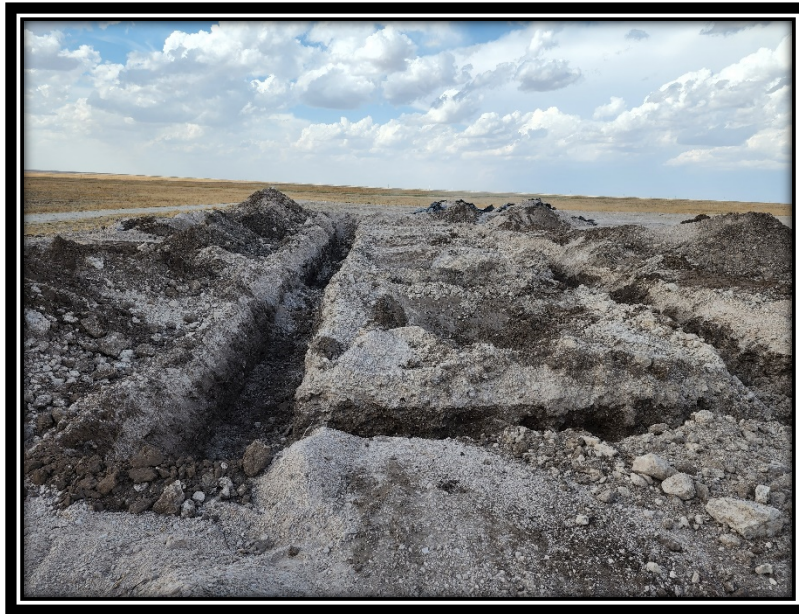
Picture 3: View 1 of Assessment Activities

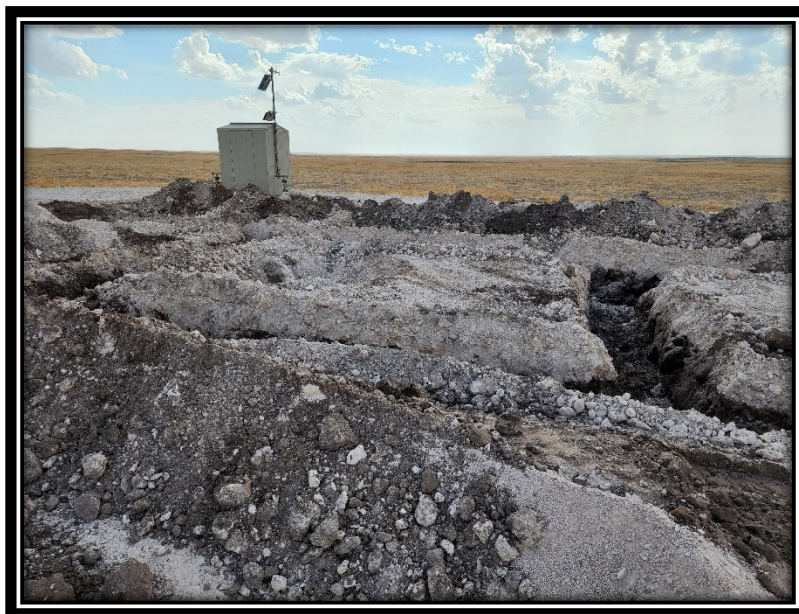
Picture 4: View 2 of Assessment Activities

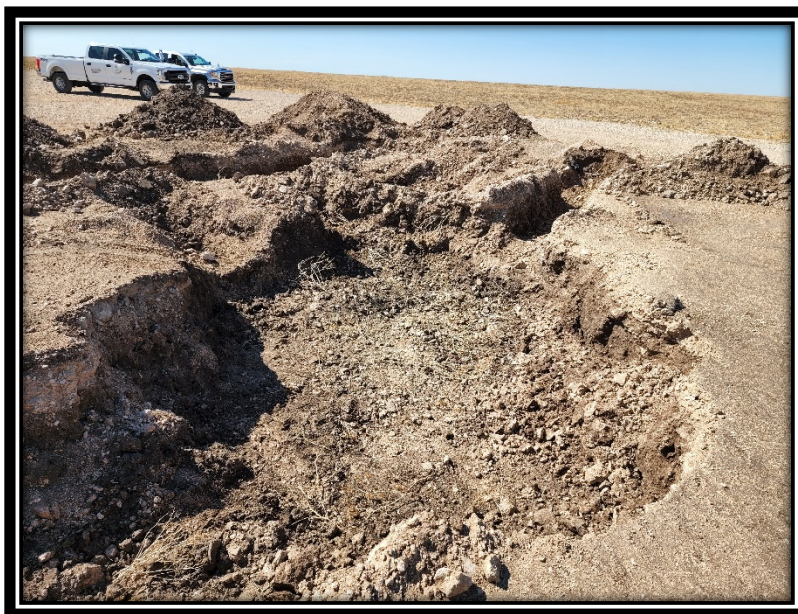
Picture 5: View 1 of Remediation Excavation (Middle Tank)

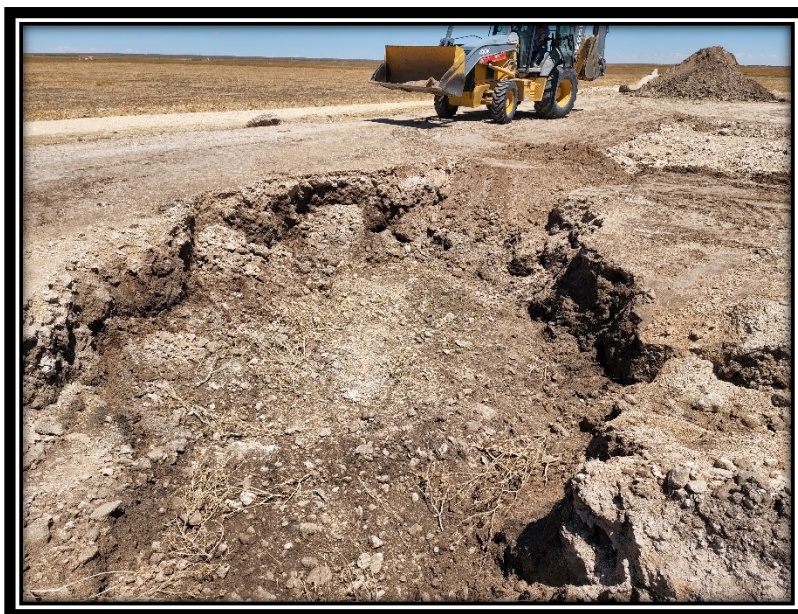
Picture 6: View 2 of Remediation Excavation (Middle Tank)

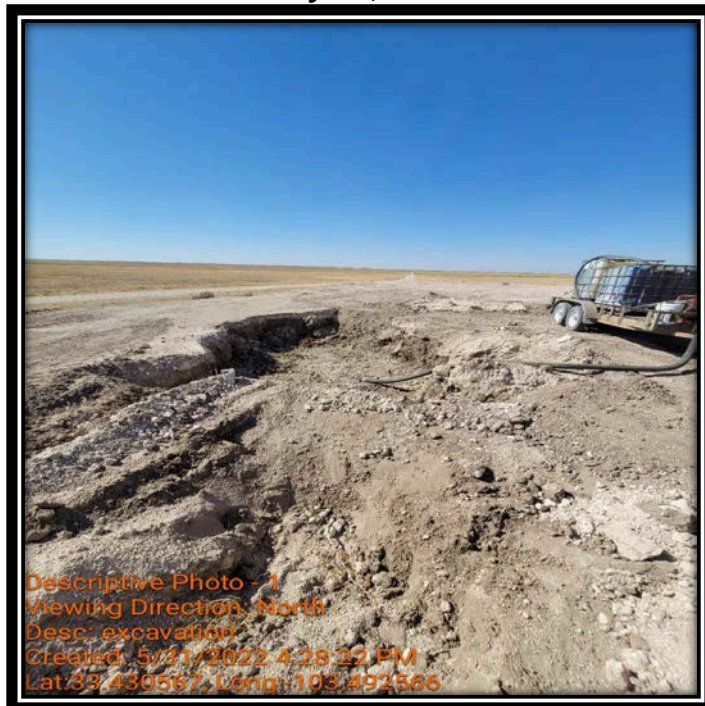
Picture 7: View of Excavation

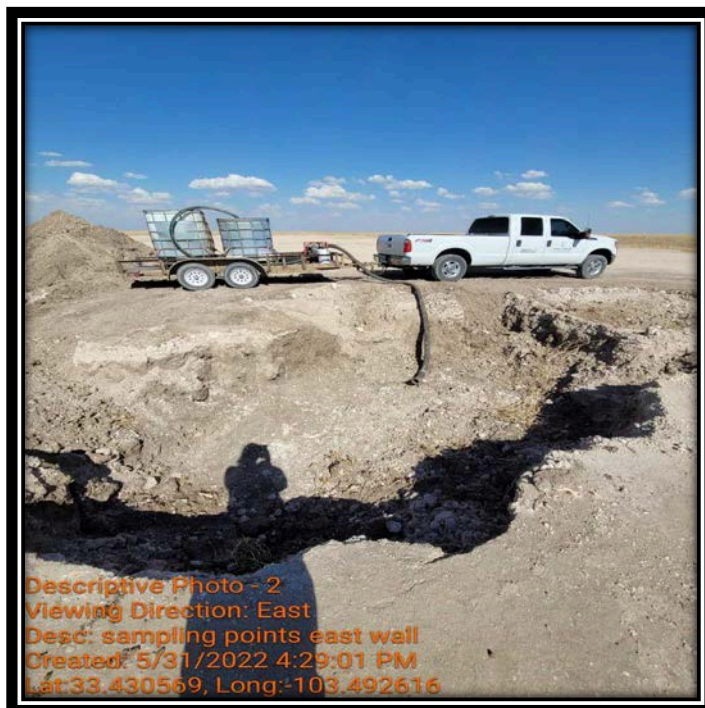
Picture 8: Sampling Points of East Wall

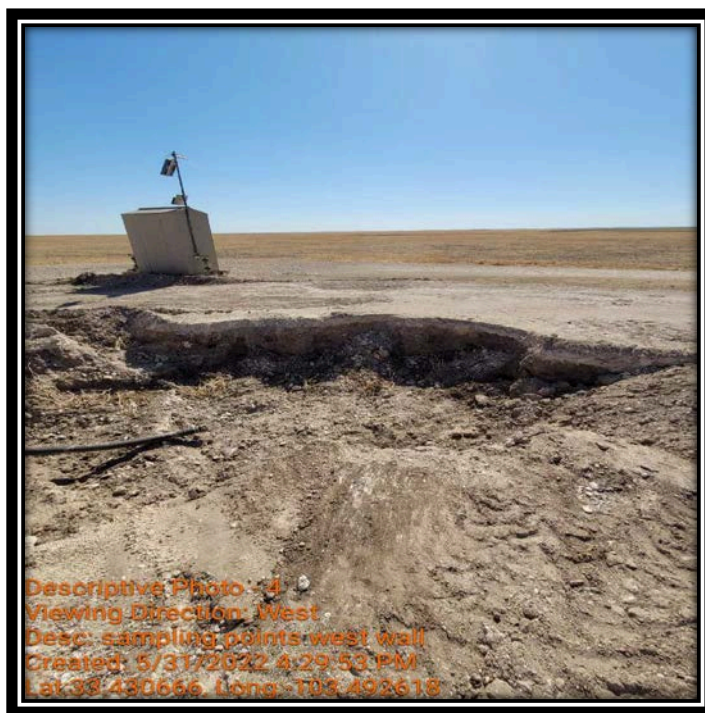
Picture 9: Sampling Points of West Wall

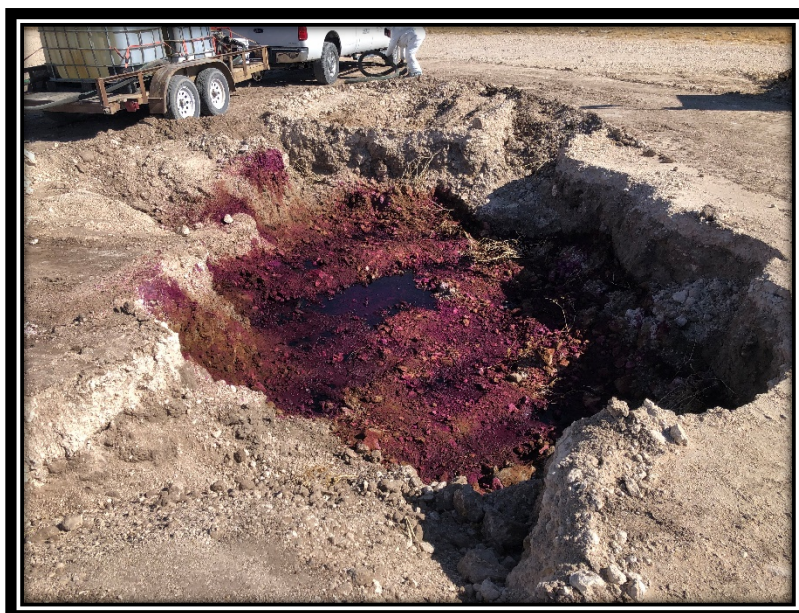
Picture 10: View of Potassium Permanganate Application

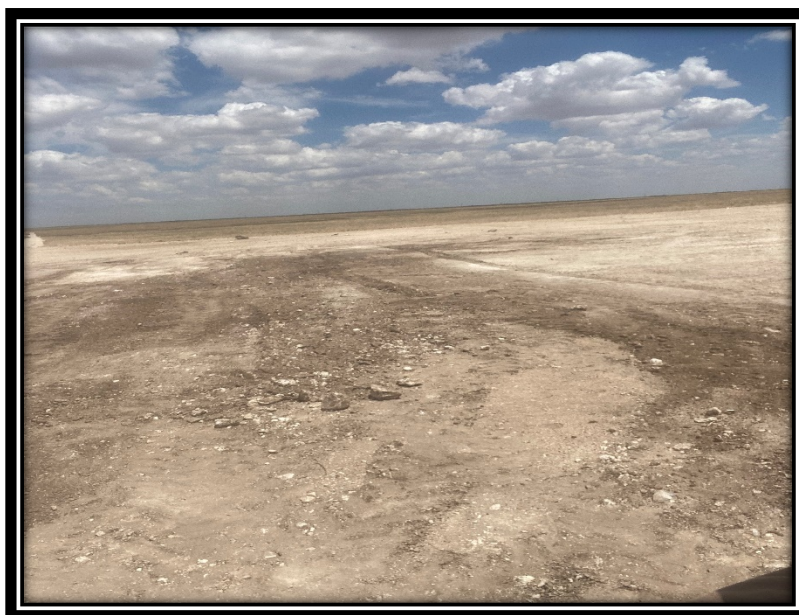
Picture 11: View 1 of Backfill

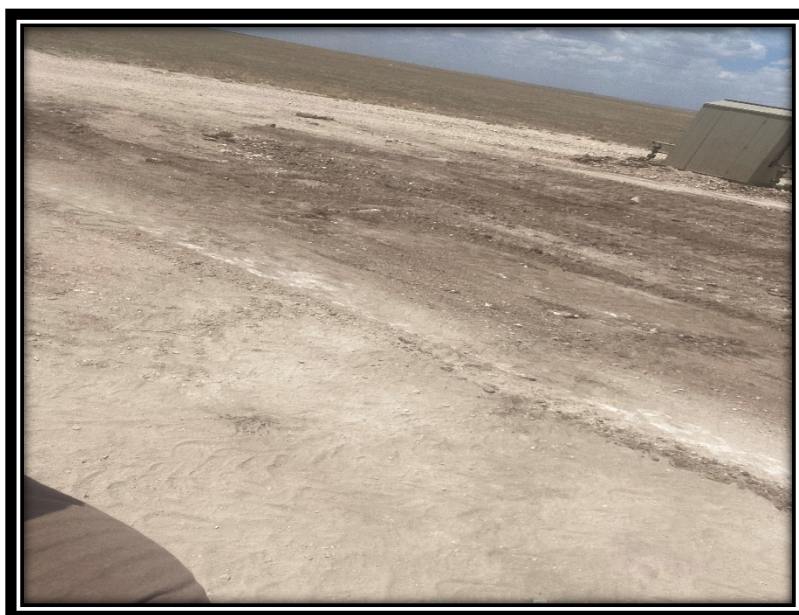
Picture 12: View 2 of Backfill

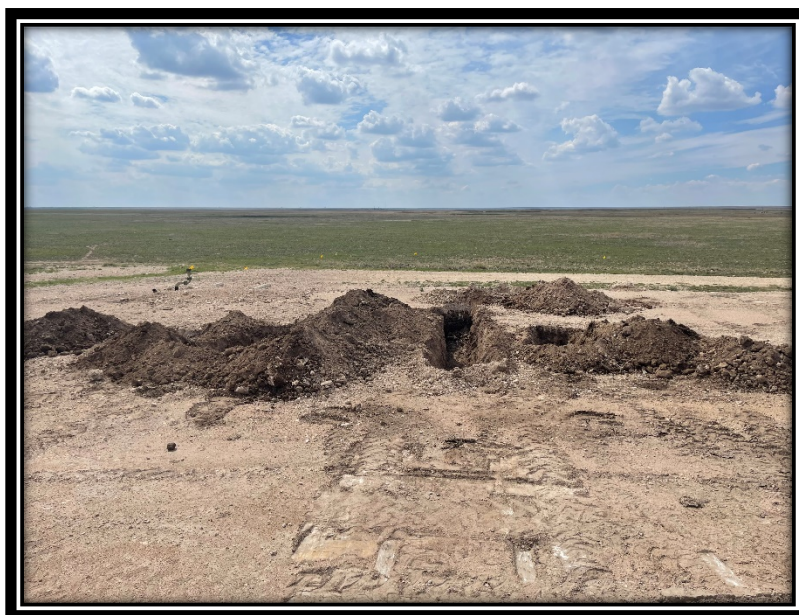
Picture 11: Delineation Activities

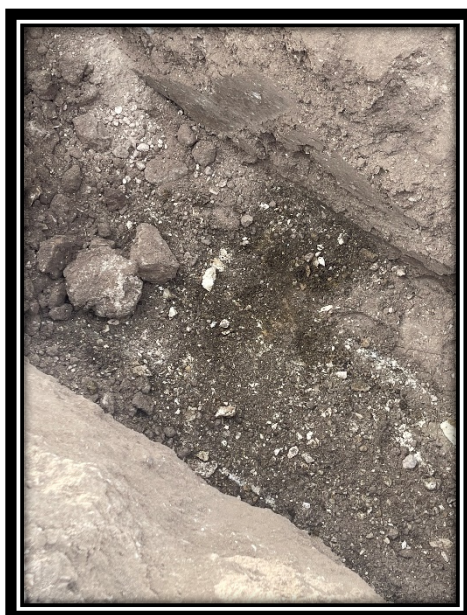
Picture 12: Competent Base With Residual Potassium Permanganate
