**Re: REVISED
Liner Inspection and Closure Request
ConocoPhillips (Heritage Concho)
Super Cobra State Com #001H Battery Valve Release
Unit Letter I, Section 13, Township 19 South, Range 34 East
Lea County, New Mexico
Incident ID# NAPP2218128367**

LINER INSPECTION AND CLOSURE REQUEST

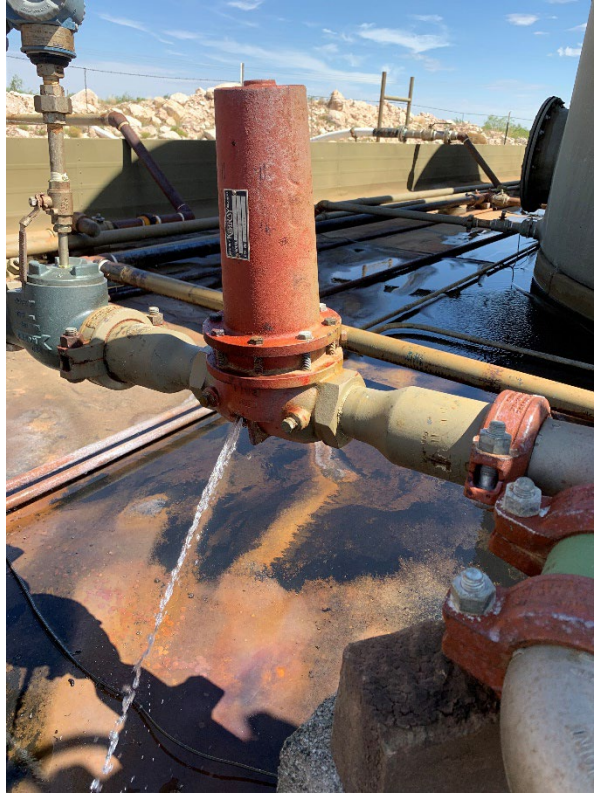
TETRA TECH, INC. PROJECT NO. 212C-MD-02810	DESCRIPTION	Initial response photo of release point provided by COP representatives onsite at that time.	1
	SITE NAME	ConocoPhillips Super Cobra Battery Valve Release	7/11/2022

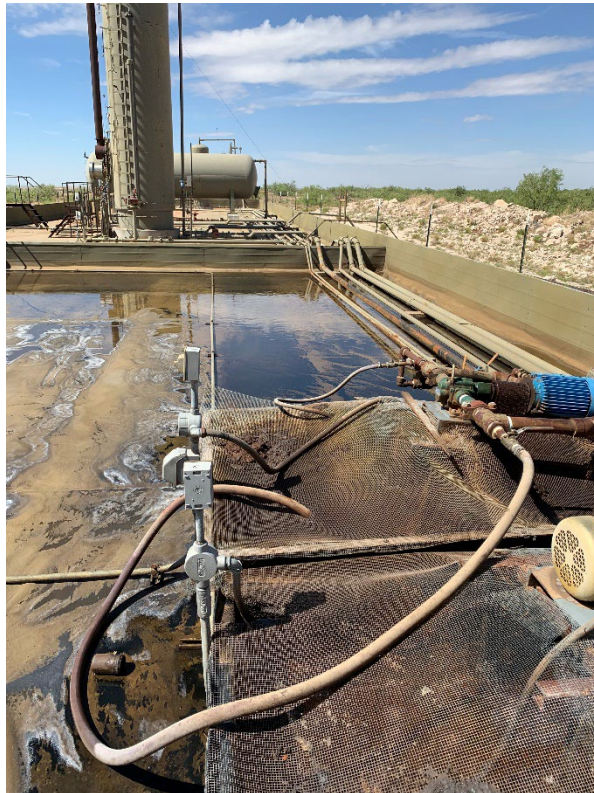
TETRA TECH, INC. PROJECT NO. 212C-MD-02810	DESCRIPTION	Initial response photo of release within the secondary containment provided by COP representatives onsite.	2
	SITE NAME	ConocoPhillips Super Cobra Battery Valve Release	7/11/2022

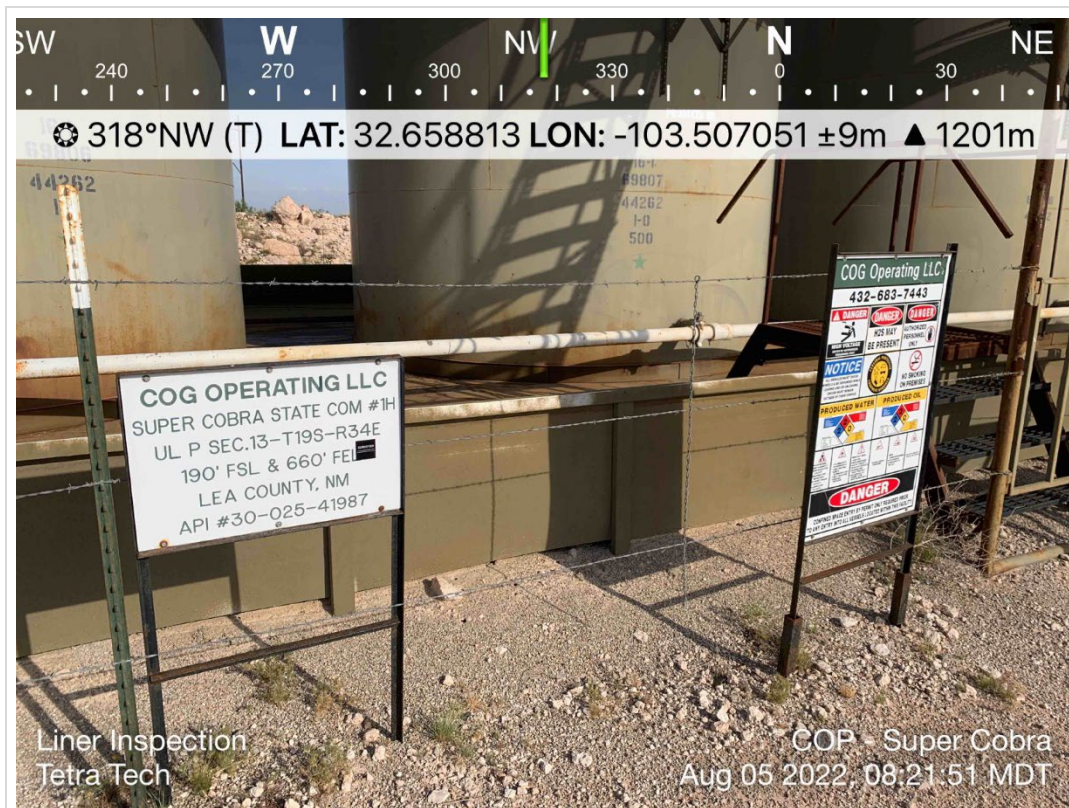
TETRA TECH, INC. PROJECT NO. 212C-MD-02810	DESCRIPTION	View of the Super Cobra Battery signage.	3
	SITE NAME	ConocoPhillips Super Cobra Battery Valve Release	8/05/2022

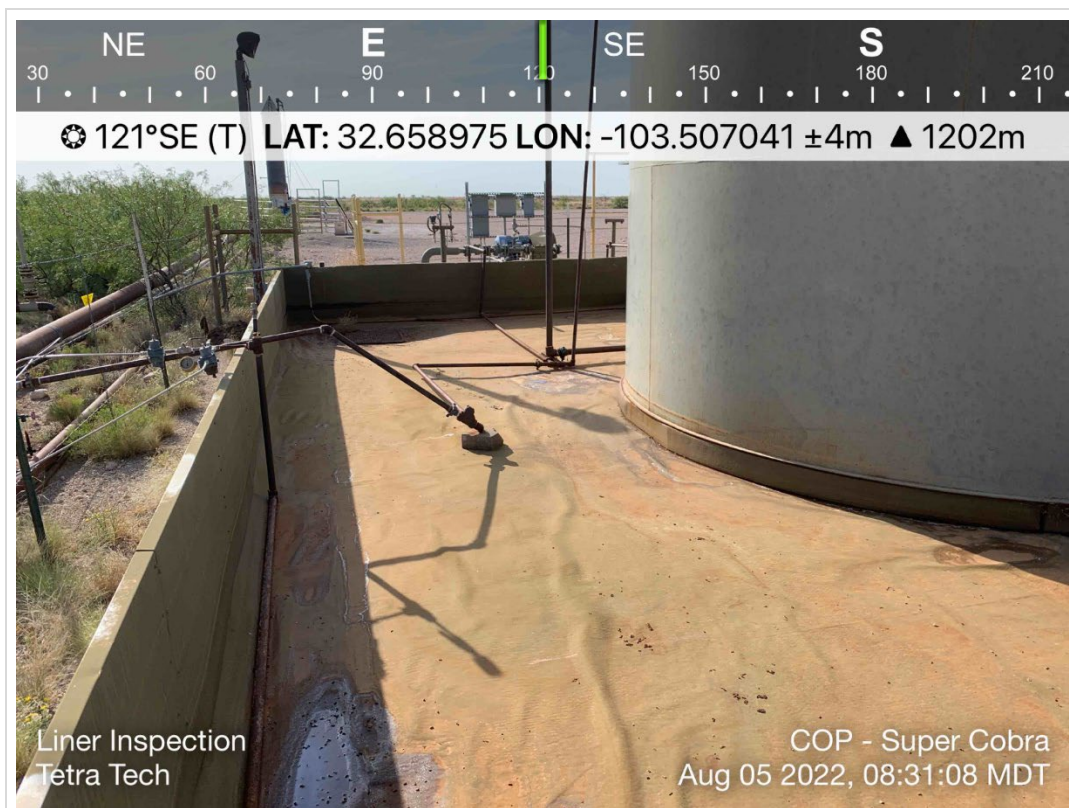
TETRA TECH, INC. PROJECT NO. 212C-MD-02810	DESCRIPTION	View inside the secondary containment of intact liner with no visual evidence of release remaining.	9
	SITE NAME	ConocoPhillips Super Cobra Battery Valve Release	8/05/2022

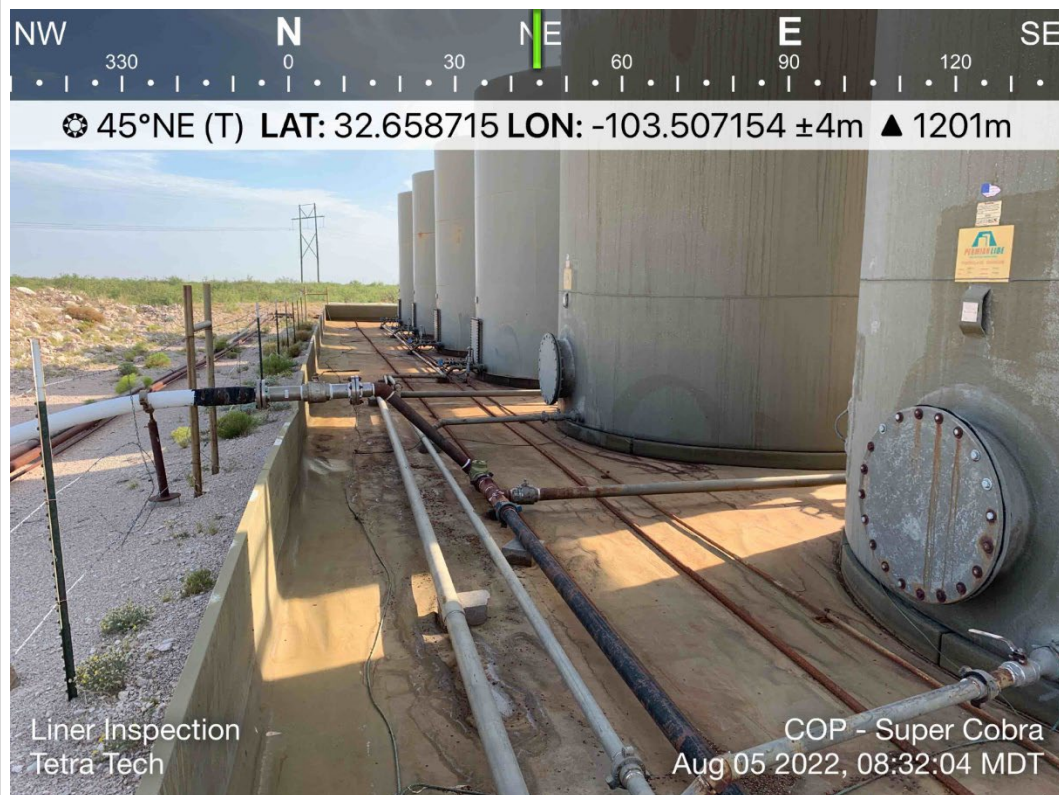
TETRA TECH, INC. PROJECT NO. 212C-MD-02810	DESCRIPTION	View inside the secondary containment of intact liner with no visual evidence of release remaining.	10
	SITE NAME	ConocoPhillips Super Cobra Battery Valve Release	8/05/2022
