Vertex Project #: 20E-00141-012

Spill Closure Report: Red Bull 31 State #001
Unit N, Section 31, Township 23 South, Range 35 East
County: Lea
API: 30-025-36798
Tracking Number: NOY1703843861

Prepared For: Devon Energy Production Company
6488 Seven Rivers Hwy
Artesia, New Mexico 88210

2020 Spill Assessment and Closure
August 2020

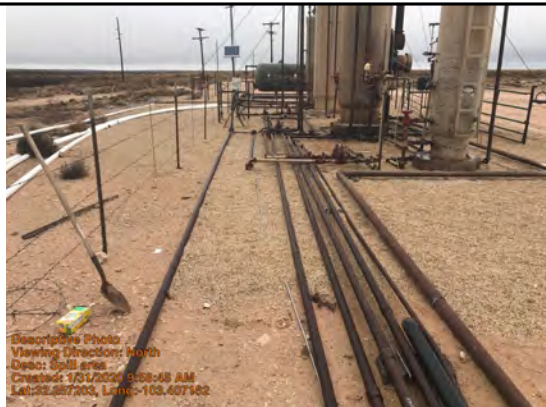
Viewing Direction: North

Spill area

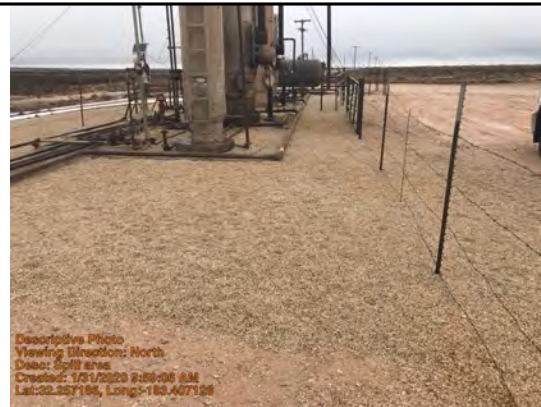
Viewing Direction: North

Spill area

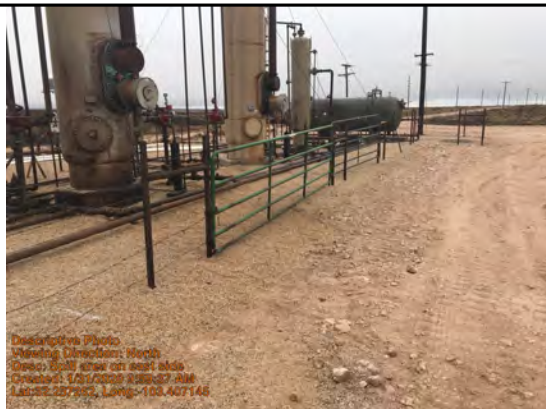
Viewing Direction: North

Spill area on east side

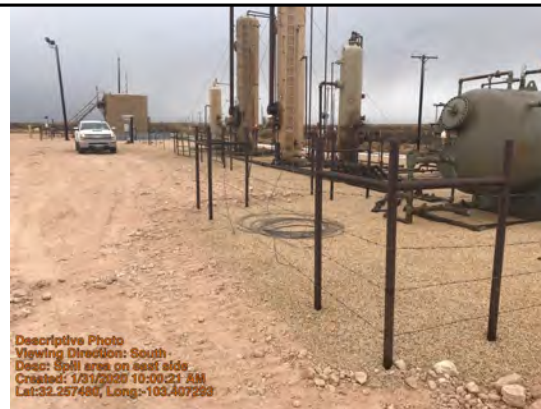
Viewing Direction: South

Spill area on east side

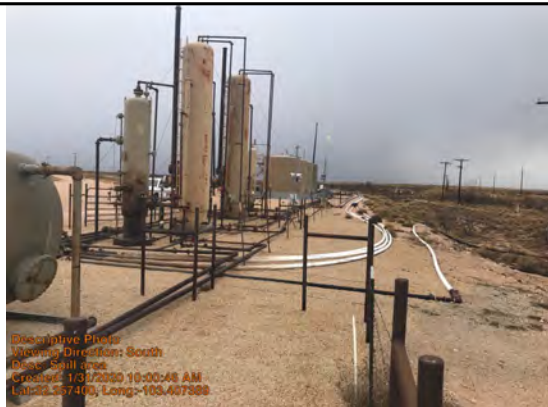
Viewing Direction: South

Spill area

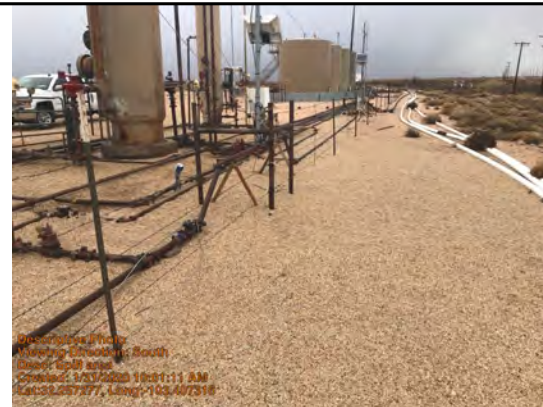
Viewing Direction: South

Spill area

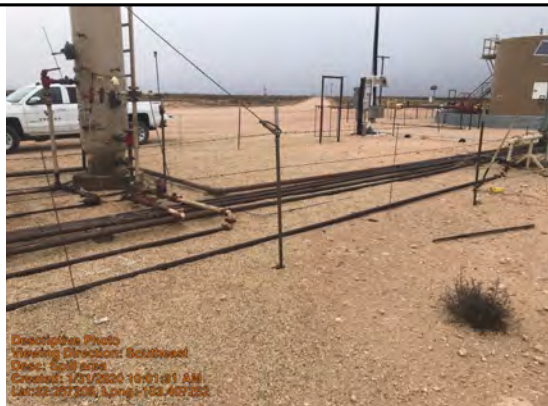
Viewing Direction: Southeast

Spill area

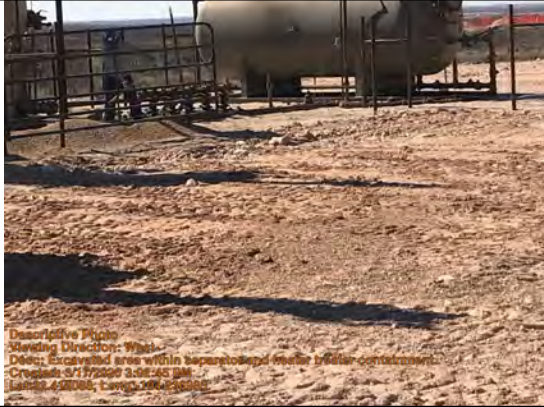
Viewing Direction: West

Excavated area within separator and heater treater containment.

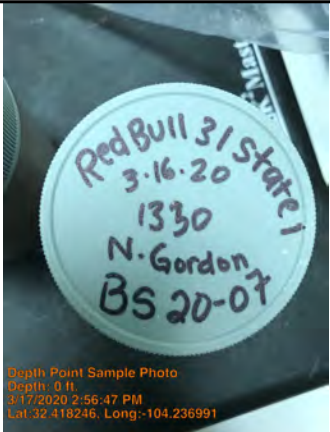
| Sample Point ID: ES-Base20-07 | |

The photo shows a white circular marker with handwritten text: 'Red Bull 31 State 1', '3-16-20', '1330', 'N. Gordon', and 'BS 20-07'. Below the photo, small orange text reads: 'Depth Point Sample Photo', 'Depth: 0 ft.', '3/17/2020 2:56:47 PM', and 'Lat: 32.418246, Long: -104.236991'.

12:37 No outside stains within excavation area. Soil has no odor
