Release Notification and Corrective Action

Name of Company: BOPCO, L.P. <i>260737</i>	Contact: Amy Ruth
Address: 522 W. Mermod, Suite 704 Carlsbad, N.M. 88220	Telephone No. 575-887-7329
Facility Name: James Ranch Unit #29 SWD Tank Battery	Facility Type: SWD

Initial response efforts, natural attenuation, and excavation of impacted soil have mitigated impacts at this Site. XTO requests no further action for RP Numbers 2RP-3082, 2RP-3302, 2RP-3726, and 2RP-4040. XTO backfilled the excavation with material purchased locally and recontoured the Site to match pre-existing site conditions. An updated NMOCD Form C-141 for each release event is included in Attachment 1.

JRU 29 SWD Tank Battery
Eddy County, New Mexico
Photographs Taken: July 2018 through March 2020

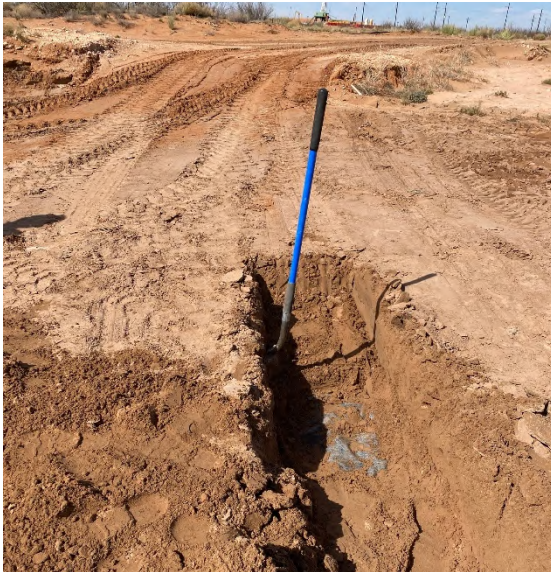
Photograph 5: North facing view of previously installed liner exposed.

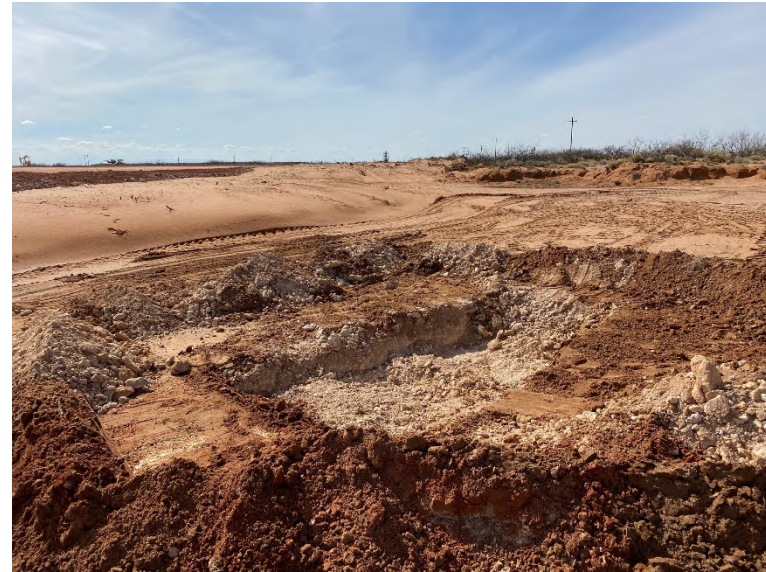
Photograph 6: West facing view of excavation area at SP-7.

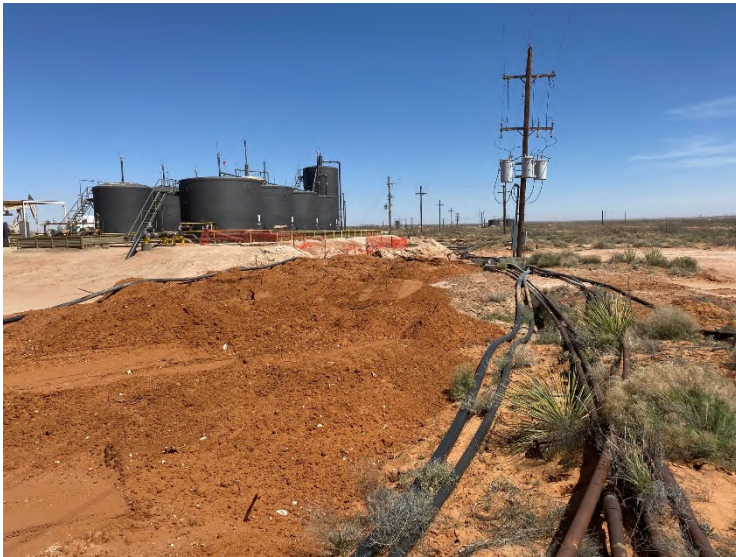
Photograph 7: East facing view during backfilling activities.

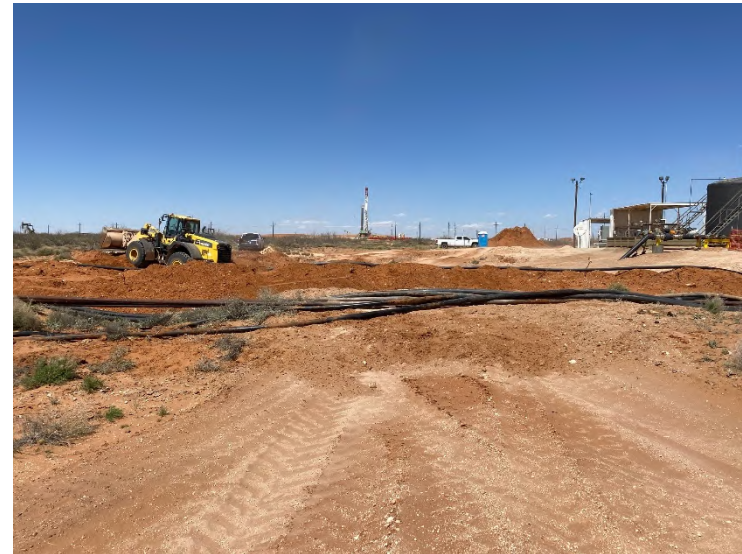
Photograph 8: North facing view during backfilling activities
