June 24, 2020

Vertex Project #: 20E-00141-051

**Spill Closure Report:** Arena Roja Federal Unit #016H  
Unit D, Section 27, Township 26 South, Range 35 East  
County: Lea  
API: 30-025-42672  
Tracking Number: NOY1722038403

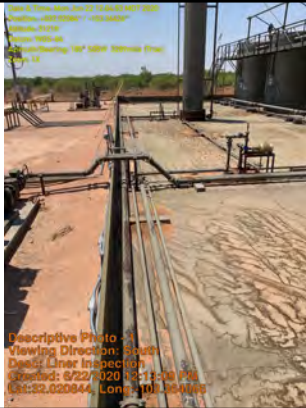
## Viewing Direction: South

**8:43** Liner has no visible tears, holes or punctures. No integrity deficiency identified.

Liner inspection

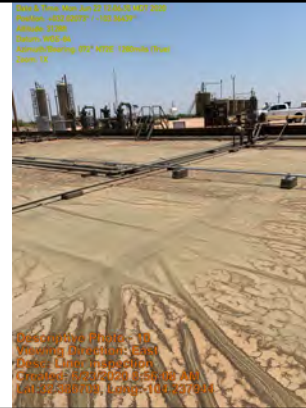
## Viewing Direction: East

Liner inspection

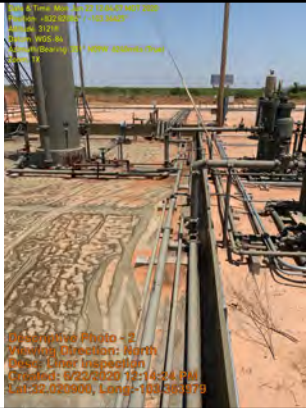
## Viewing Direction: North

Liner inspection

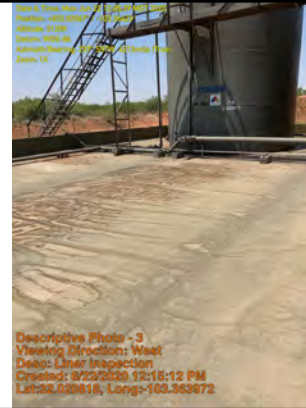
## Viewing Direction: West

Liner inspection

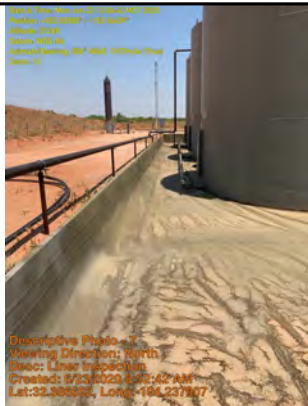
<p> <small> Date &amp; Time: Mon, Aug 23 12:45:43 PM 2020  Position: -402.851407° / -104.237628°  Altitude: 3114ft  Camera: WGS-84  Azimuth/Bearing: 69° N/W 510degaz True  Zoom: 1X </small> </p> <p> <b>Descriptive Photo - 7</b>  Viewing Direction: North  Desc: Liner Inspection  Created: 8/23/2020 8:45:42 AM  Lat:32.386693, Long:-104.237607 </p> <p>Liner inspection</p>

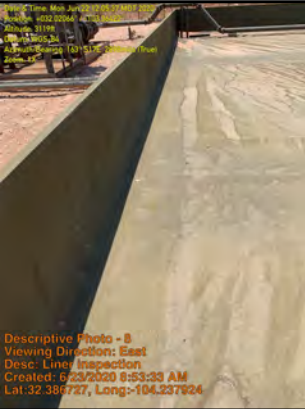
<p>Photo - 8 Viewing Direction: East Desc: Liner Inspection Created: 6/23/2020 8:53:33 AM Lat:32.386727, Long:-104.237924</p>

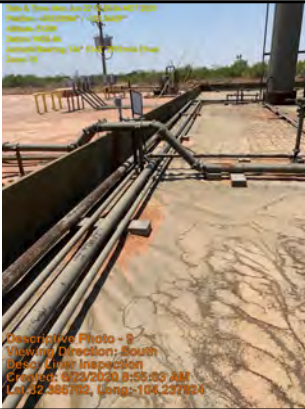
<p>Photo - 8 Viewing Direction: South Desc: Liner Inspection Created: 6/23/2020 8:55:33 AM Lat:32.386792, Long:-104.237924</p>
Liner inspection	Liner inspection
