Release Notification

Site Name: Eagle 35 L Fed 23	Site Type: Oil Well Location
Date Release Discovered: 08-13-2014	API# 30-015-41441

Closure

SITE PHOTOS

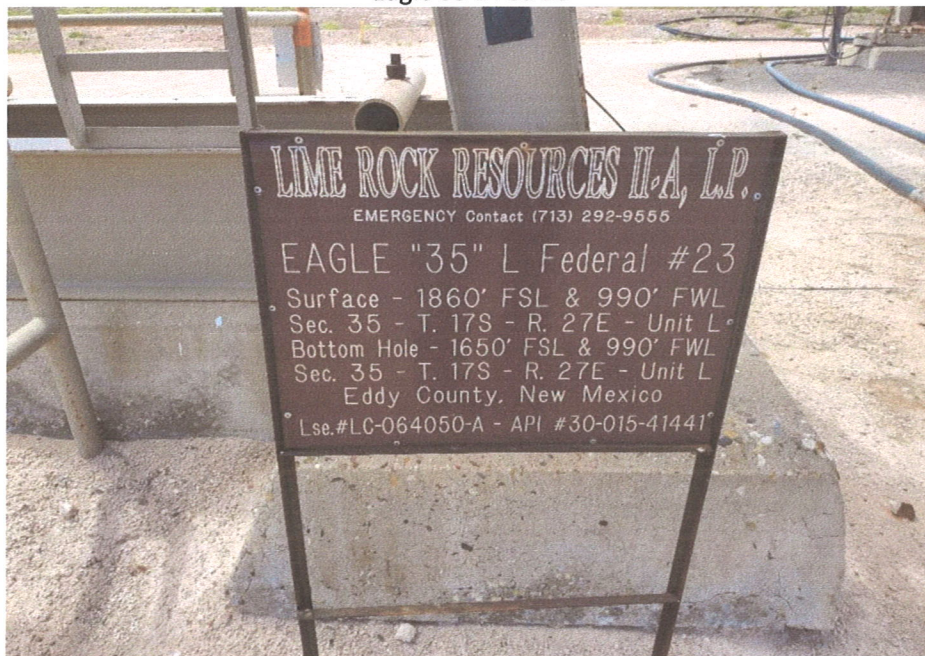
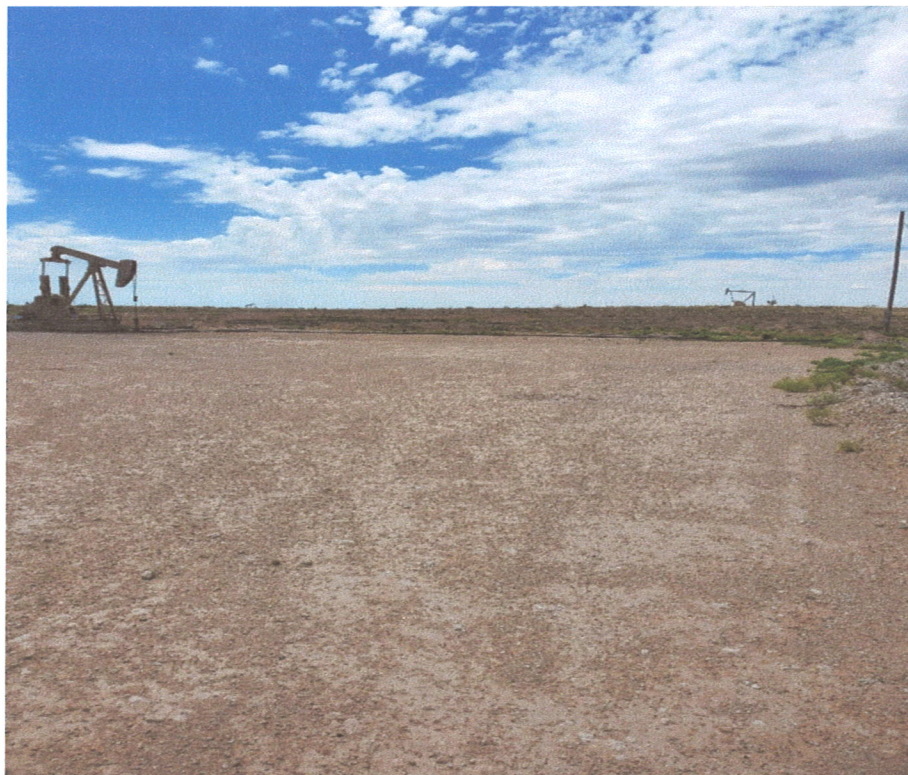
While completing a well, Lime Rock personnel discovered a frac tank containing hydrochloric acid to be leaking. 40 bbls were lost and 5 bbls were recovered with a vac truck. The impacted area was subsequently neutralized with soda ash.

On May 27, 2020, Talon/LPE personnel sampled the impacted area for pH. The sample locations are illustrated on the attached site plan along with the complete laboratory report. As shown, all (6) samples tested between 7.75-8.00 pH units.
