**Re: First Quarter 2022 – SVE System Update**

Lambe #2C  
San Juan County, New Mexico  
Hilcorp Energy Company  
NMOCD Incident Number: NVF1836050592  
Ensolum Project No. 07A1988008

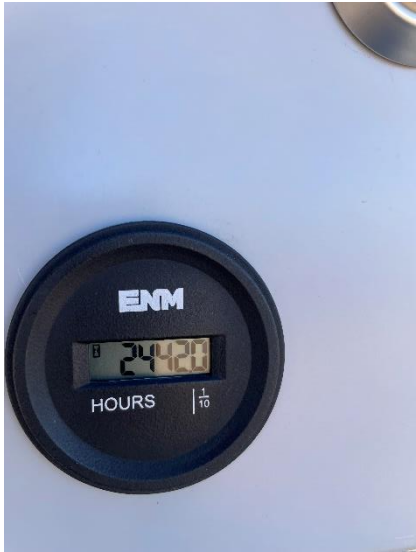
<p><b>Photograph 1</b></p> <p>Runtime meter taken on January 7, 2022</p>

During the first quarter of 2022, WSP USA Inc. (WSP, third-party environmental consultant for the Site) and Hilcorp personnel performed bi-weekly operation and maintenance (O&M) visits to ensure the system was operating as designed and to perform any required maintenance. Field notes taken during O&M visits are presented in Appendix A. During the first quarter of 2022, SVE well MW01 was operated in order to induce flow in impacted soil zone. Between January 7 and March 15, 2022, the SVE system operated for 1,444.9 hours for a runtime efficiency of 90 percent (%). Based on runtime hours collected during monthly O&M visits, it appears that the system performed at a runtime efficiency greater than 97% between January 7 and March 3, 2022. Between March 3 and March 9, 2022, power outages at the Site caused extensive downtime that reduced the quarterly runtime efficiency to 90%. Appendix B

presents photographs of the runtime meter taken during the first and last field visits of the quarter. Table 1 presents the SVE system operational hours and percent runtime.

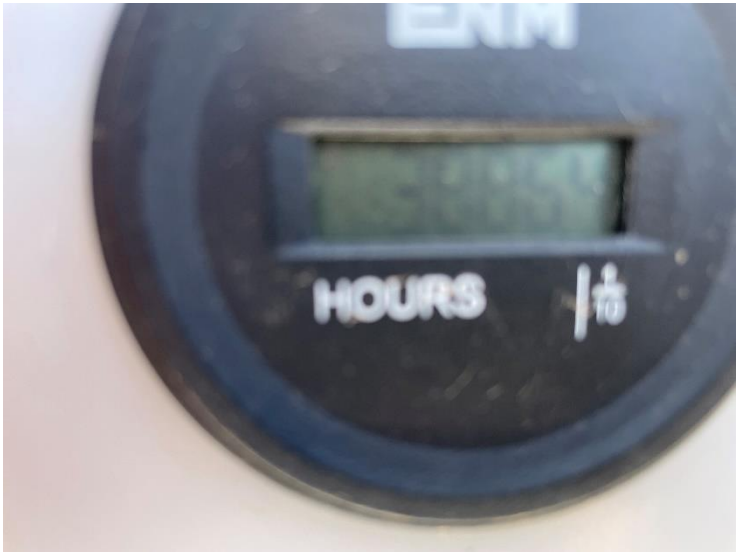
<p><b>Photograph 2</b></p> <p>Runtime meter taken on March 15, 2022</p>
