CLOSURE REPORT

Corral Fly 35-26 Fed Com 23H

**Eddy County, New Mexico
32.16496 N, 103.95897 W
NMOCD Incident ID: NMAP1825436823
RP No.: 2RP-4961
API No.: 30-015-44704**

July 13, 2022
Ensolum Project No. 03B1417033

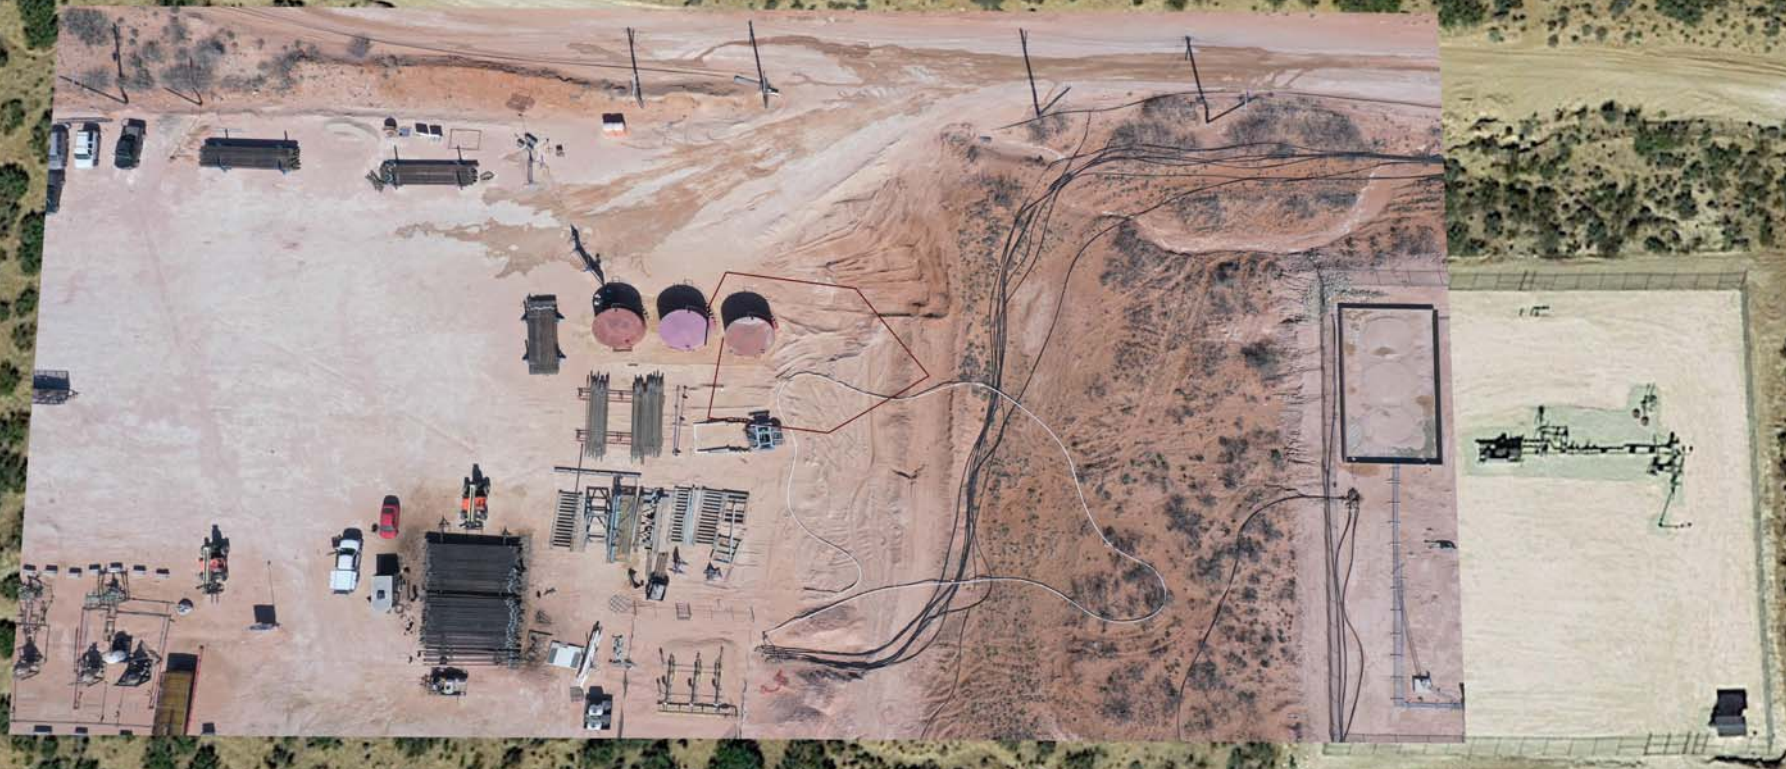
Aerial drone picture taken 2/12/19 to verify leak is on a new location that does not exist in the current Google Earth Image

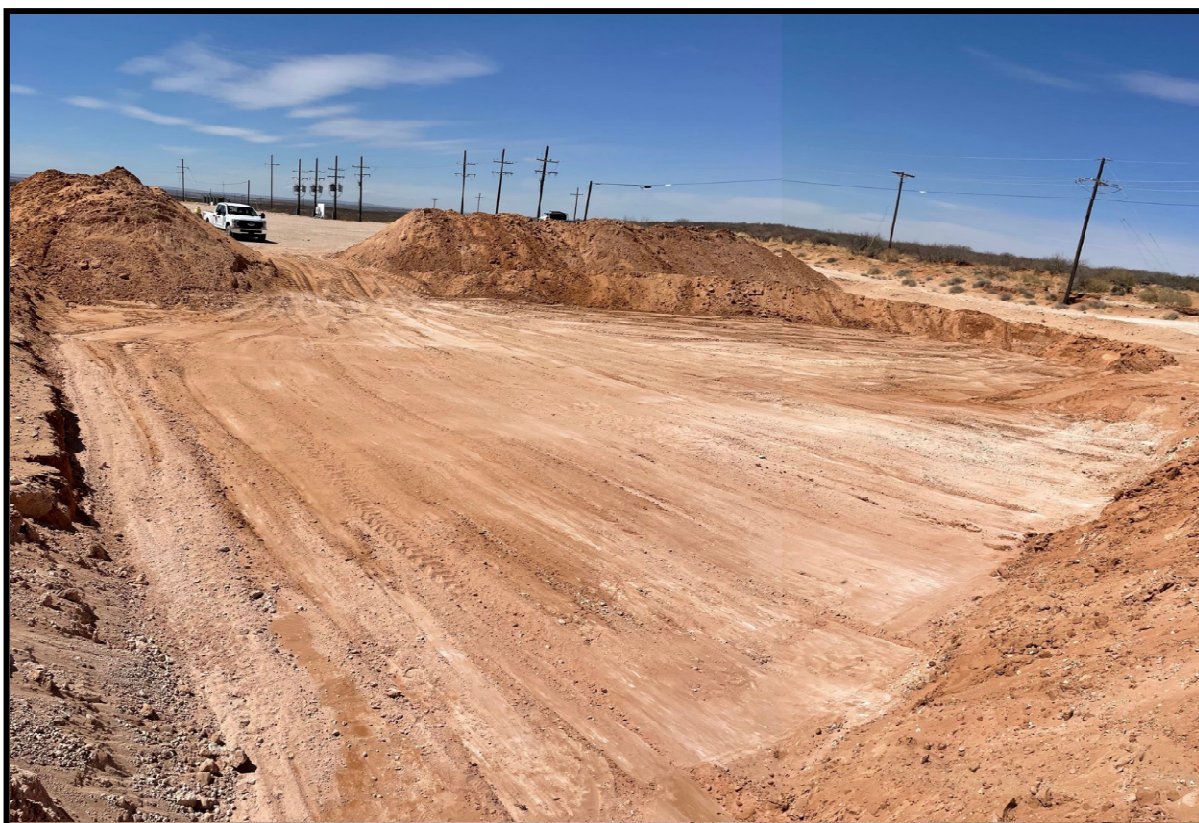
View of the initial excavation area (March 31, 2022), facing north.

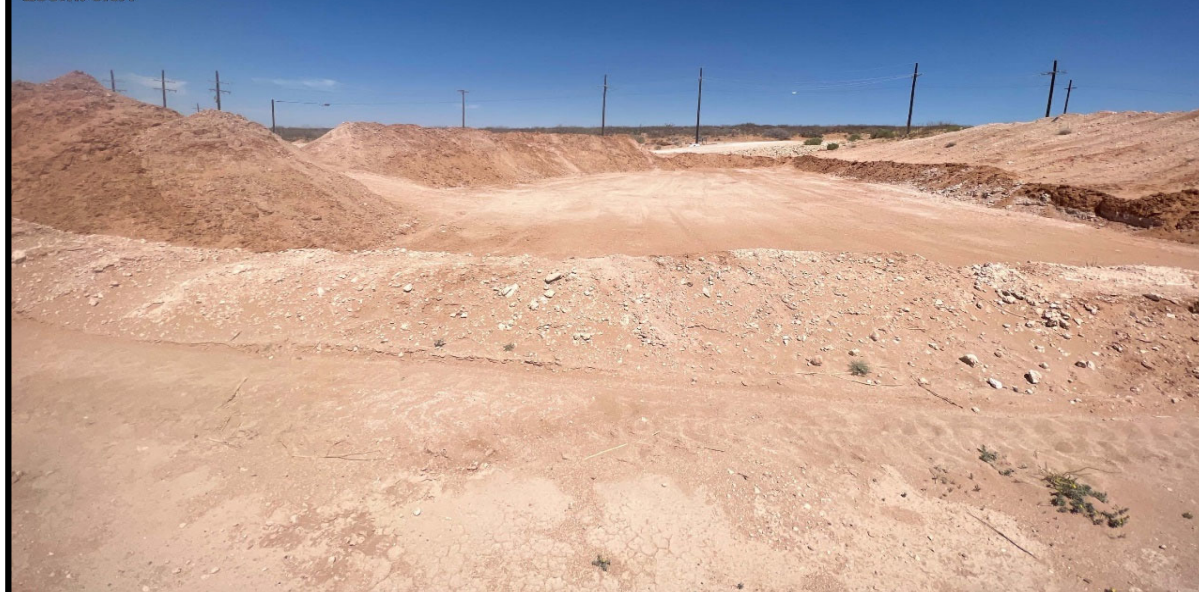
View of the excavation area during initial confirmation sampling (April 5, 2022), facing north.

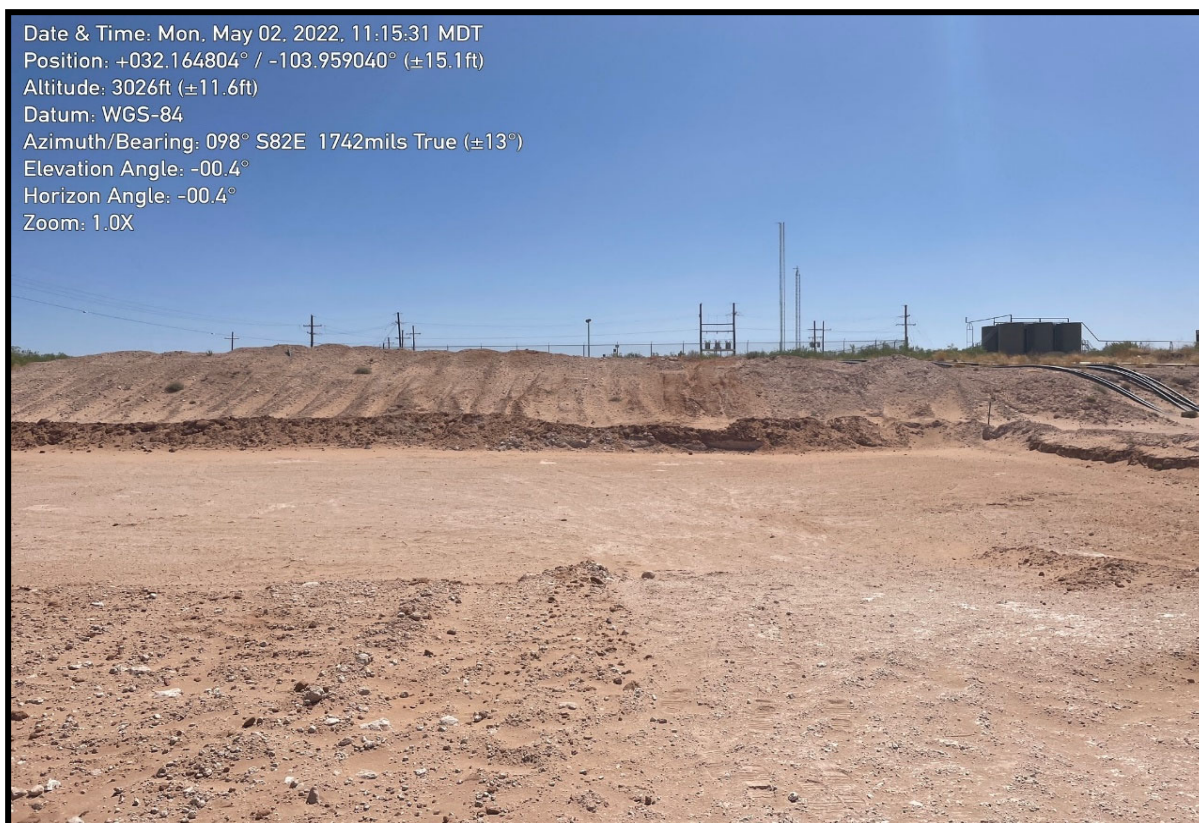
View of the excavation area (May 2, 2022), facing southeast.

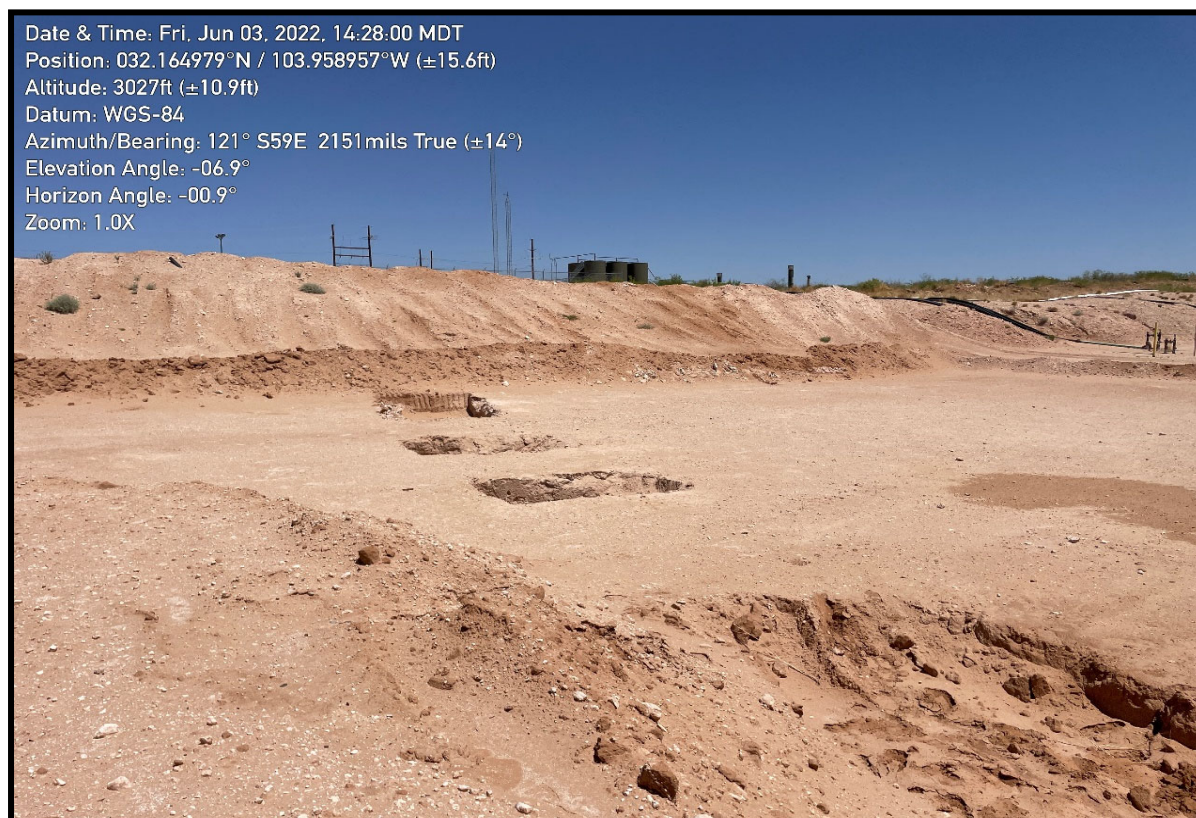
View of the excavation area during final confirmation sampling (June 3, 2022), facing southeast.
