Closure Report

Tenneco SWD #1
Lea County, New Mexico
API # 30-025-25762
nAPP2222440612

EOG Resources Inc.
104 S. 4th Street
Artesia, NM 88210

Talon/LPE
408 W. Texas Avenue
Artesia, New Mexico 88210

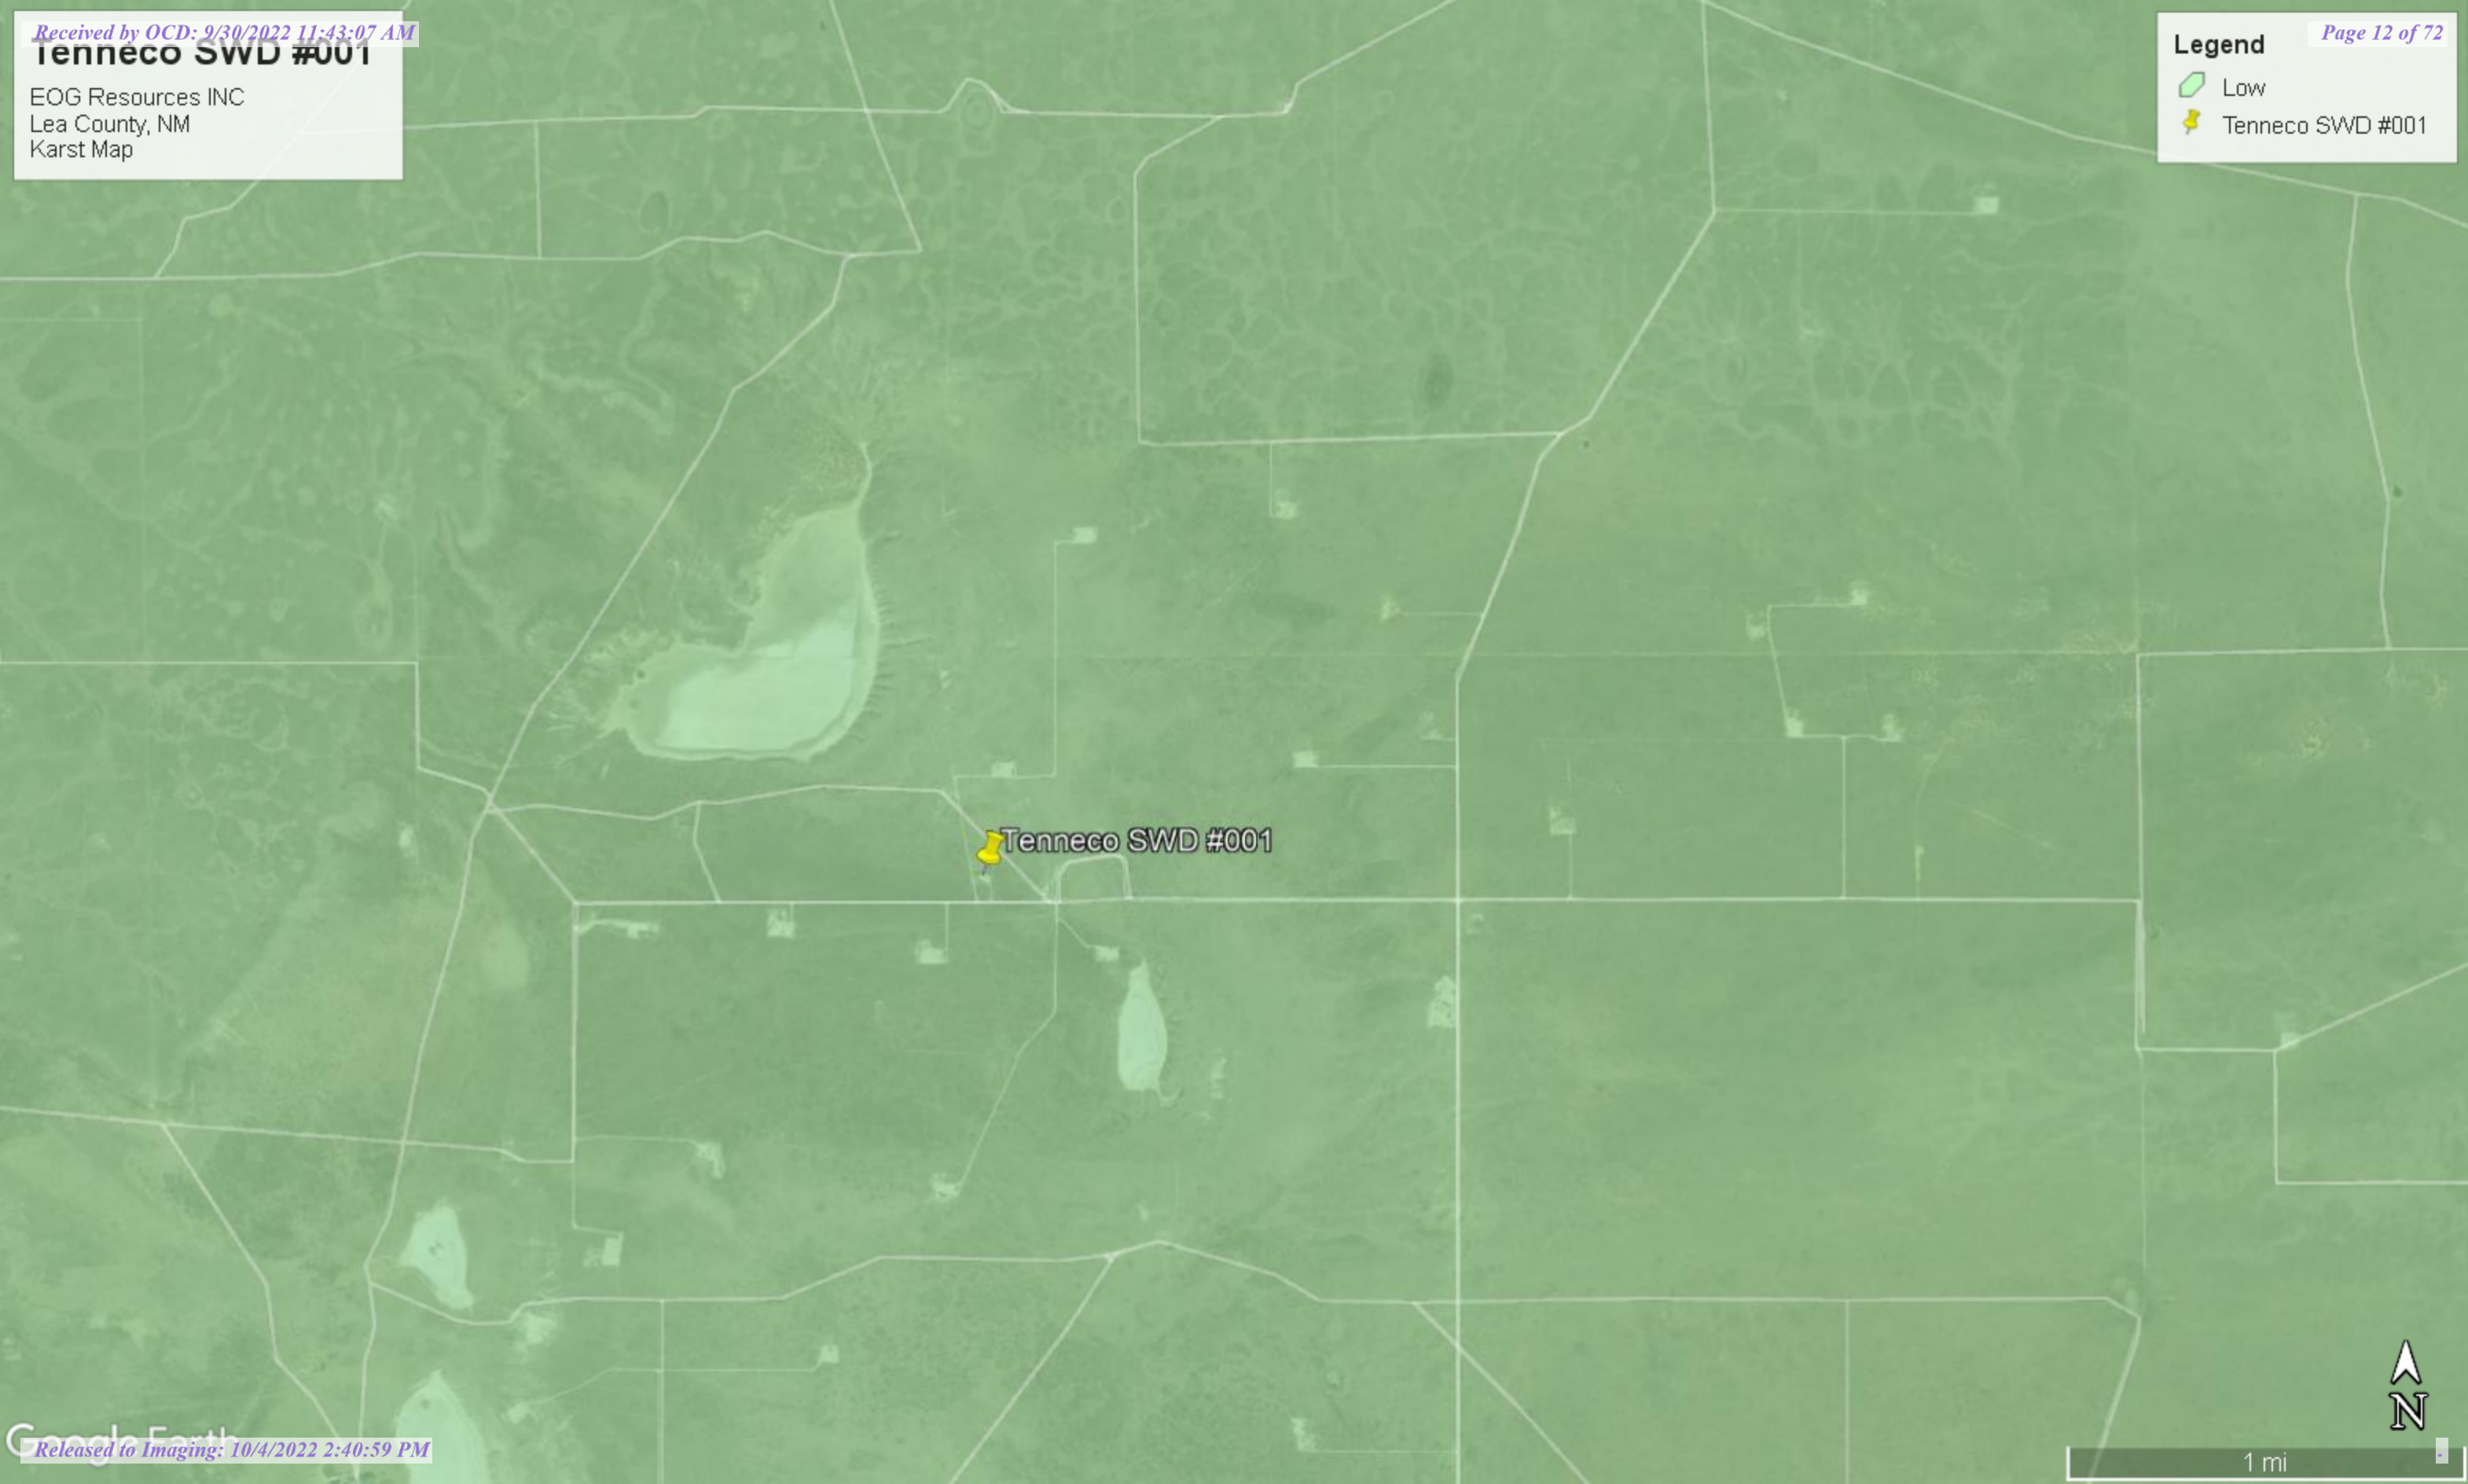
EOG Resources INC
Lea County, NM
Karst Map

The New Mexico Office of the State Engineer Database indicates the nearest reported depth to groundwater is 24 feet below ground surface (bgs). See [Appendix II](#) for the referenced groundwater depth. Further research of the Bureau of Land Management Karst data indicates that this site is not situated within a Karst area.

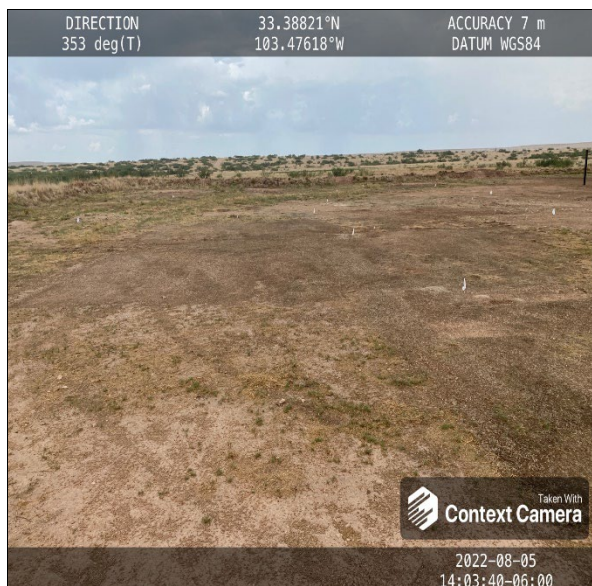
Photograph No.2 Description:

Impacted Area flagged for sample positions.

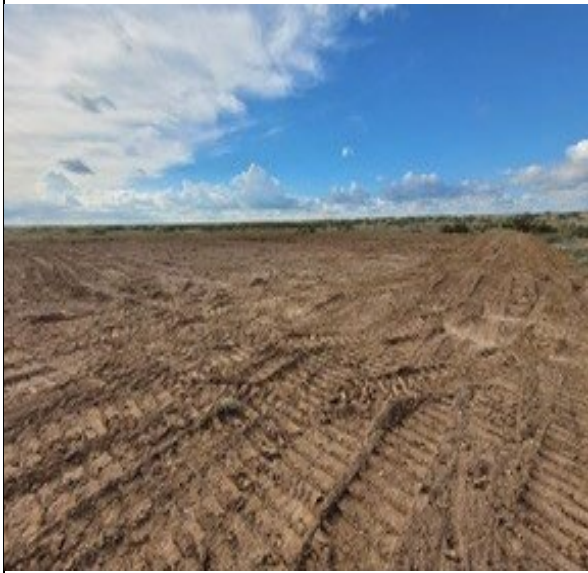
Photograph No.5 Description:

Backfill of excavation.

- The impacted area was excavated from depths of 4 feet to 5 feet bgs, and to the horizontal extent that all surface staining and hydrocarbon odors were removed. Laboratory analysis confirms that NMOCD closure criteria has been met.
- Background samples at S-5, S-6, and S-8 as well as sidewall samples were obtained in order to confirm horizontal remediation had been achieved.
- The top 4 feet bgs has been reclaimed in accordance with NMOCD 19.15.29.13(D)(1) NMAC.
- All contaminated soil was transported to Gandy Marley, LLC, a NMOCD approved solid waste disposal facility.
- The excavated area was backfilled with clean caliche to 2 feet bgs, followed with a 2 foot cap of clean topsoil-sand native to the area, and reseeded in accordance with NMSLO guidelines.

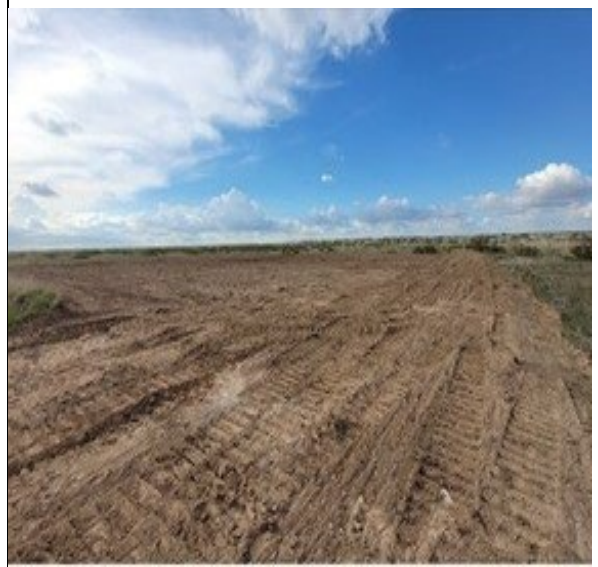
Photograph No.6 Description:

Location terraced, and seeded.
