Re: Site Remediation and Closure Report
Onyx PWU 29 #3H
API No. 30-015-39373
GPS: Latitude 32.630019 Longitude -104.104116
UL "L", Sec. 29, T19S, R29E
Eddy County, NM
NMOCD Ref. No. NAB1601137117 (2RP-3481)

Pima Environmental Services, LLC (Pima) has been contracted by Devon Energy Production Company (Devon) to perform a spill assessment and remediation activities for an oil release that occurred at the Onyx PWU 29 #3H (Onyx). The initial C-141 was submitted on January 5th, 2016 (Appendix C). This incident was assigned Incident ID NAB1601137117 (2RP-3481), by the New Mexico Oil Conservation Division (NMOCD).

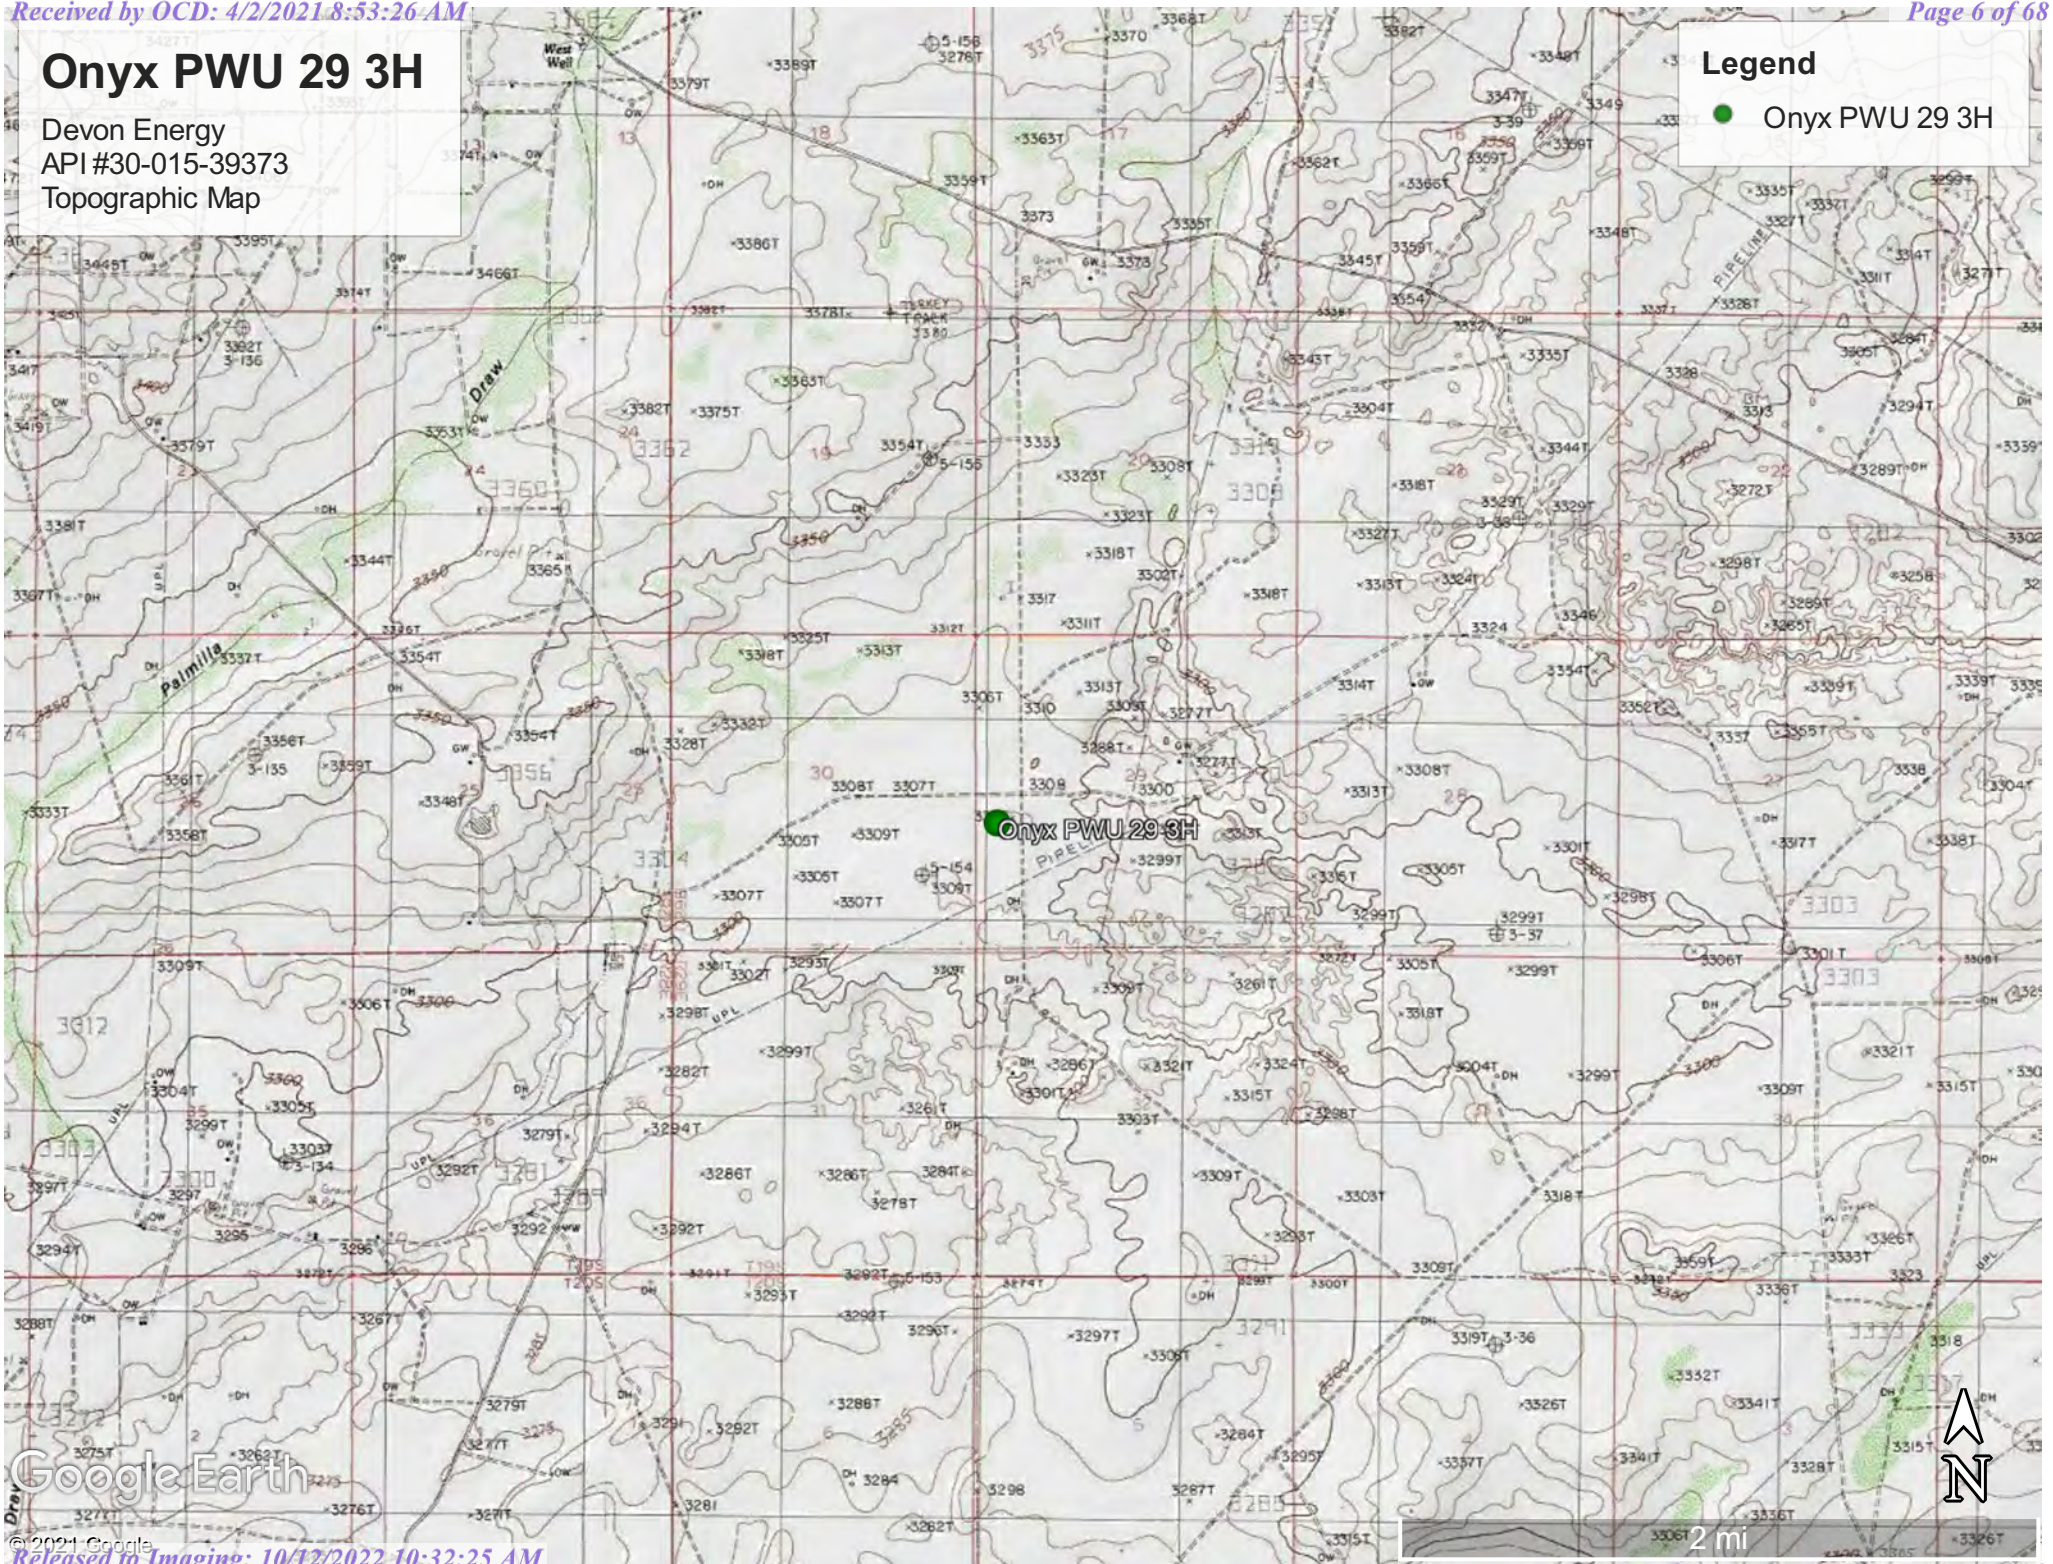
Devon Energy
API #30-015-39373
Topographic Map

Reference Figure 2 for a TOPO Map.

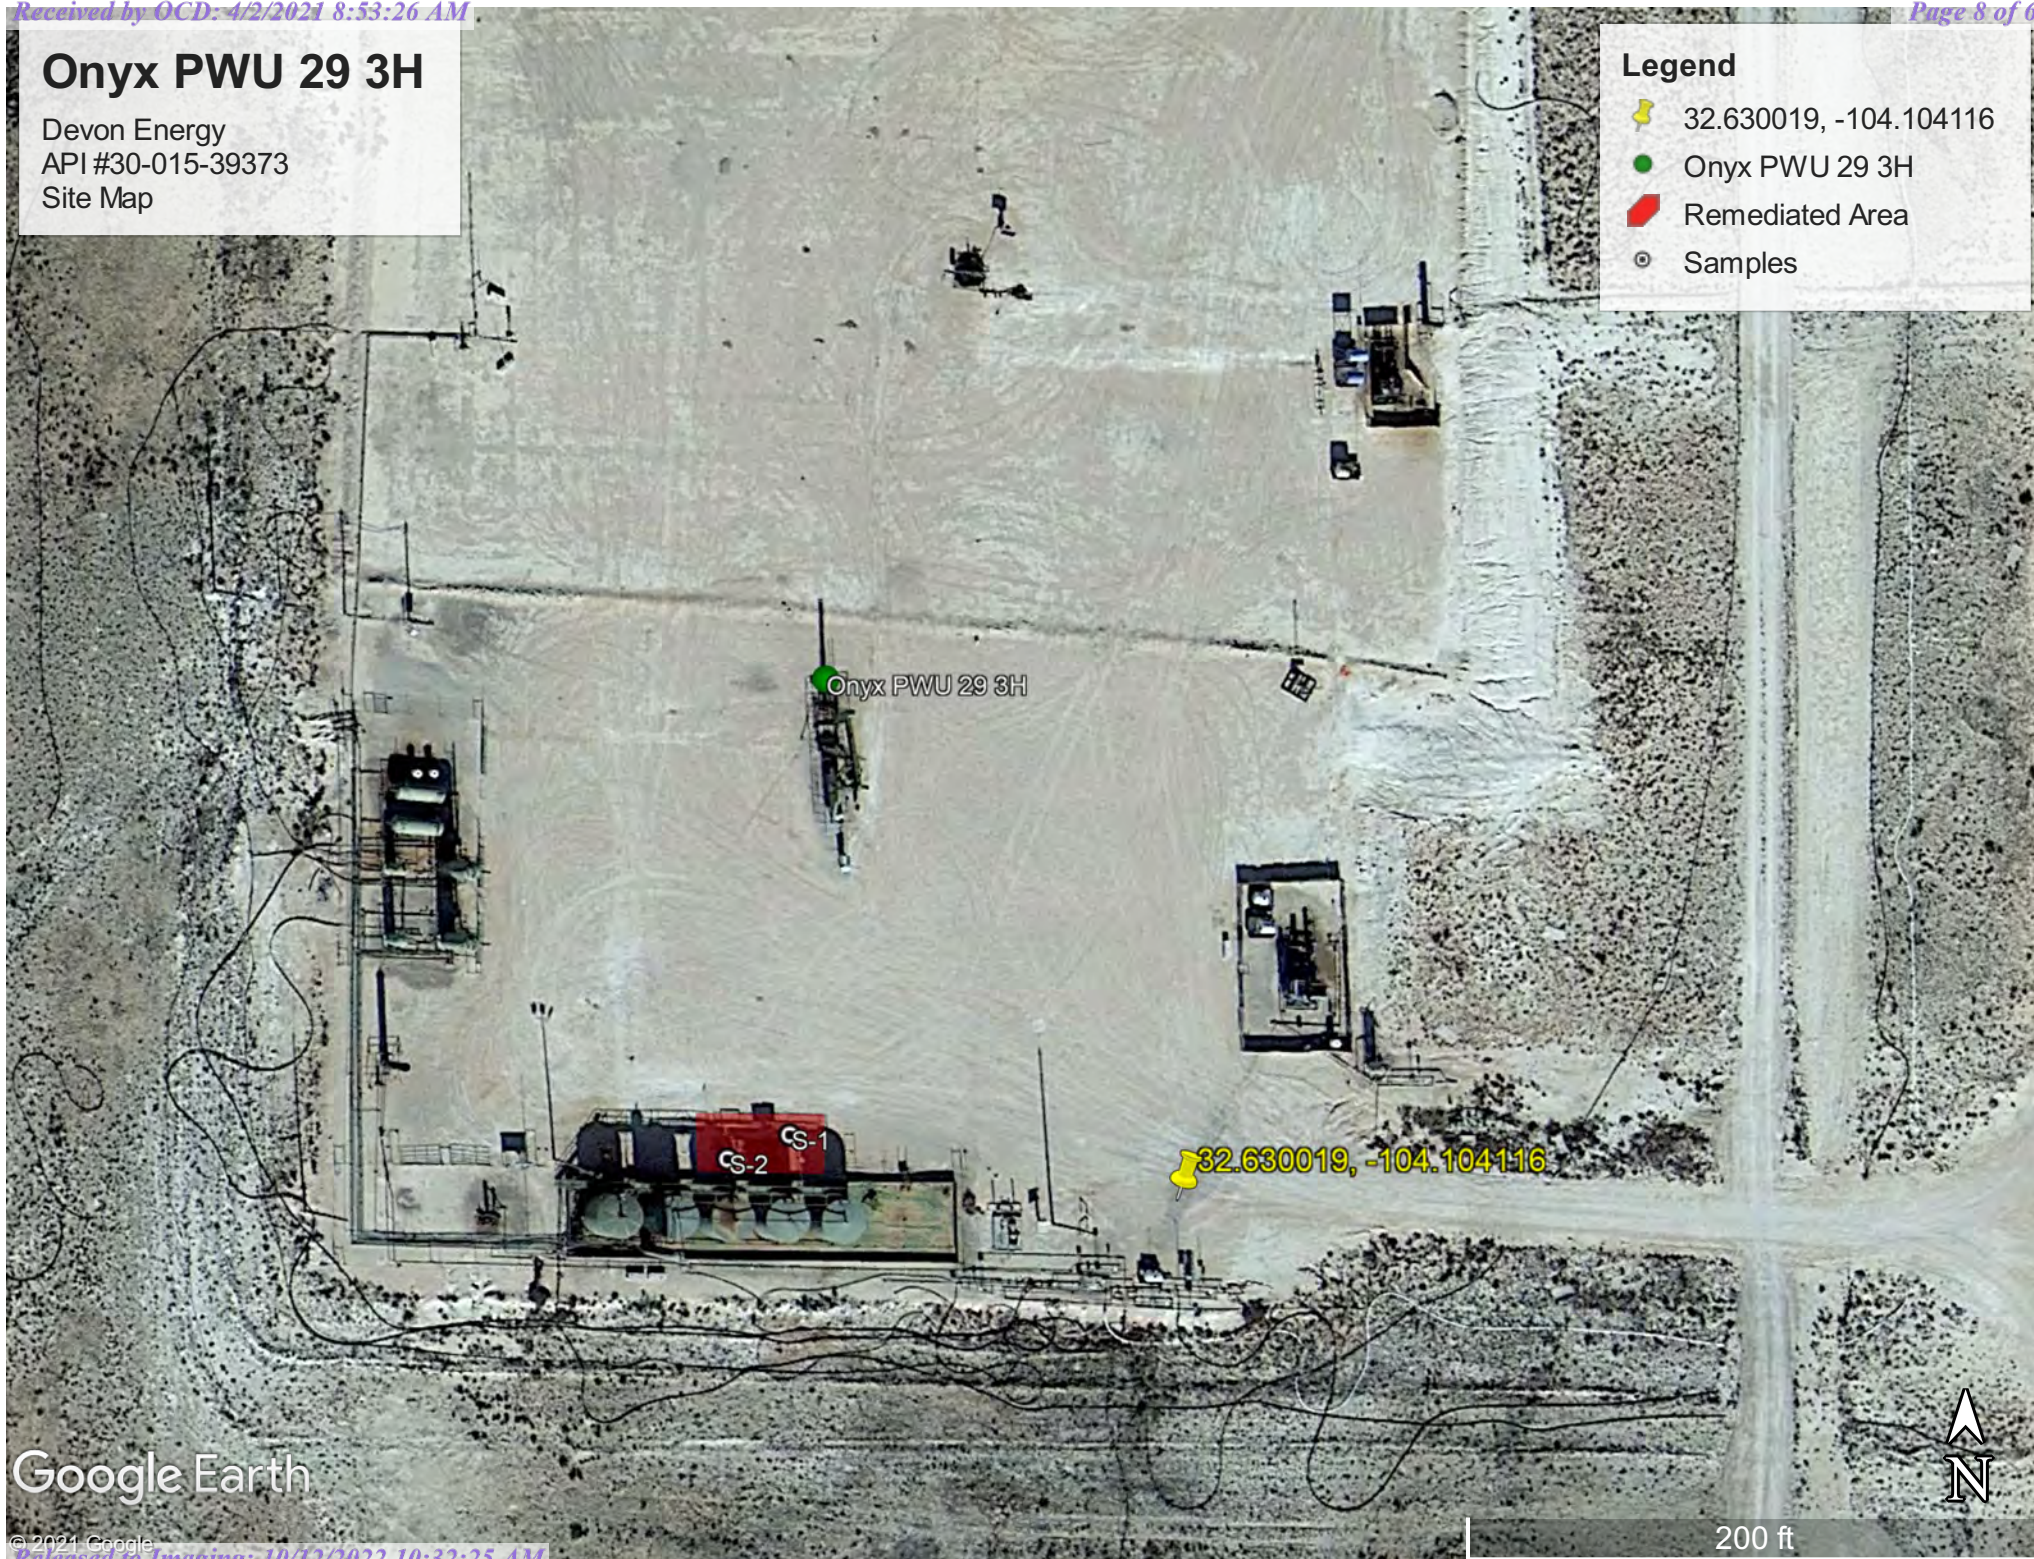
Devon Energy
API #30-015-39373
Site Map

On August 20th, 2020, Pima mobilized personnel and equipment to conduct remedial activities. We treated the areas around the LACT unit with a Micro-Blaze solution. After 60 days, we gathered confirmation samples. These samples were collected on March 10th, 2021. See Appendix D for photographic documentation. The laboratory results of this sampling event can be found in the following data table.

Based on the sample results, the bottom and sidewalls were below NMOCD Closure Criteria 19.15.29 NMAC.

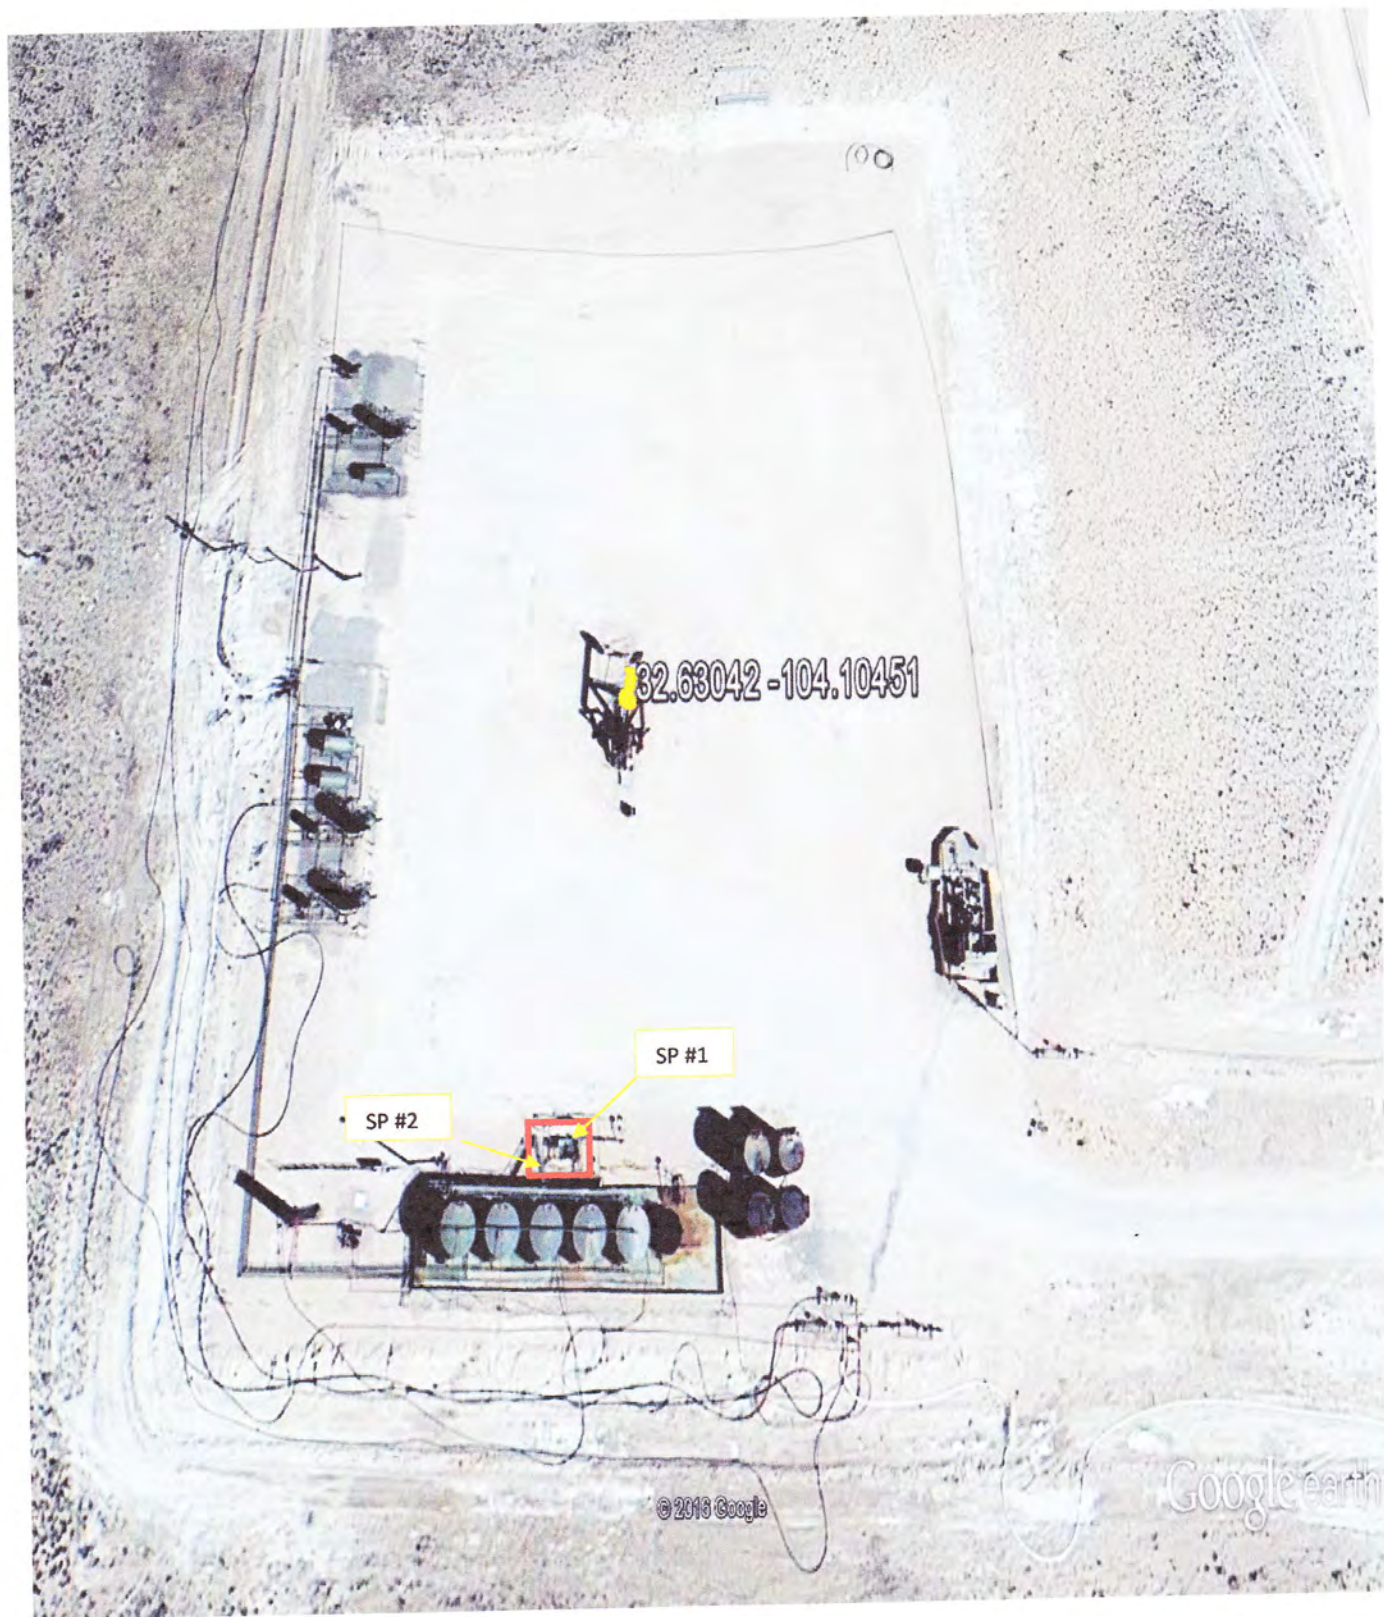
Devon Energy Production Company-Onyx PWU 29 Fed #3H

This release was due to a leak on the LACT unit. All fluids released remained on the caliche pad, nothing off the pad was impacted. The impacted area is approximately 25' x 35'.

Impacted area is 25' x 35' around LACT Unit-noted by red .

I propose to conduct the remediation by using the in-situ method. Hand tools will be used to prepare the impacted soil. Once the soil has been prepared, a solution of a 10% mixture of MicroBlaze will be liberally applied to the impacted area. Loosening of the soil will allow a complete penetration of the MicroBlaze thereby speeding the process of the hydrocarbon remediation.
