**RE: Closure Request  
Arco 5 Fed # 1  
Incident Number nAPP2213330681  
Eddy County, New Mexico**

WSP USA Inc. (WSP) on behalf of Frontier Field Services, LLC (Frontier), presents the following Closure Request detailing the site assessment, excavation, and soil sampling activities performed at the Arco 5 Fed # 1 (32.78145, -103.90131) (Site) in Unit A, Section 6, Township 18 South, Range 31 East, in Eddy County, New Mexico (Figure 1). This Site resides on federal land which is managed by the Bureau of Land Management (BLM). The purpose of this site assessment, excavation and soil sampling was to address impacts to soil following the release of natural gas from an internally and externally corroded pipeline at the Site. Based on the excavation activities and soil sample laboratory analytical results, Frontier is submitting this Closure Request, describing remediation that has occurred and requesting no further action (NFA) for Incident Number nAPP2213330681.

**FIGURE 1B**  
**FEMA FLOODPLAIN MAP**  
**MAL 12-27-2 ARCO 5 FED #1**  
**UNIT A SEC 6 T18S R31E**  
**EDDY COUNTY, NEW MEXICO**  
**FRONTIER FIELD SERVICES, LLC**

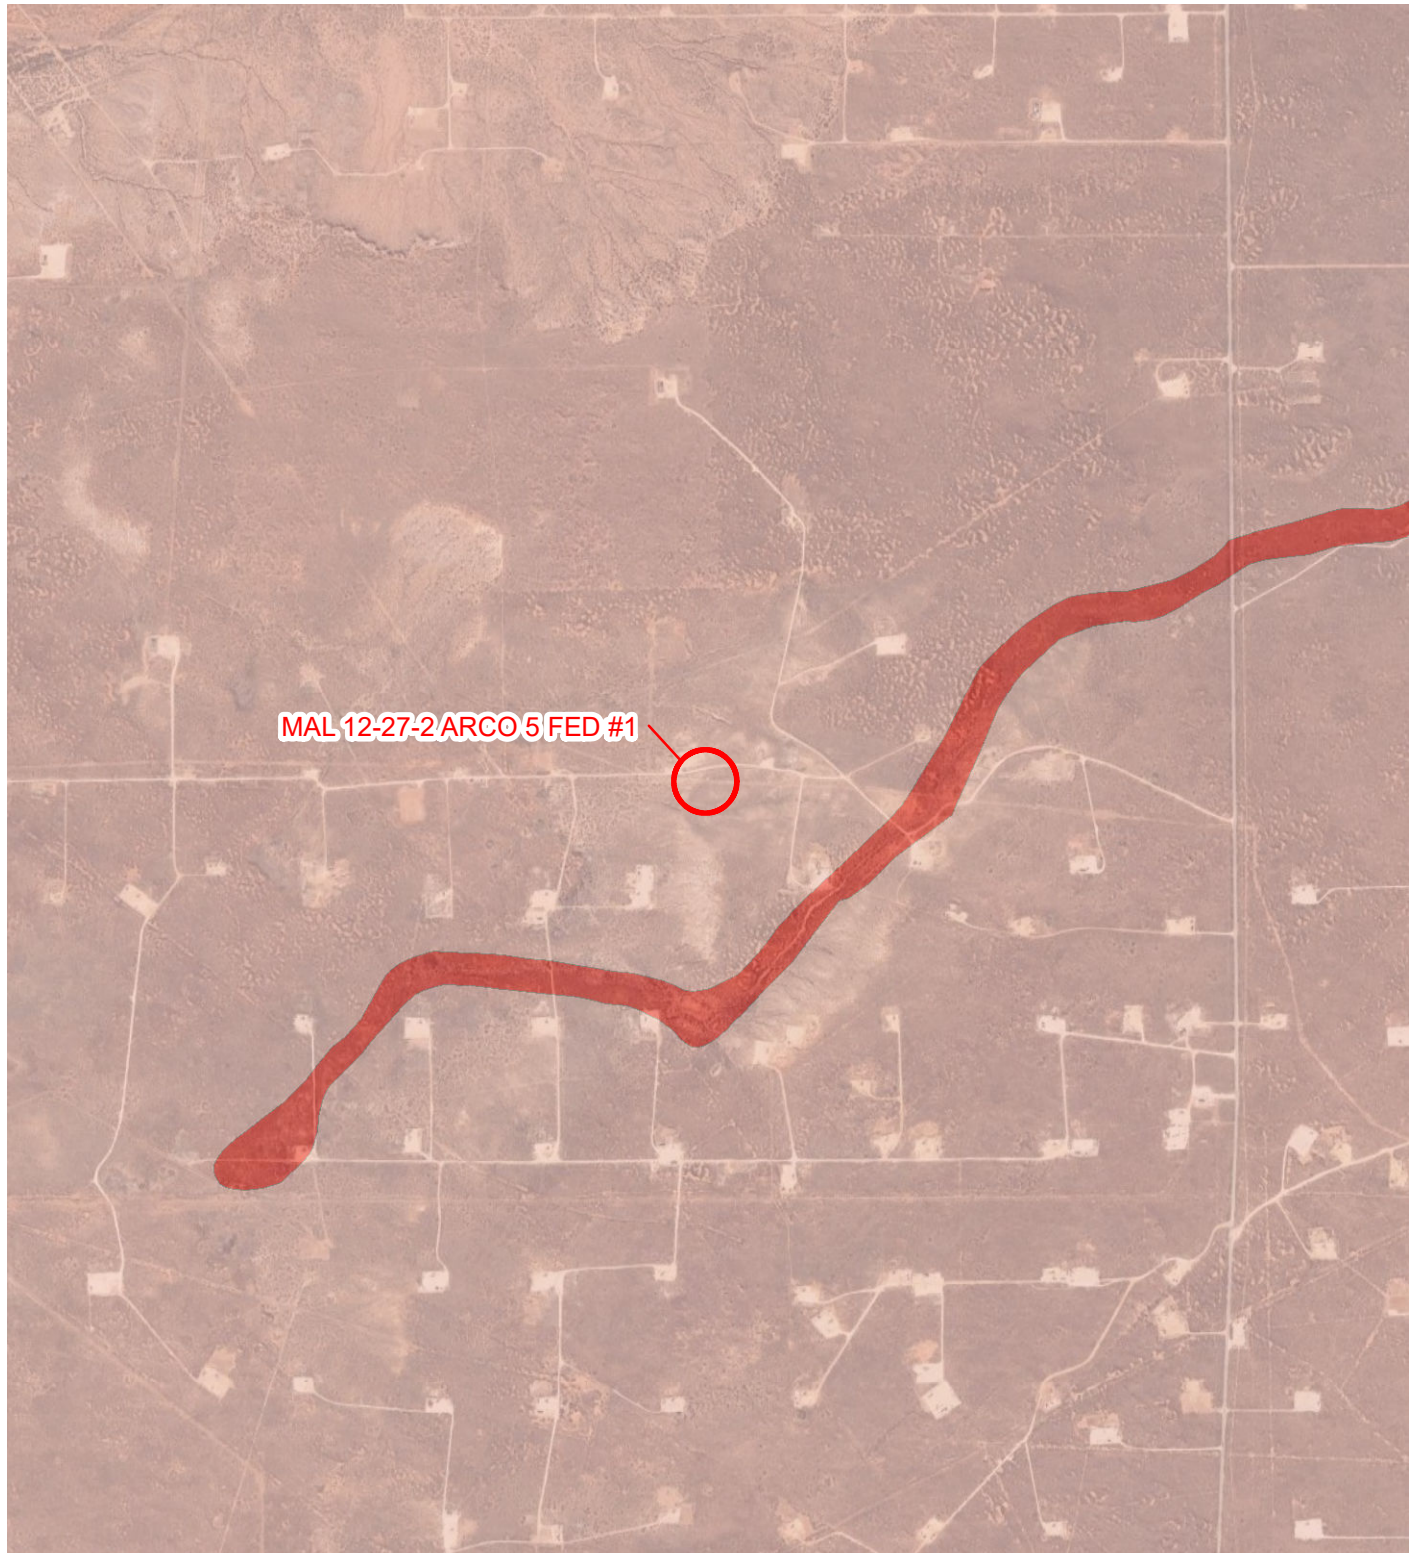
**FEMA NATIONAL FLOOD HAZARD (NFHL)**

100-YEAR FLOODPLAIN

AREA OF MINIMAL FLOOD HAZARD

The closest continuously flowing or significant watercourse to the site is an intermittent riverine, located approximately 1,660 feet northwest of the site. The site is greater than 200 feet from a lakebed, sinkhole, or playa lake and greater than 300 feet from an occupied residence, school, hospital, institution, church, or wetland (Figure 1C). The site is greater than 1,000 feet away from a freshwater well or spring and is not within a 100-year floodplain or overlying a subsurface mine (Figure 1B). The site is likely not underlain by unstable geology (low potential karst designation area). Site receptors are identified on Figure 1A.

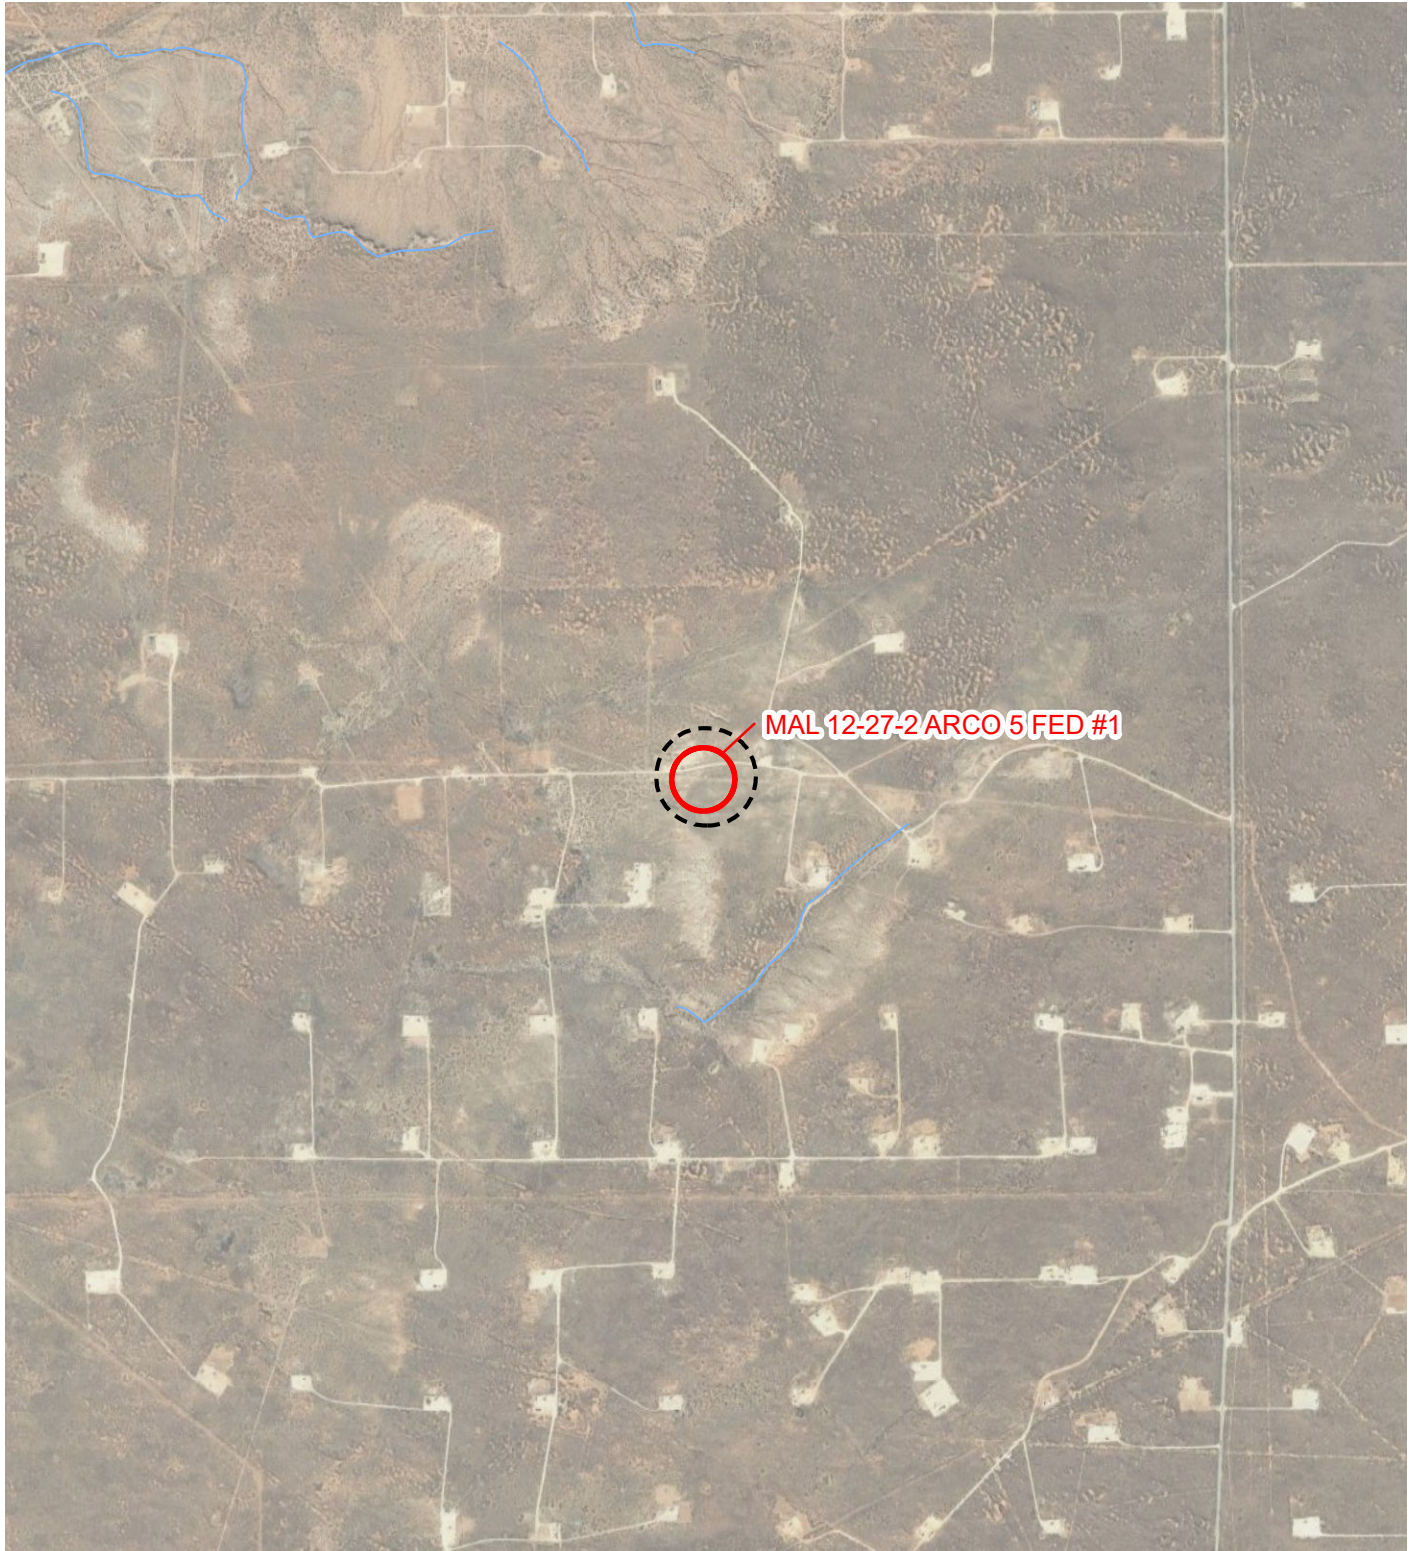
**FIGURE 1C**  
**NWI WETLANDS MAP**  
**MAL 12-27-2 ARCO 5 FED #1**  
**UNIT A SEC 6 T18S R31E**  
**EDDY COUNTY, NEW MEXICO**  
**FRONTIER FIELD SERVICES, LLC**

-   SITE LOCATION
- NATIONAL WETLANDS INVENTORY (NWI)**
-   RIVERINE
-   500-FOOT RELEASE BUFFER

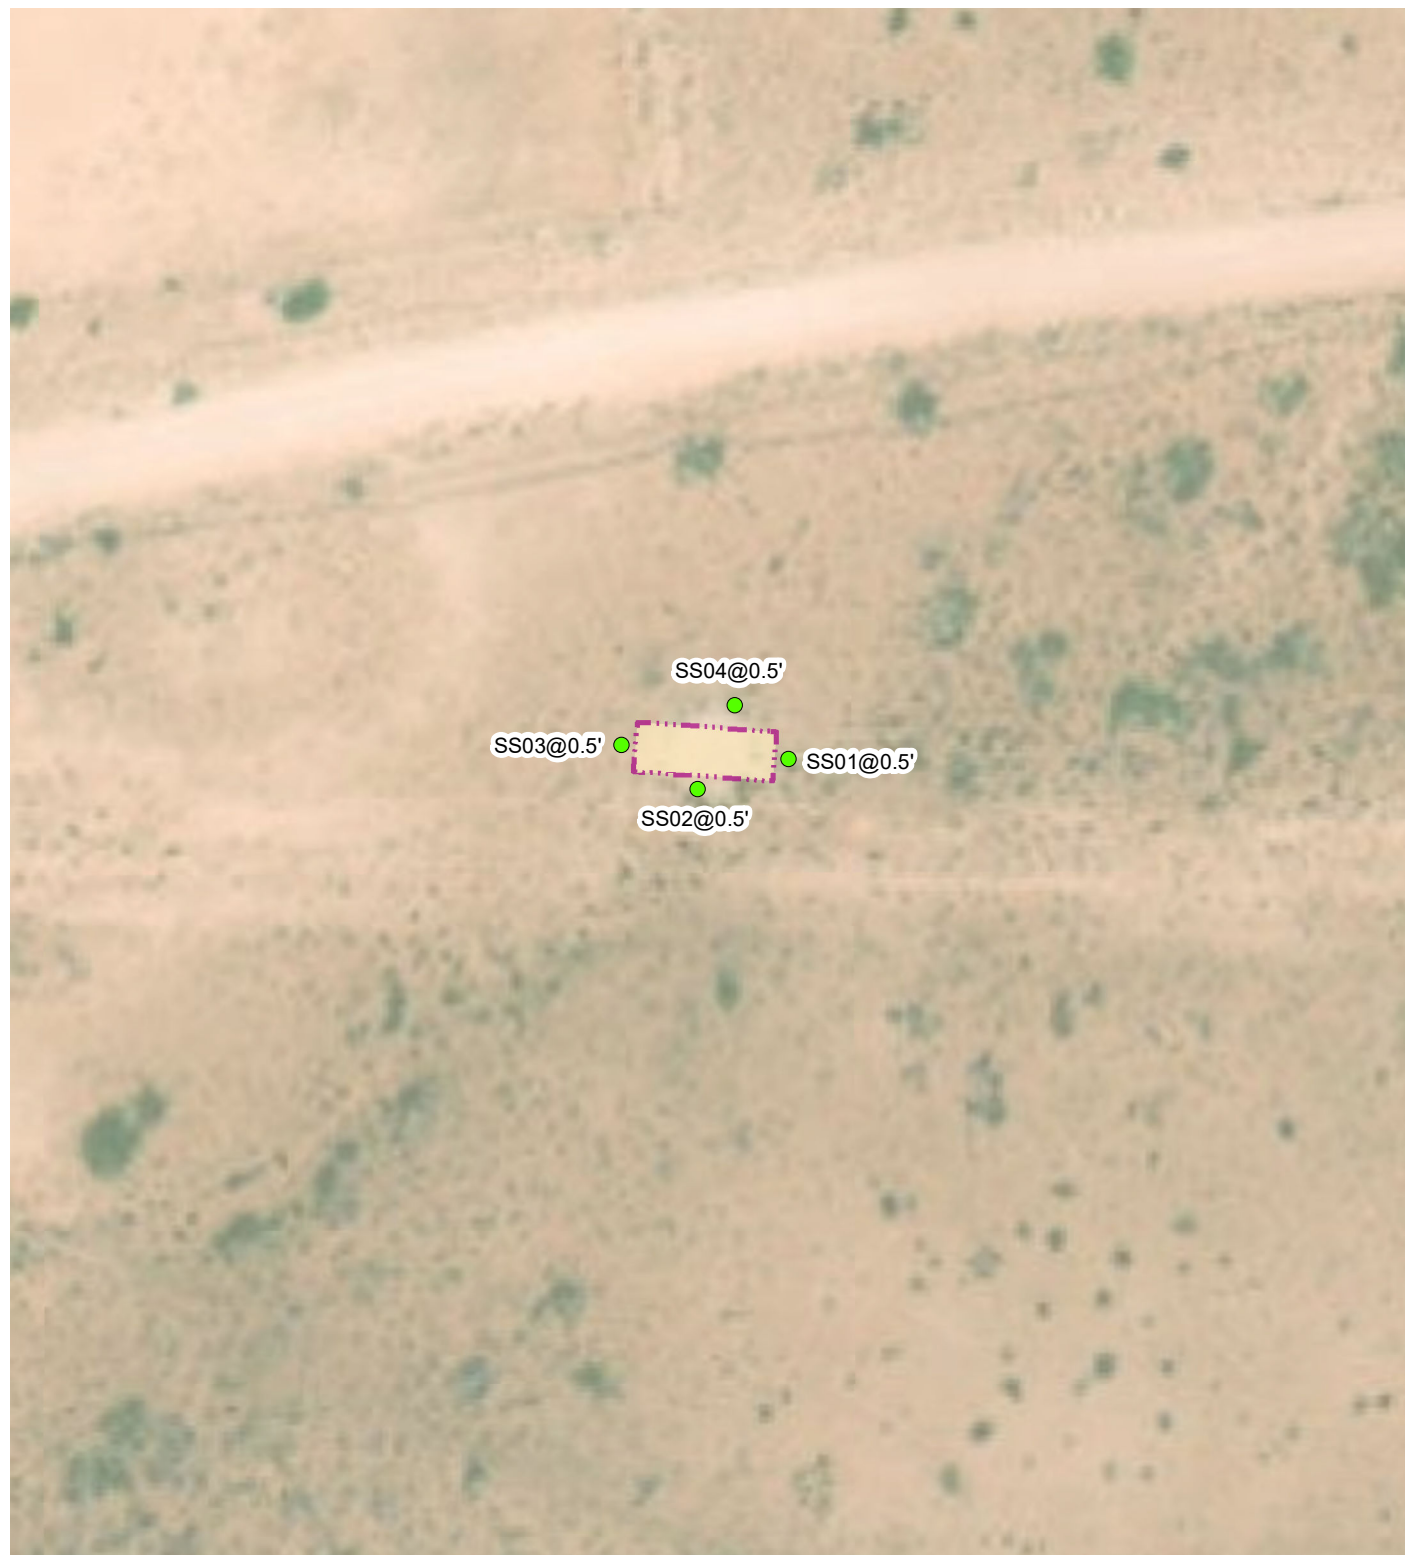
**FIGURE 2**  
**PRELIMINARY SOIL SAMPLE LOCATIONS**  
MAL 12-27-2 ARCO 5 FED #1  
UNIT A SEC 6 T18S R31E  
EDDY COUNTY, NEW MEXICO  
**FRONTIER FIELD SERVICES, LLC**

PRELIMINARY SOIL SAMPLE IN COMPLIANCE WITH APPLICABLE CLOSURE CRITERIA
-

RELEASE EXTENT

NOTE: INCIDENT NUMBER nAPP2213330681  
SAMPLE ID@DEPTH BELOW GROUND SURFACE (FEET)

On June 9, 2022, WSP personnel visited the site to evaluate the release extent and subsequent excavation activities that were overseen by Frontier, based on information provided on the Form C-141 and visual observations. Three preliminary surface samples SS01 - SS03 (Figure 2) were collected outside the excavation extent at a depth of 0.5 feet bgs to assess the lateral extent of impacted soil. WSP also collected four initial 5-point composite soil samples at the locations of FS01, FS02, SW01 and SW02 (shown on Figure 3) at depths ranging from 0 – 4 feet bgs to determine if additional remediation of impacted soil was warranted. These soil samples were then field screened for volatile aromatic hydrocarbons and chloride utilizing a calibrated photo-

ionization detector (PID) and Hach® chloride QuanTab® test strips, respectively. Based on visual observations and field screening activities, further excavation activities were warranted to remove additional impacted soil. These initial composite soil samples collected by WSP were not submitted for laboratory analysis.

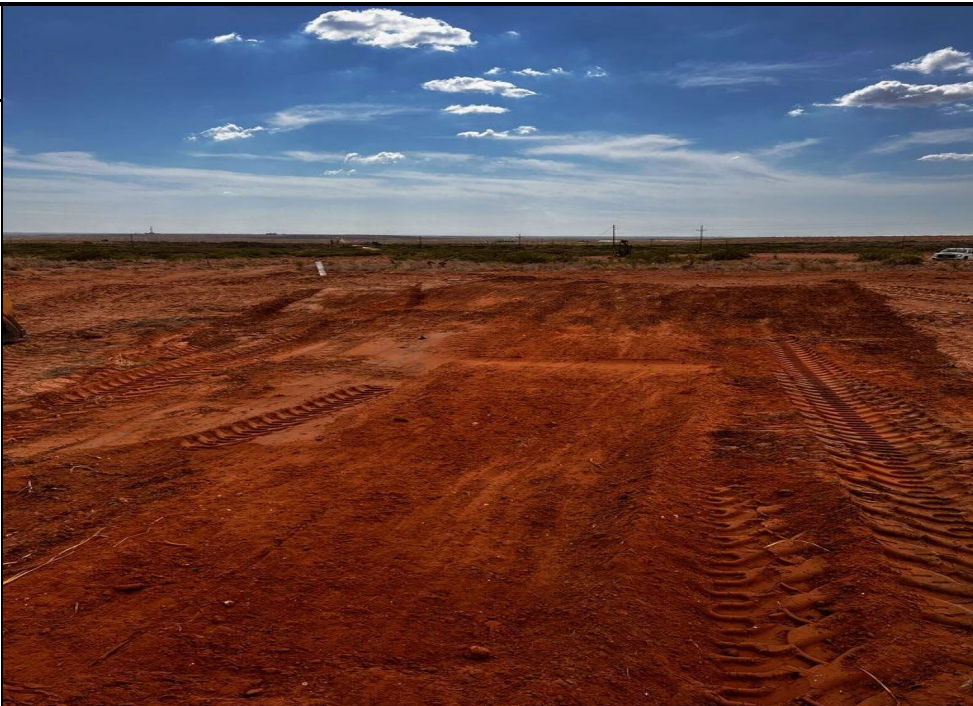
Photo No.	Date	
5	July 5, 2022	
View of backfilled excavation facing east

A wide-angle photograph of a large, flat, reddish-brown dirt field under a bright blue sky with scattered white clouds. The ground shows deep tire tracks and some sparse vegetation in the distance.
