Release Notification and Corrective Action

South Shoebar 15 State 2

44 bbl pw and oil spill 1.3.16

Re: Site Assessment and Closure Report
South Shoebar 15 State 2
API No. 30-025-34702
GPS: Latitude 32.837299 Longitude -103.439331
UL H, Sec. 15, T17S, R35E
Lea County, NM
NMOCD Ref. No. NKJ1600726055

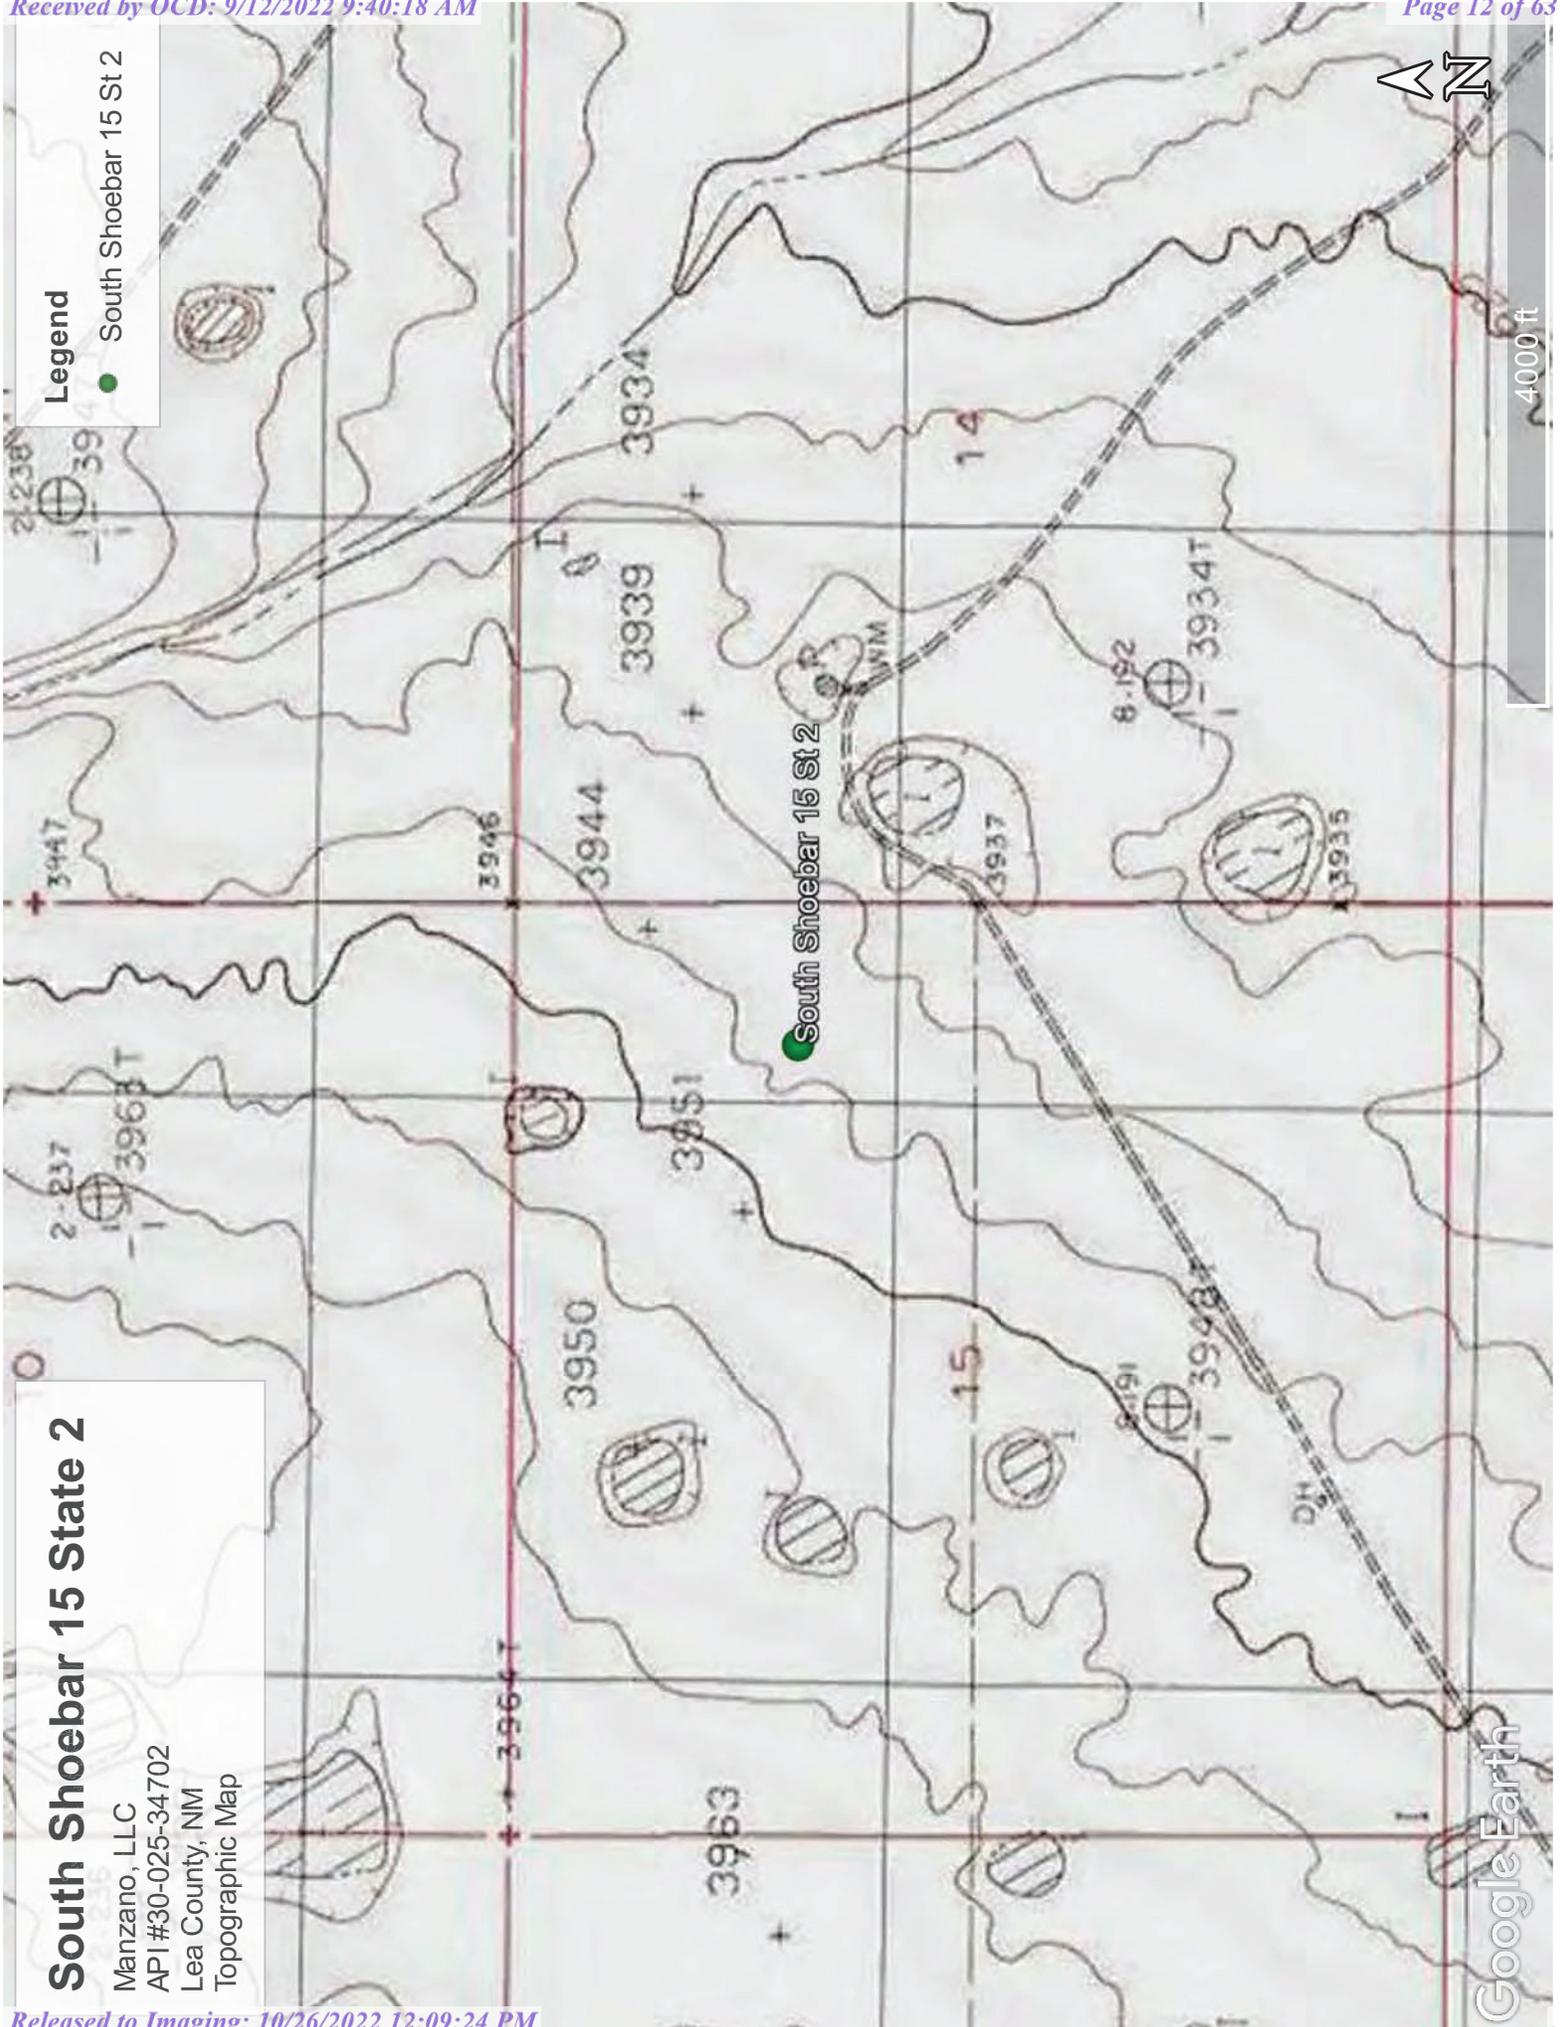
3-Karst Map

Per the New Mexico Bureau of Geology and Mineral Resources, the geology is made up deposits of Alluvial and eolian deposits, and petrocalcic soils of the southern High Plains. Locally includes Qoa. May locally include uppermost Ogallala Formation. The soil in this area is made up of Kimbrough-Lea complex, 0 to 3 percent slopes according to the United States Department of Agriculture Natural Resources Conservation Service soil survey (Appendix B). The drainage courses in this area are well drained. There is a low potential for karst geology to be present around the Shoebar (Figure 3).

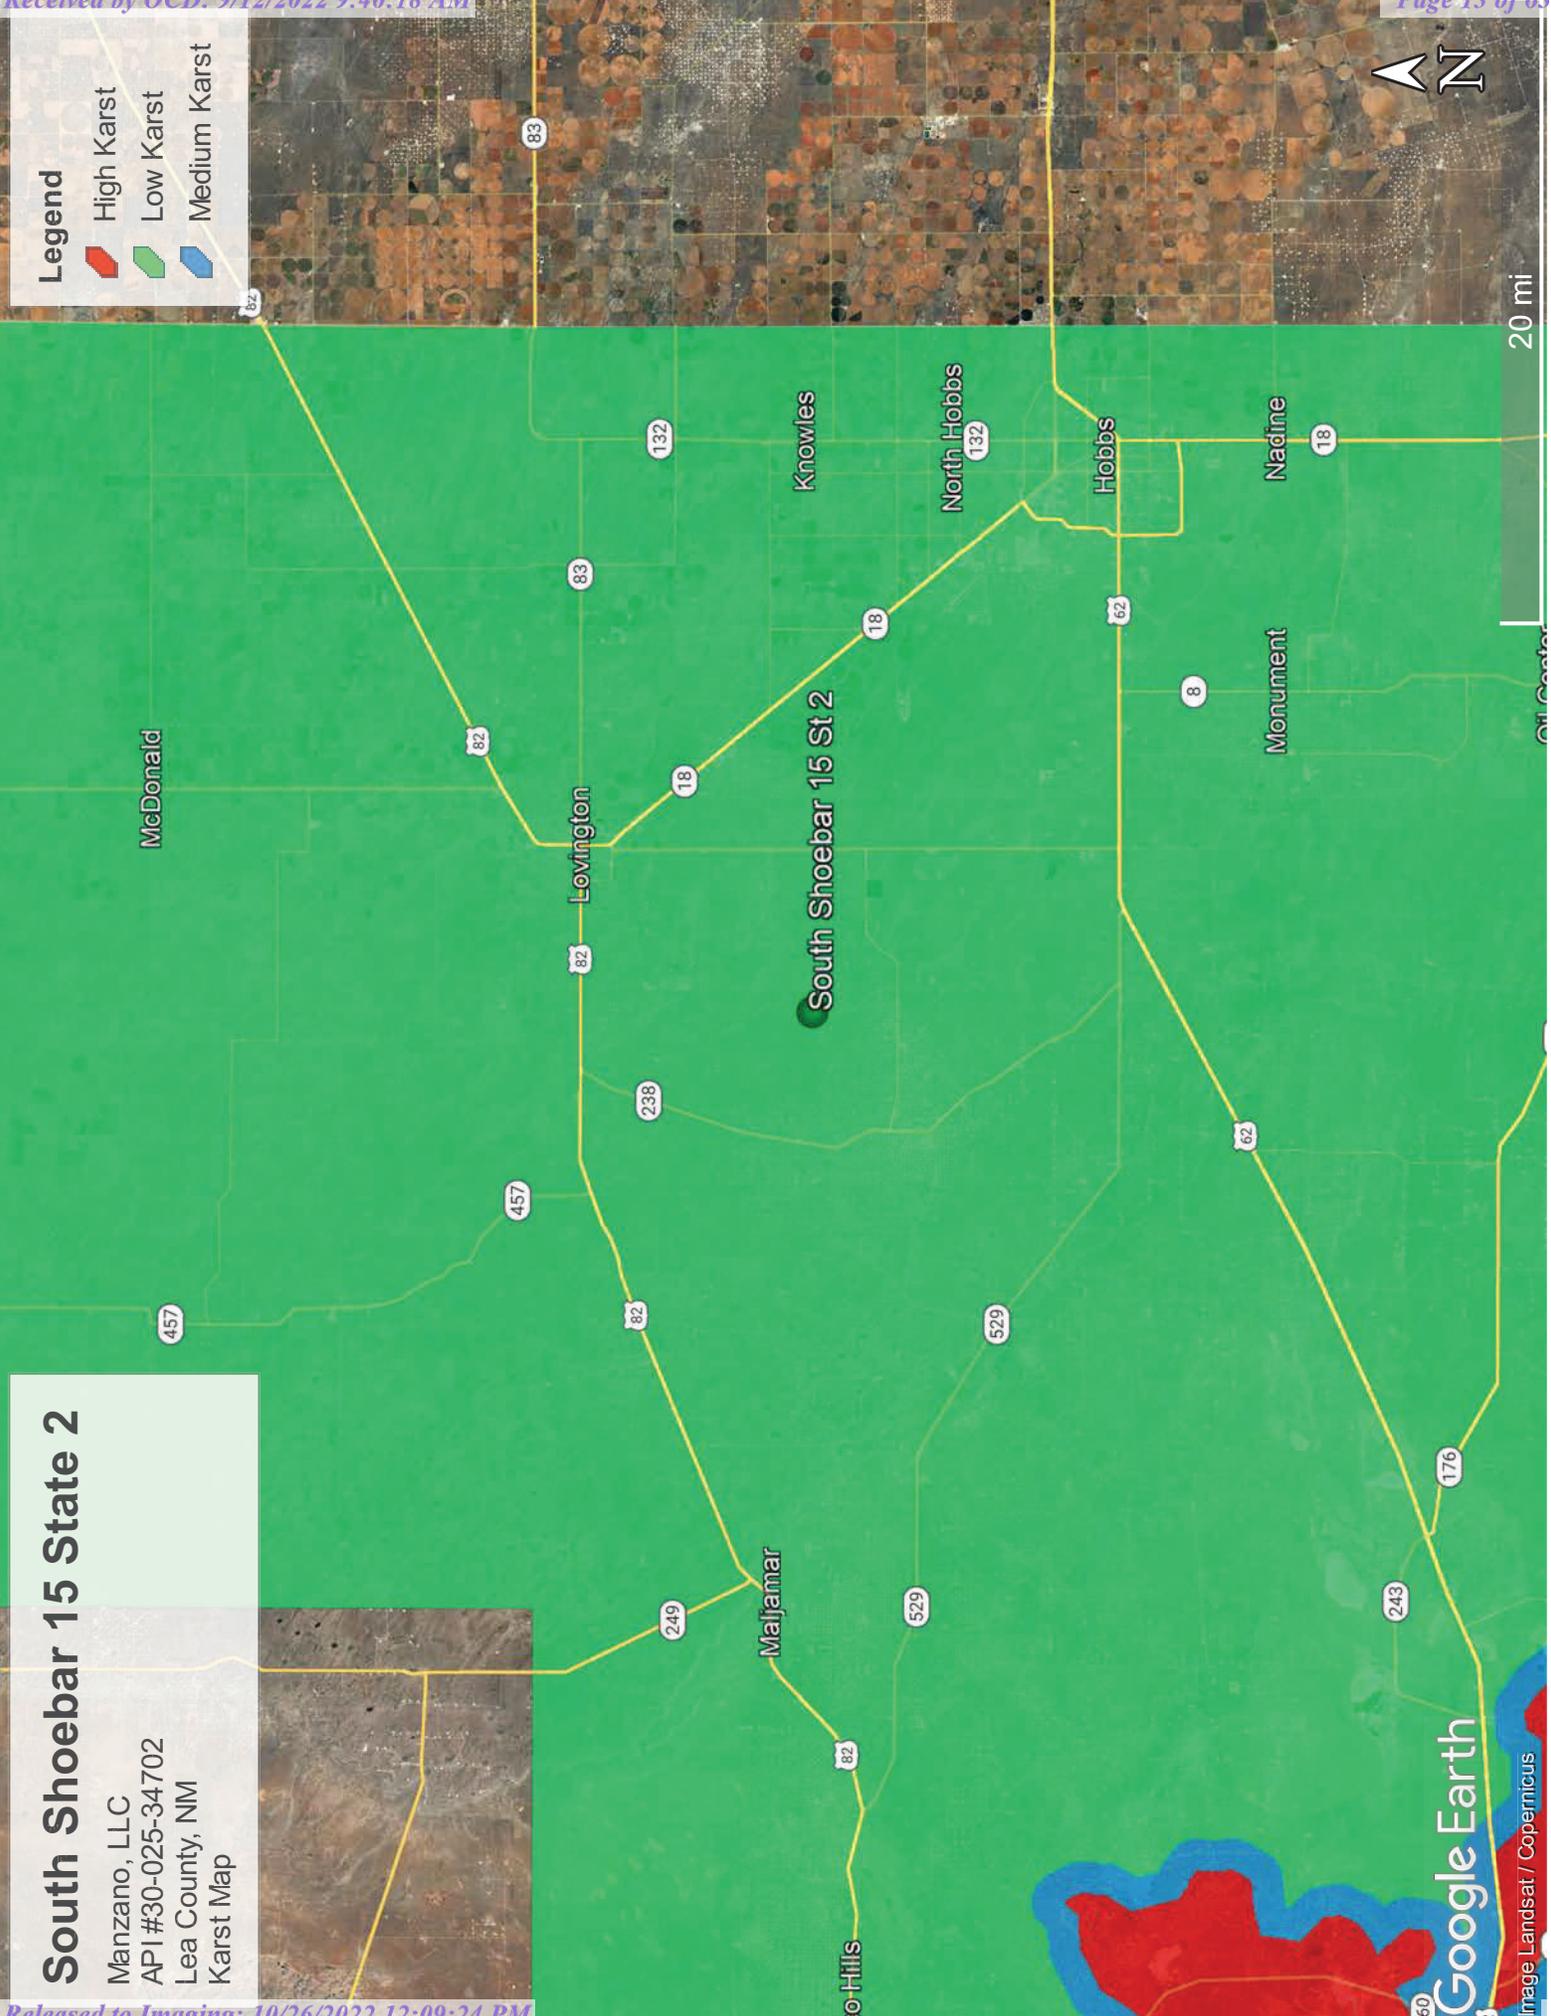
4-Site Map

On August 25, 2022, Pima mobilized personnel to the site to assess the area. We sampled the impacted area around the tanks and outside the berm. Laboratory results of this sampling event can be found in the following data table. A Site Map can be found in Figure 4.

Spill Area-720sqft

Based on the sample results, the bottom and sidewalls were below NMOCD Closure Criteria 19.15.29 NMAC.

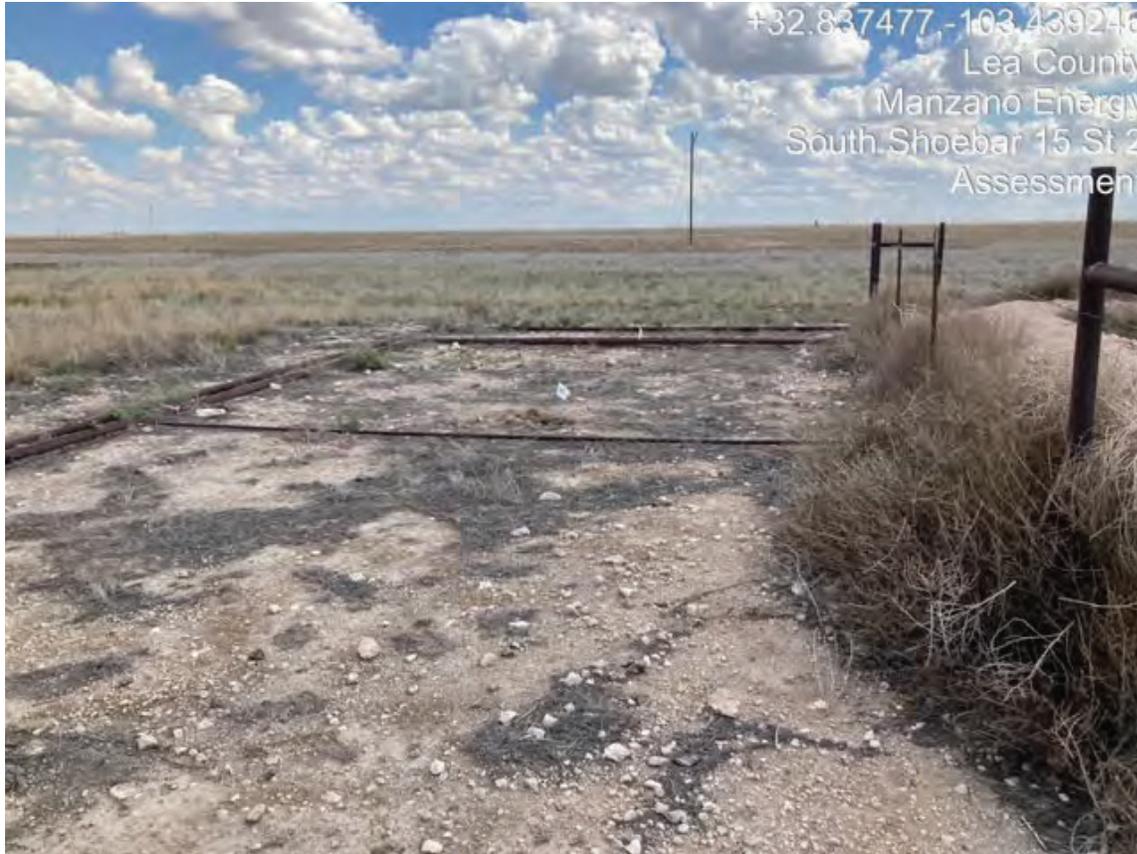
+32.837477, -103.439246
Lea County
Manzano Energy
South Shoebar 15 St 2
Assessment

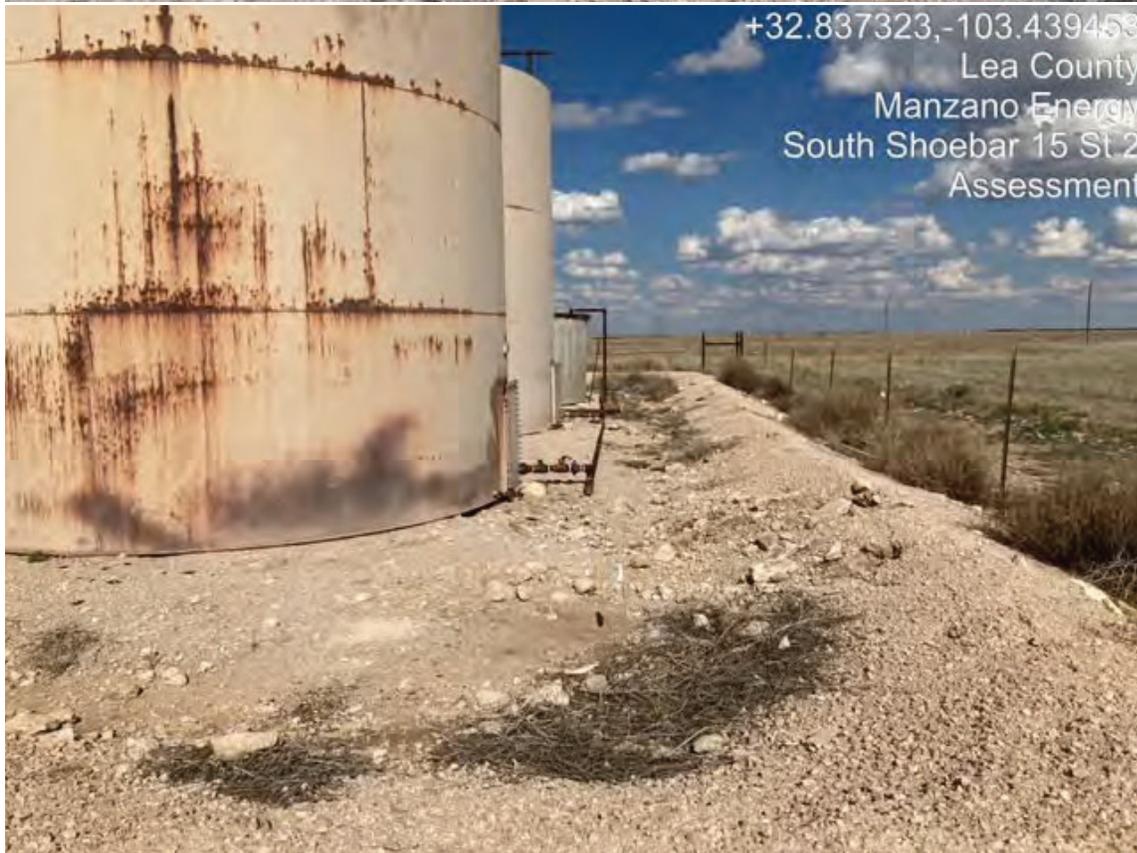
+32.837323, -103.439453
Lea County
Manzano Energy
South Shoebar 15 St 2
Assessment
