**Subject: Site Characterization and Closure Report  
Cotton Draw Unit 172H (May 2016)  
2RP-3683  
Eddy County, New Mexico**

HRL Compliance Solutions, Inc. (HRL) is pleased to submit this site characterization and closure report for the May 6, 2016 release at the Cotton Draw Unit 172H (Site). The release was at latitude 32.151932353 and longitude -103.726815365 in Eddy County, New Mexico (Figure 1) (Attachment A, Photographs).

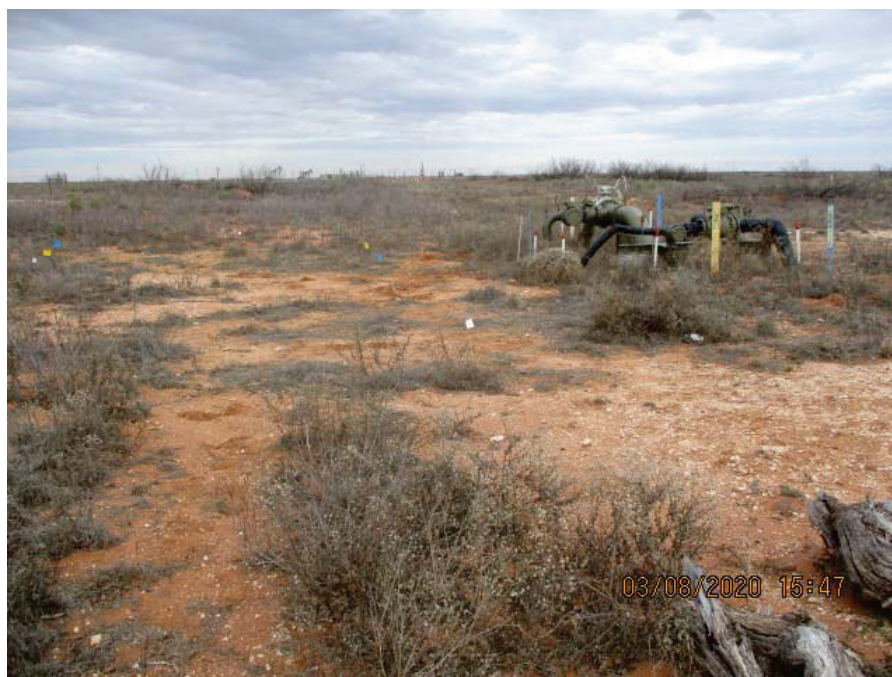
Photograph of  
the release,  
view to the west

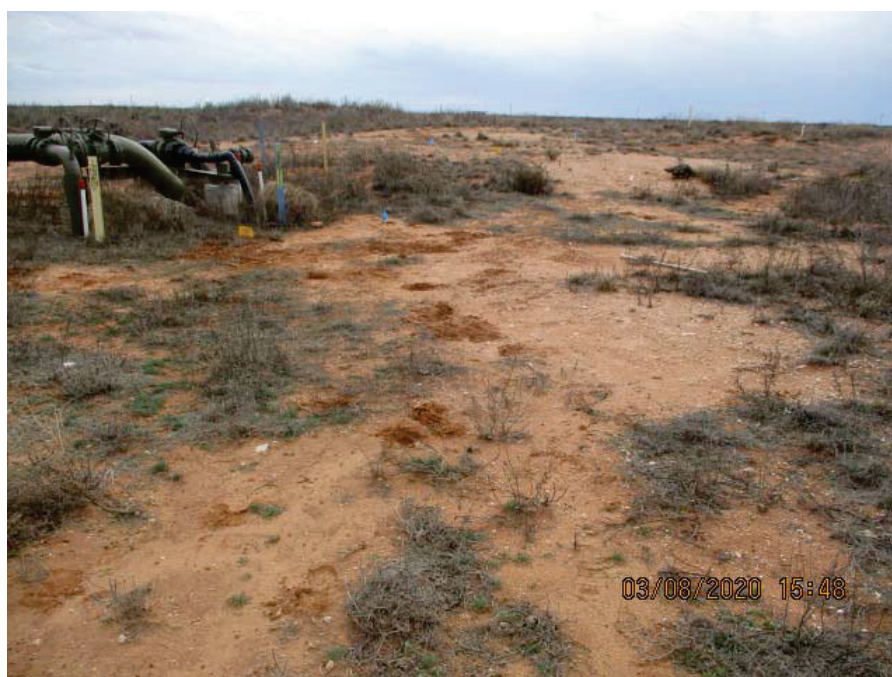
Photograph of  
the release,  
view to the east
