## Report Type: Closure Report 2RP-5354

Site:	Lost State AIS State TB					
Company:	EOG Resources					
Section, Township and Range	Unit N	Sec 36	T 21S	R 31E		
County:	Eddy County					
GPS:	32.42950			-103.73350		
Surface Owner:	State					
Directions:	From the intersection of Wipp Rd and Louis Whitlock Rd in rural Eddy Co., New Mexico, head north on Lous Whitlock for 5.23 miles, turn east onto unnamed lease road and go 1.82 miles, turn north and go 0.1 miles and arrive at location.

<b>Date Released:</b>	3/26/2019
<b>Type Release:</b>	Produced Water and Crude Oil
<b>Source of Contamination:</b>	Water tank top blew off and tank was on its side
<b>Fluid Released:</b>	152 bbls water / 8 bbls oil
<b>Fluids Recovered:</b>	61 bbls water / 4 bbls oil

**Re: Closure Report for the EOG Resources, Lost Tank AIS State TB, Unit N, Section 36, Township 21 South, Range 31 East, Eddy County, New Mexico.  
2RP-5354**

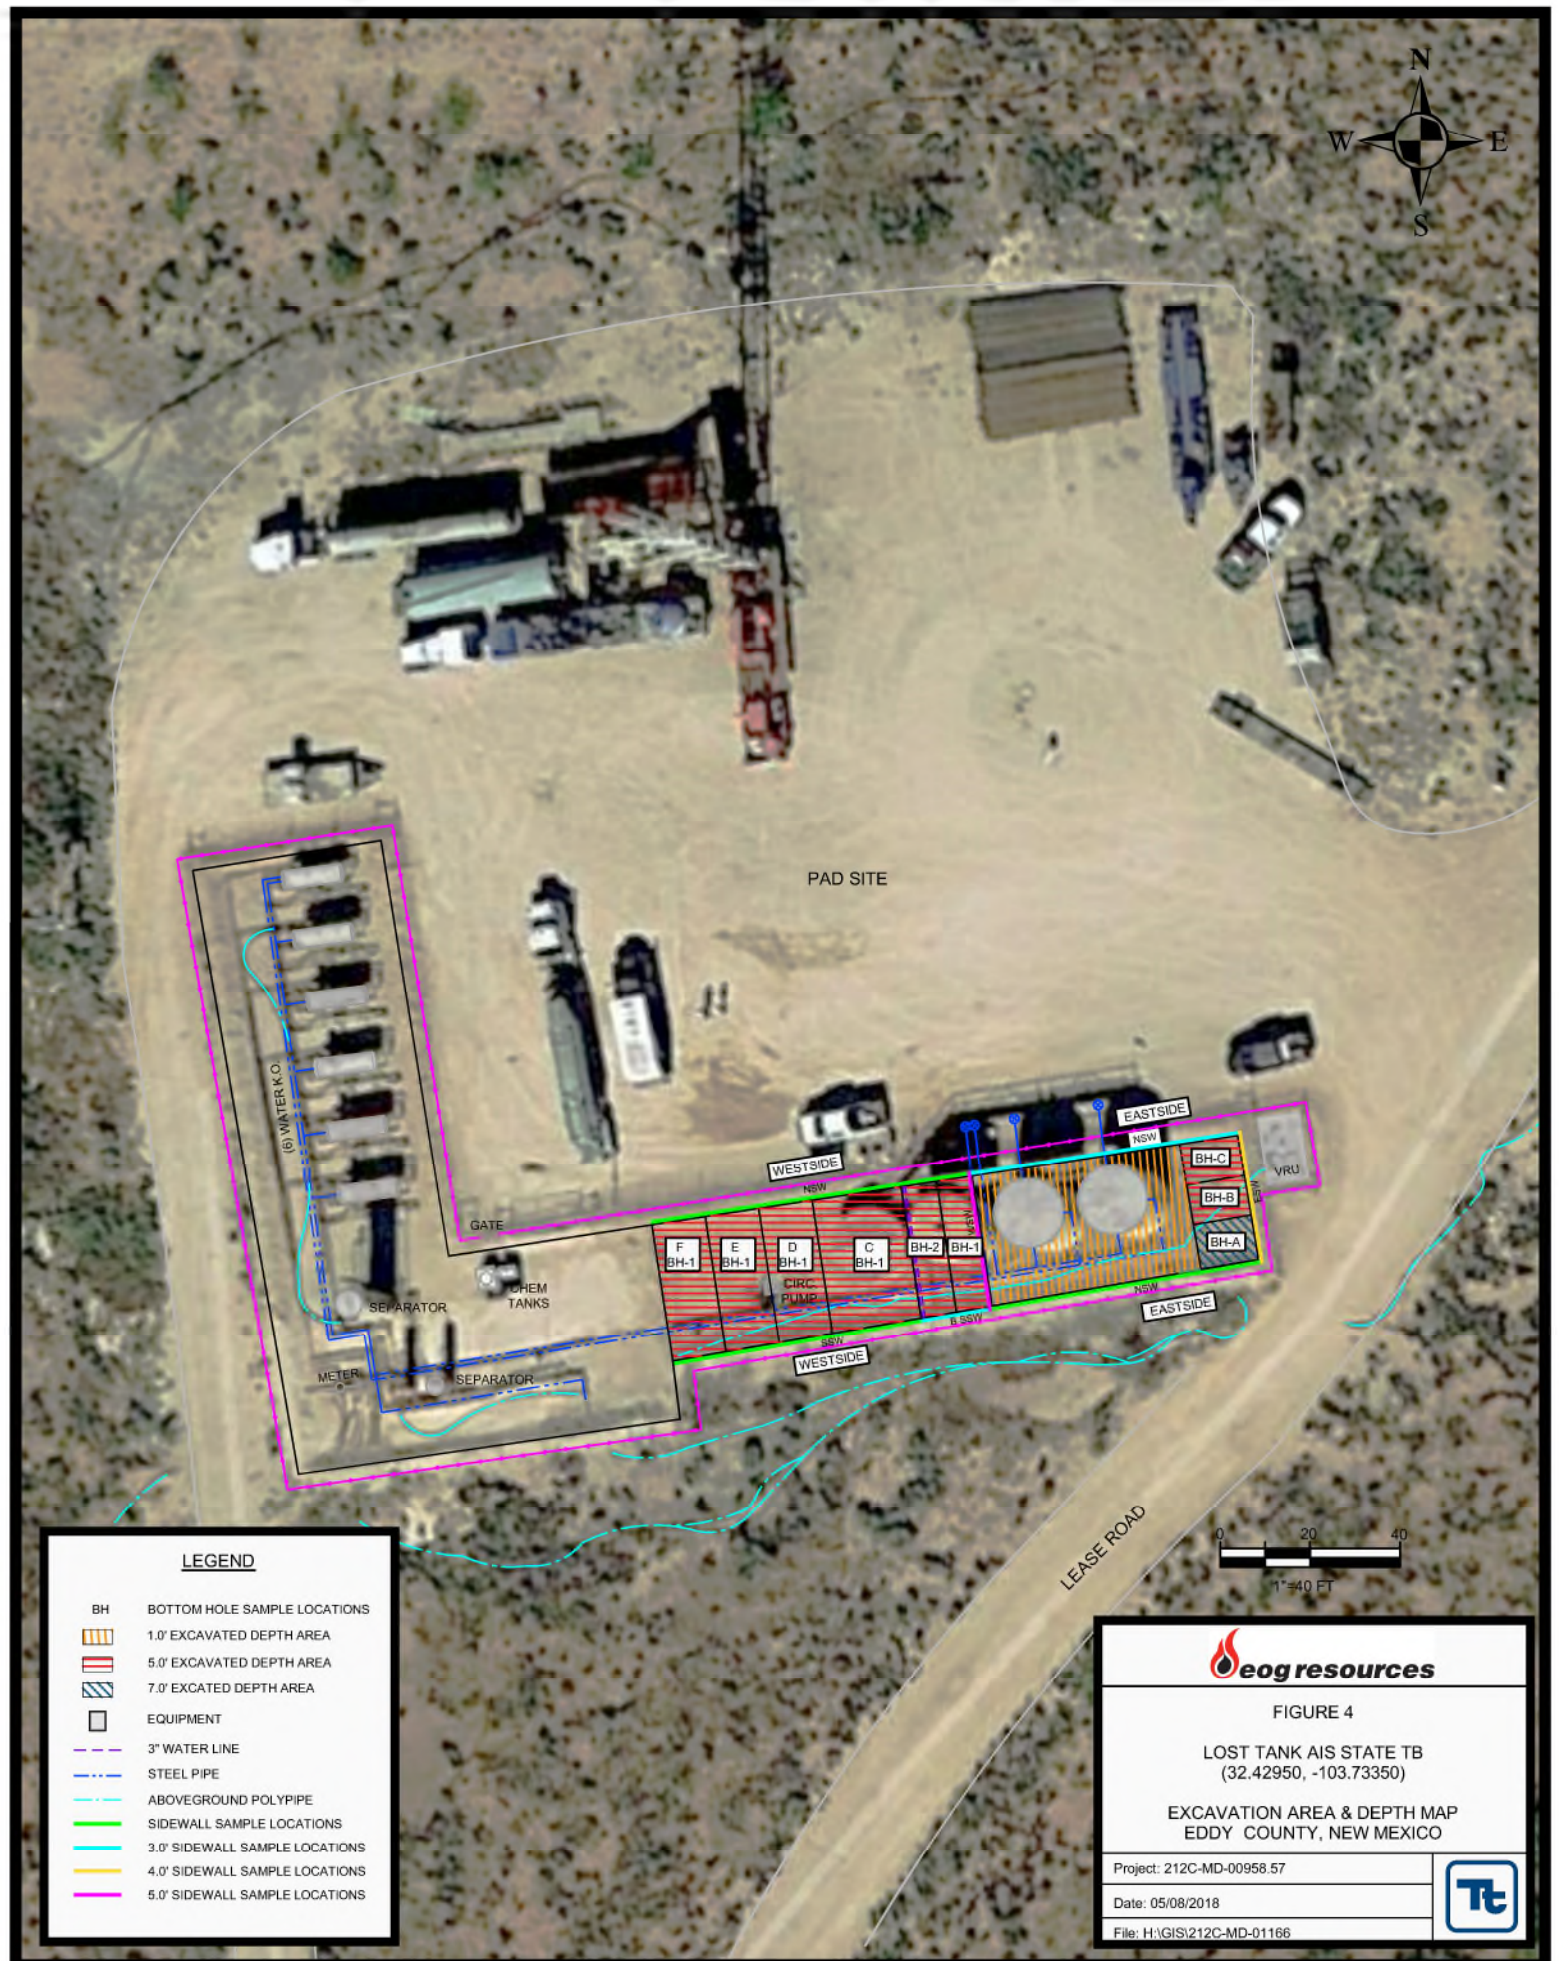
Tetra Tech personnel were onsite from April 8 through April 15, 2019 to supervise the remediation activities. The impacted area within the tank battery was excavated to total depths of 5.0' – 7.0' below surface. Bottom hole and sidewall confirmation samples were collected every 200 square feet to ensure proper removal of the impacted soils. Nine (9) bottom hole composite samples (Eastside BH-A, Eastside BH-B, Eastside BH-C, Westside BH-1, Westside BH-2, Westside C BH, Westside D BH-1, Westside E BH-1, Westside F BH-1) and seven (7) sidewall composite samples (Eastside NSW 3', Eastside SSW, Eastside ESW 4', Eastside WSW 5', Westside B SSW 3', Westside NSW, and Westside SSW) were collected in. The samples were submitted to the laboratory to be analyzed for TPH method 8015 extended, BTEX method 8021B, and Chloride by EPA Method 300.0. The sampling results are summarized in Table 1. The excavation depths and sample locations are shown in Figure 4.

Referring to Table 1, all collected confirmation samples showed benzene, total BTEX, TPH, and chloride concentrations below the RRAL's.

Approximately 200 cubic yards of material was excavated and transported offsite for proper disposal. The areas were then backfilled with clean material to surface grade.

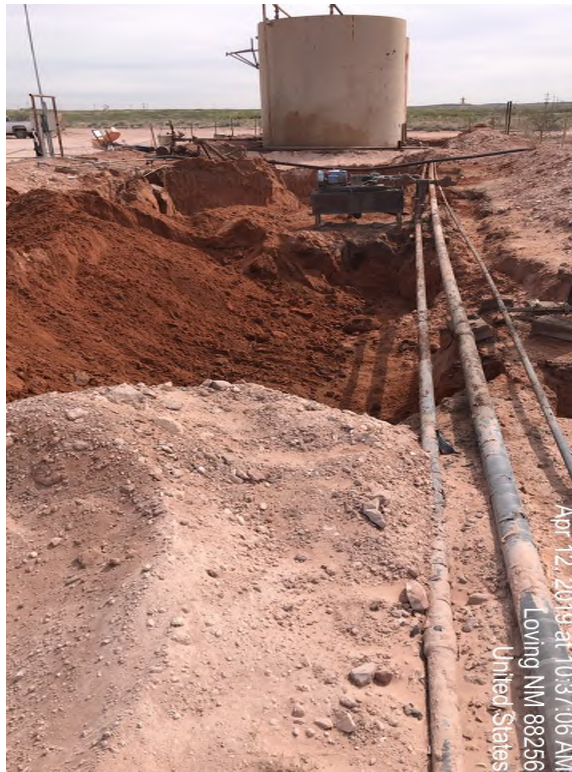
View East – Area of Excavation

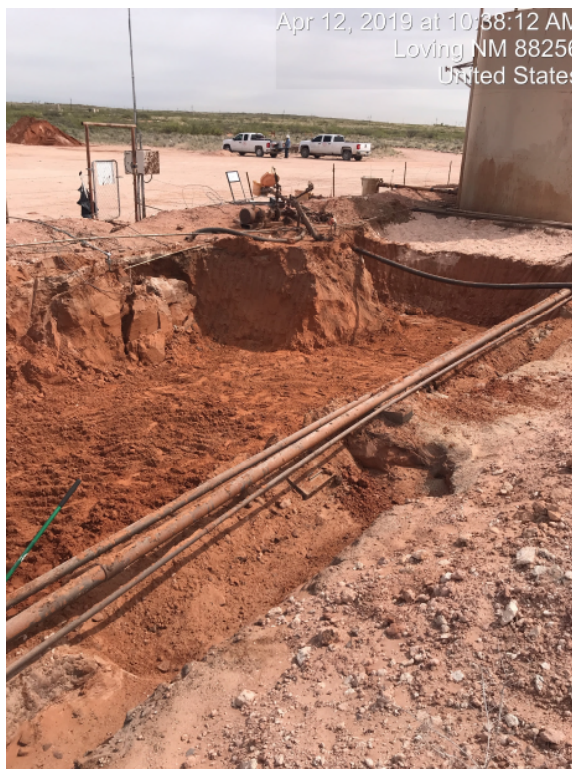
View Northeast – Area of Excavation

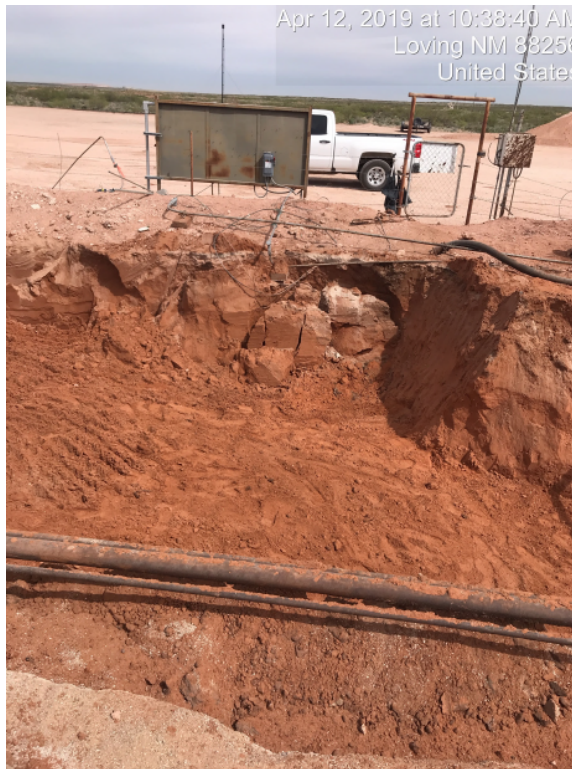
View North – Area of Excavation

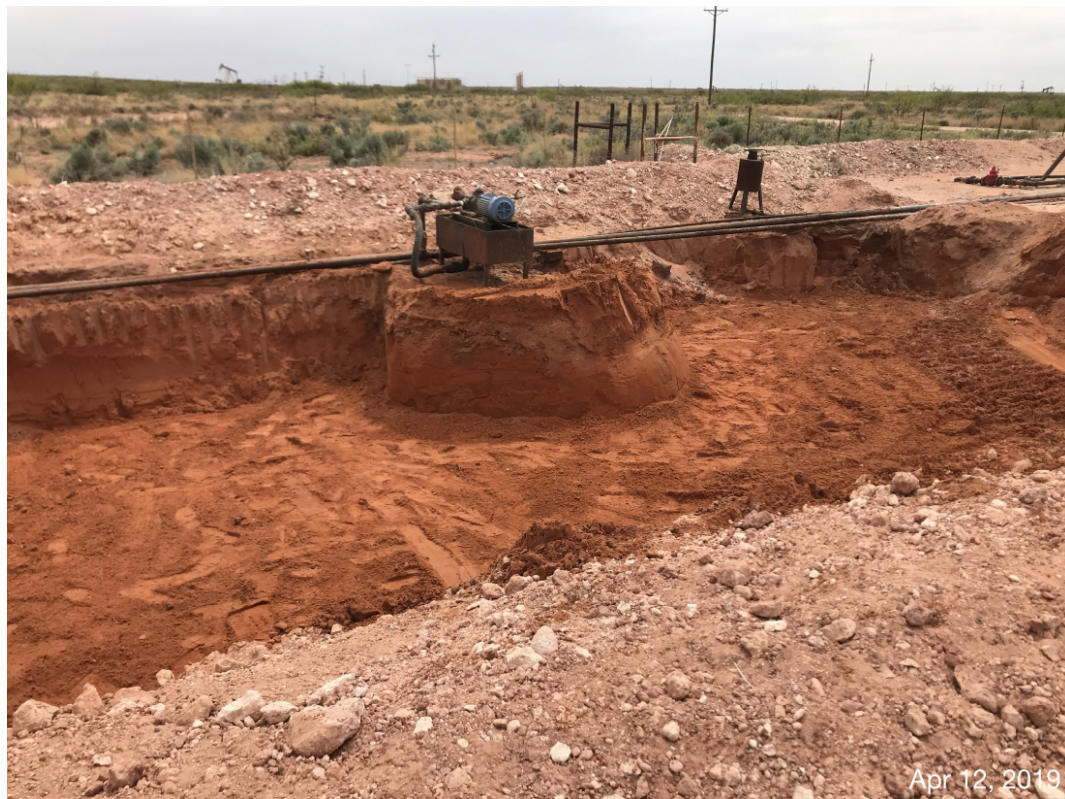
View South – Area of Excavation
