State of New Mexico
Oil Conservation Division

Incident ID	NAPP2114127159
District RP	
Facility ID	
Application ID

Based on laboratory analytical results, field activities conducted to date and conditions at the site, Caprock Services LLC, recommends Devon Energy provide a copy of this Remediation Summary and Closure Report to the NMOCD and request closure be granted to the Mesquite Booster Trunkline Site.

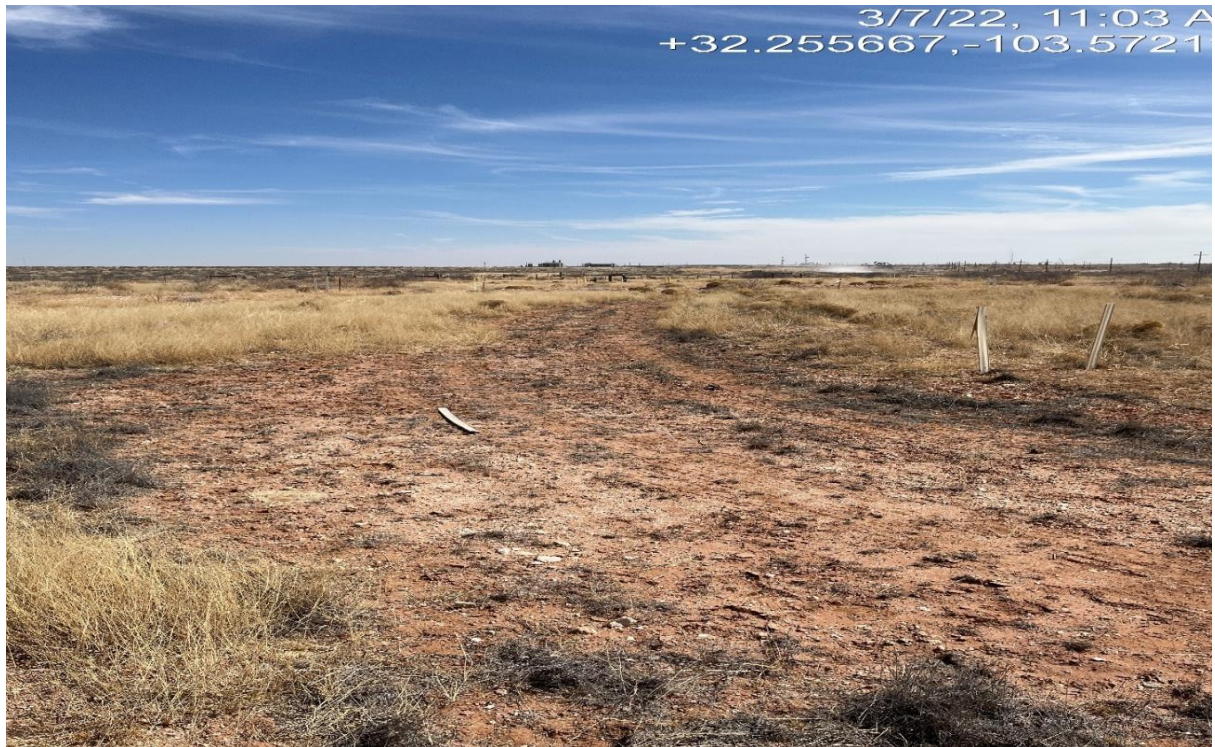
Figure 3 View of release looking west.

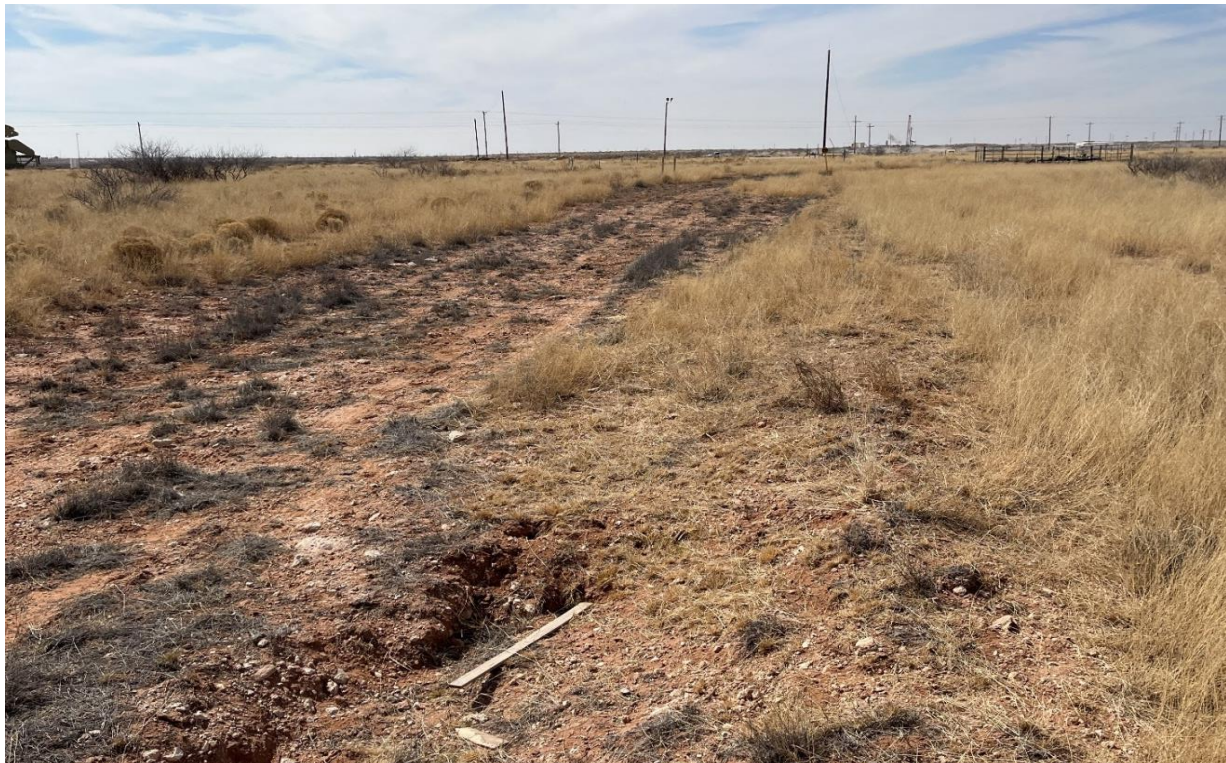
Figure 4 View of release looking south west towards release point.

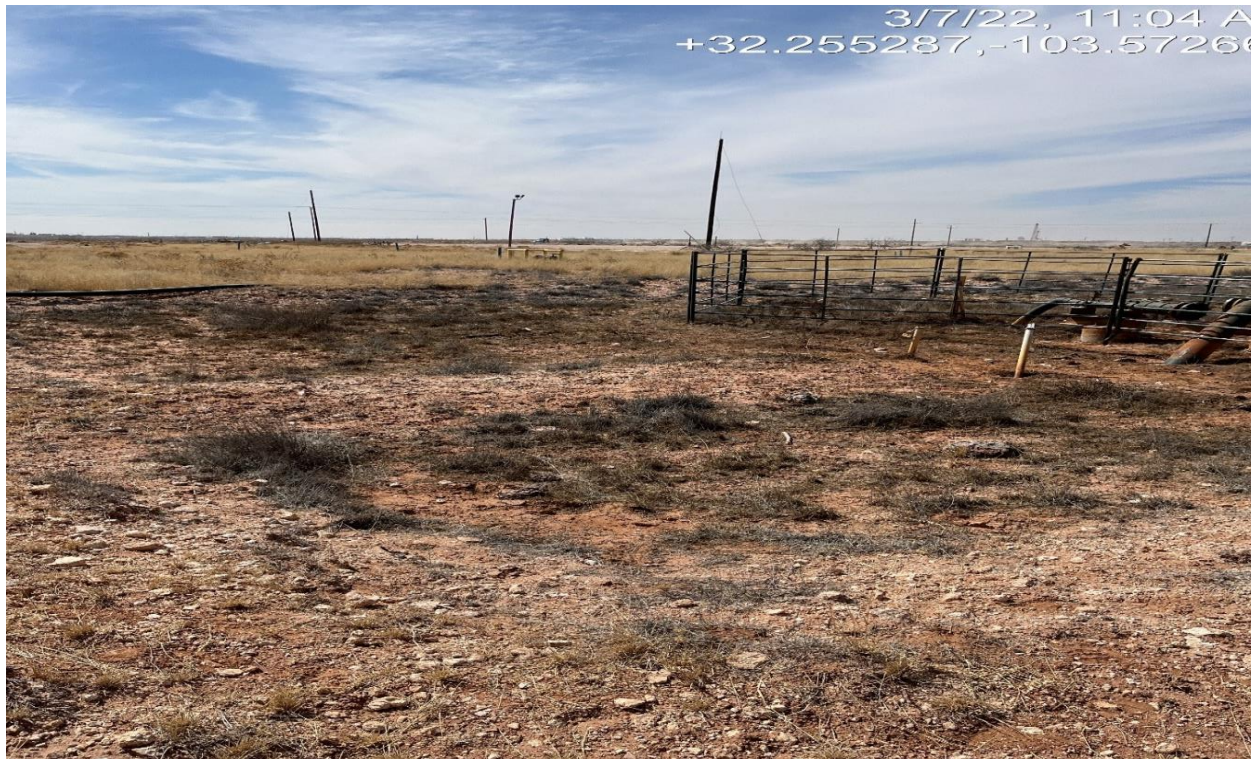
Figure 5 View of release looking south to release point.

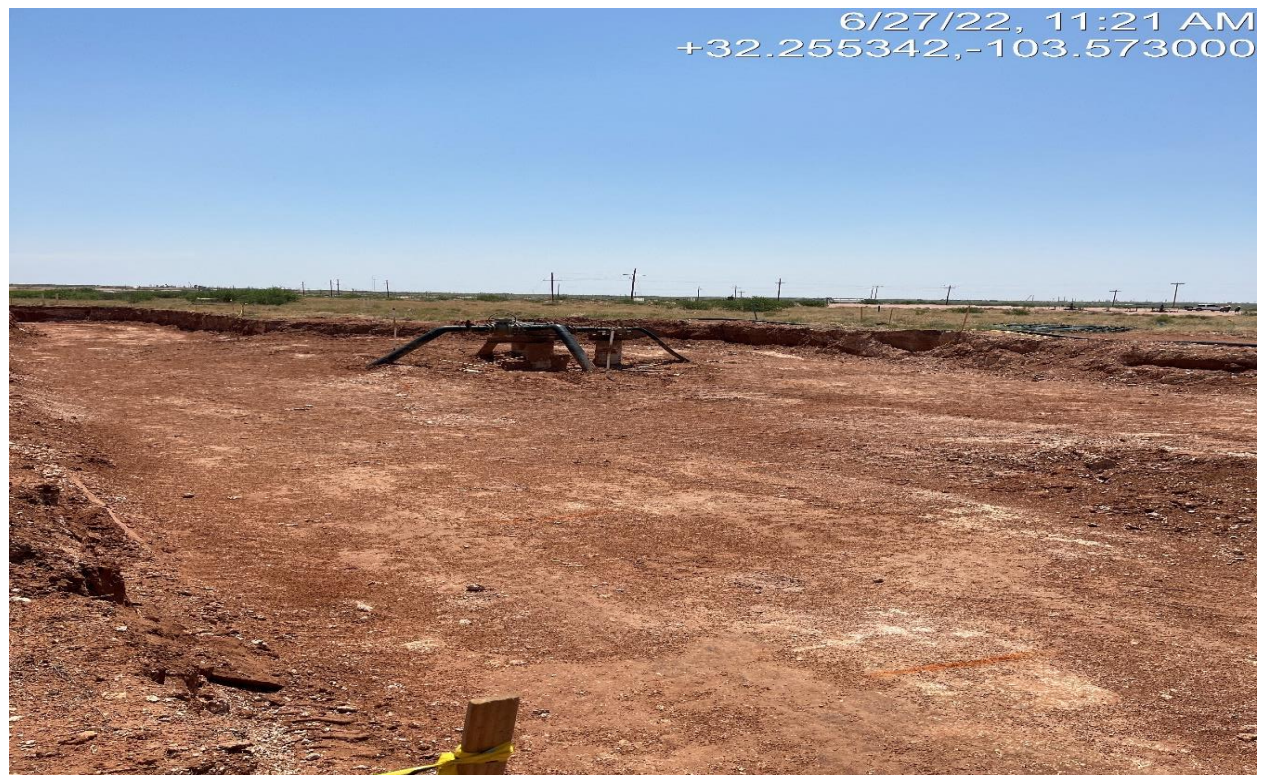
Figure 6 View looking south east towards release point.

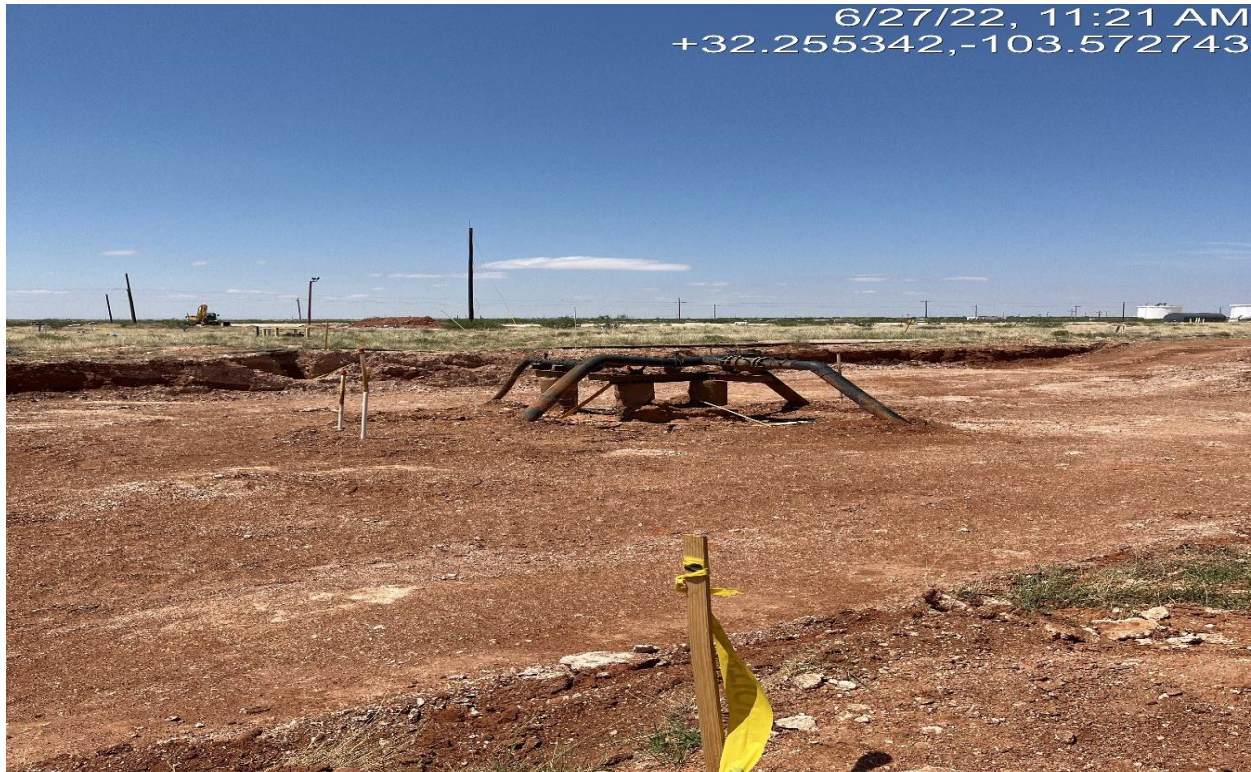
Figure 7 View looking to the south west towards release point.

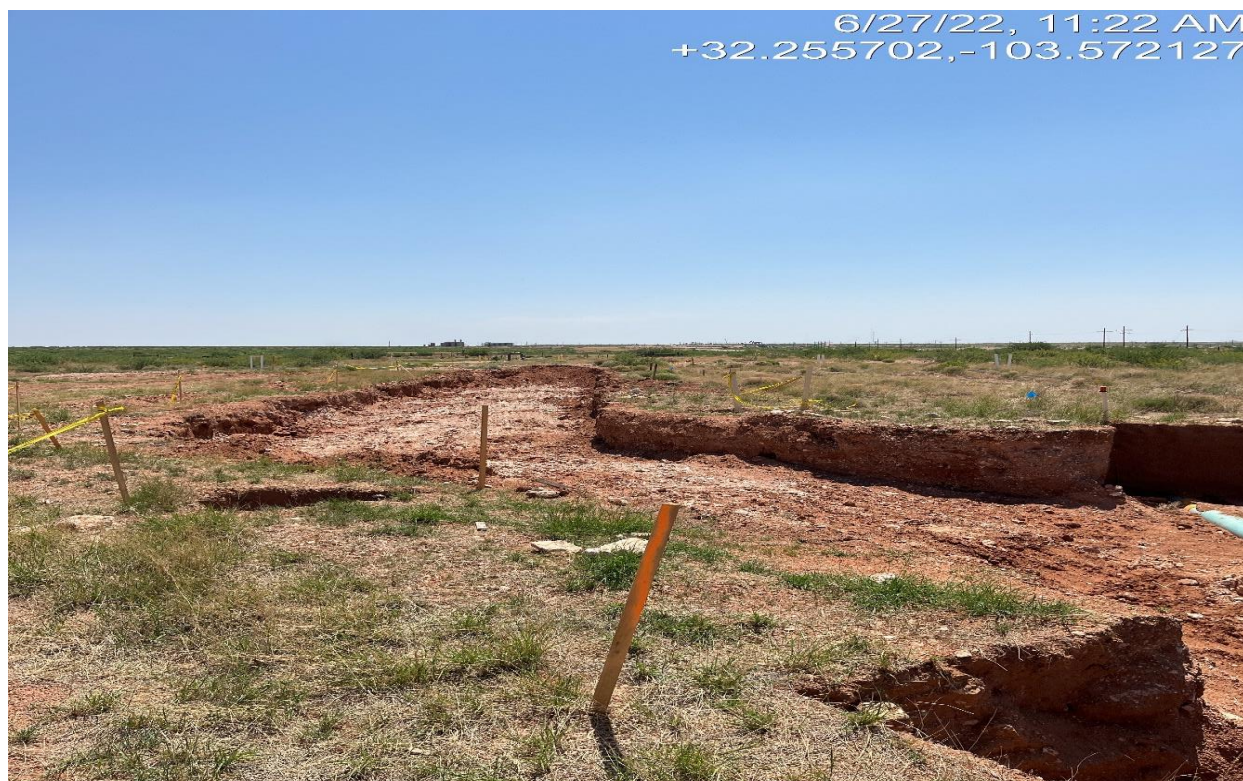
Figure 9 View looking east to end of excavation.

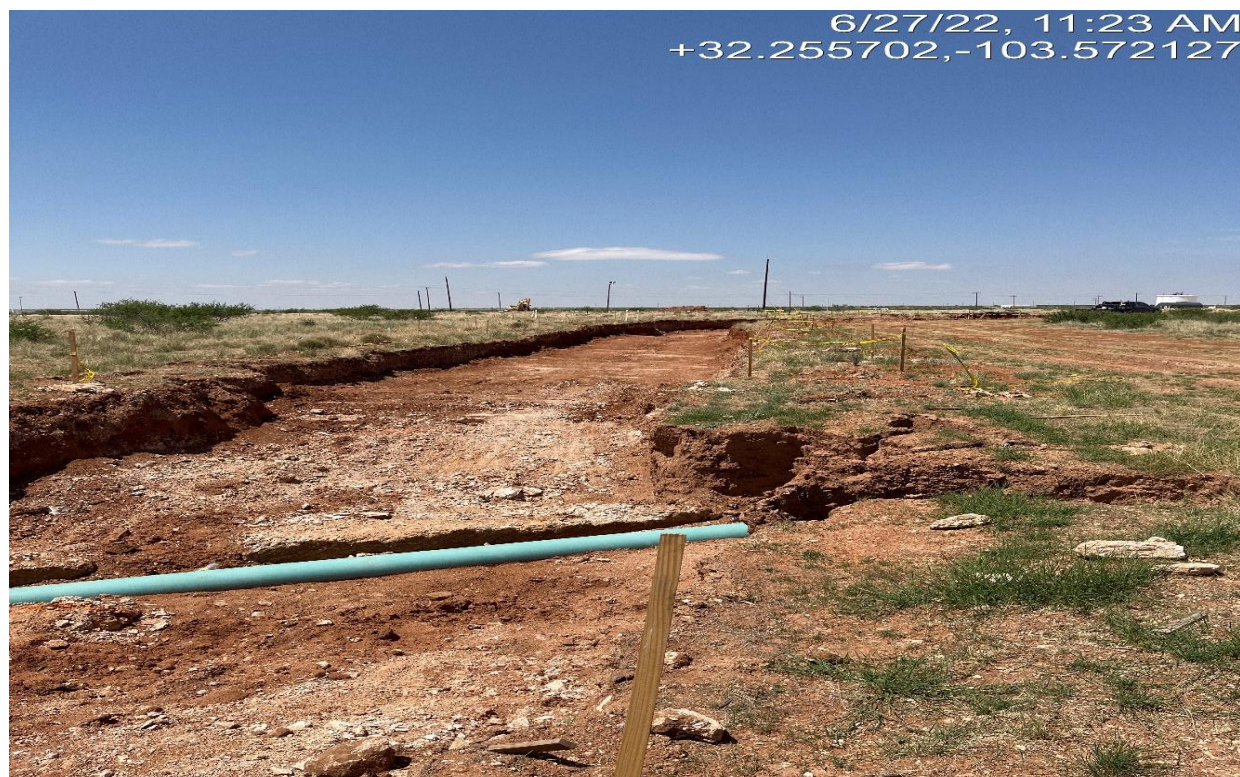
Figure 10 View looking west towards release point.

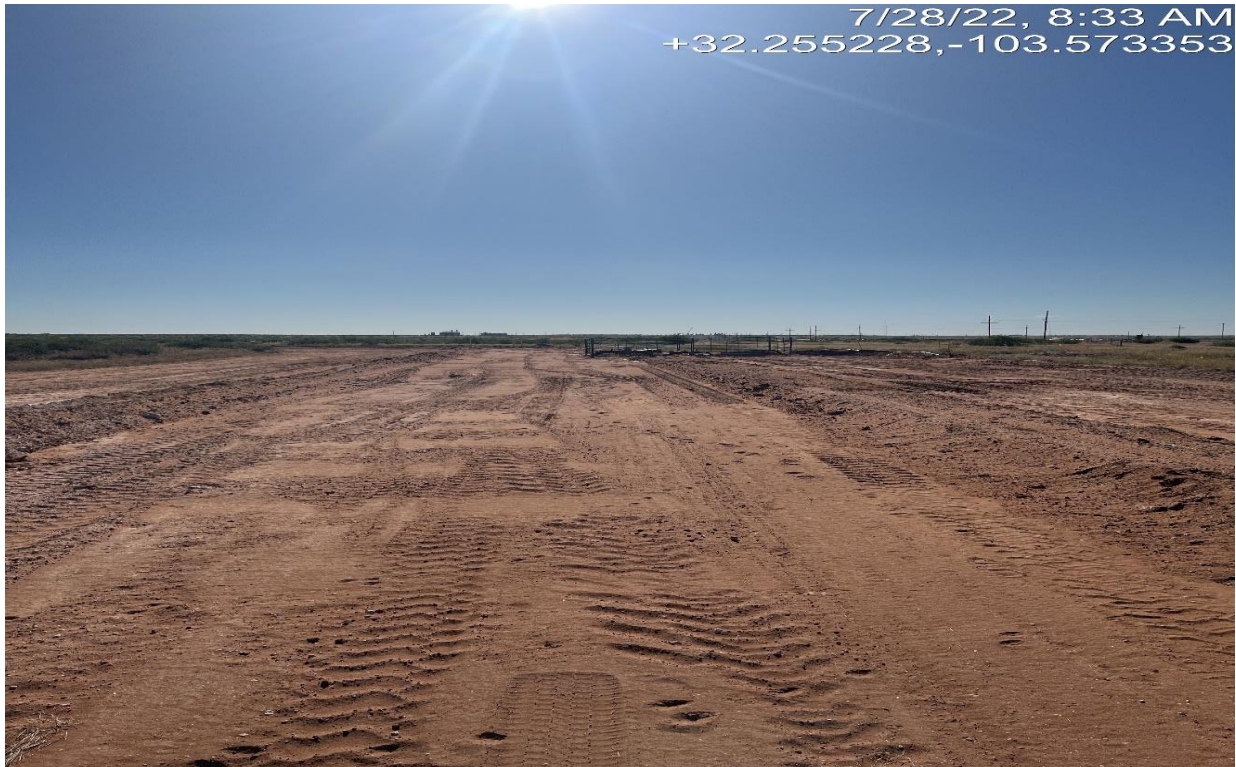
Figure 11 Backfill photograph looking east.

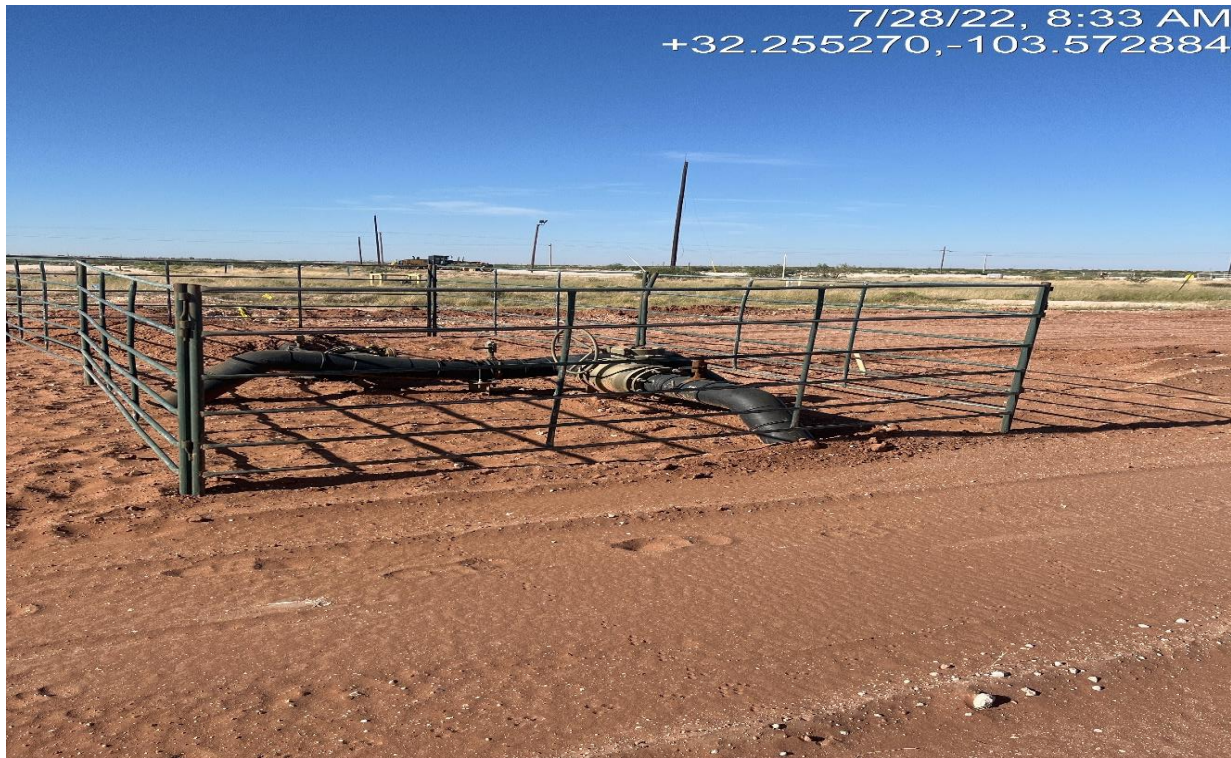
Figure 12 view looking at release point after backfill.
