**CLOSURE REQUEST**

**DEVON ENERGY COMPANY**

## RE: CLOSURE REQUEST

<b>COMPANY</b>	Devon Energy Company
<b>LOCATION</b>	North Brushy Header
<b>API</b>	N/A
<b>PLSS</b>	Unit M Sec 36 T25S R29E
<b>GPS</b>	32.079119, -103.944930
<b>INCIDENT ID</b>	nAPP2134442133

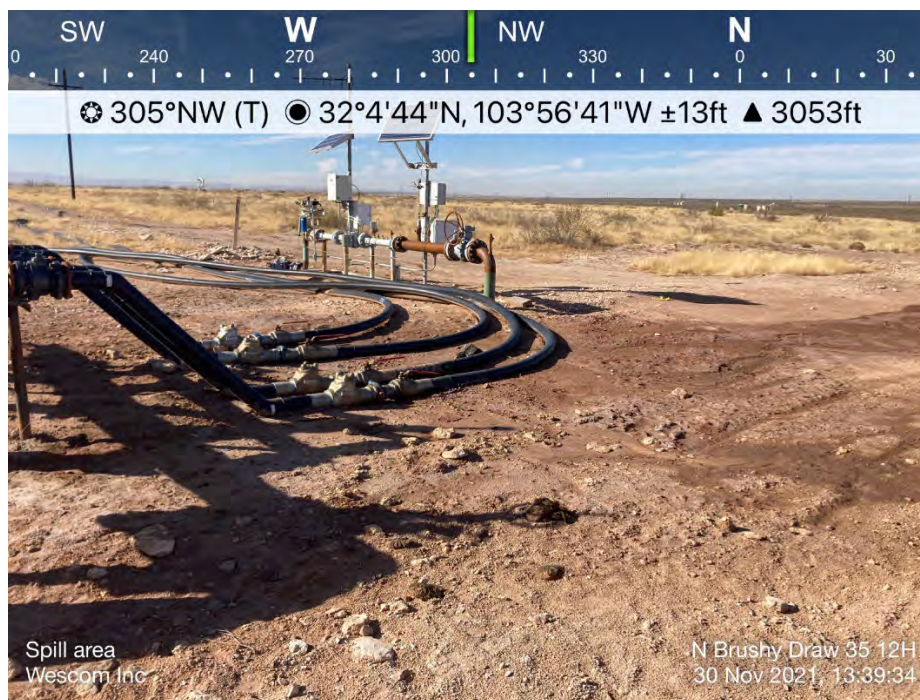
Spill Area

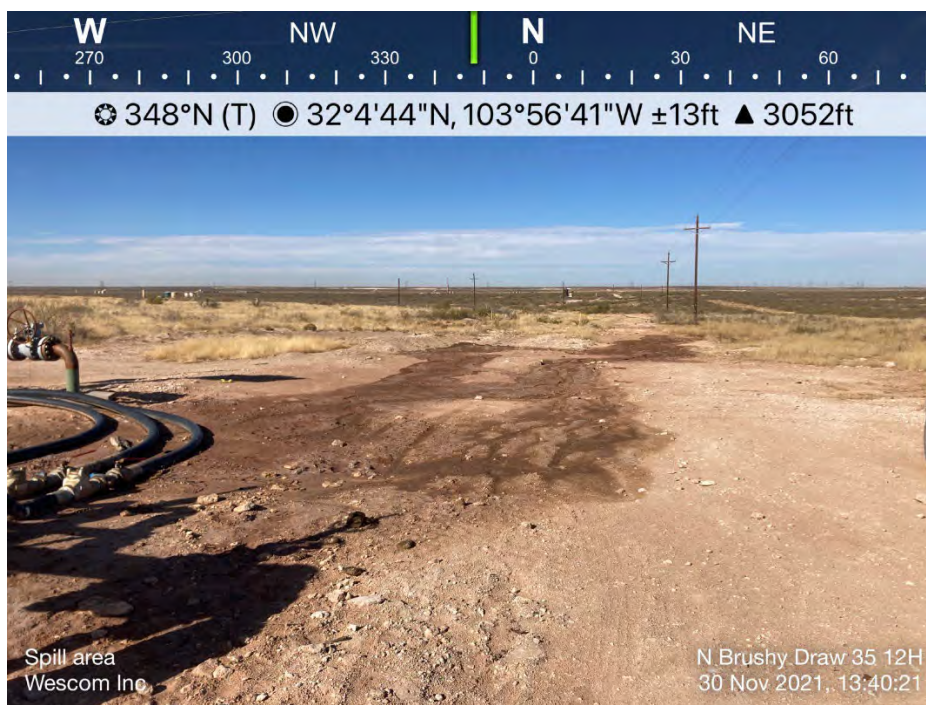
Spill Area

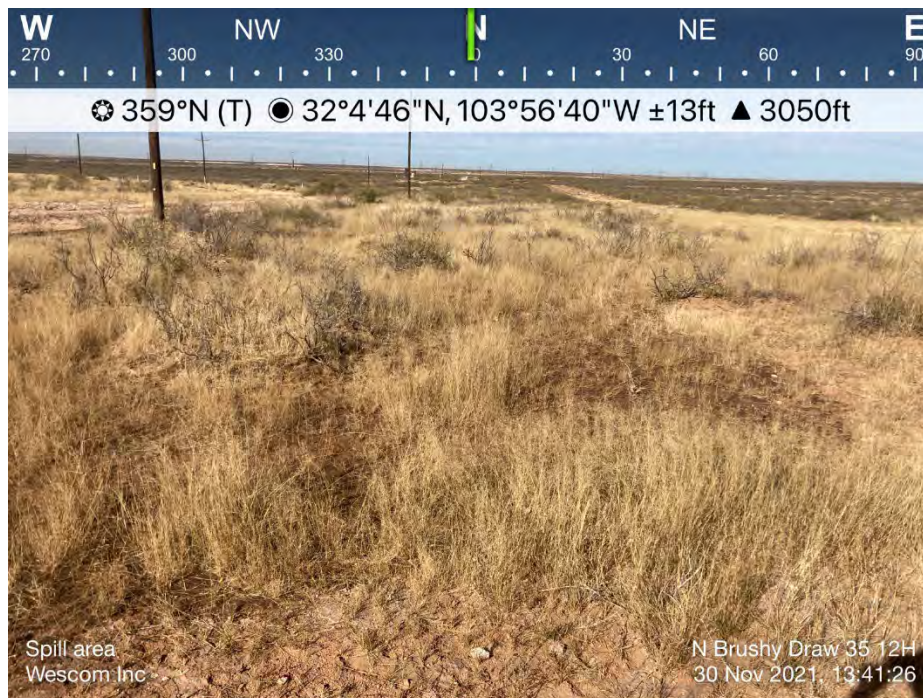
Spill Area

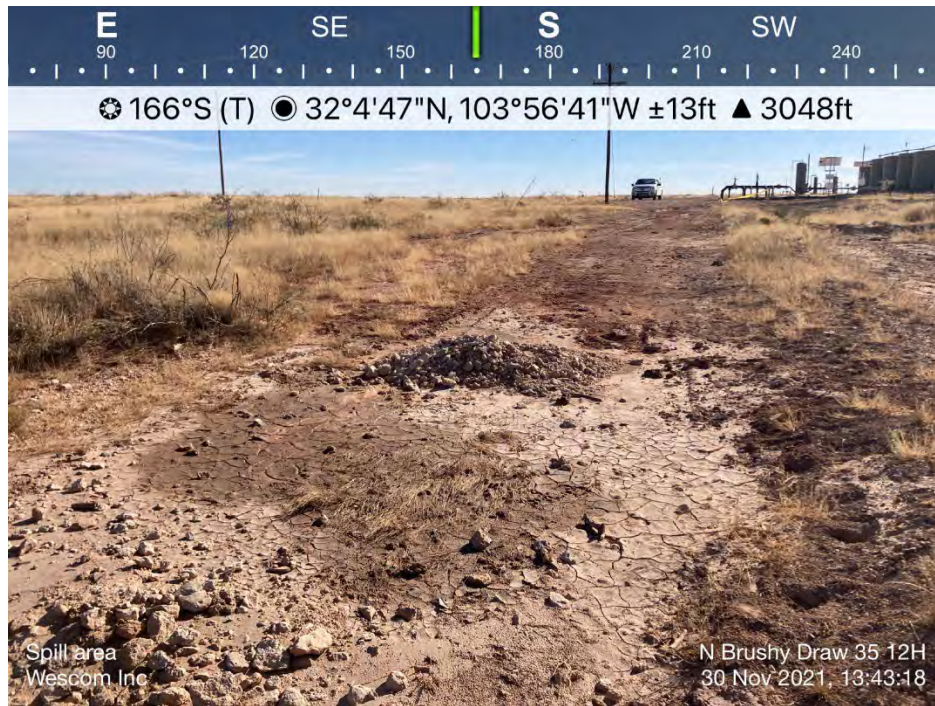
Spill Area

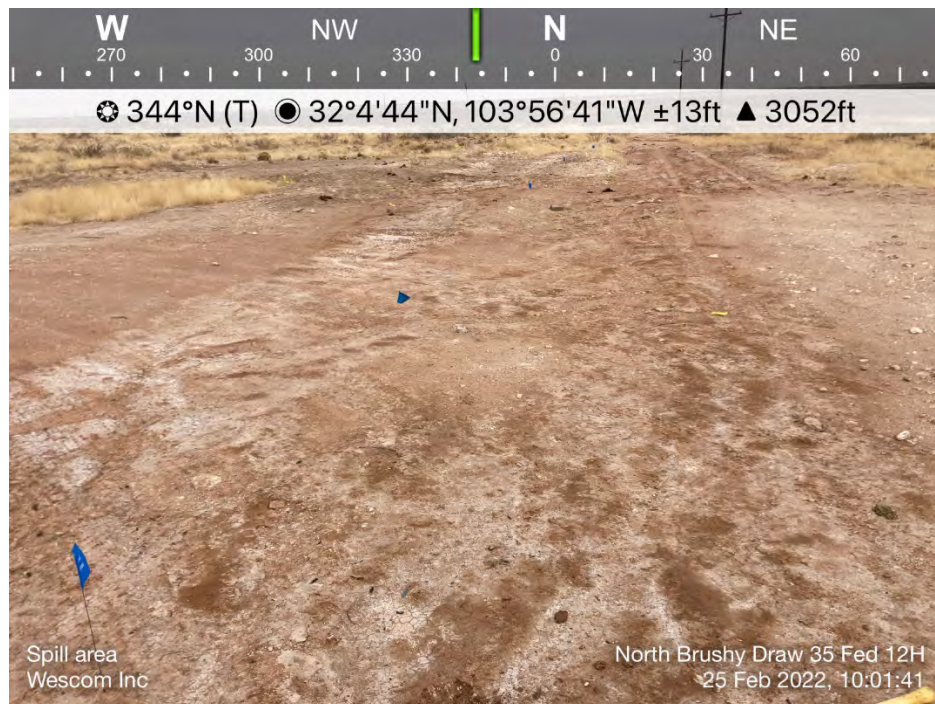
Spill Delineation

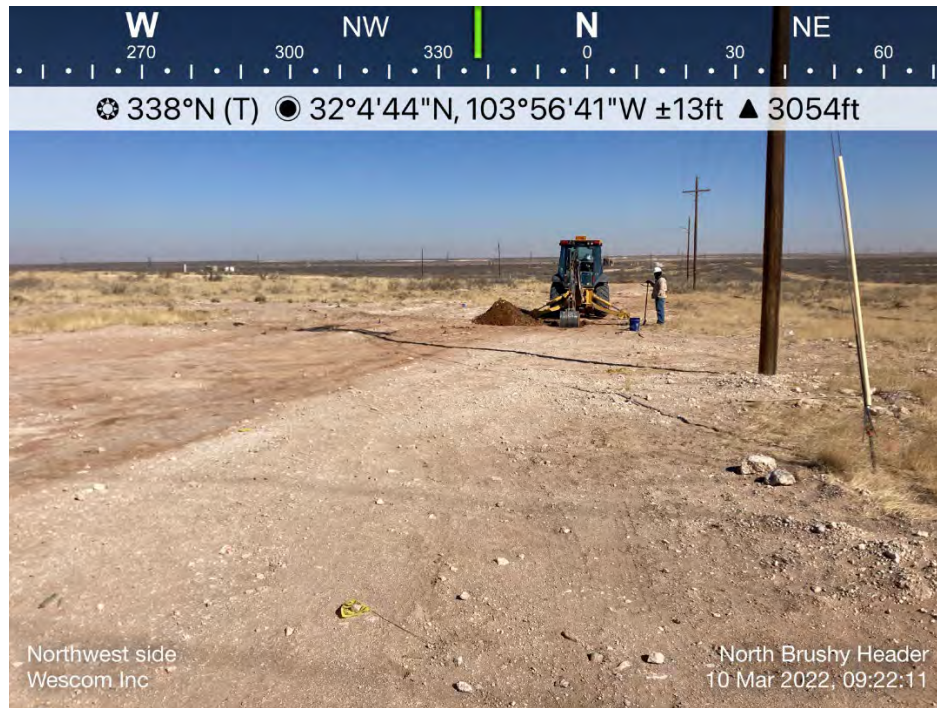
*Spill Delineation*

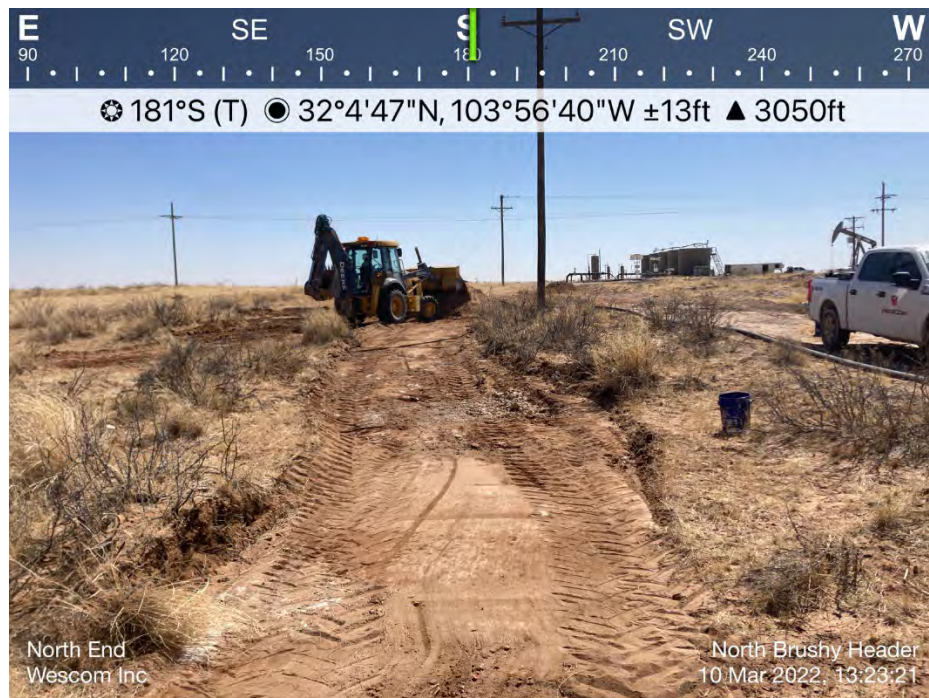
*Initial Scrape*

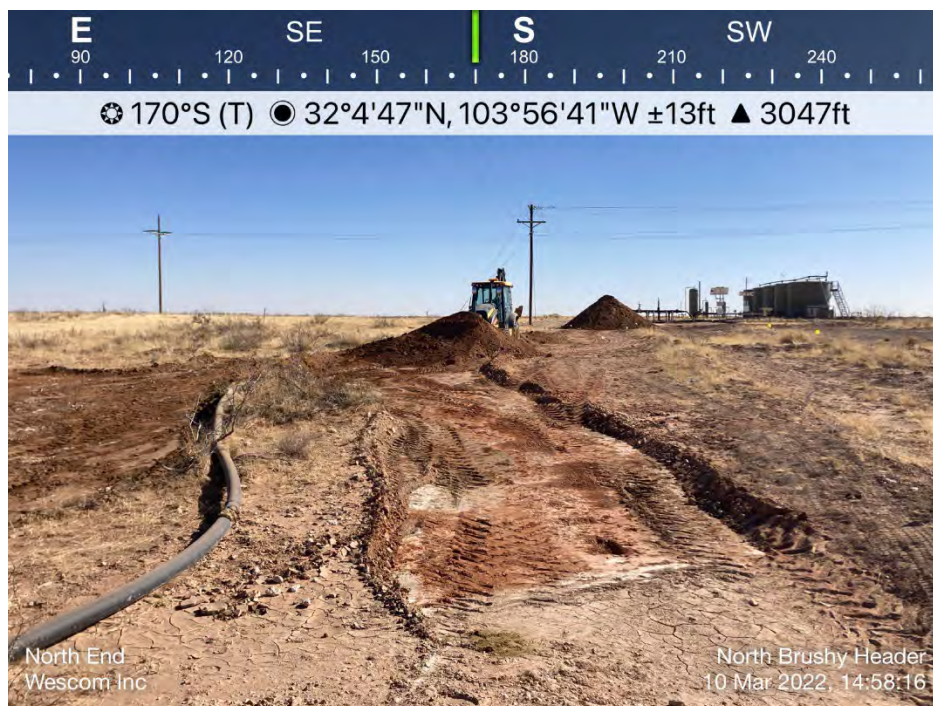
Initial Scrape and Contaminated Soil Pile

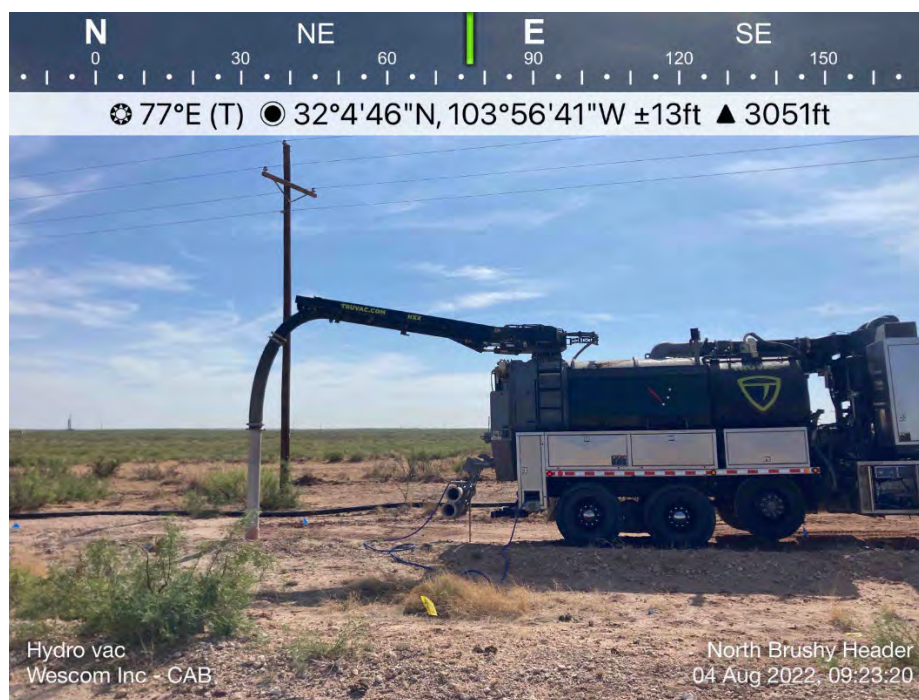
Hydrovac Water and Gas Lines

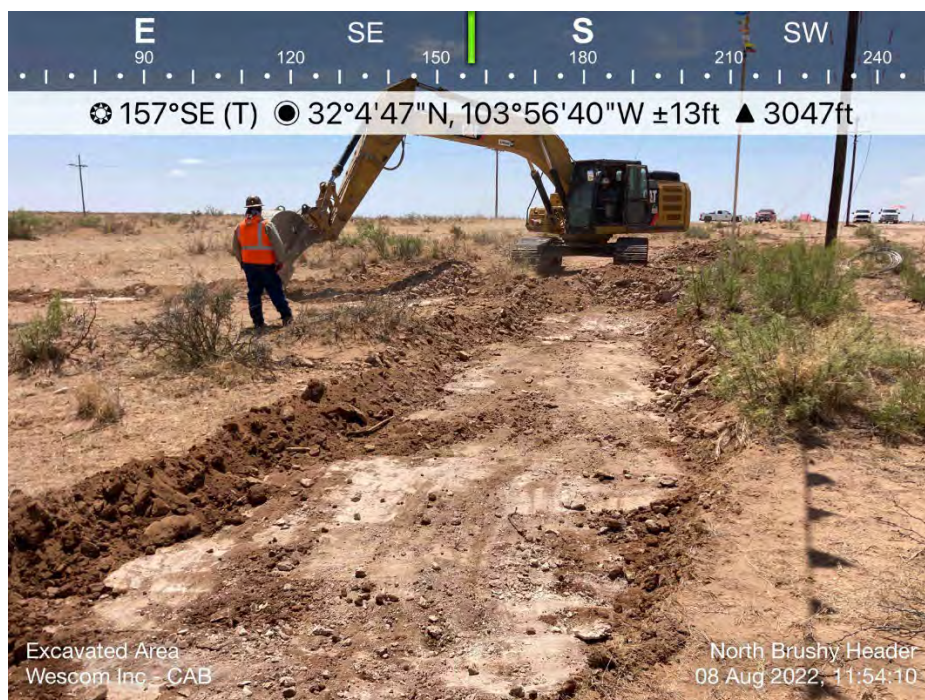
Excavation of Spill Area – North End

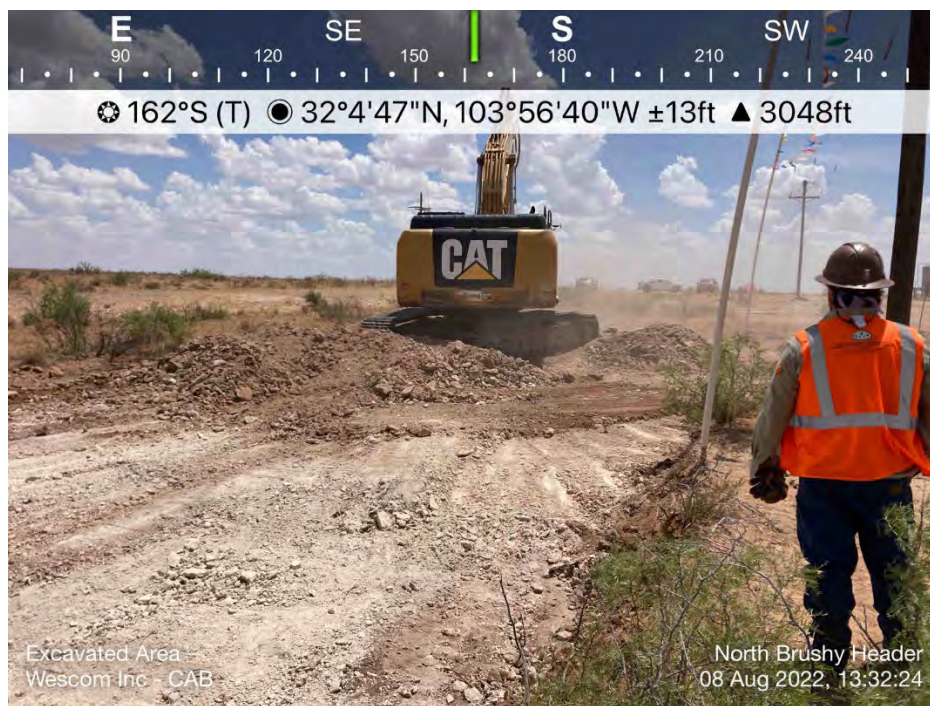
Excavation of Spill Area – Northeast Side

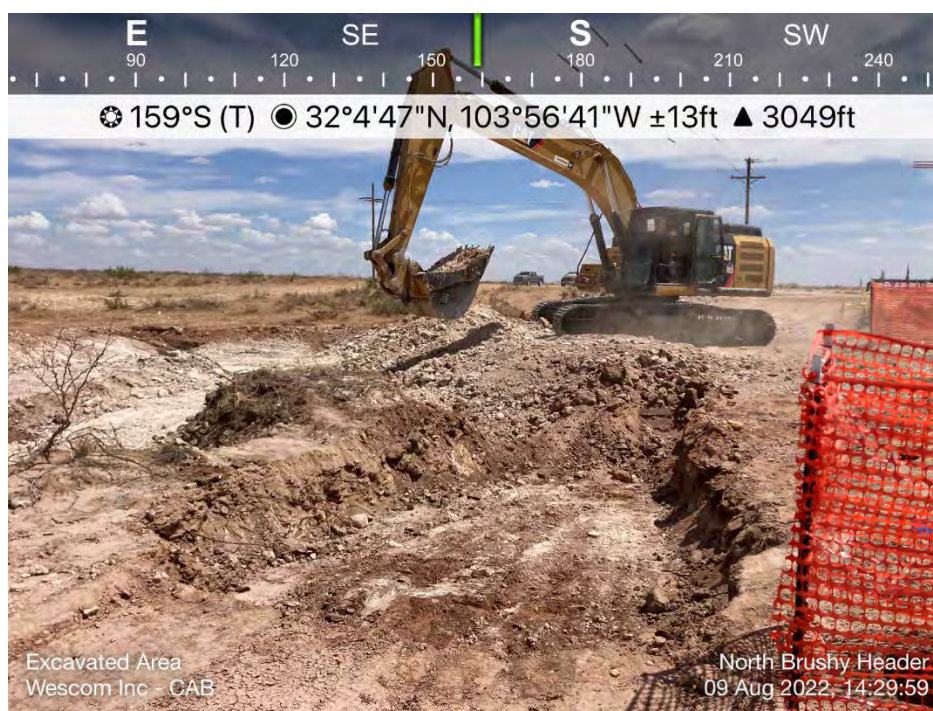
Excavation of Spill Area – Center of Spill

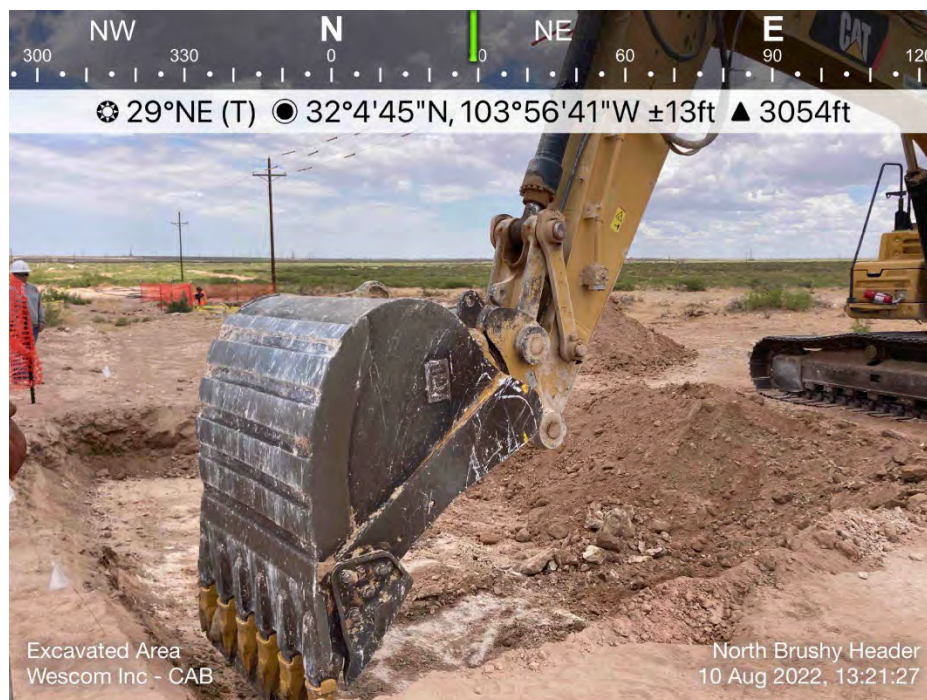
Excavation of Spill Area - Between Pipelines

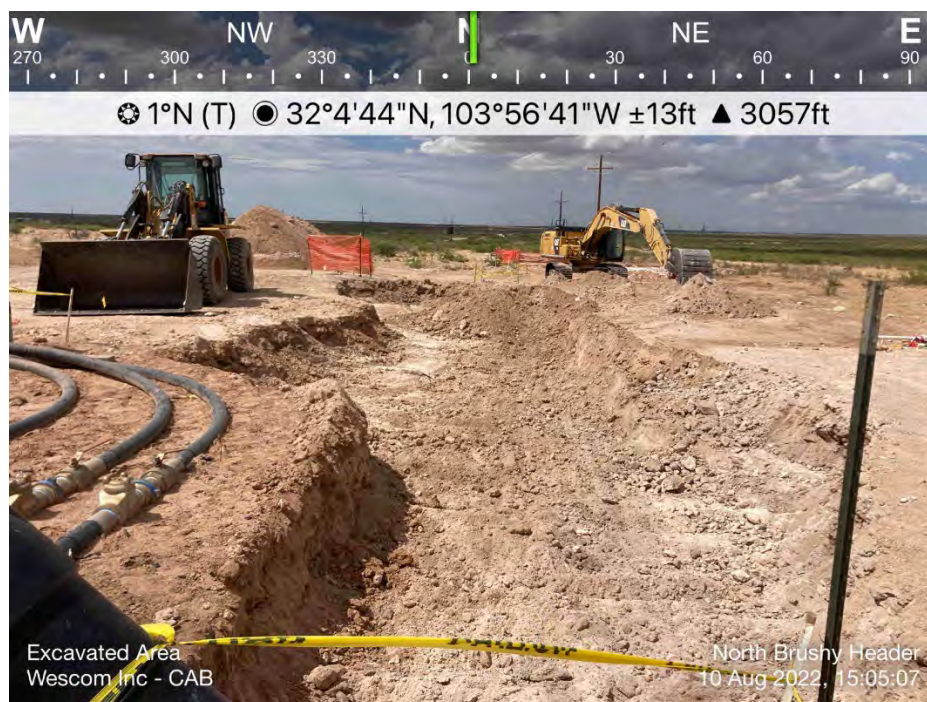
Excavation of Spill Area - South End

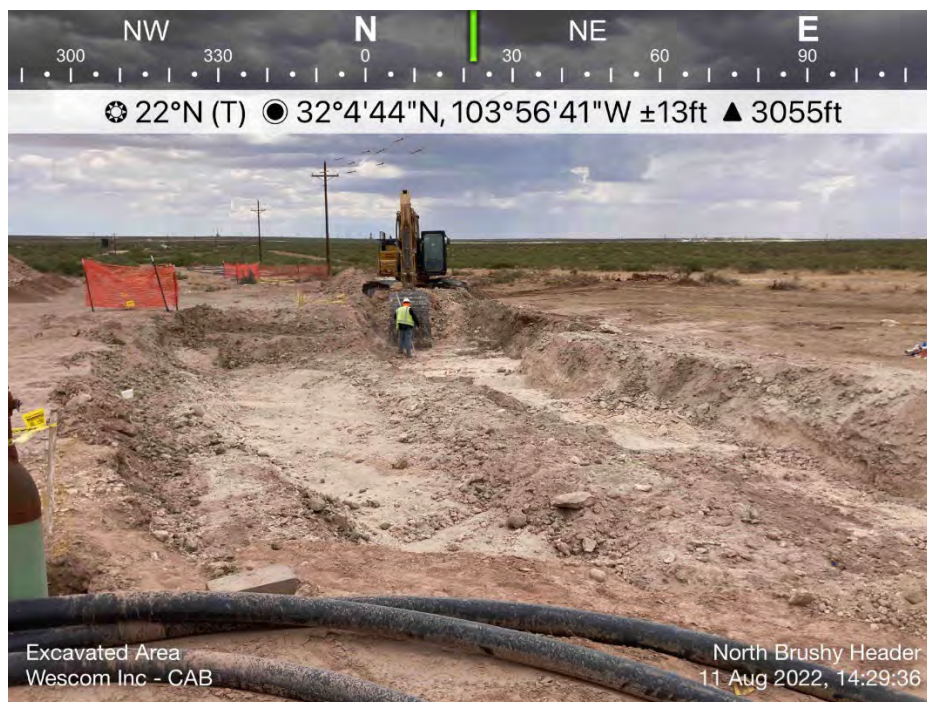
Excavation of Spill Area - South End

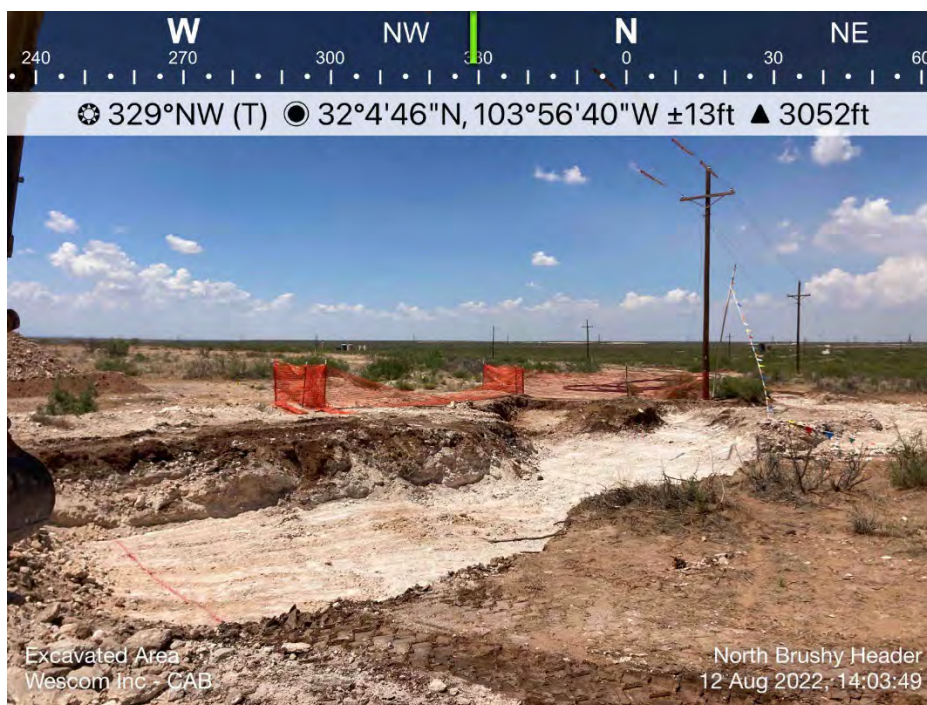
Excavation of Spill Area - Center of Spill

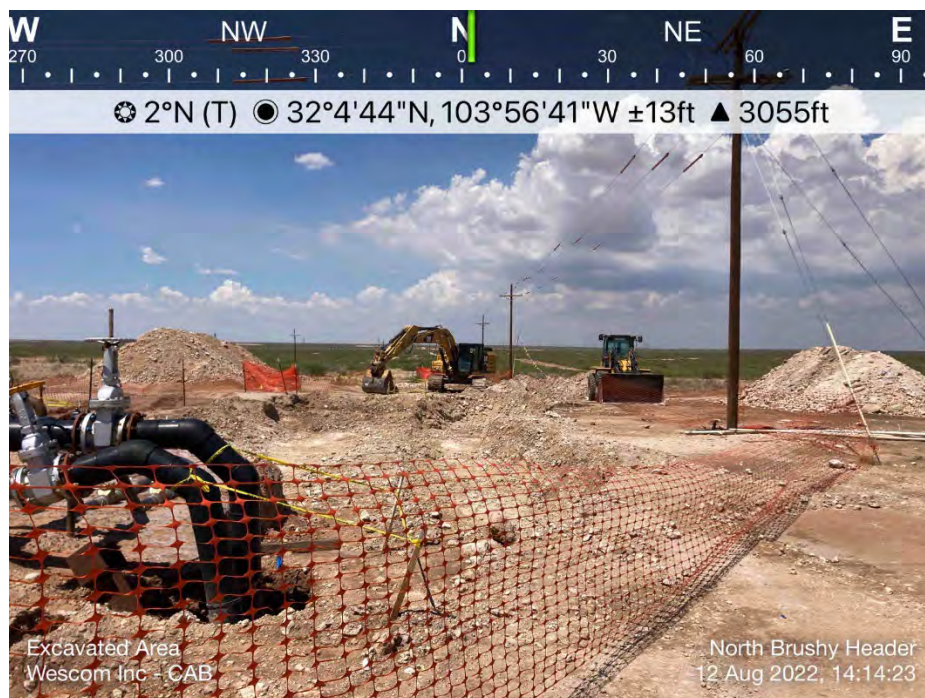
Excavation of Spill Area – South Side

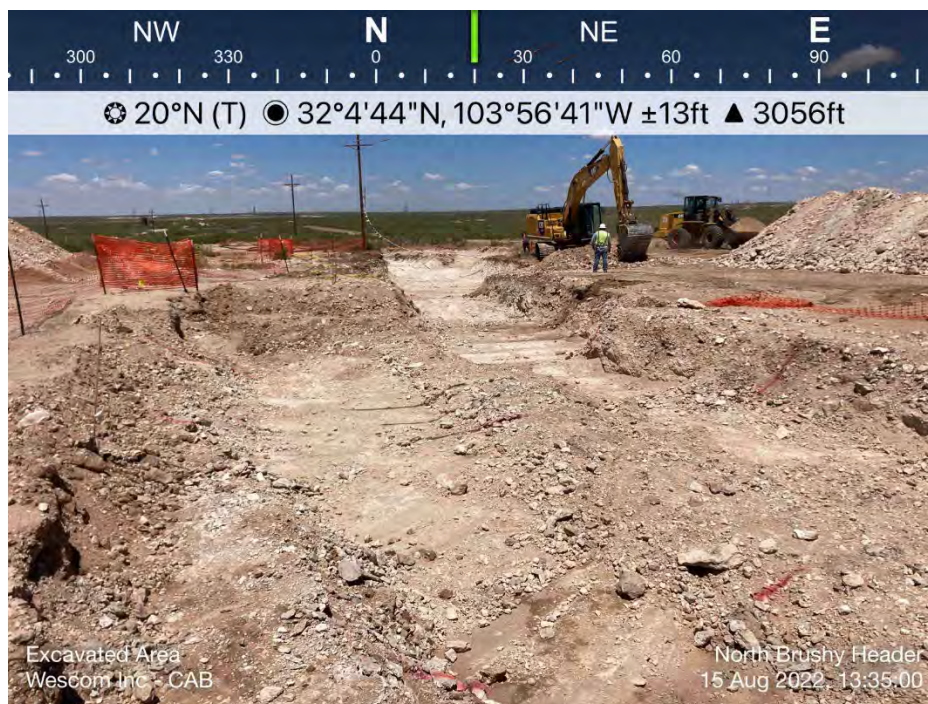
Excavated Area Completed

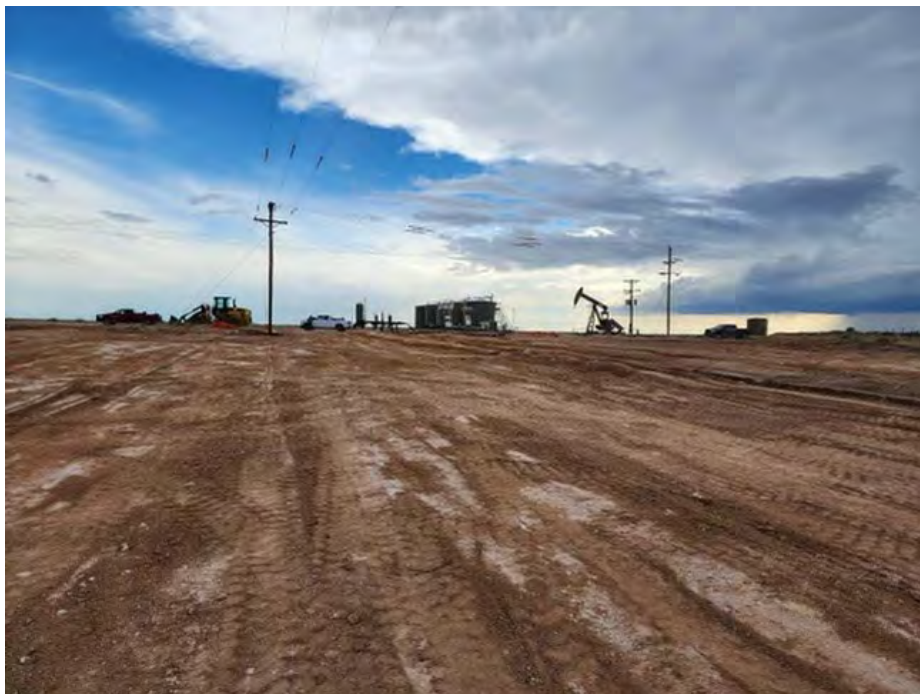
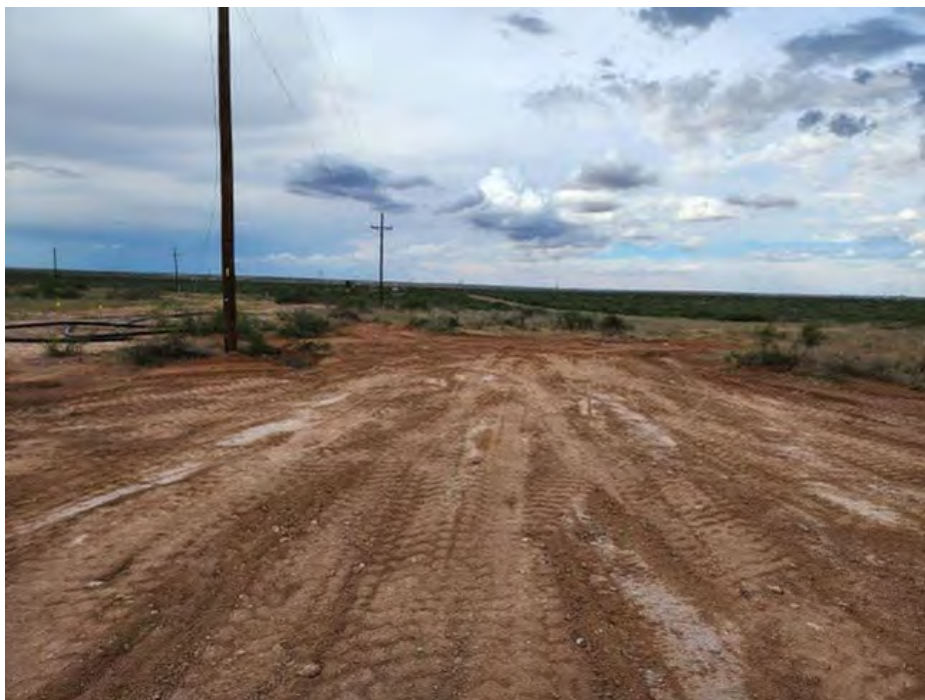
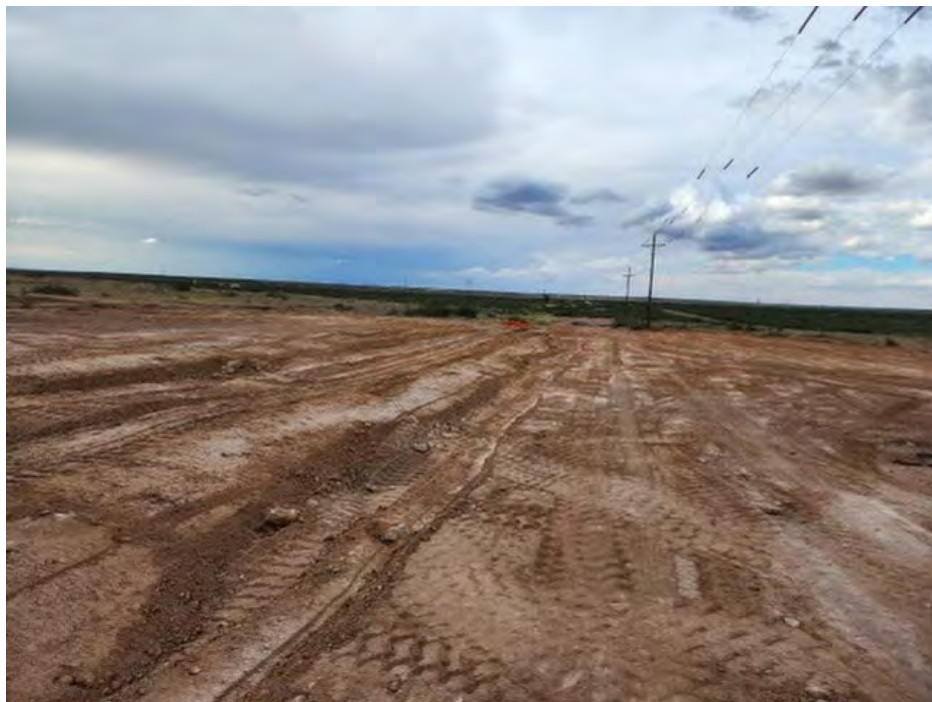
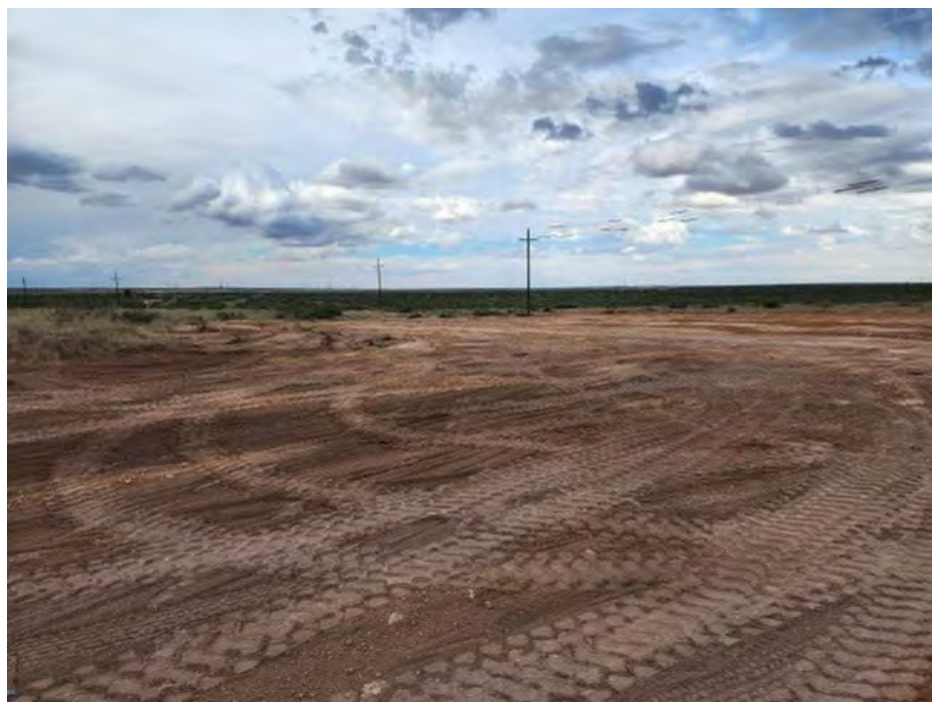
*Backfill and Reseed Completed*
