**Re: Release Characterization and Closure Request
ConocoPhillips
Heritage Concho
Loco Hills SWD Main Line Release
Unit Letter G, Section 24, Township 17 South, Range 30 East
Eddy County, New Mexico
Incident ID# nAB1514733807**

Release Characterization and Closure Request
February 11, 2022

**LOCO HILLS SWD MAINLINE
OVERVIEW MAP**

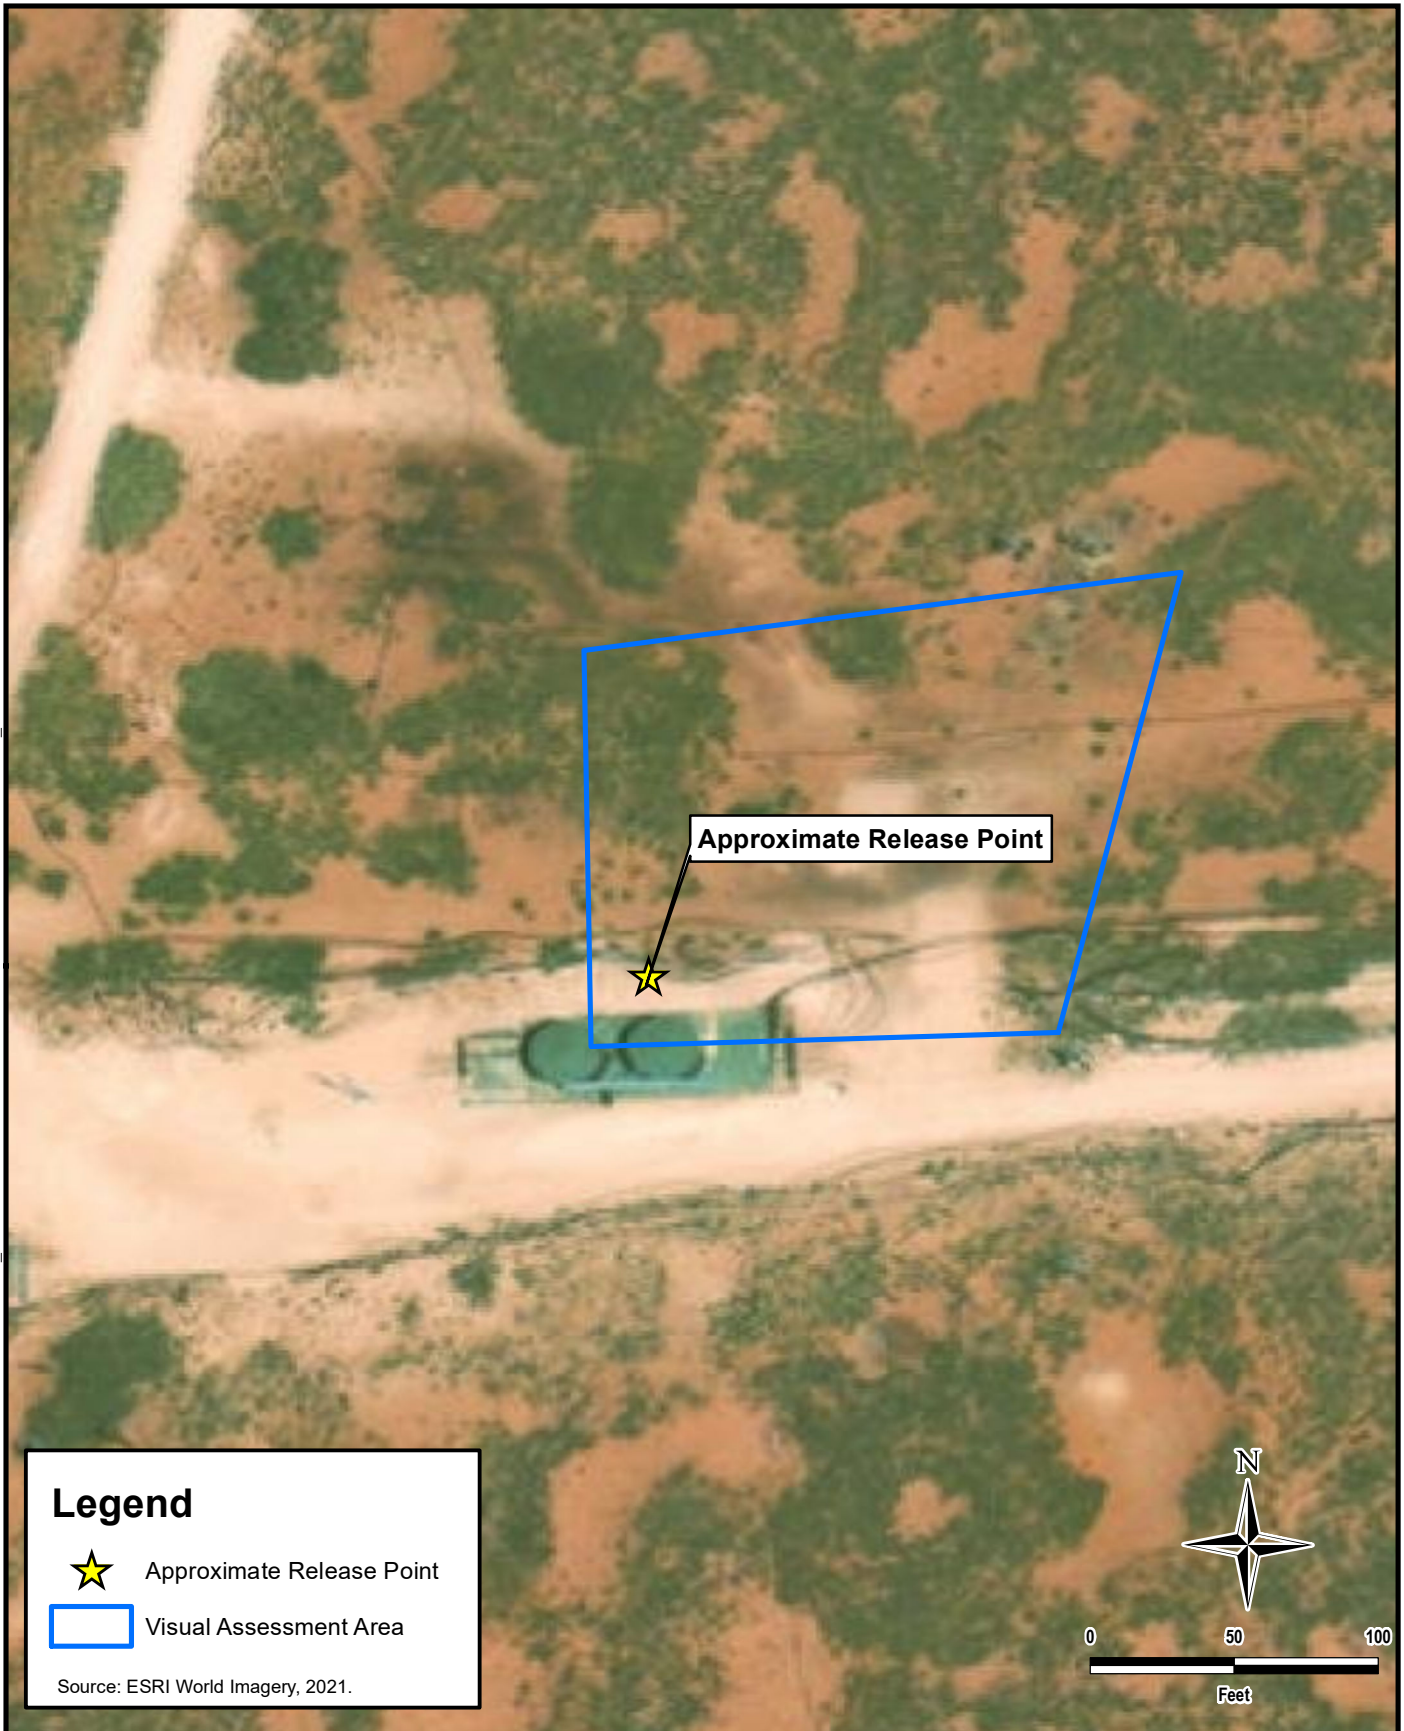
**LOCO HILLS SWD MAINLINE
VISUAL ASSESSMENT AREA**

Tetra Tech conducted a visual Site inspection on December 28, 2021 to observe the status of revegetation and obtain photographic documentation of current Site conditions. Based on observations made by Tetra Tech's field personnel and photographic evidence acquired during the site monitoring, vegetation has established in the former release Site. Figure 3 is attached as a reference to depict the area observed during Tetra Tech's site monitoring in December 2021.

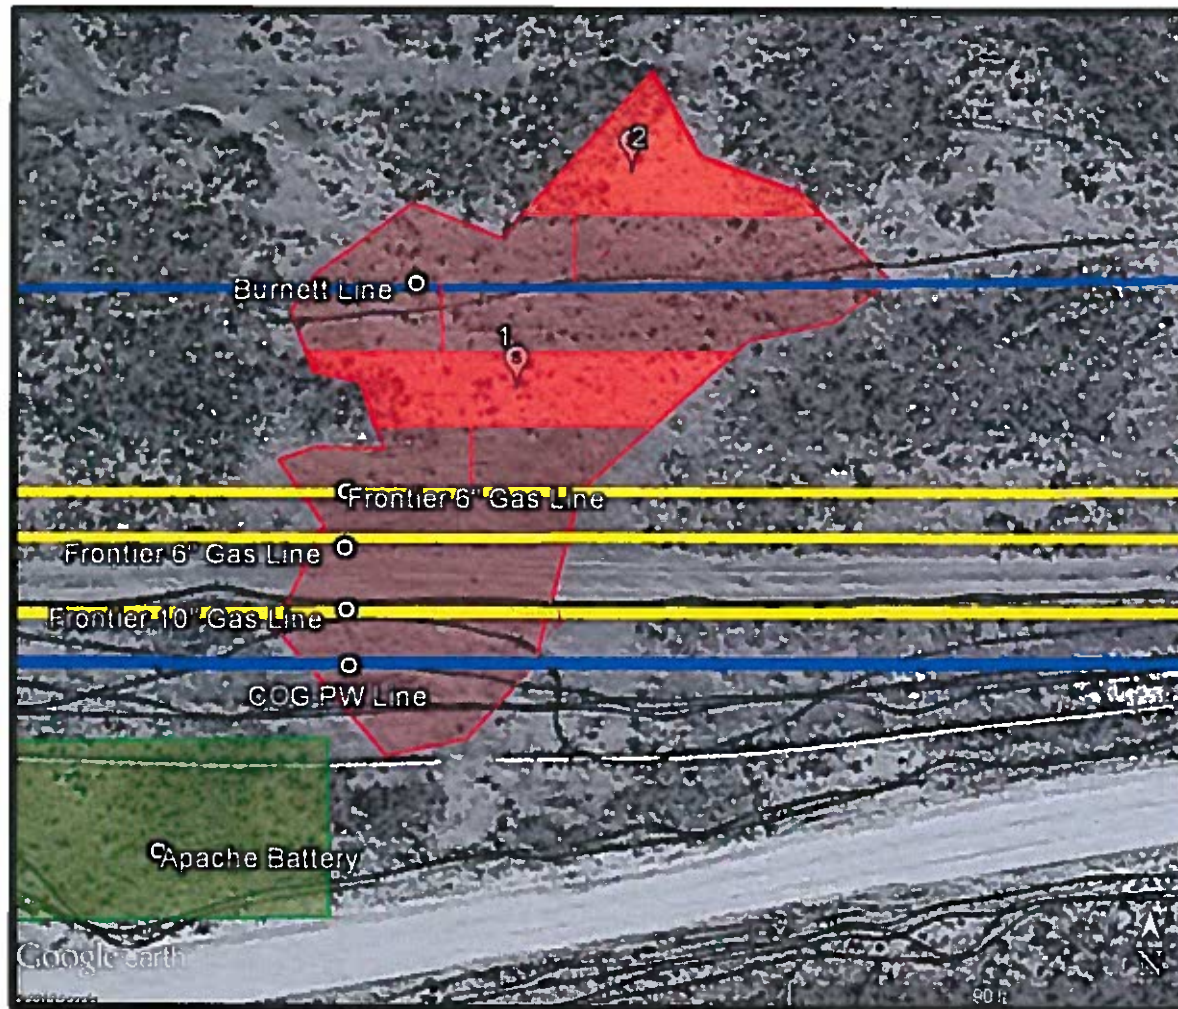
Site Diagram and Summary Table
Laboratory Analysis

The release was caused when A.R.C. Power-Line Construction drilled into COG's Loco Hills SWD Mainline while setting a power pole for an Apache Corporation Facility. An area measuring approximately 9340 square feet was impacted to the north of the Apache facility. A hydrovac crew was called into daylight buried lines. In addition to the 8" COG SWD line, 4 other lines belonging to Frontier and Burnett were discovered. Frontier will not allow excavation within 15' of a buried pipeline.

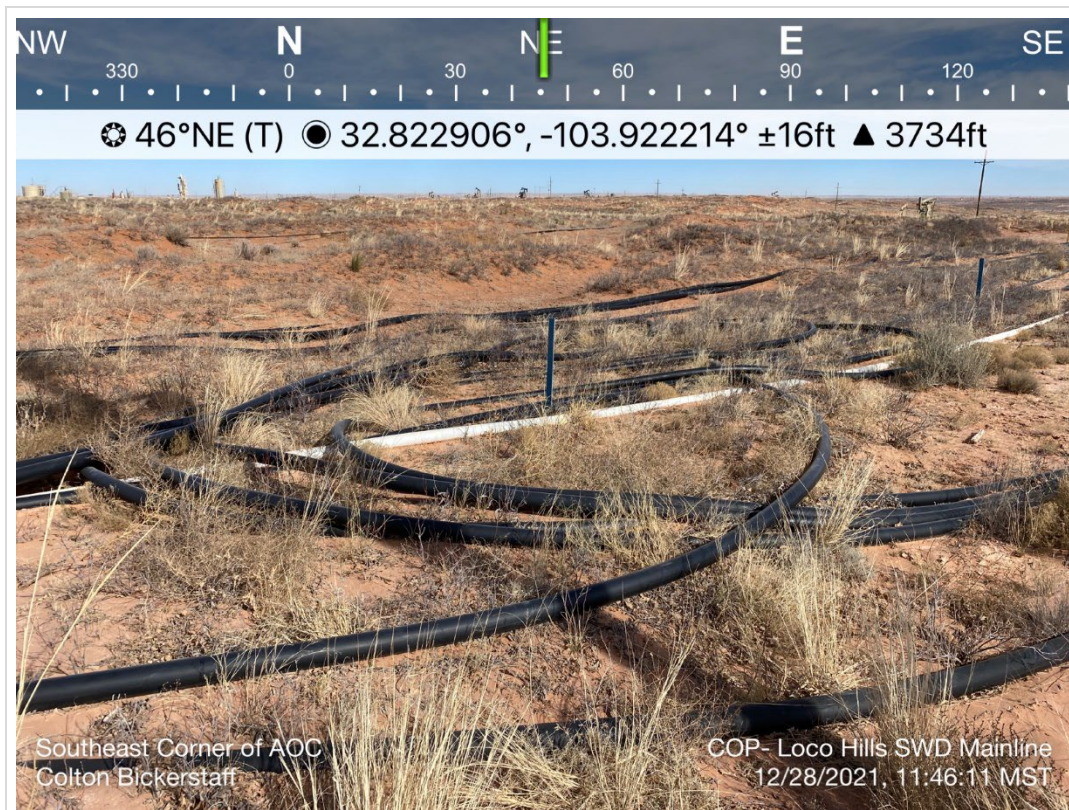
| TETRA TECH, INC. PROJECT NO. 212C-MD-02621 | DESCRIPTION | View northeast. Southeast corner of visually assessed area. | 1 |

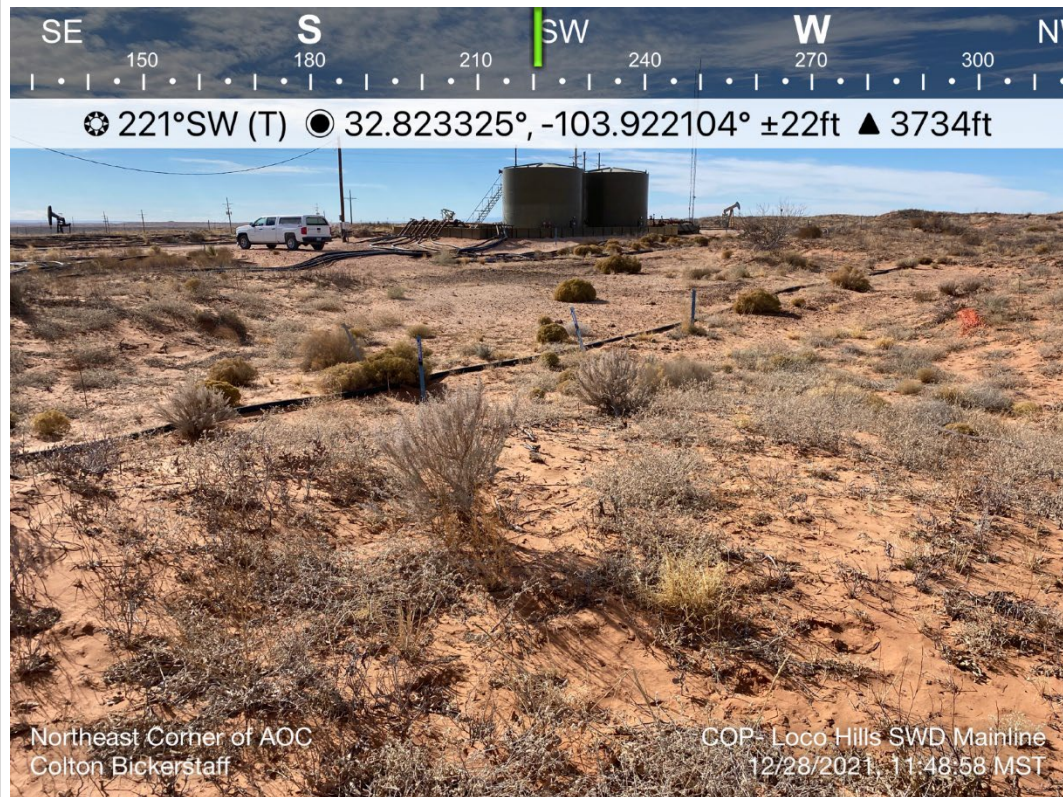
| TETRA TECH, INC. PROJECT NO. 212C-MD-02621 | DESCRIPTION | View southwest. Northeast of tank battery. | 2 |

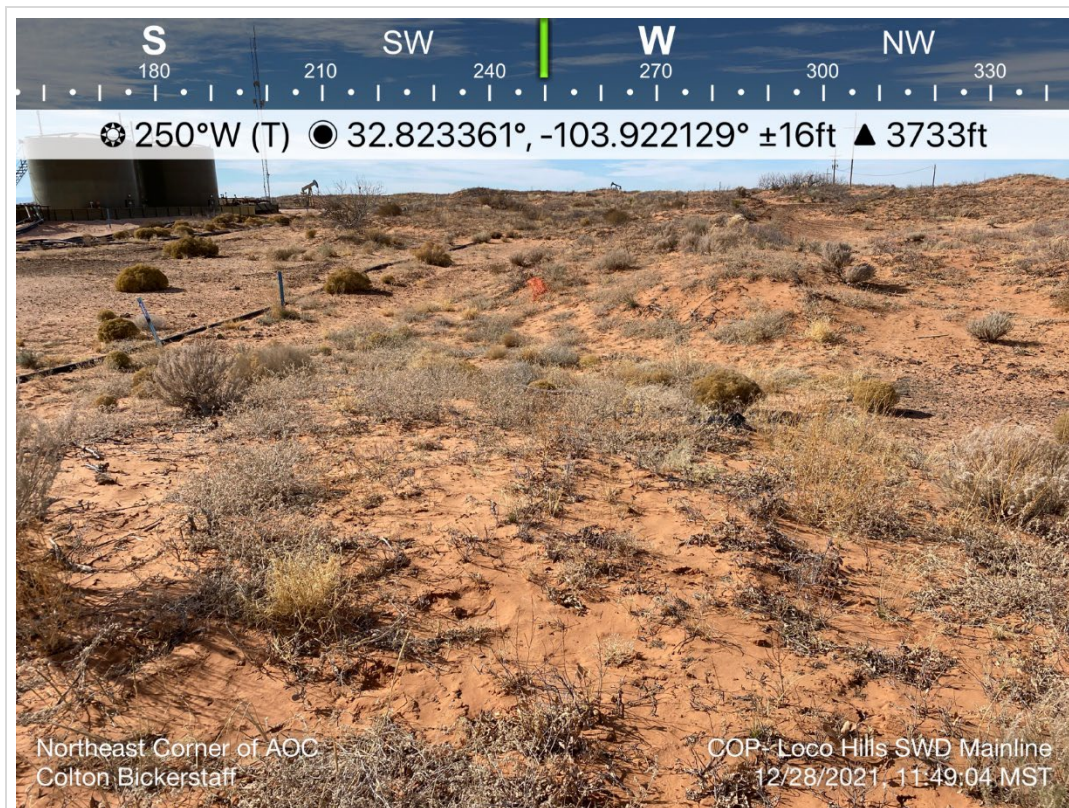
| TETRA TECH, INC. PROJECT NO. 212C-MD-02621 | DESCRIPTION | View west-southwest. Northeast corner of former release area. | 5 |

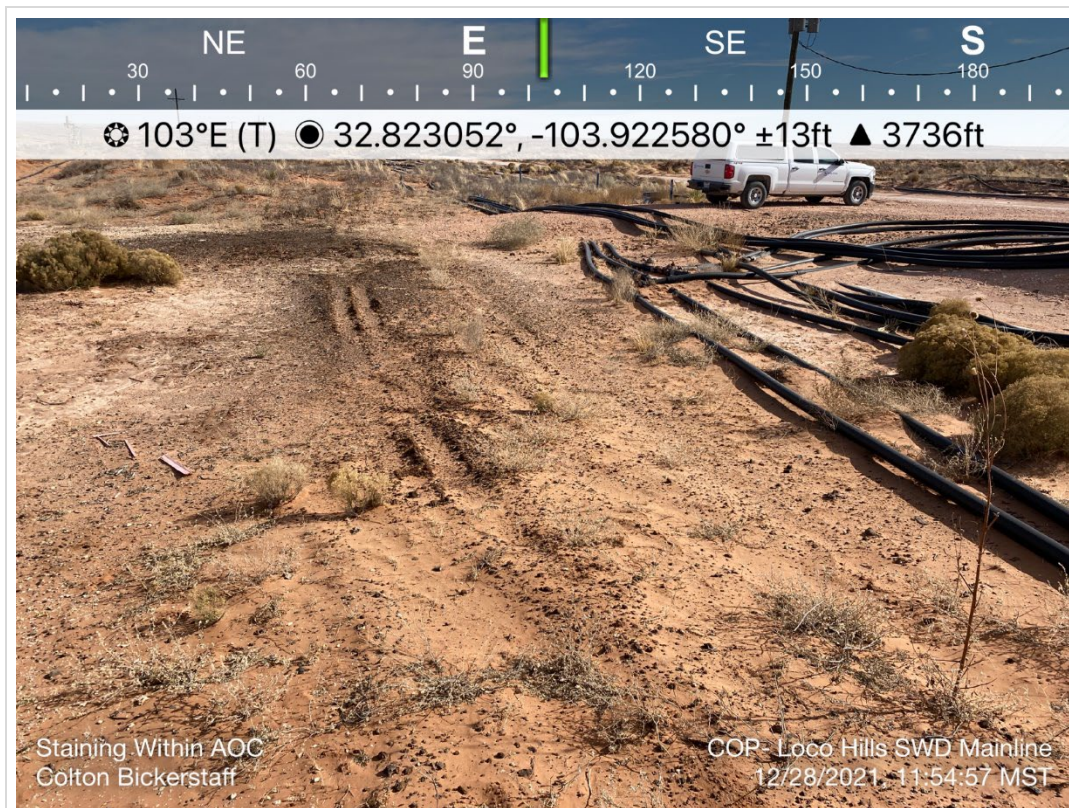
Moderate asphaltic staining was observed during the December 2021 site visit, as shown in the photographic documentation presented in Appendix F. Considering that the May 2015 Concho release being addressed in this report was a produced water release, the asphaltic staining is considered unrelated. A NMOCD file search was conducted, along with an aerial imagery review, to identify the source of the observed asphaltic staining. Firstly, a review of aerial imagery from February 2014 revealed evidence of an apparent hydrocarbon release in the pasture immediately northwest of the May 2015 release extent. Imagery from February 2017 revealed further evidence of possible remedial actions taken at that Site. The historical aerial imagery is presented in Appendix G.

| TETRA TECH, INC. PROJECT NO. 212C-MD-02621 | DESCRIPTION | View east. Eastern portion of visually assessed area. Surface staining visible. | 7 |

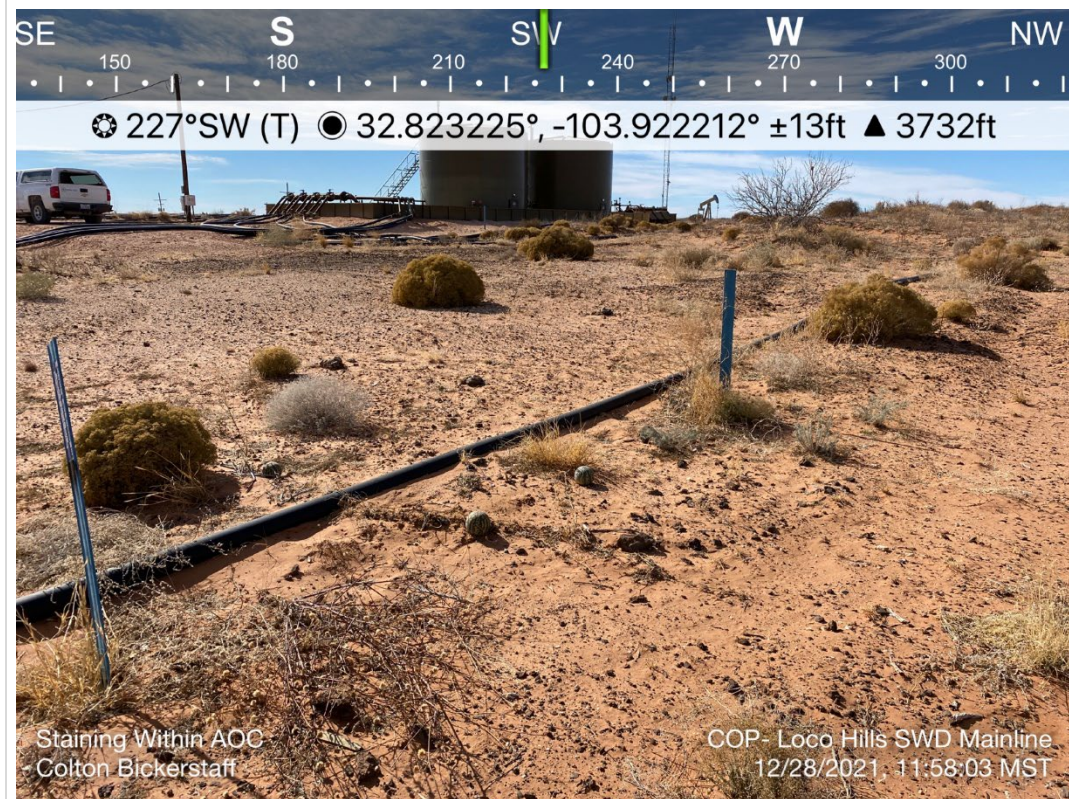
| TETRA TECH, INC. PROJECT NO. 212C-MD-02621 | DESCRIPTION | View southwest. Northeast of tanks. Surface staining visible. | 8 |
