Closure Report

Voni East Fed Tank Battery
Eddy County, New Mexico
Incident # **nAPP2202659785**
B-21-26S-31E

Subject: **Closure Report**
 Voni East Fed Tank Battery
 Eddy County, New Mexico
 Incident # **nAPP2202659785**

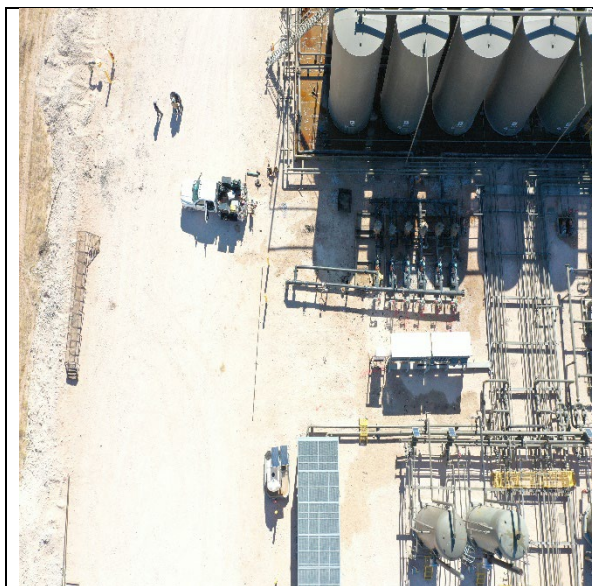
Photograph No.1 Description:

Aerial of spill area at source.

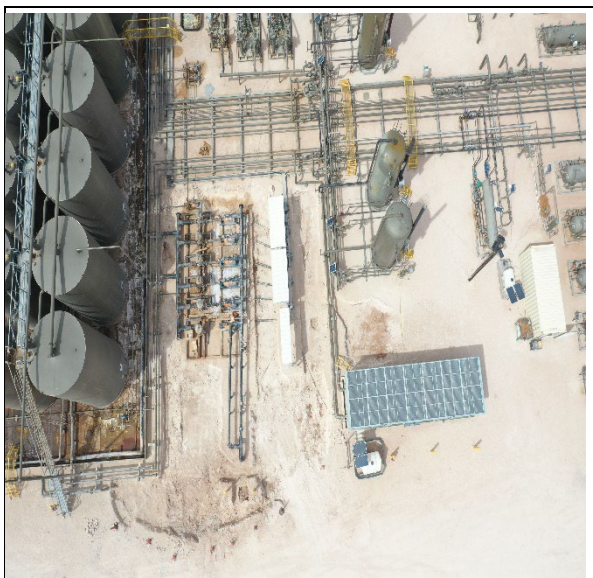
Photograph No.3 Description:

Aerial of excavation at source.

- The impacted area of the pad was excavated to depths from 2 feet to 3 feet in depth. and to the horizontal extent that sidewalls tested below the remediation levels for NMOCD Table 1 guidelines. All surface staining was removed. Laboratory analysis confirms that NMOCD closure criteria for soil remediation vertically and horizontally has been achieved.

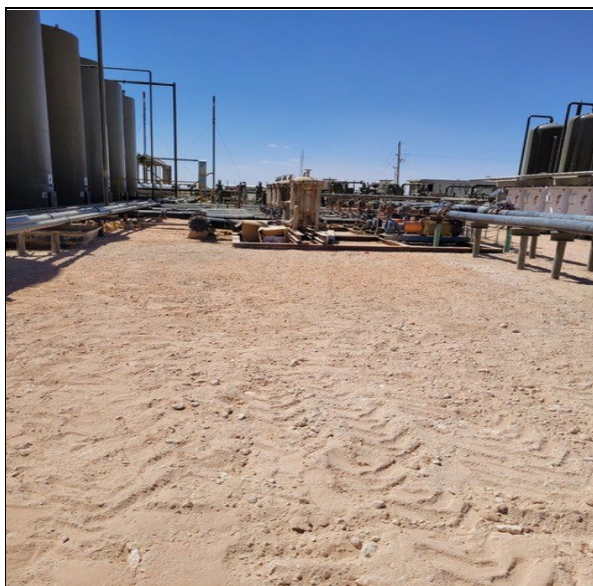
Photograph No.5 Description:

Backfill at source and returned to grade.

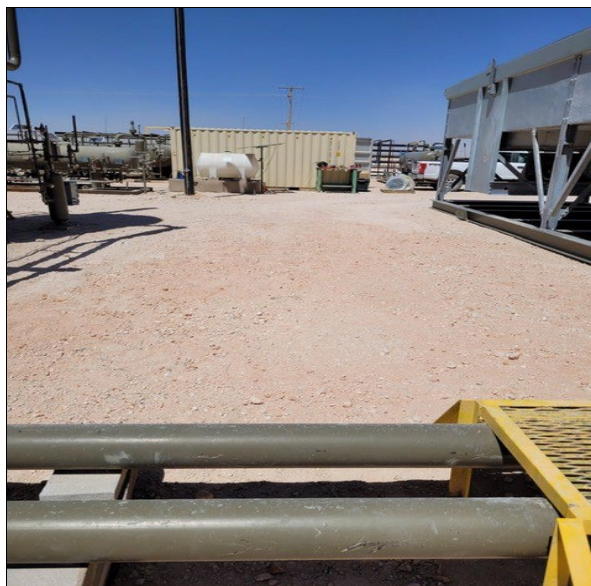
Photograph No.6 Description:

North side backfilled and restored to grade.

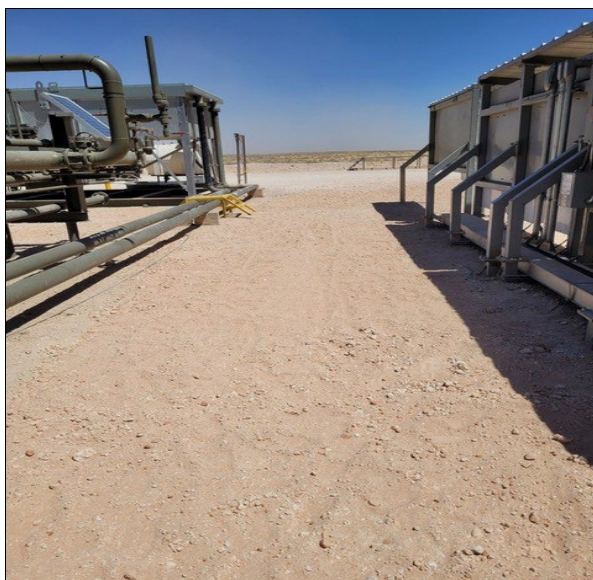
Photograph No.5 Description:

Backfill north side of electrical units

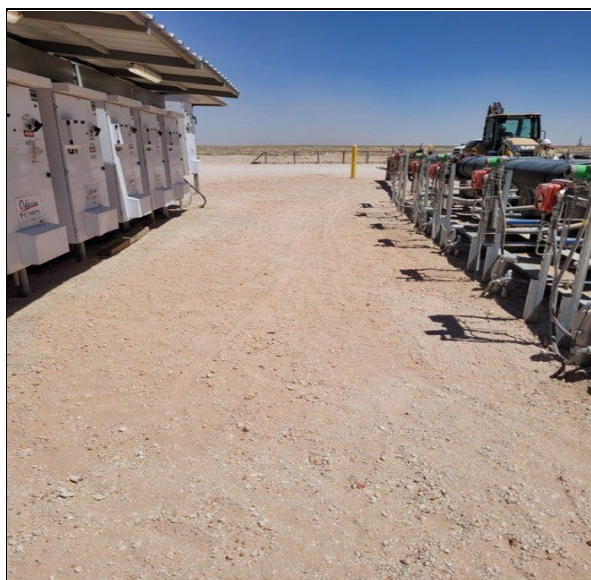
Photograph No.6 Description:

Backfill south side of electrical units
