Closure Report

Site Name:	Blue Jay Federal #001H
Company:	COG Operating LLC
Legal Description:	U/L O, Section 18, T20S, R35E
County:	Lea County, NM
GPS Coordinates:	N 32.56627 W-103.49564

COG, Blue Jay Federal #001H

Leak date: 7/11/17
Lea County, NM
AP# 30-025-42338
1RP-4758

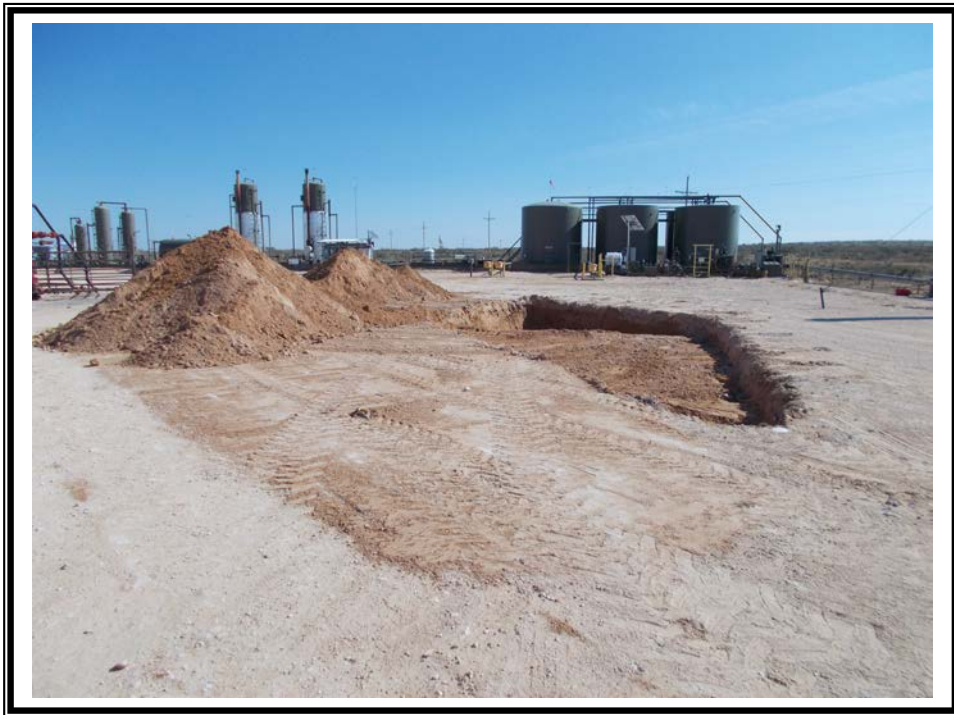
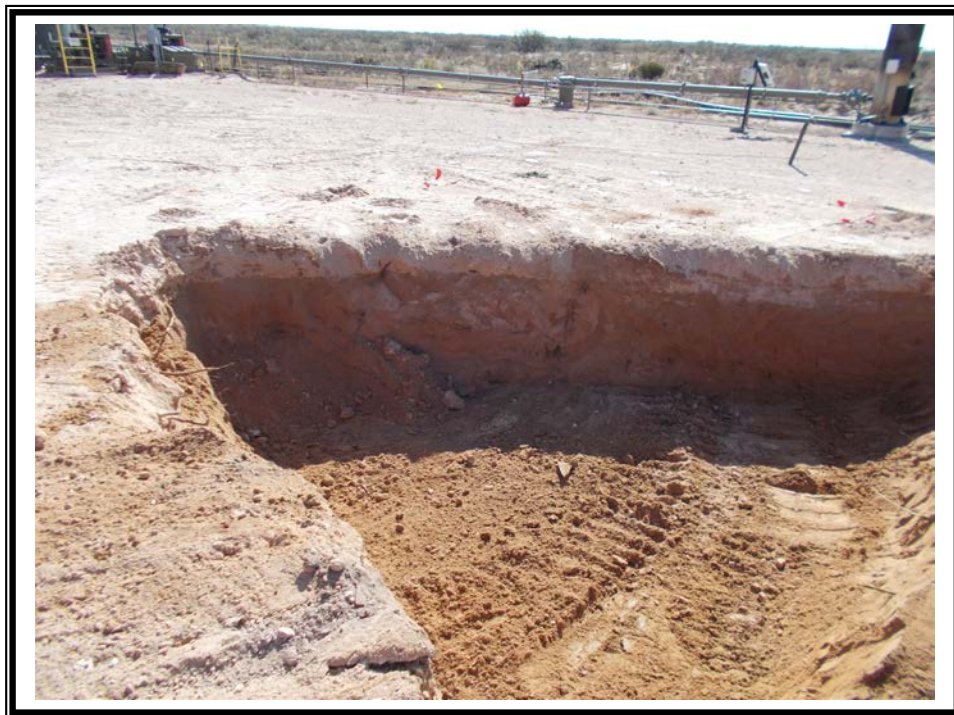
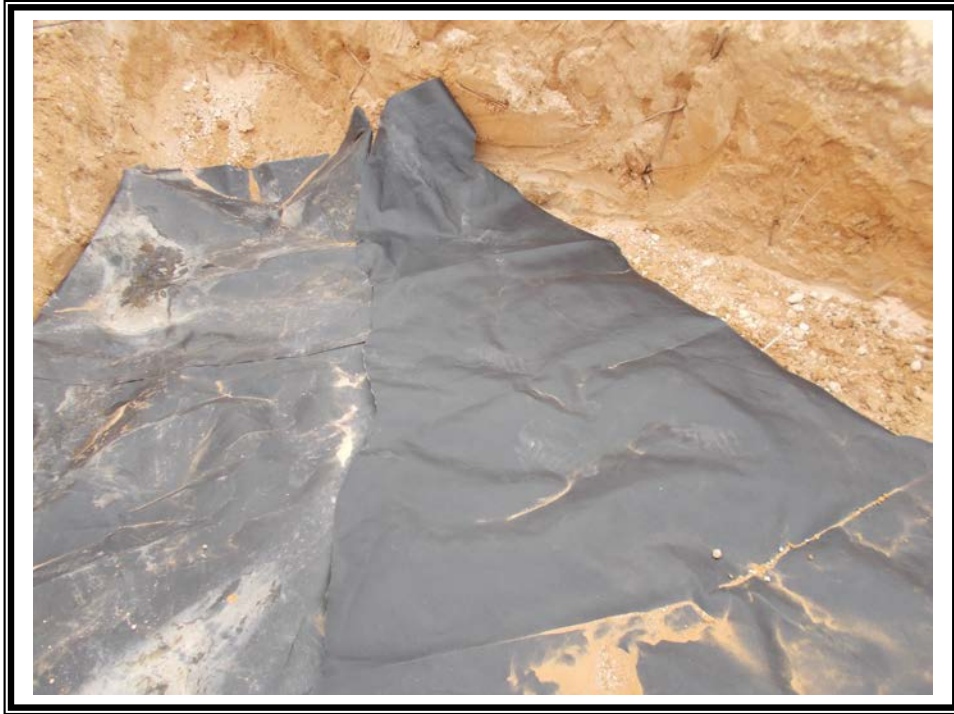
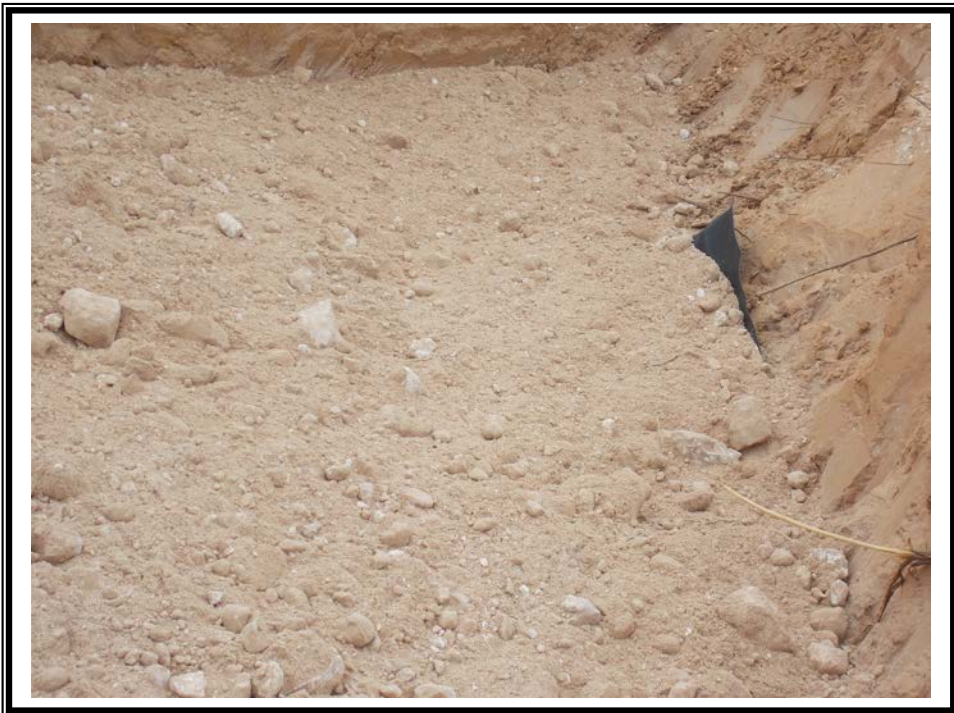
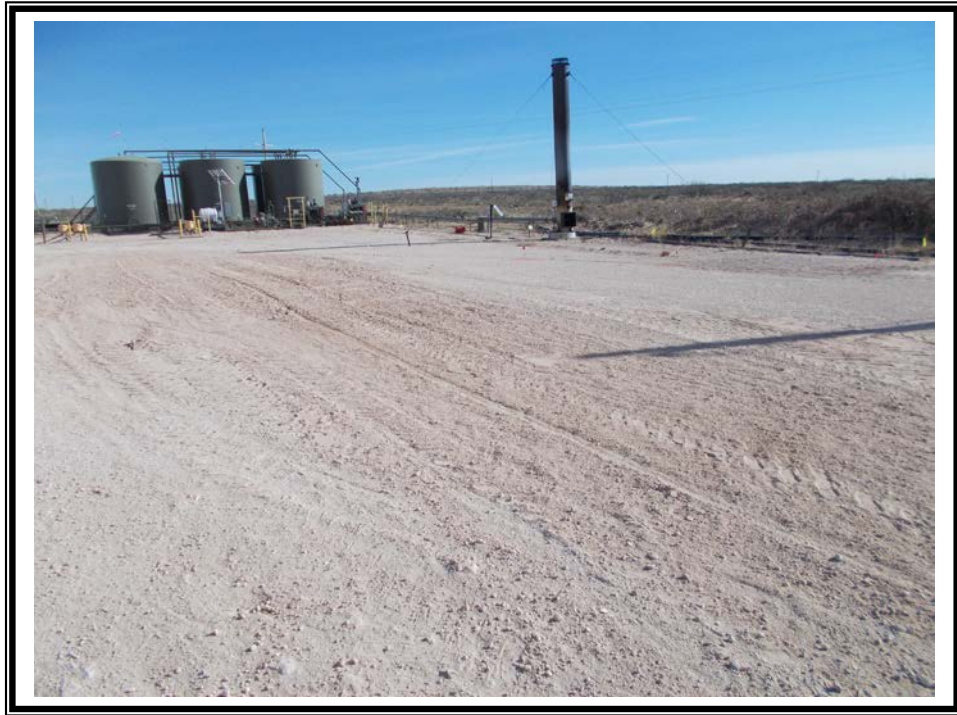
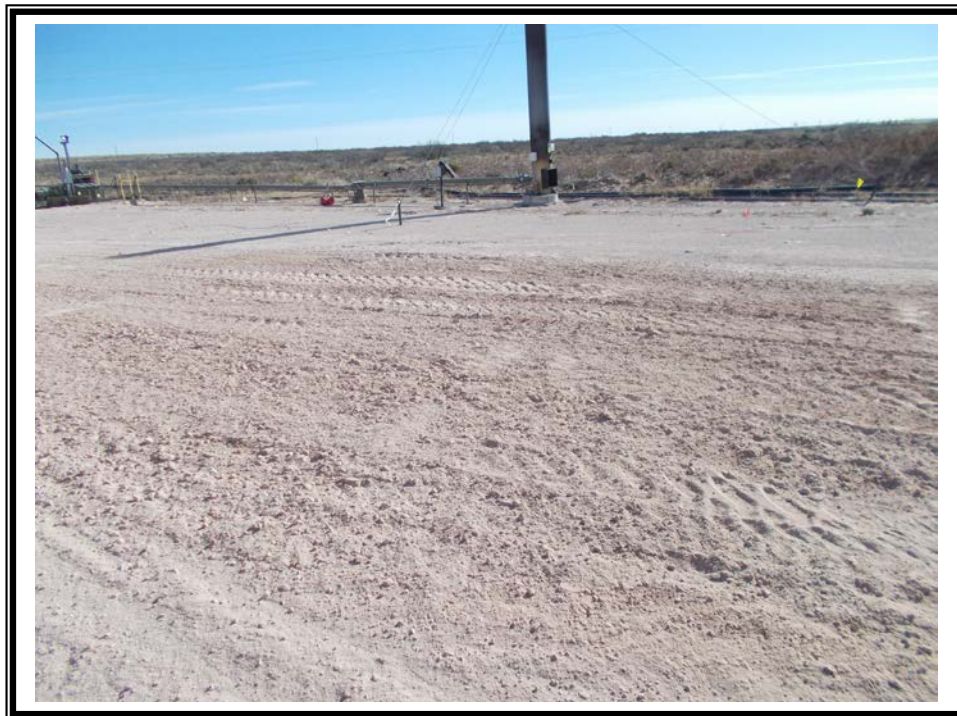
Initial C-141	Signed 7/16/2017
Final C-141	Signed 12/13/2018
Site Diagram	November 2018
Pictures	Remediation, liner, and backfill 11/19/18 to 11/26/18

Remediation Parameters:	Excavate the area of SP1 to a depth of 4 feet and put a liner in the excavation. Excavate the area of SP2 to a depth of 1 foot. Obtain confirmation bottom and sidewall samples. Backfill the site with clean soil.	
Remediation Activities:	11/19/18 to 11/26/18	
Plan Sent to OCD:	6/20/2018	Email from Cliff Brunson to Olivia Yu
OCD Approval of Plan:	7/17/2018	Email from Olivia Yu to Cliff Brunson
Plan Sent to BLM:	6/20/2018	Email from Cliff Brunson to Henryetta Price
BLM Approval of Plan:	7/6/2018	Email from Henryetta Price to Cliff Brunson
