**Closure Report**  
**Condor State #002H**  
**API#: 30-025-41025**  
**RP#: 1RP-5116**  
**DOR: June 30, 2018**  
**GPS: 32.740326 -103.481736**  
**Unit Letter C, Section 20, Township 18 South, Range 35 East**  
**Lea County, New Mexico**

# Condor State #002H

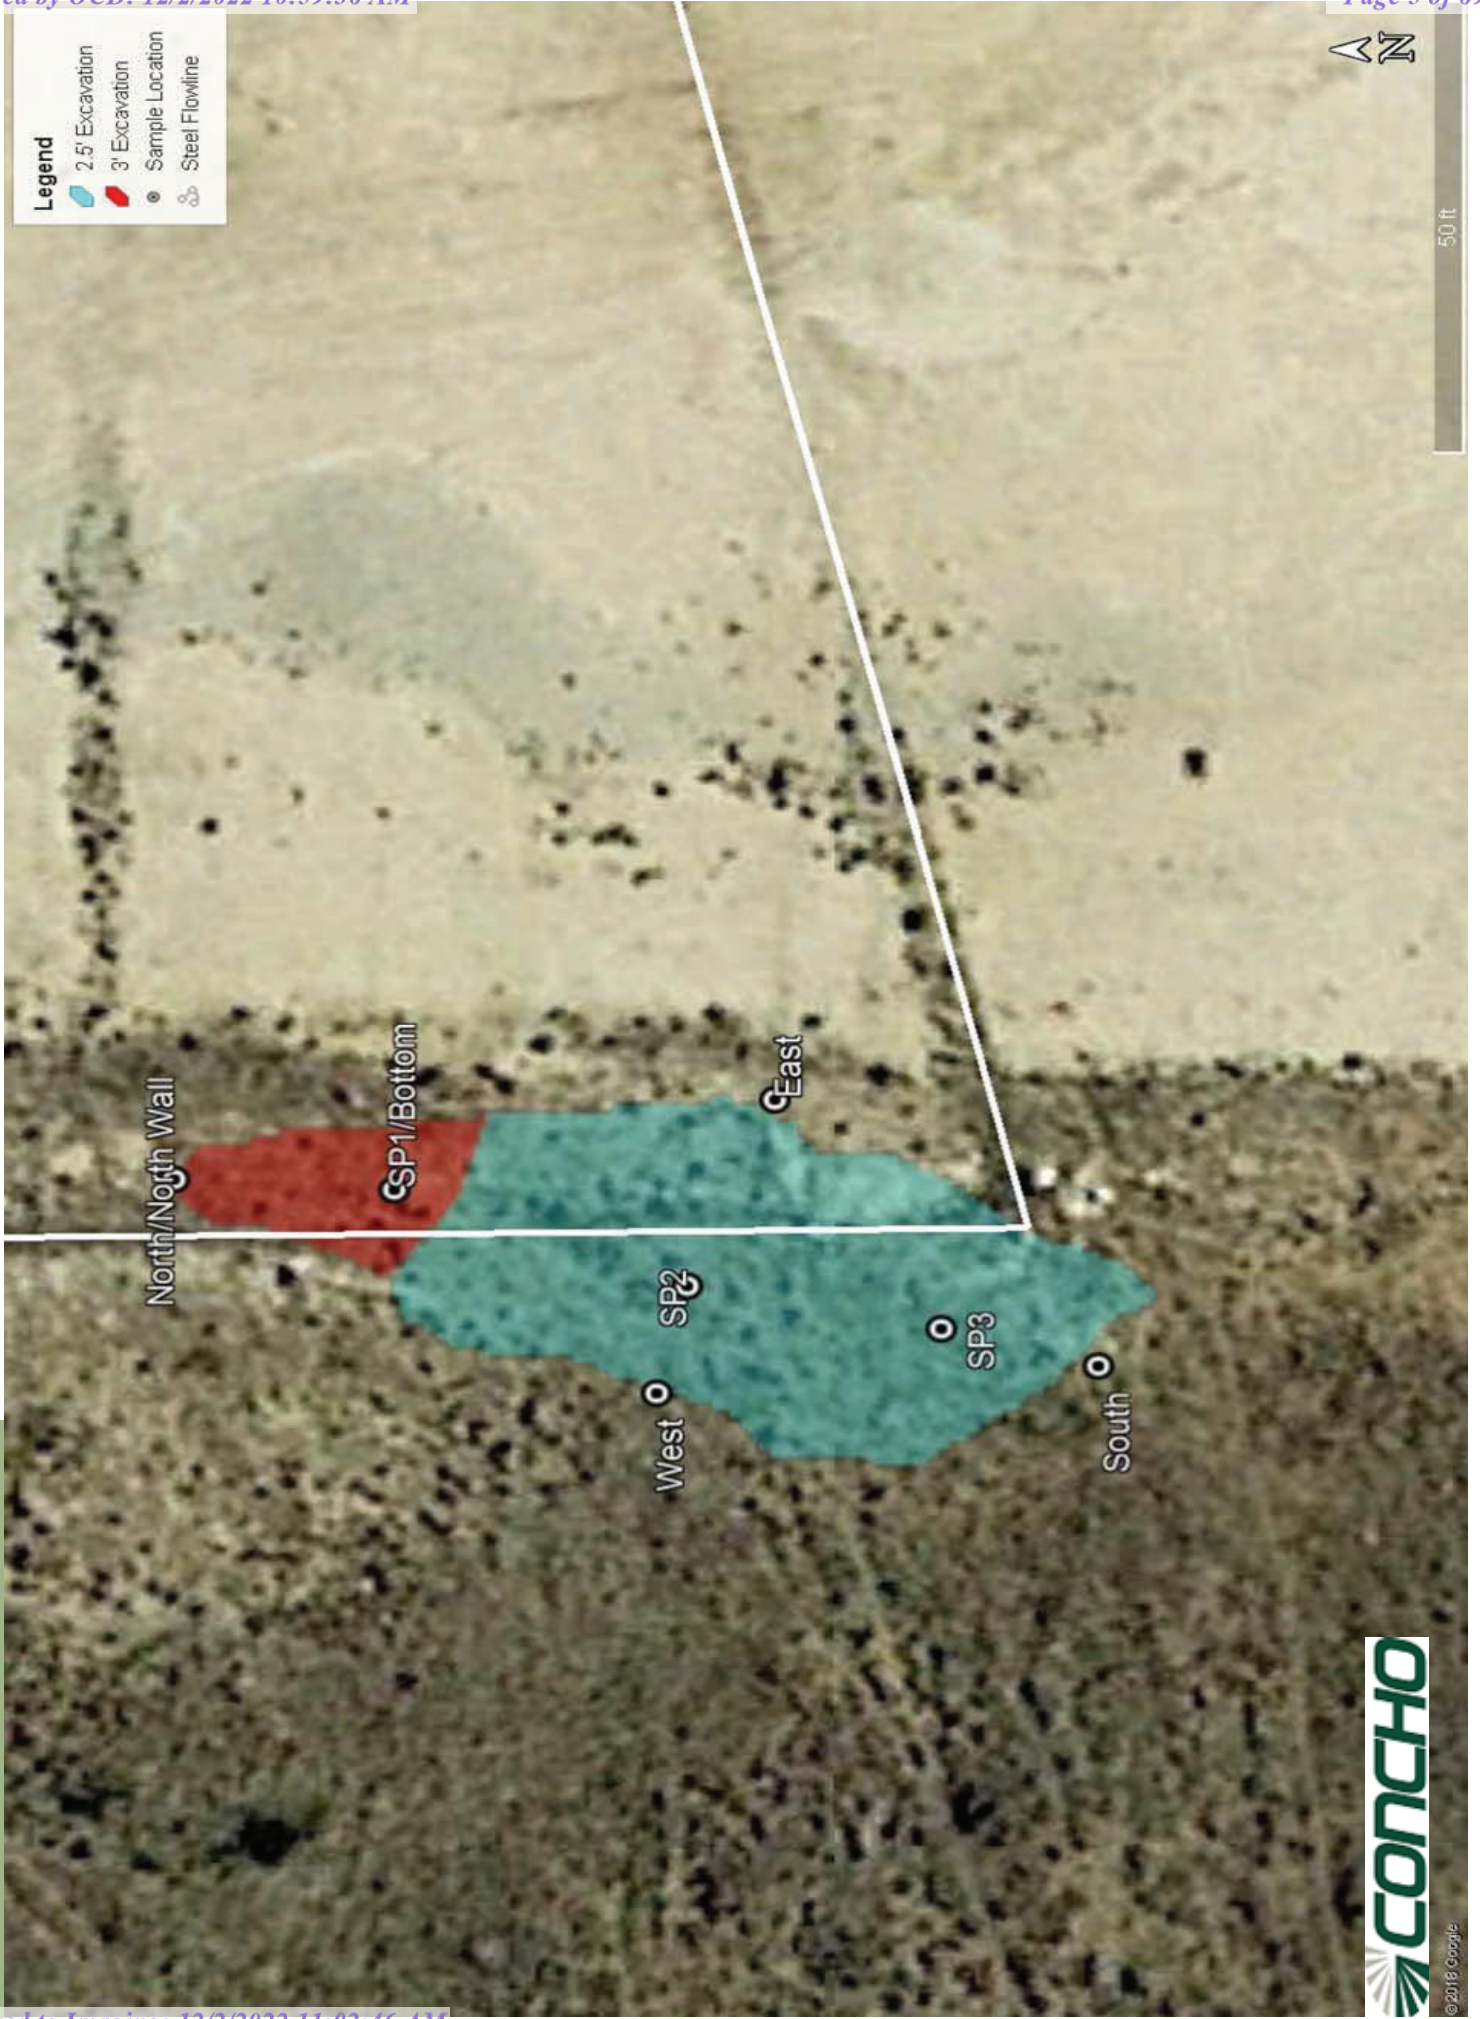
- The impacted area was excavated to depths from two and one-half (2.5) feet and three (3) feet BGS. See site diagram in Appendix I.
- Confirmation soil samples were taken from the bottom and sidewalls of the excavated area.
- All of the excavated material was hauled to an NMOCD approved solid waste disposal facility.
- Upon receipt of analytical results confirming that all impacted soil above NMOCD RRAL's was successfully removed the excavation was backfilled and contoured to match the surrounding location.

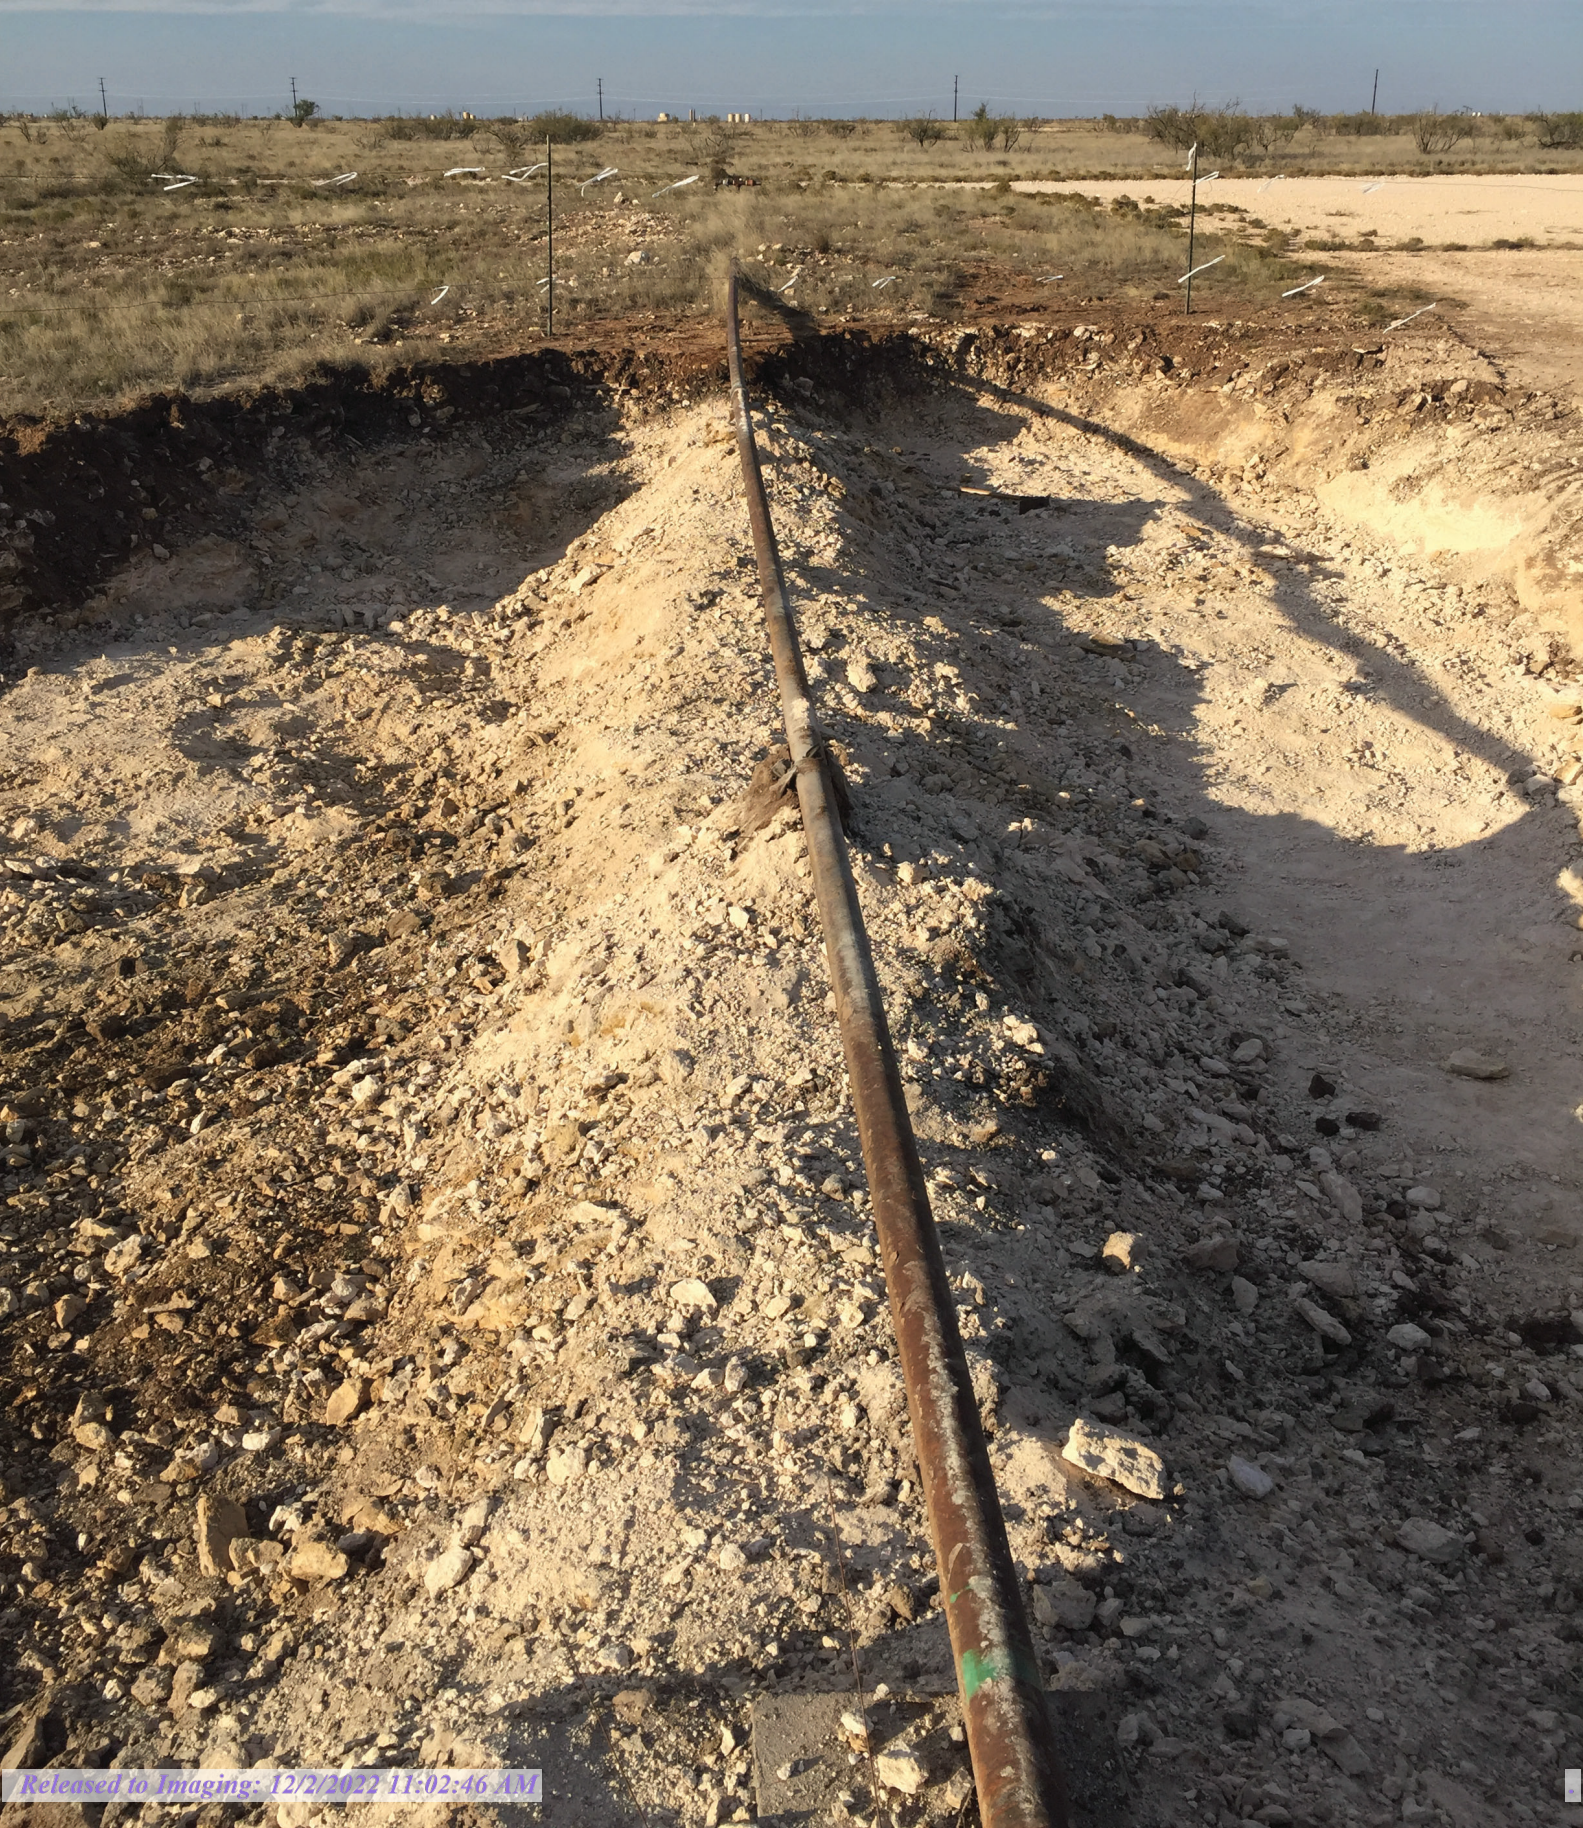
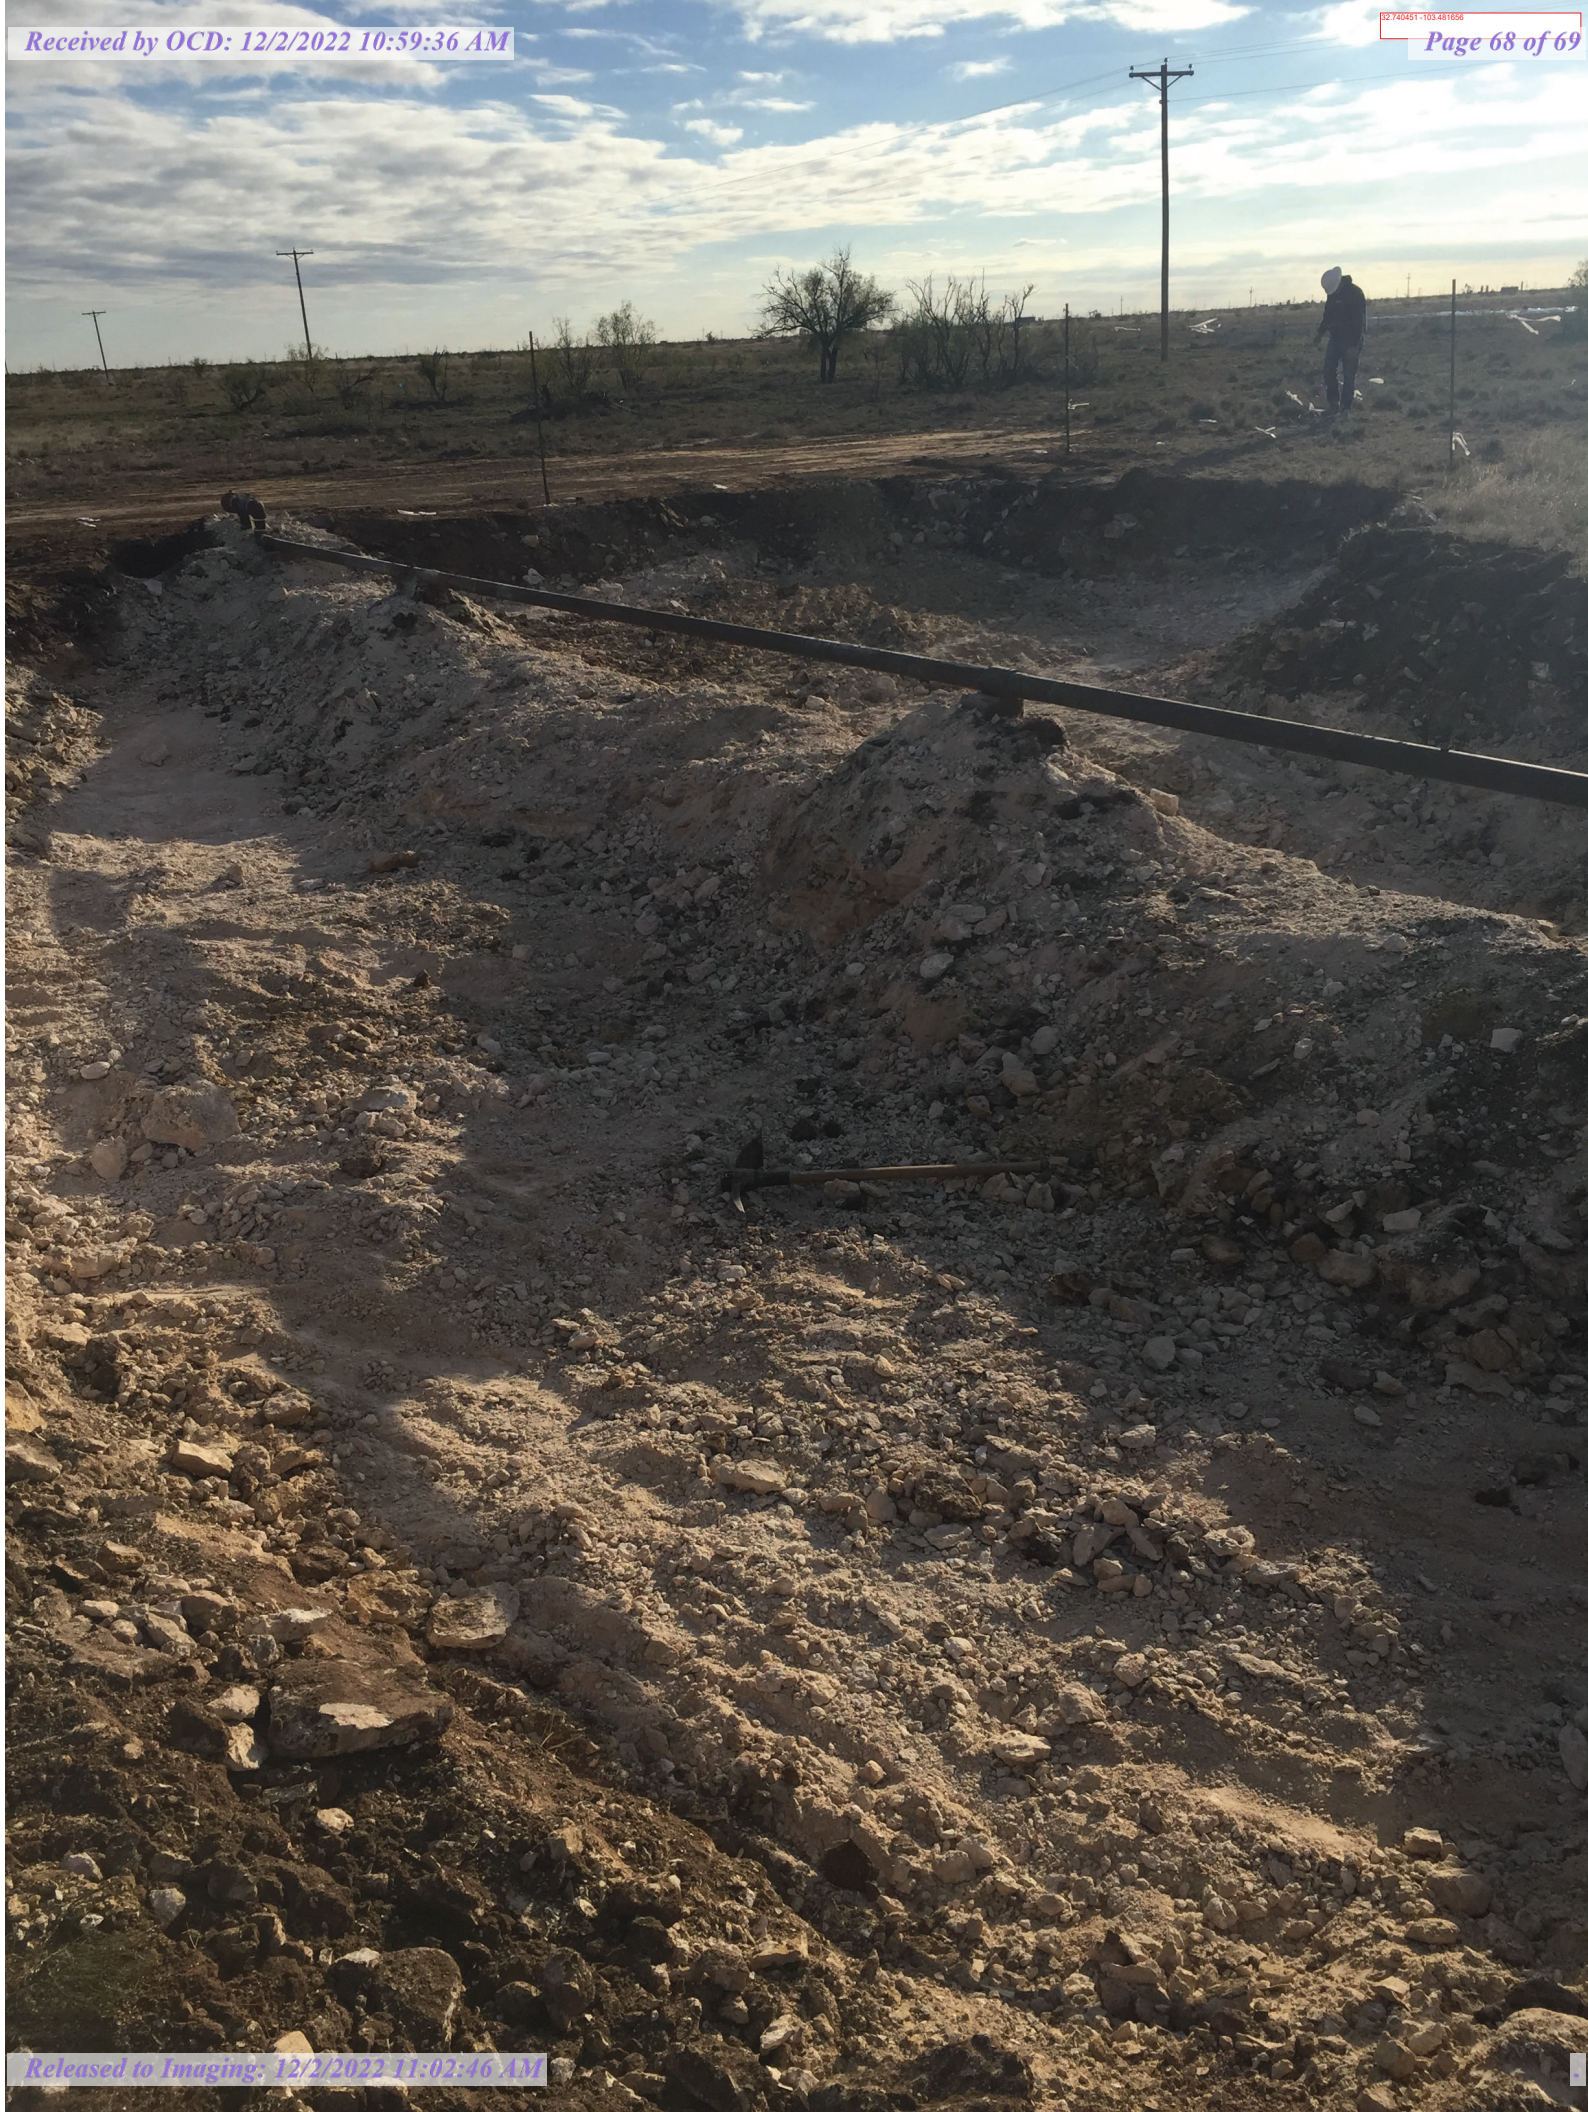
# APPENDIX VII

132.740203 -103.481916
