## Remediation Summary and Soil Closure Request

**Grizzly Energy, LLC**  
**Aspen 32 State Com No 1 Transfer Line Historical**  
Eddy County, New Mexico  
Unit Letter J, Section 32, Township 17 South, Range 28 East  
Latitude 32.77555 North, Longitude 104.20605 West  
**NMOCD Reference No. nAB1535756628 (2RP-3465)**

**Etech Environmental & Safety Solutions, Inc.**  
3100 Plains Highway  
Lovington, New Mexico 88260

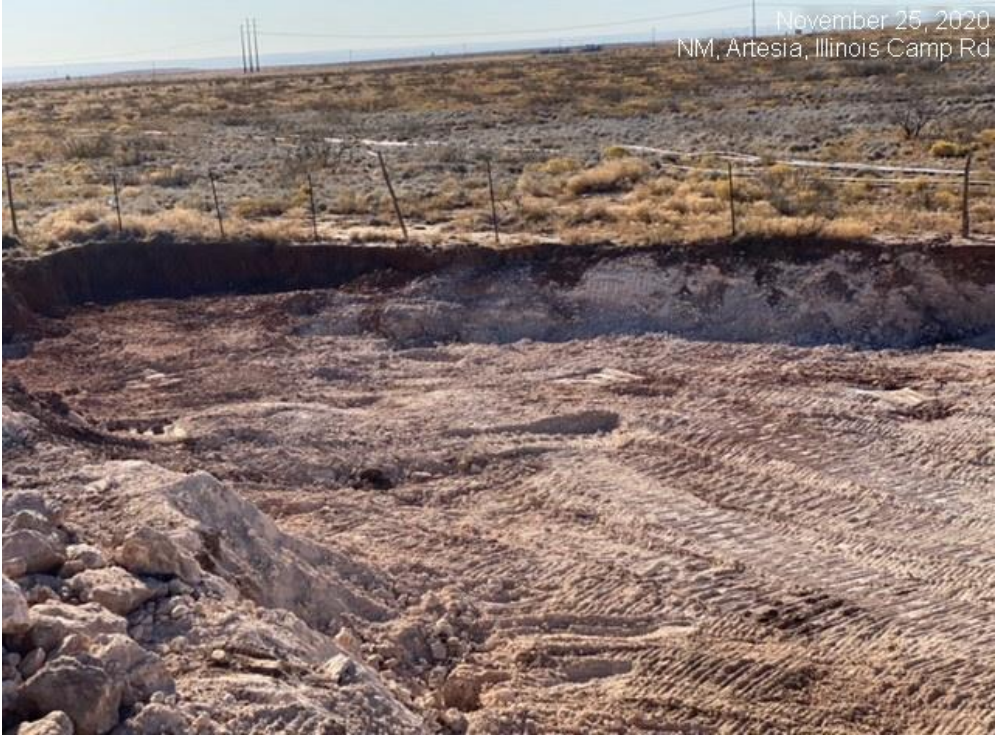
| <b>Photo Number:</b><br>1 | |

| <b>Photo Direction:</b><br>Southwest | |
| <b>Photo Description:</b><br><br>Excavation | |

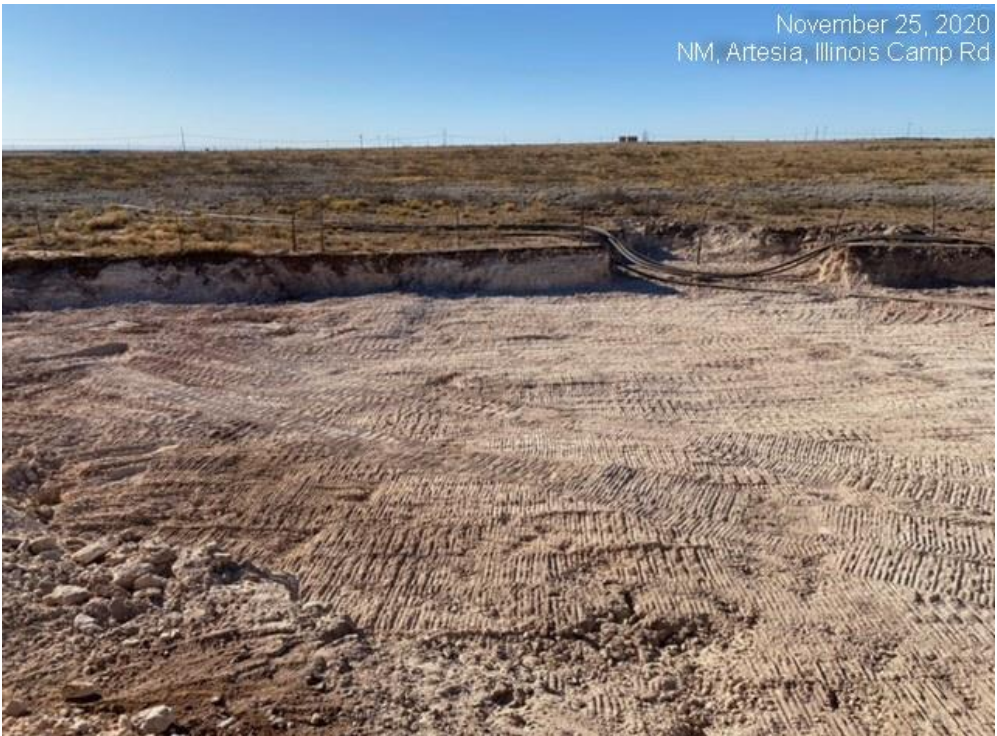
| <b>Photo Number:</b><br>2 | |

| <b>Photo Direction:</b><br>West | |
| <b>Photo Description:</b><br><br>Excavation | |

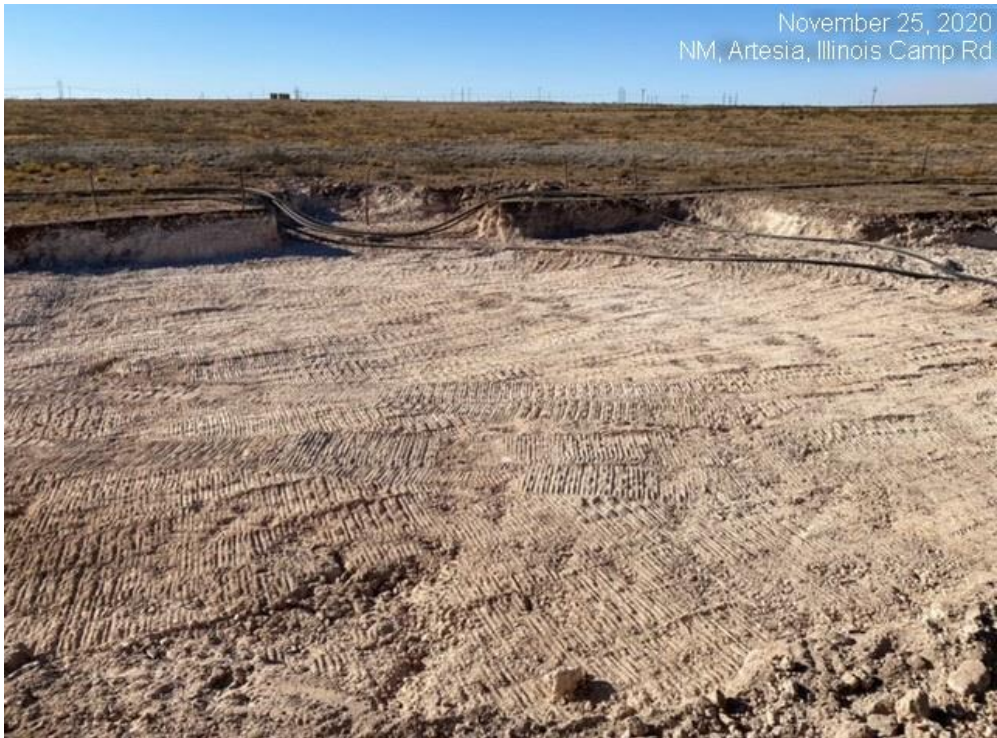
| <b>Photo Number:</b><br>3 | |

| <b>Photo Direction:</b><br>Northwest | |
| <b>Photo Description:</b><br><br>Excavation | |

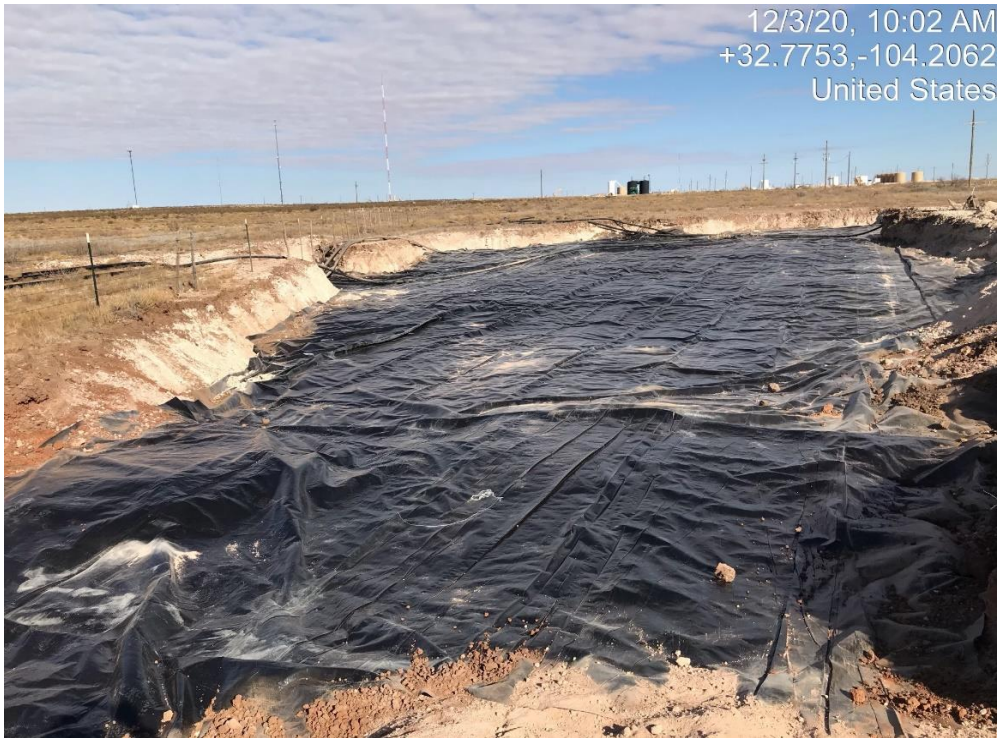
| <b>Photo Number:</b><br>4 | |

| <b>Photo Direction:</b><br>North-Northwest | |
| <b>Photo Description:</b><br><br>Liner Installation | |

On December 3, 2020, pursuant to the approved 2017 work plan, a 20-mil polyethylene liner was installed on the floor of the excavated area. Prior to installation of the liner, the area characterized by sample point FL-1 was backfilled to 4 feet bgs to match the topography of the remainder of the excavation. An approximate 6-inch layer of pad material was installed above and below the liner in an effort to maintain its integrity during backfilling activities. This engineering control is designed to inhibit the vertical migration of contaminants left in-situ.

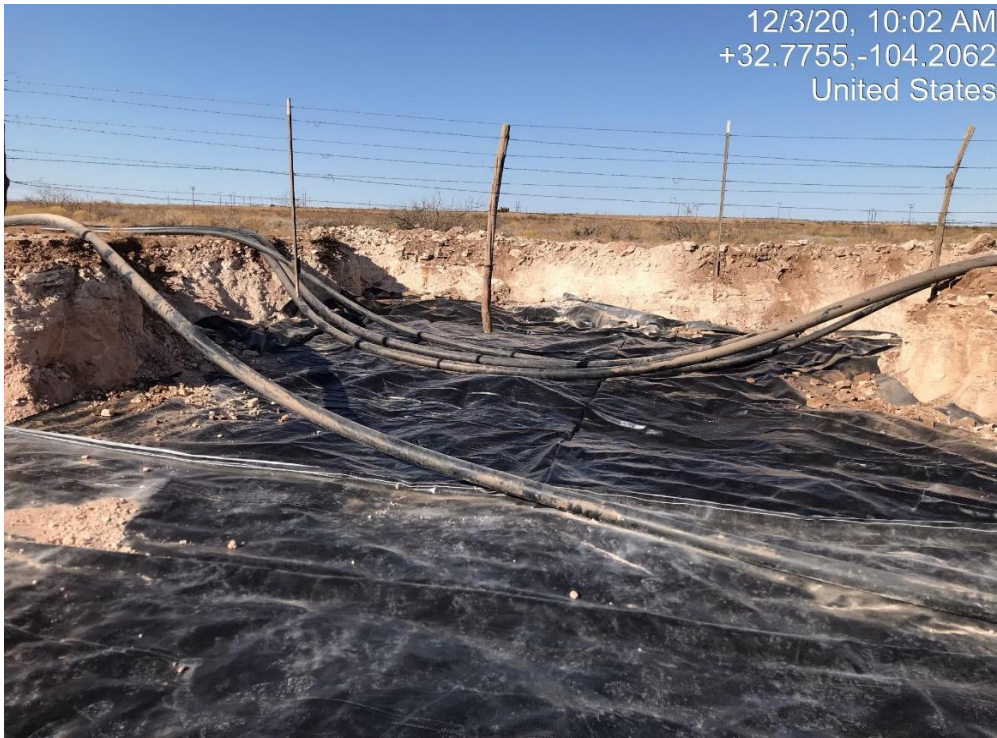
| <b>Photo Number:</b><br>5 | <p>12/3/20, 10:02 AM<br/>+32.7755,-104.2062<br/>United States</p> |

| <b>Photo Direction:</b><br>West | |
| <b>Photo Description:</b><br><br>Liner Installation | |

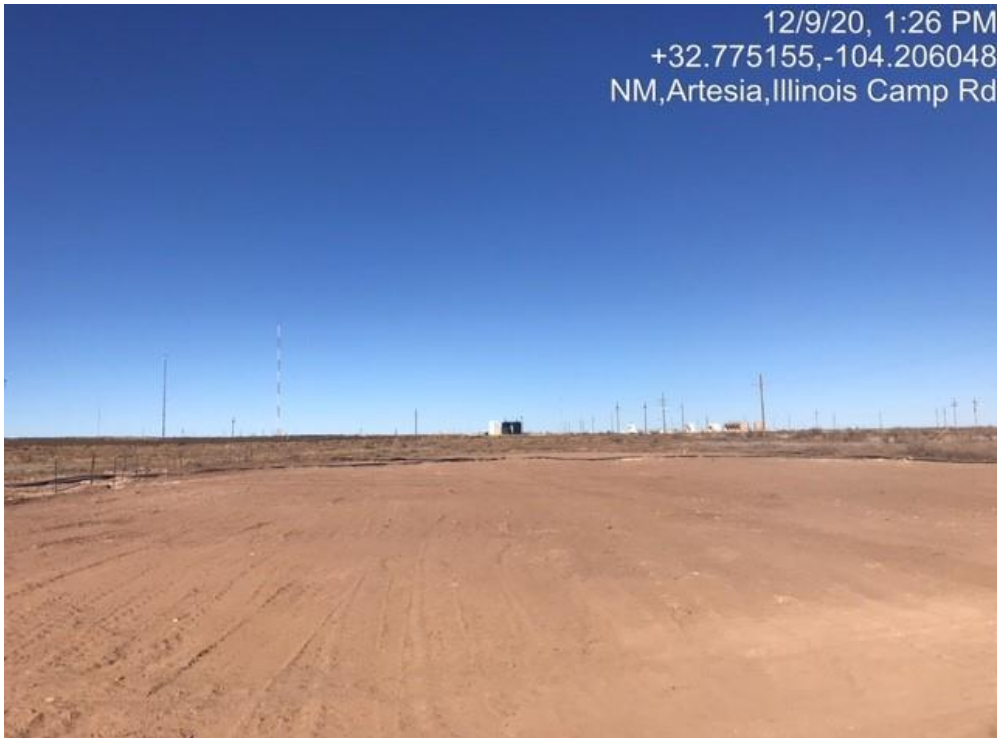
| <b>Photo Number:</b><br>6 | <p>12/9/20, 1:26 PM<br/>+32.775155,-104.206048<br/>NM, Artesia, Illinois Camp Rd</p> |

| <b>Photo Direction:</b><br>North-Northwest | |
| <b>Photo Description:</b><br><br>Backfilled Excavation | |

Upon receiving laboratory analytical results from confirmation soil samples, excavated areas were backfilled with locally sourced, non-impacted "like" material placed at or near original relative positions. The affected area was contoured and/or compacted to achieve erosion control, stability and preservation of surface water flow to the extent practicable. Affected areas will be reseeded with an agency and/or landowner-approved seed mixture free of noxious weeds during the first favorable growing season following closure of the site.

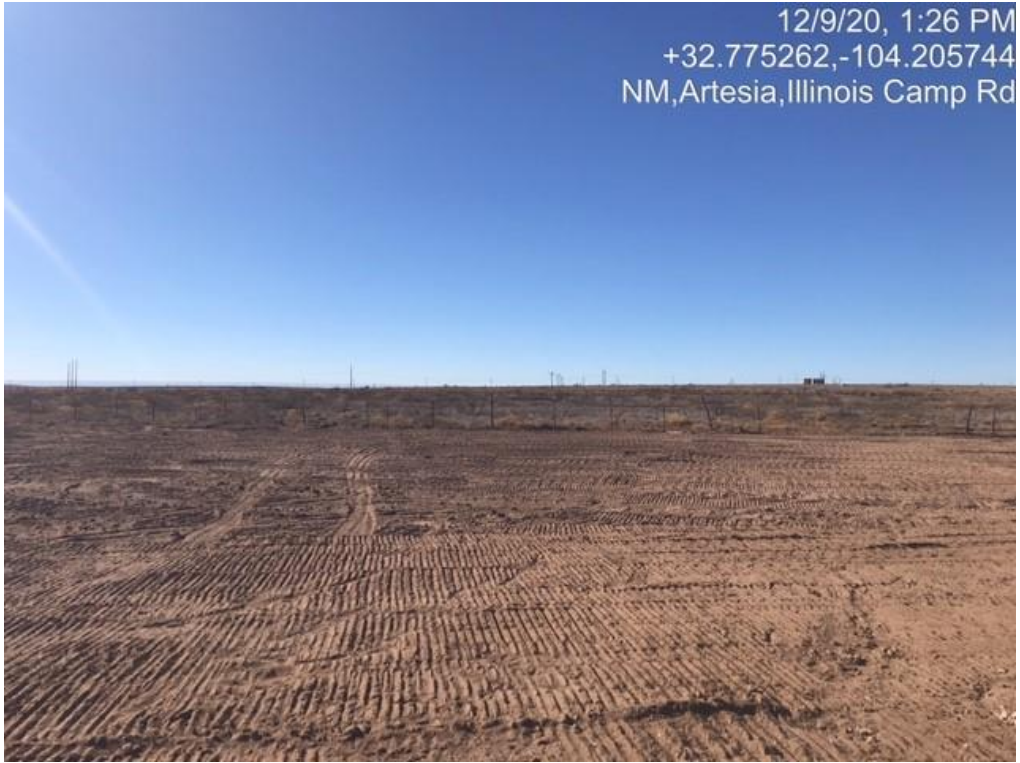
| <b>Photo Number:</b><br>7 | <p>12/9/20, 1:26 PM<br/>+32.775262,-104.205744<br/>NM,Artesia,Illinois Camp Rd</p> |

| <b>Photo Direction:</b><br>West | |
| <b>Photo Description:</b><br><br>Backfilled Excavation | |

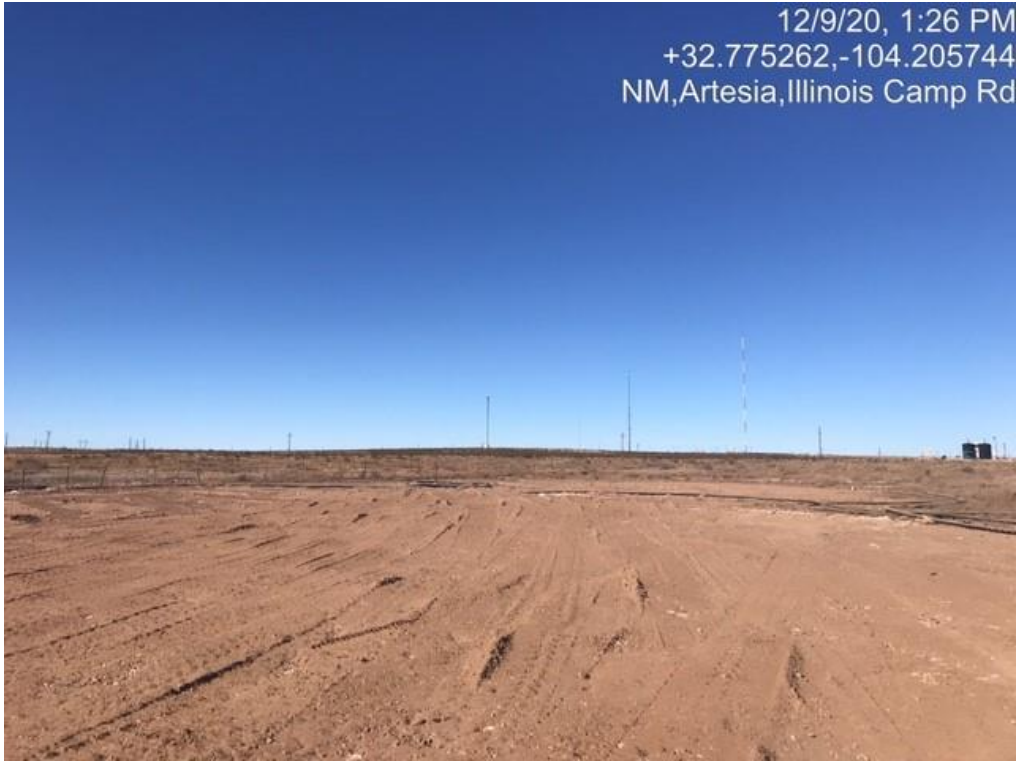
| <b>Photo Number:</b><br>8 | <p>12/9/20, 1:26 PM<br/>+32.775262,-104.205744<br/>NM,Artesia,Illinois Camp Rd</p> |

| <b>Photo Direction:</b><br>Northwest | |
| <b>Photo Description:</b><br><br>Backfilled Excavation | |
