December 15, 2022

**Re: REVISED
Release Characterization and Remediation Work Plan
ConocoPhillips
Heritage Concho
Roy Batty Federal Com #003H Flange Release
Unit Letter O, Section 11, Township 24 South, Range 33 East
Lea County, New Mexico
Incident ID NOY1811735138**

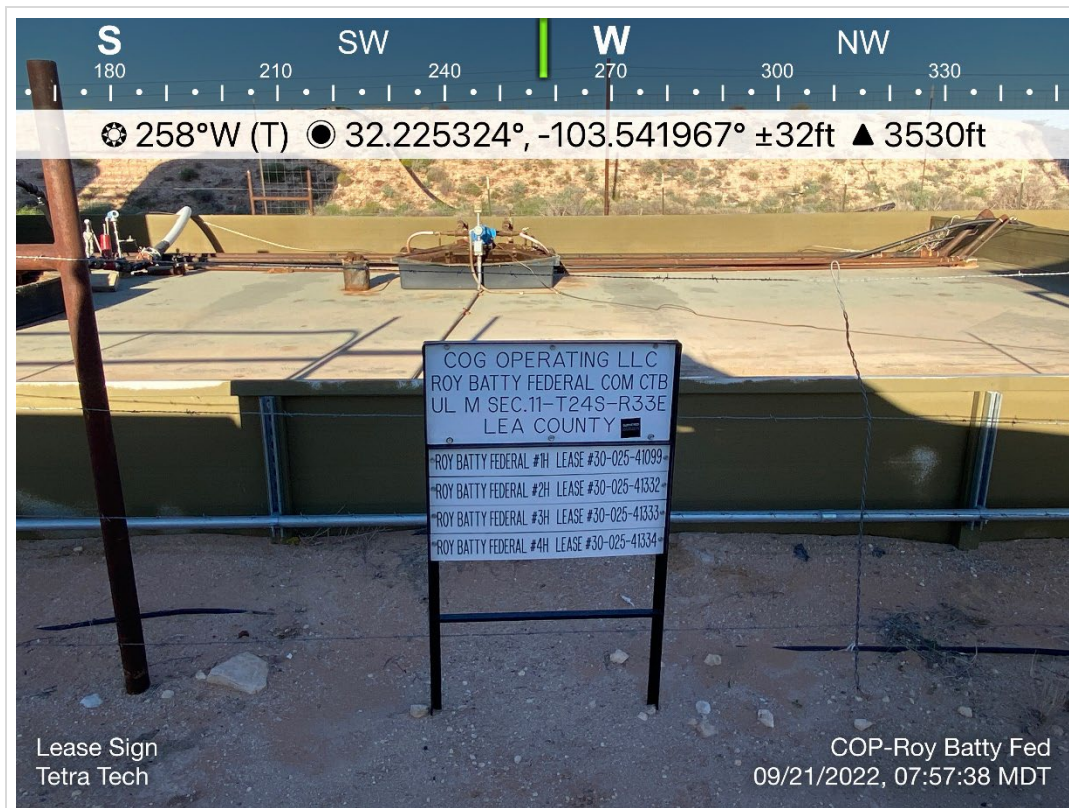
TETRA TECH, INC. PROJECT NO. 212C-MD-02847	DESCRIPTION	Site signage and location information; Roy Batty Federal Com CTB.	1
	SITE NAME	ConocoPhillips Roy Batty Fed Com #003H	9/21/2022

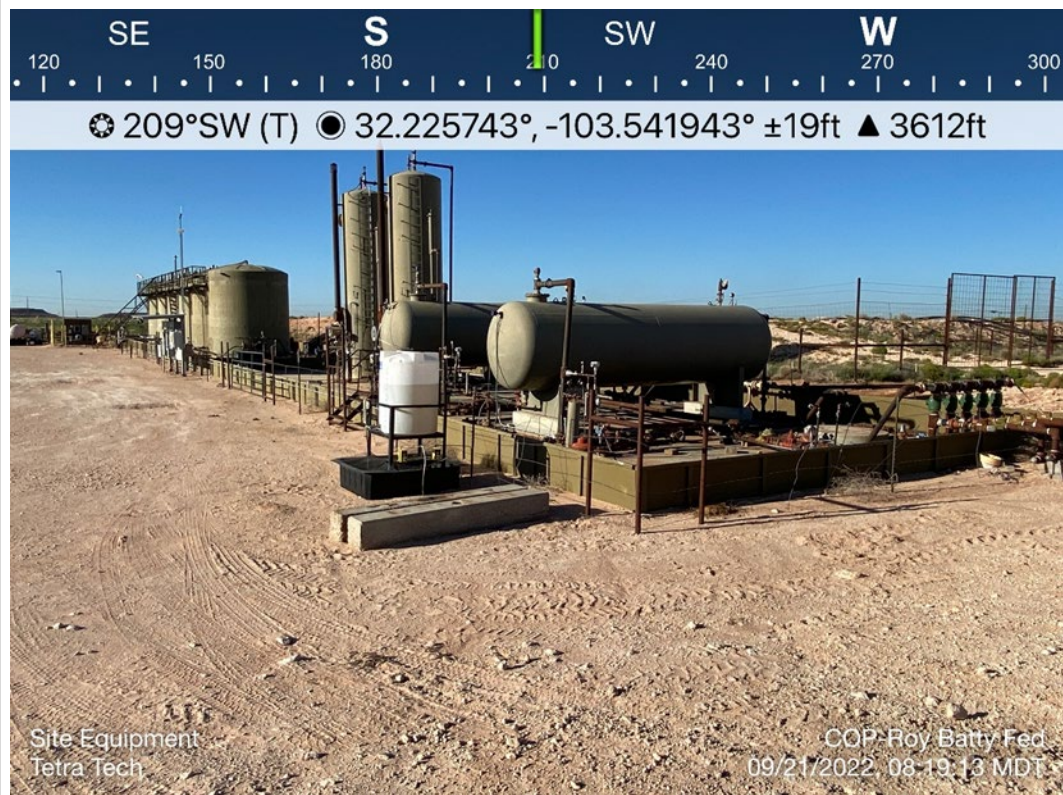
TETRA TECH, INC. PROJECT NO. 212C-MD-02847	DESCRIPTION	View south, southwest. Separators located along the western edge of the pad.	2
	SITE NAME	ConocoPhillips Roy Batty Fed Com #003H	9/21/2022

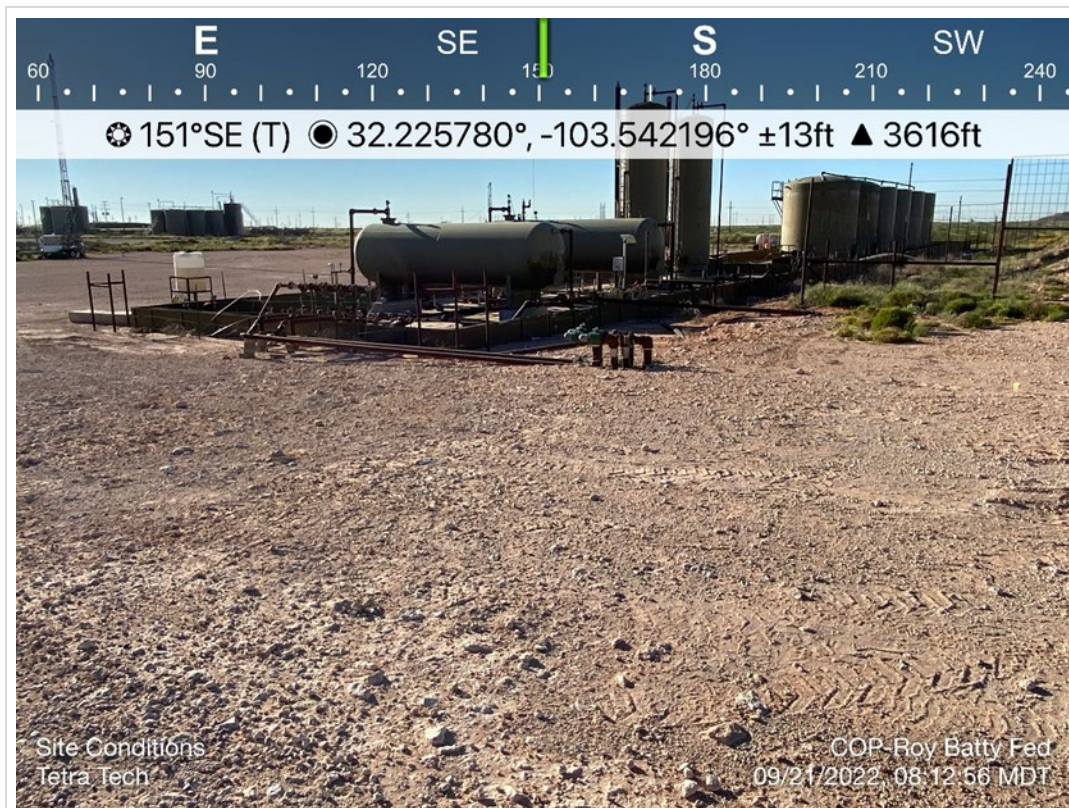
TETRA TECH, INC. PROJECT NO. 212C-MD-02847	DESCRIPTION	View southeast. View from the lease road towards the lease pad.	3
	SITE NAME	ConocoPhillips Roy Batty Fed Com #003H	9/21/2022

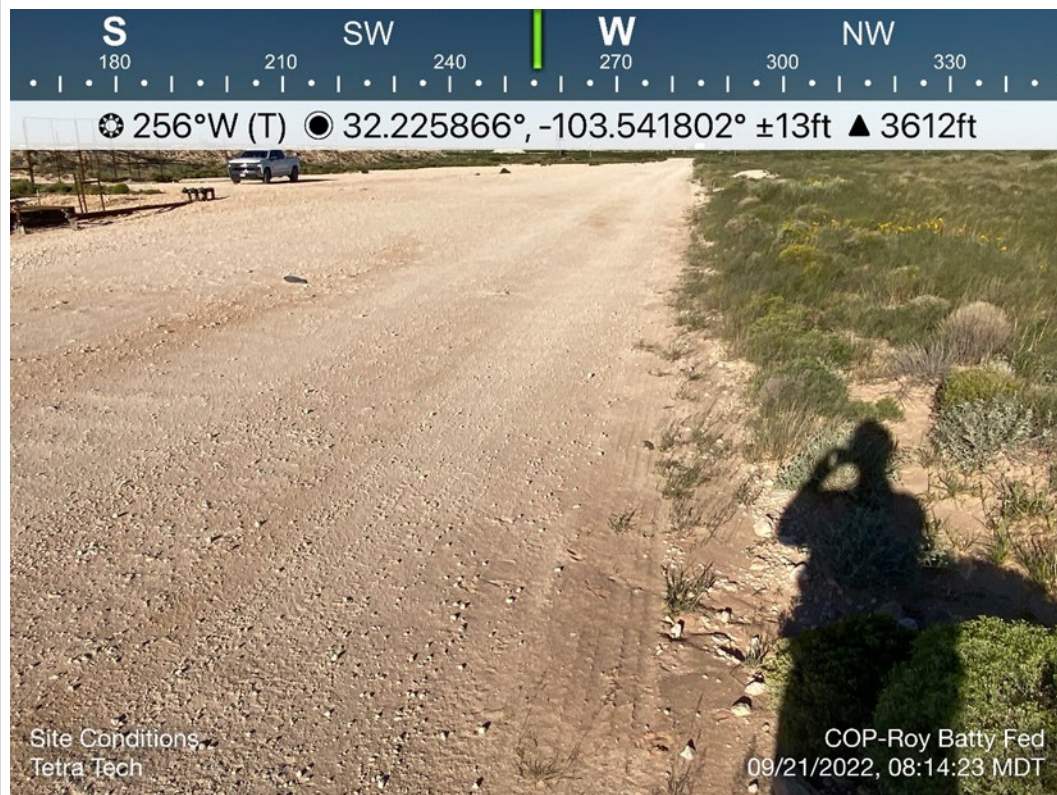
TETRA TECH, INC. PROJECT NO. 212C-MD-02847	DESCRIPTION	View west. View from lease road, looking towards the west. Assumed flow path, no visible evidence of impact.	4
	SITE NAME	ConocoPhillips Roy Batty Fed Com #003H	9/21/2022

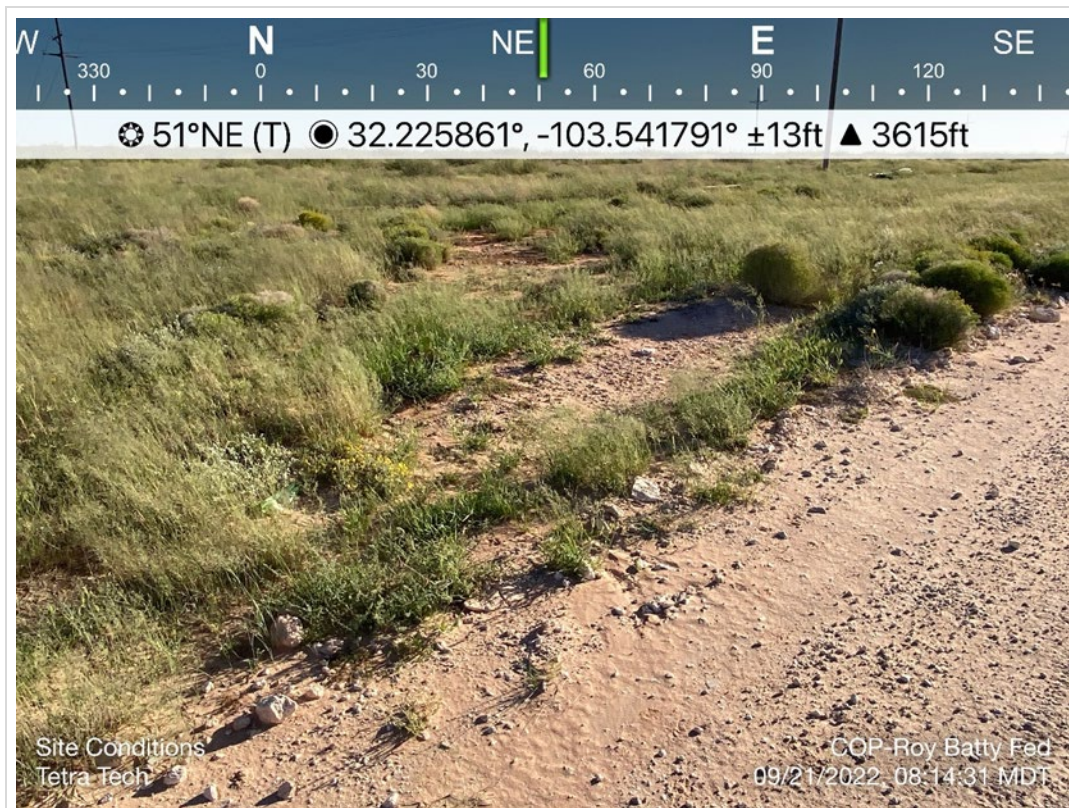
TETRA TECH, INC. PROJECT NO. 212C-MD-02847	DESCRIPTION	View northeast. North side of lease road. Assumed flow path, no visible evidence of impact.	5
	SITE NAME	ConocoPhillips Roy Batty Fed Com #003H	9/21/2022

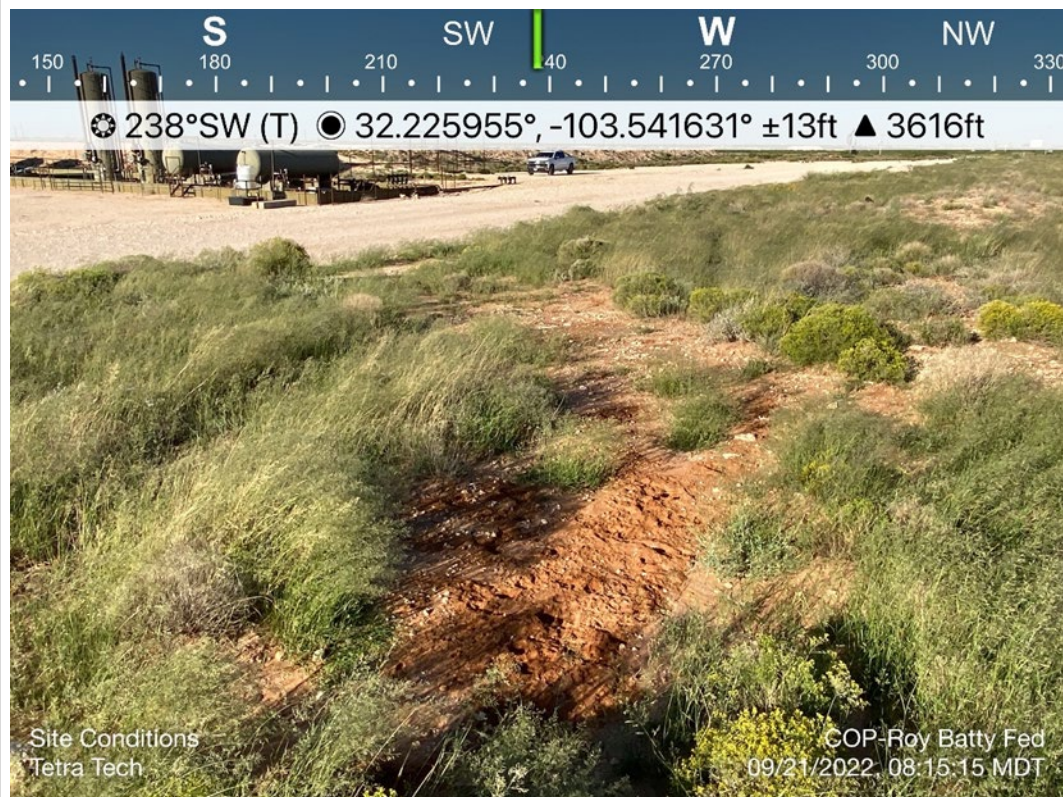
TETRA TECH, INC. PROJECT NO. 212C-MD-02847	DESCRIPTION	View southwest. Sparse vegetation along the likely flow path, heading back towards the southwest.	6
	SITE NAME	ConocoPhillips Roy Batty Fed Com #003H	9/21/2022

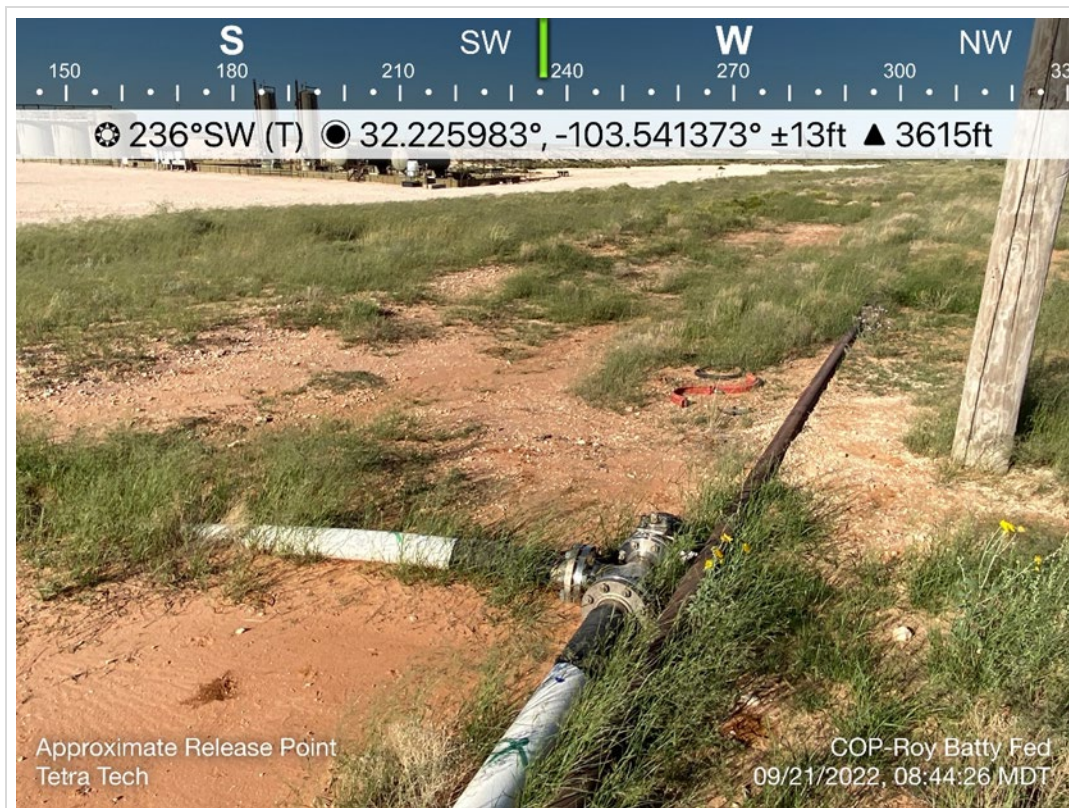
TETRA TECH, INC. PROJECT NO. 212C-MD-02847	DESCRIPTION	View southwest. Approximate release point in the pasture north of the pad, sparse vegetation present.	7
	SITE NAME	ConocoPhillips Roy Batty Fed Com #003H	9/21/2022

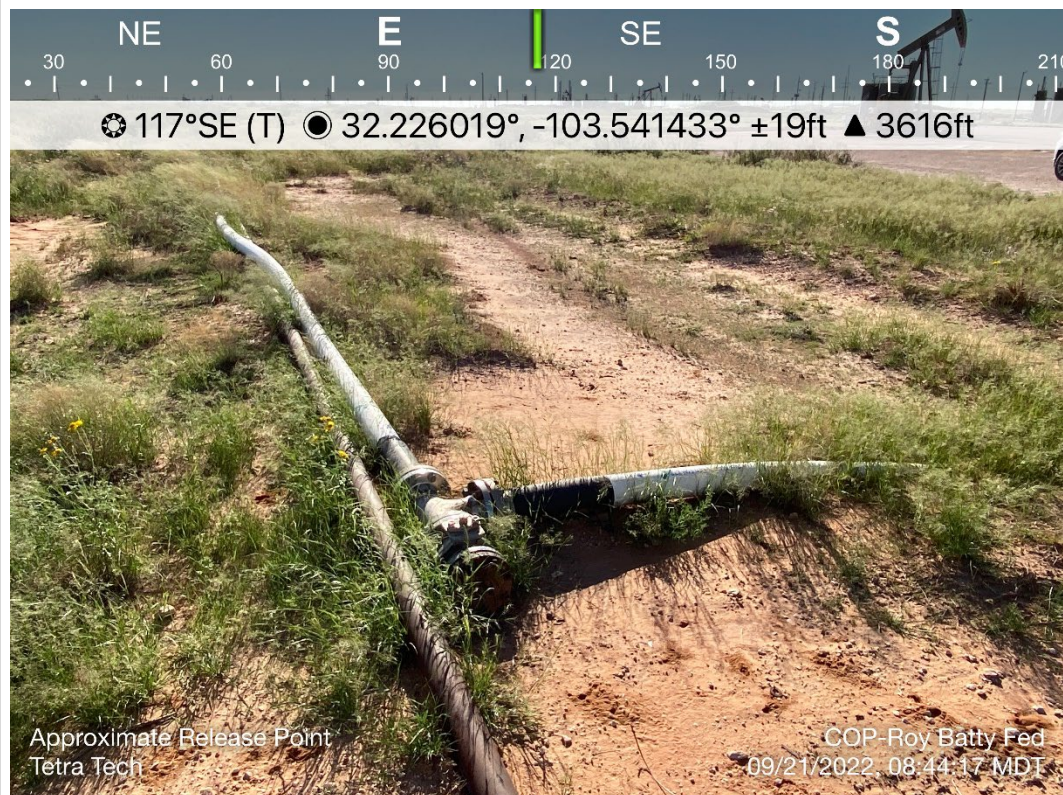
TETRA TECH, INC. PROJECT NO. 212C-MD-02847	DESCRIPTION	View southwest. Sparse vegetation east of the approximate release point.	8
	SITE NAME	ConocoPhillips Roy Batty Fed Com #003H	9/21/2022

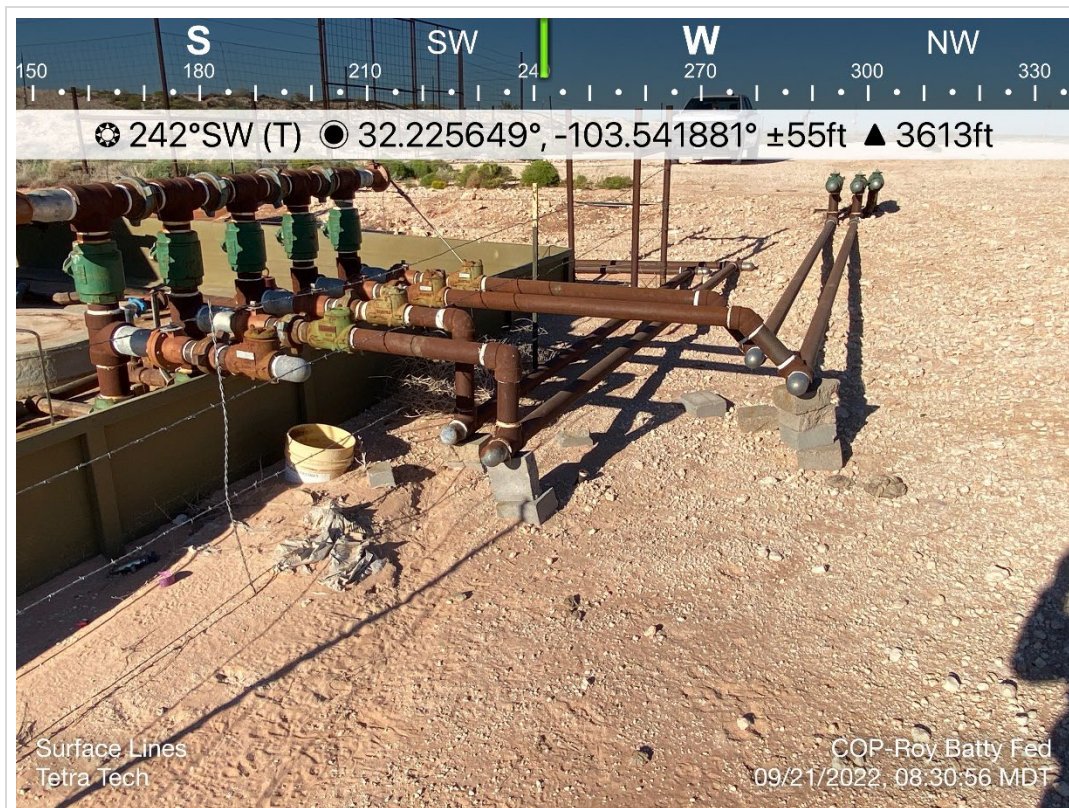
TETRA TECH, INC. PROJECT NO. 212C-MD-02847	DESCRIPTION	View southwest. No visible evidence of impact.	9
	SITE NAME	ConocoPhillips Roy Batty Fed Com #003H	9/21/2022

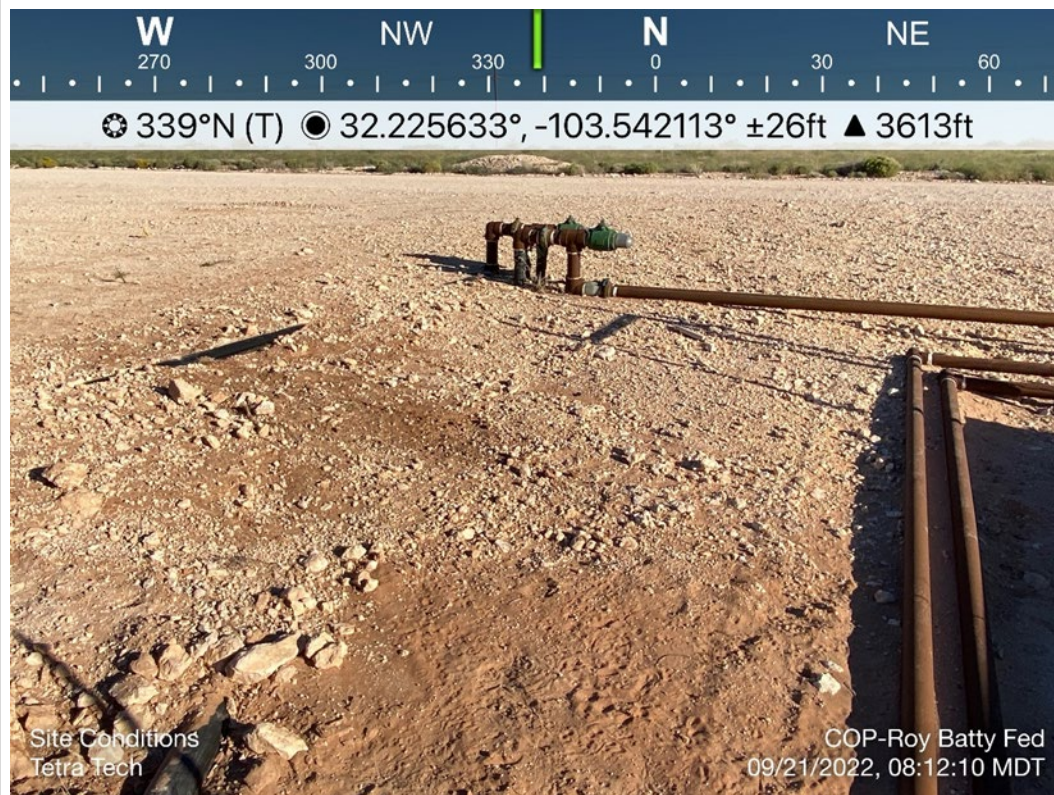
TETRA TECH, INC. PROJECT NO. 212C-MD-02847	DESCRIPTION	View north northwest. Southern end of release extent. No visible evidence of impact.	10
	SITE NAME	ConocoPhillips Roy Batty Fed Com #003H	9/21/2022
