**RE: Liner Inspection and Closure Report  
Coral PWU 28-4 Battery  
API No. N/A  
GPS: Latitude 32.625565 Longitude -103.074747  
UL- P, Section 28, Township 19S, Range 29E  
NMOCD Reference No. NAPP2212223374**

Devon Energy Production Company (Devon) has contracted Pima Environmental Services, LLC (Pima) to perform a liner inspection and prepare this closure report for a release that happened on the Coral PWU 28-4 Battery (Coral). An initial C-141 was submitted on May 17, 2022, and can be found in Appendix B. This incident was assigned Incident ID NAPP2212223374, by the New Mexico Oil Conservation Division (NMOCD).

On May 9, 2022, after sending the 48-hour notification email, Pima Environmental conducted a liner inspection at this location. We concluded that this liner and containment maintained its integrity and was able to retain the fluids. The liner inspection form and photographic documentation can be found in Appendix C.

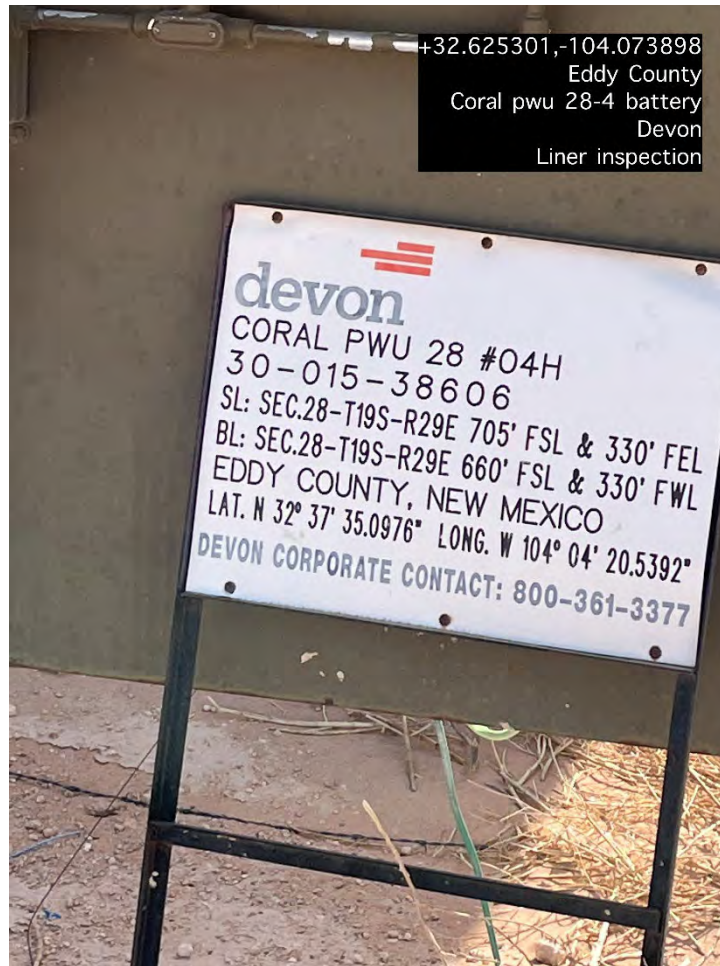
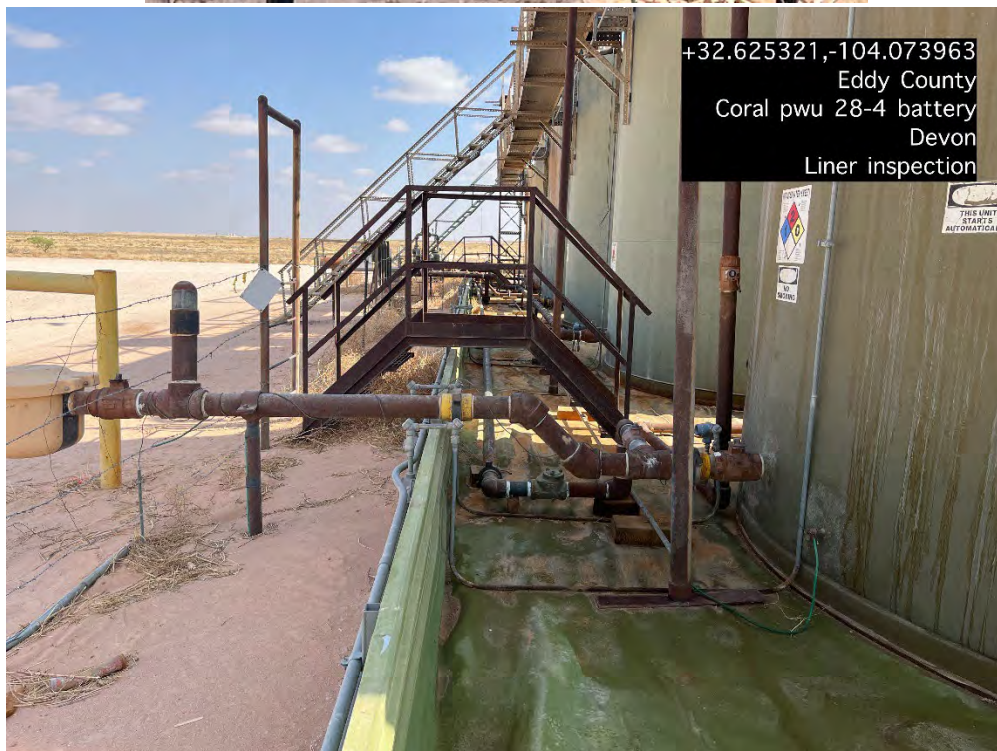
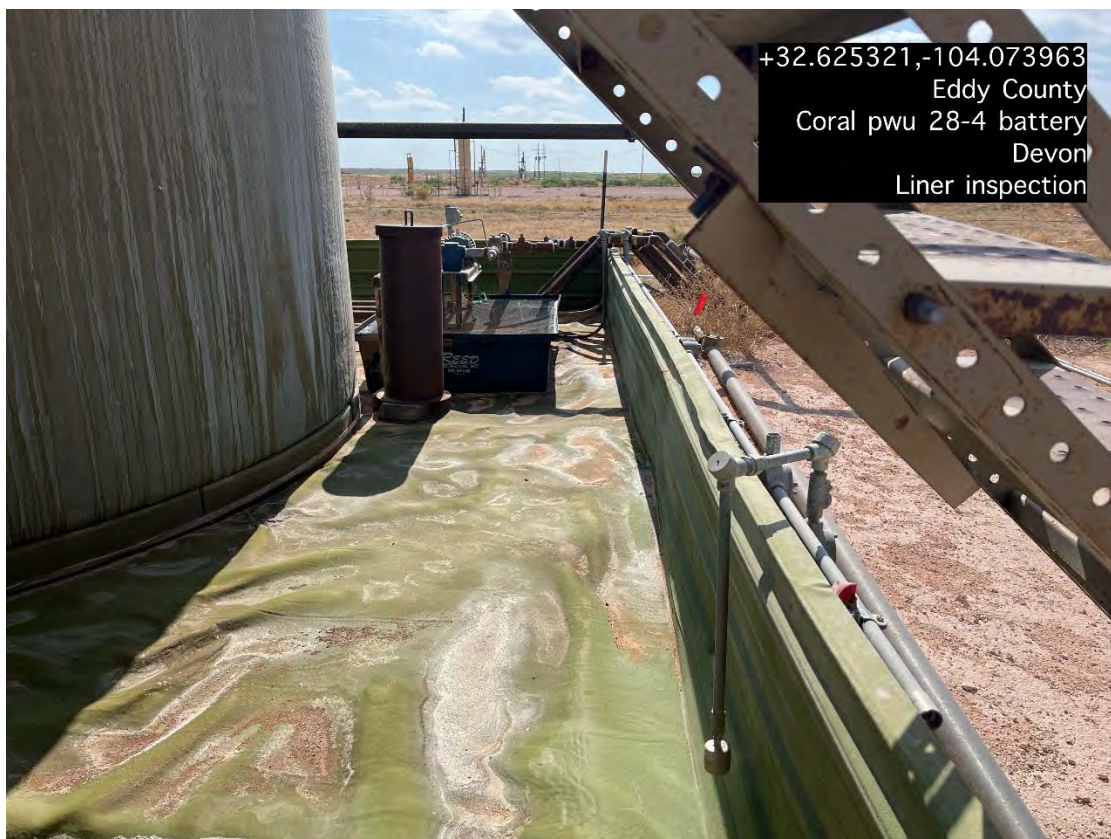
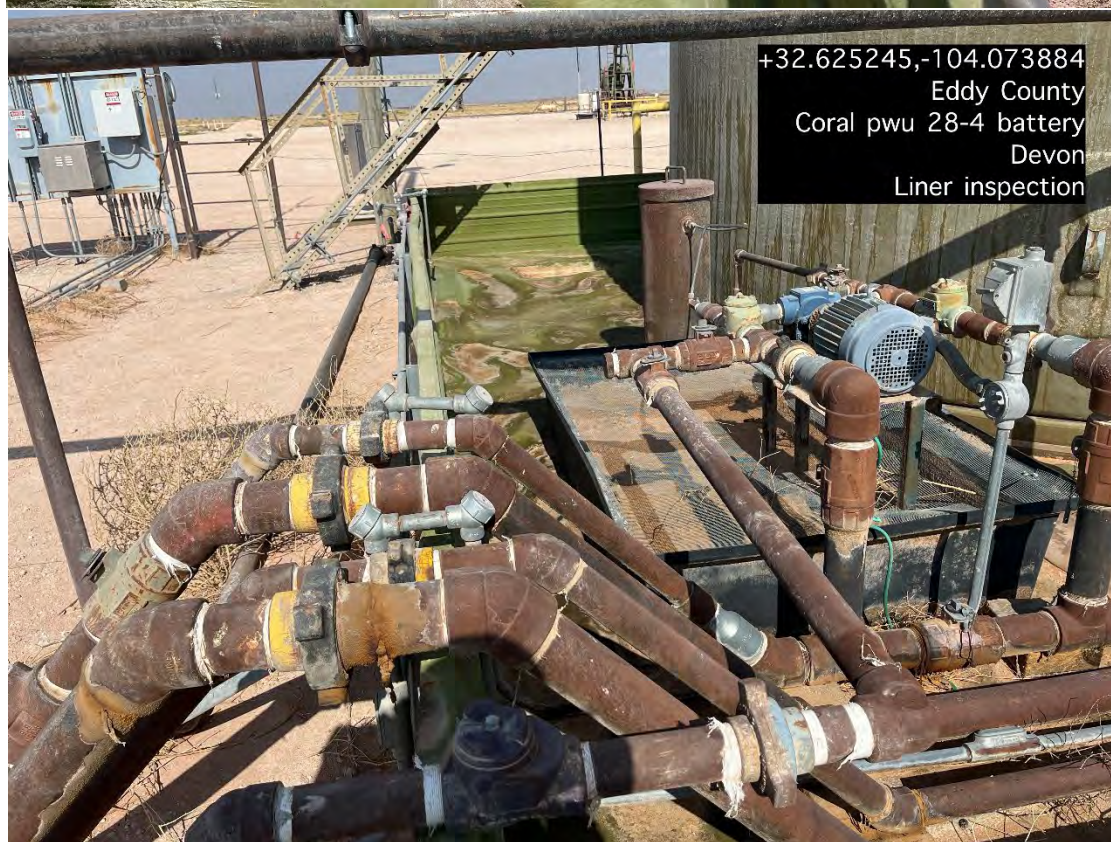
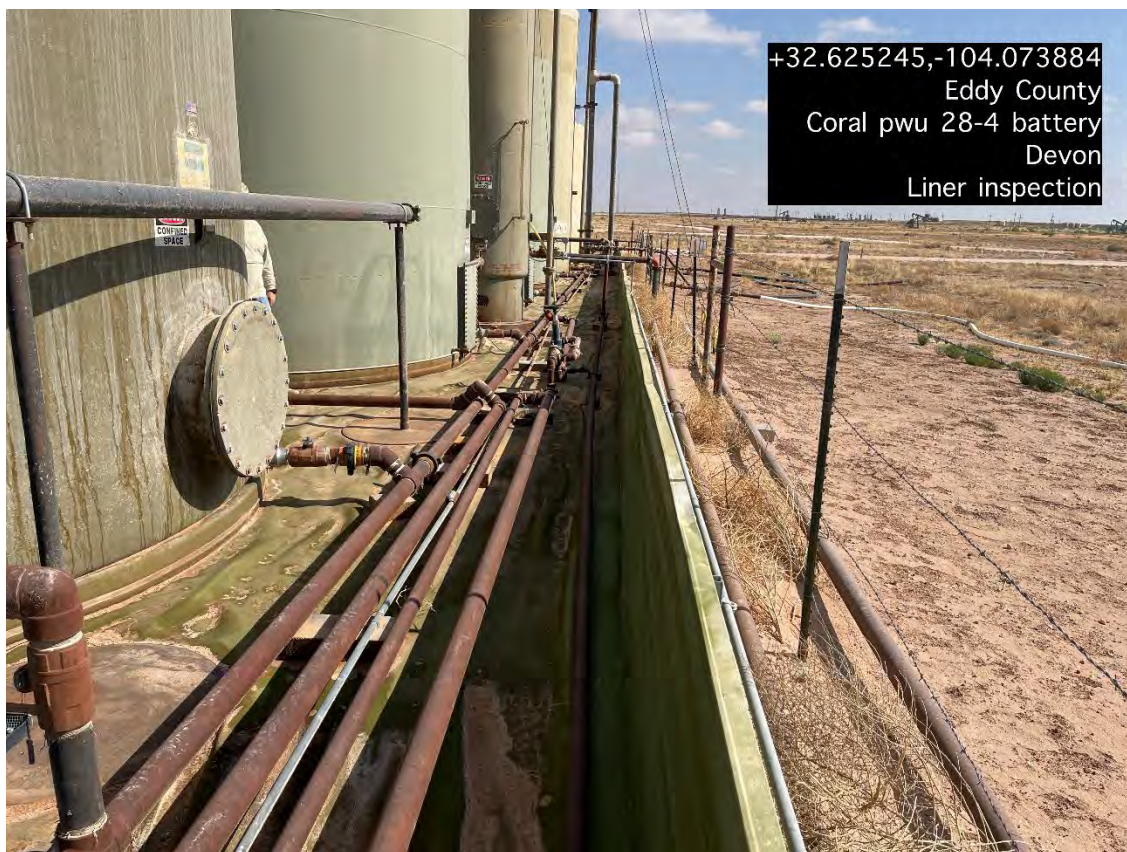
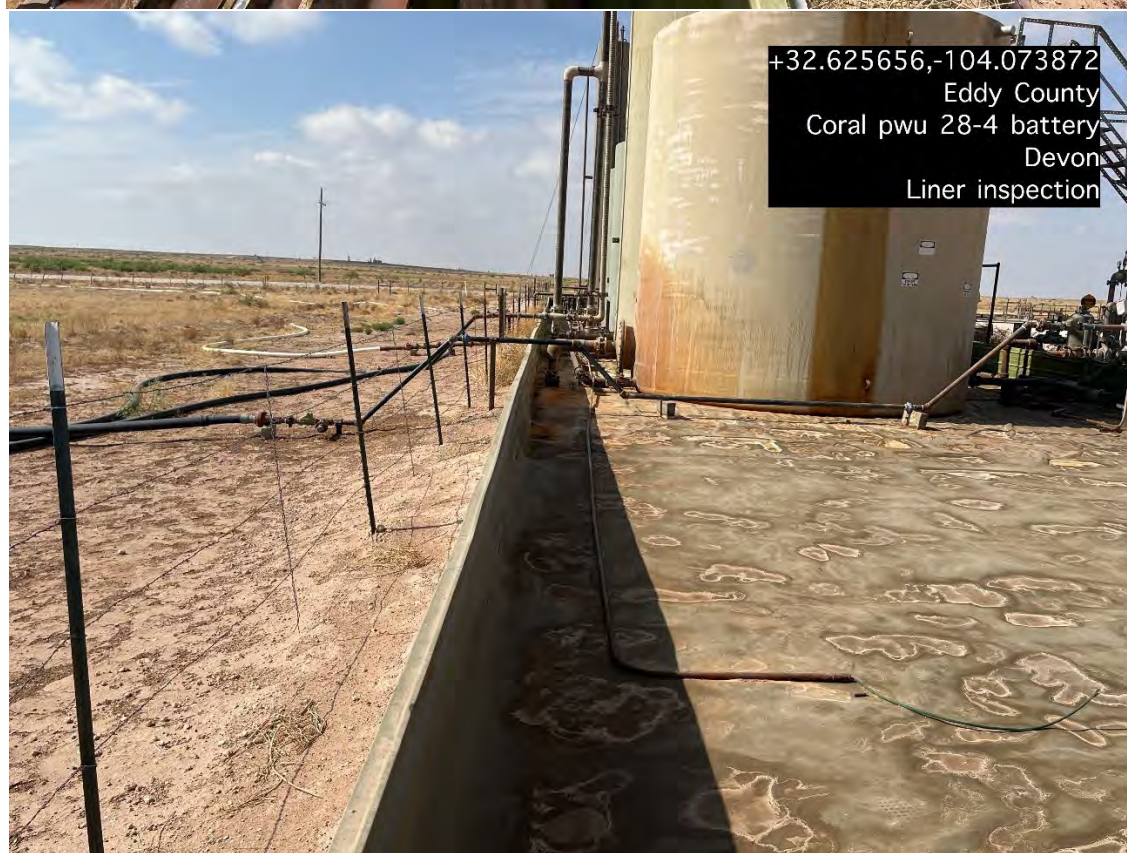
Photographic Documentation

Visualization	Yes	No	Comments
Is there a tear in the liner?		X	
Are there holes in the liner?		X	
Is the liner retaining any fluids?		X	
Does the liner have integrity to contain a leak?	X
