Incident ID	NAB1511038592
District RP	
Facility ID	
Application ID

Devon Energy Production Company (Devon) has contracted Pima Environmental Services, LLC (Pima) to perform a site assessment, liner inspection, and prepare this closure report for a crude oil/produced water mixed release that happened at the Rigel 20 Federal Com #003H (Rigel). An initial C-141 was submitted on April 20, 2015, and can be found in Appendix C. This incident was assigned Incident ID NAB1511038592, by the New Mexico Oil Conservation Division (NMOCD).

SITE PHOTOGRAPHS LINER INSPECTION

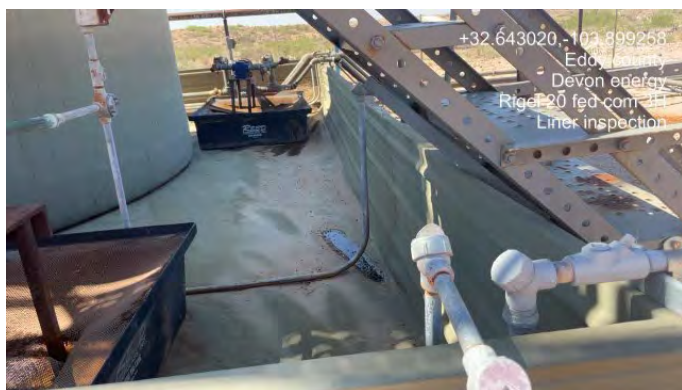
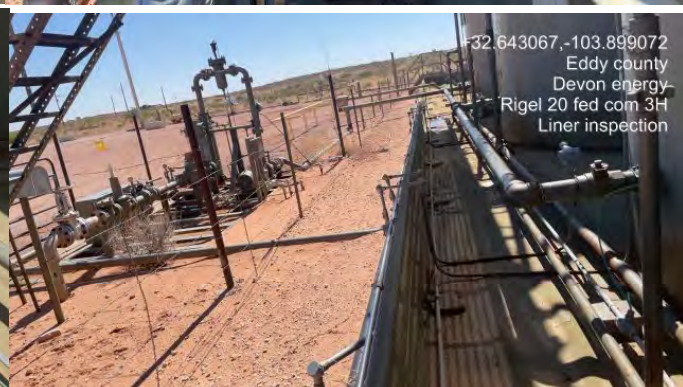
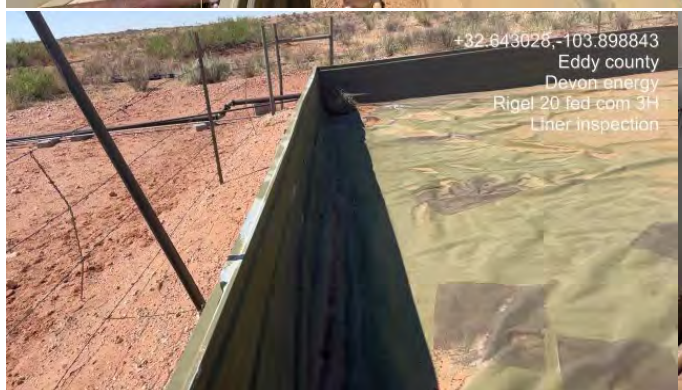
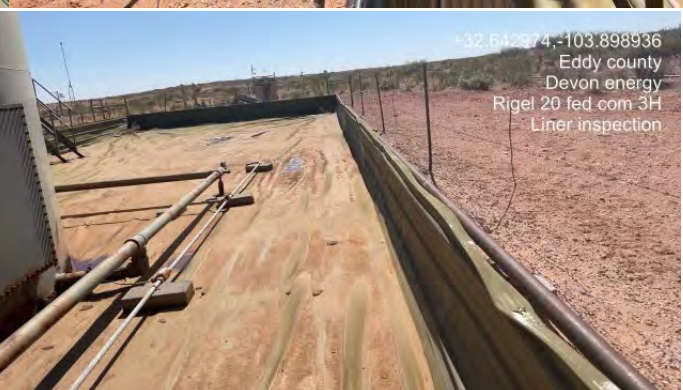
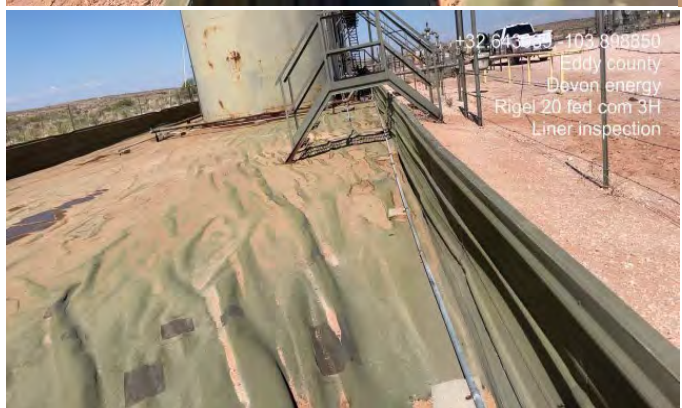
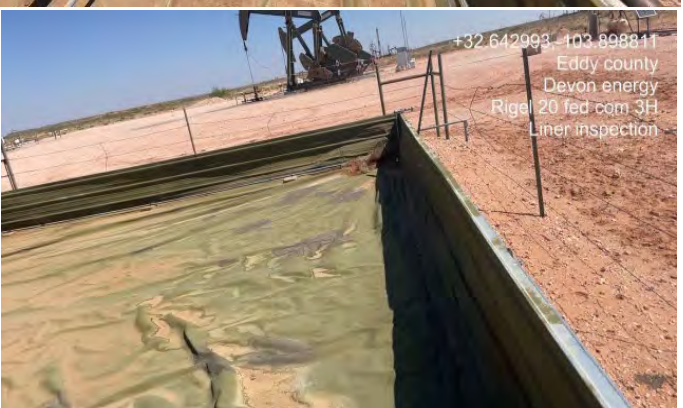
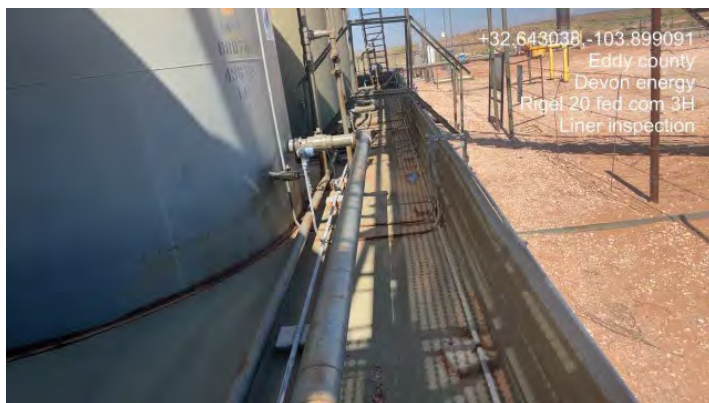
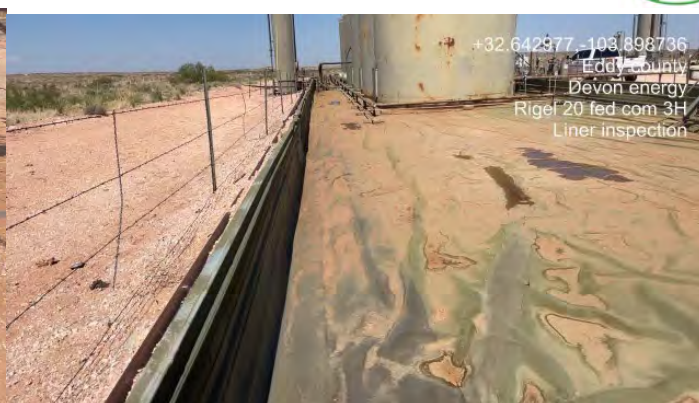
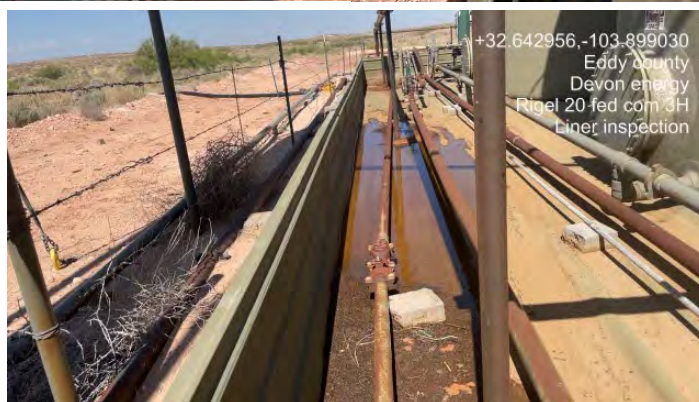
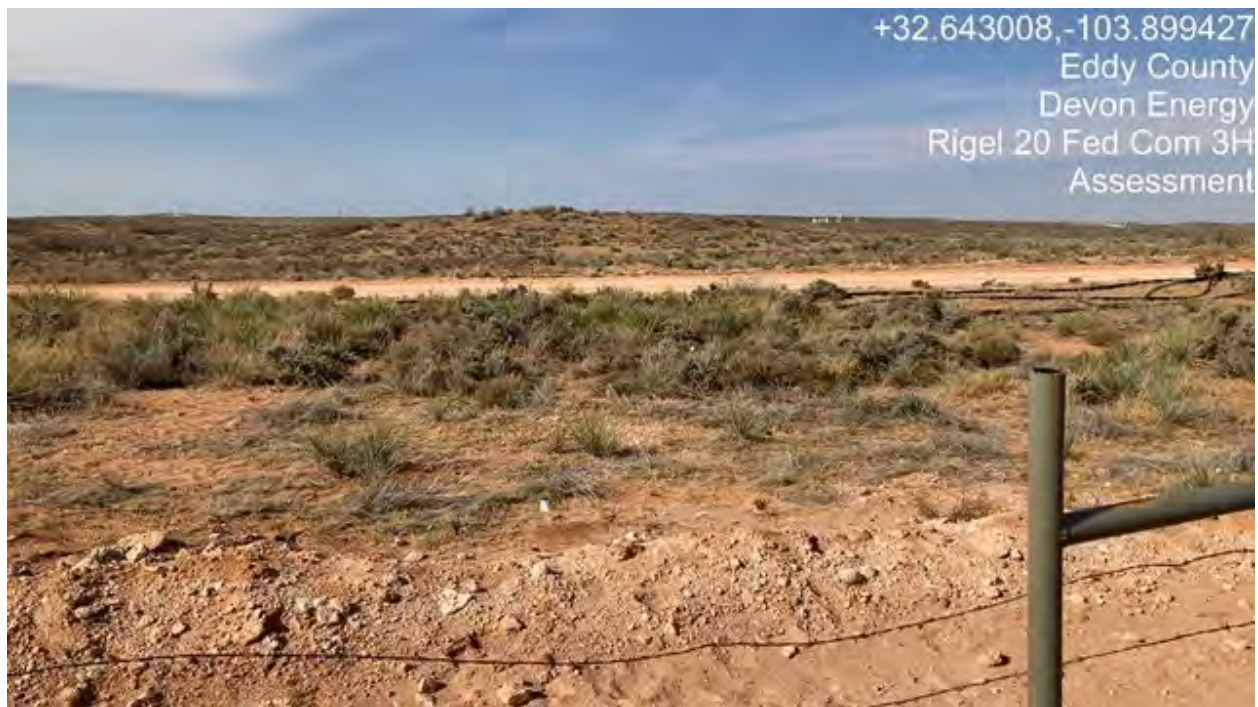
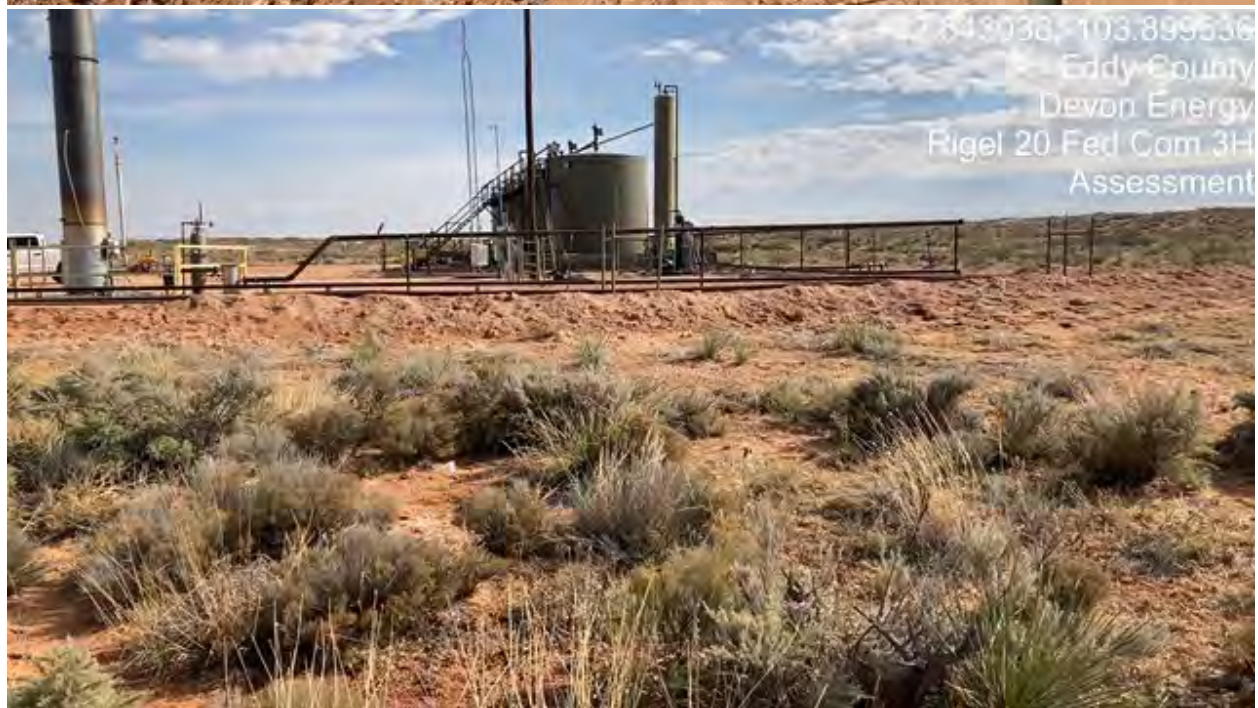
On July 2, 2022, after sending the 48-hour notification email, Pima Environmental conducted a liner inspection at this location. We concluded that this liner and containment maintained its integrity and was able to retain the fluids. The liner inspection form and photographic documentation can be found in Appendix C.

Visualization	Yes	No	Comments
Is there a tear in the liner?		X	
Are there holes in the liner?		X	
Is the liner retaining any fluids?	X		Rain Water
Does the liner have integrity to contain a leak?	X
