Release Notification

Site Name: CARRACAS 23A #004	Site Type: WELL
Date Release Discovered: 09/27/2022	API# (if applicable): 30-039-27550

MorningStar Operating, LLC's Carracas 23A #004 Soil Sampling Plan

Operator	MorningStar Operating, LLC (MorningStar)
Location Name	Carracas 23A #004
Legal Location	Section 23, Township 32 North, Range 5 West
API	30-039-27550
Incident ID	nAPP2227139978

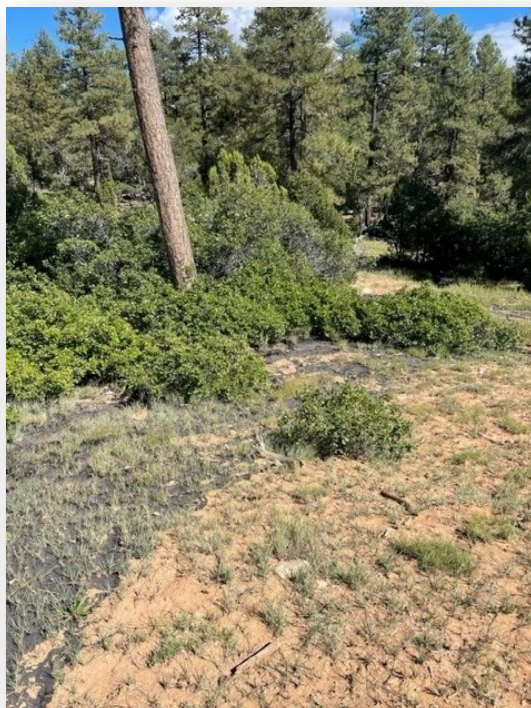
Figure 3. Flow Path of Spill

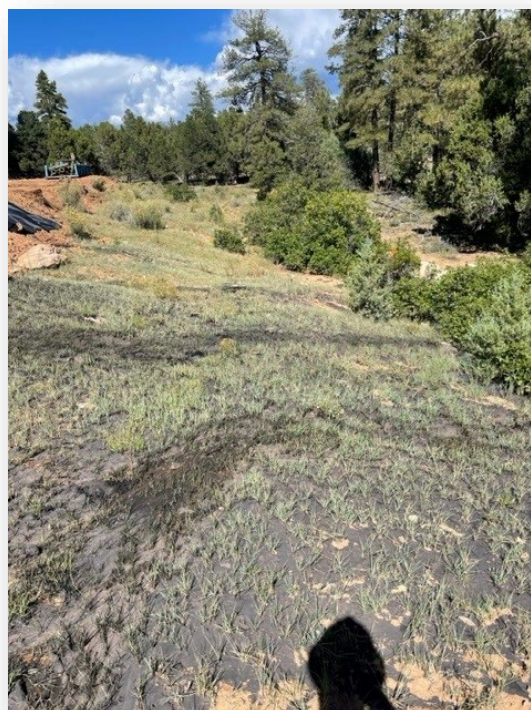
Figure 4. Flow Path of Spill

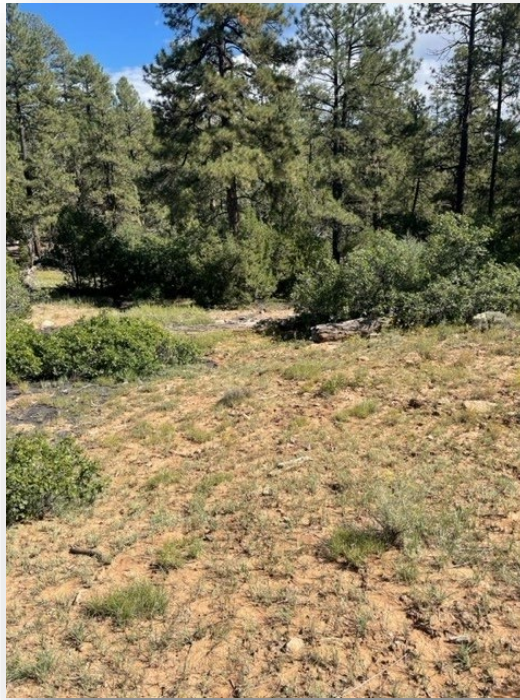
Figure 5. Flow Path of Spill

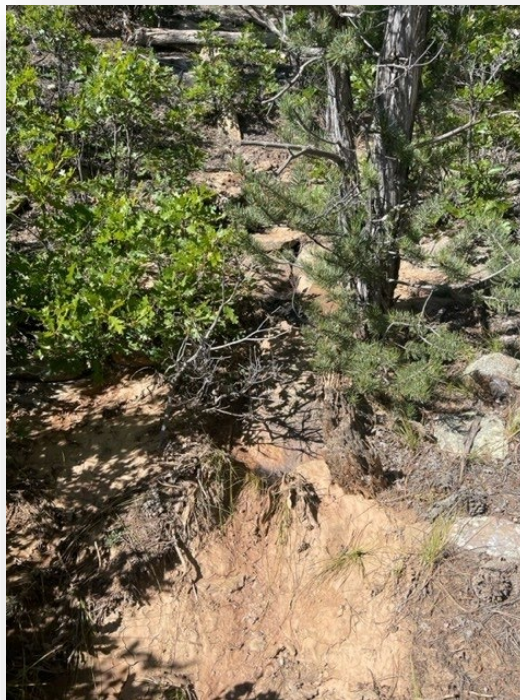
Figure 6. Flow Path of Spill

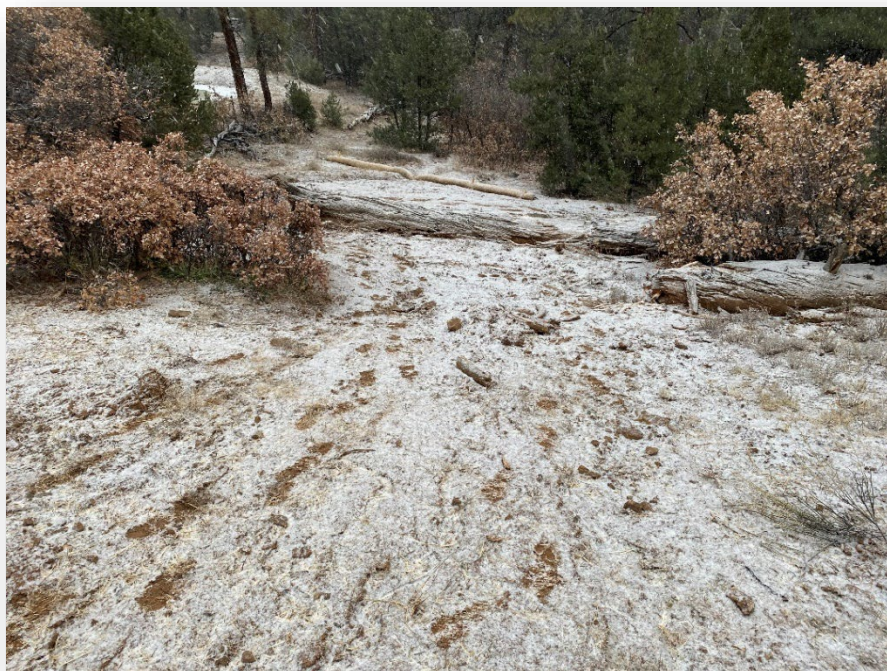
Figure 7. Start of Spill After Cleanup

As mentioned above, initial cleanup and remediation occurred immediately after the release. Based on sampling results from this proposed plan, if levels of contaminants exceed ~~Table 1 (ground water greater the 100 feet)~~, MorningStar will submit a remediation plan to further remediate and reclaim the impacted area. If the samples come back clean and levels of contaminants are below ~~the Table 1 (ground water greater the 100 feet)~~, MorningStar will pursue the closure of the incident with NMOCD via a C-141 based on the remediation and reclamation that has already occurred. The Carson National Forest will be consulted for any required reclamation of the area to meet their reclamation standards.

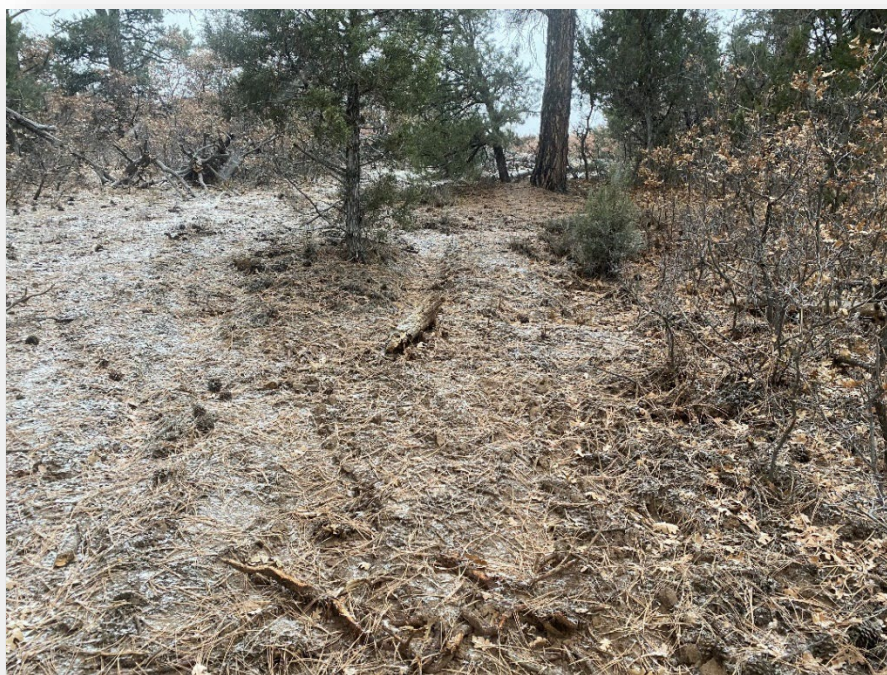
Figure 8. Flow Path After Cleanup

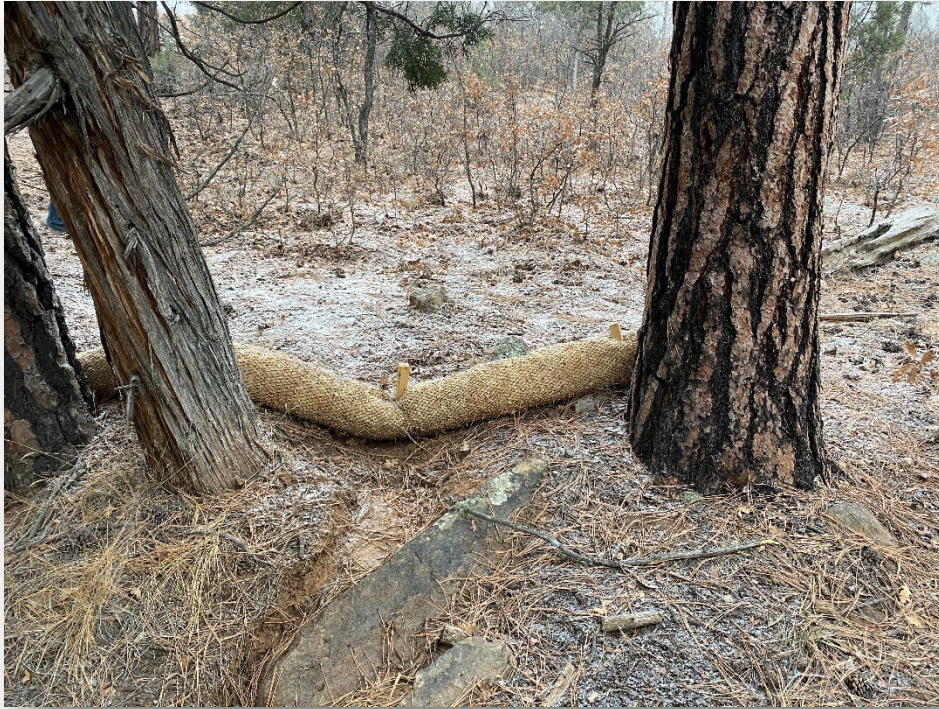
Figure 9. Flow Path After Cleanup

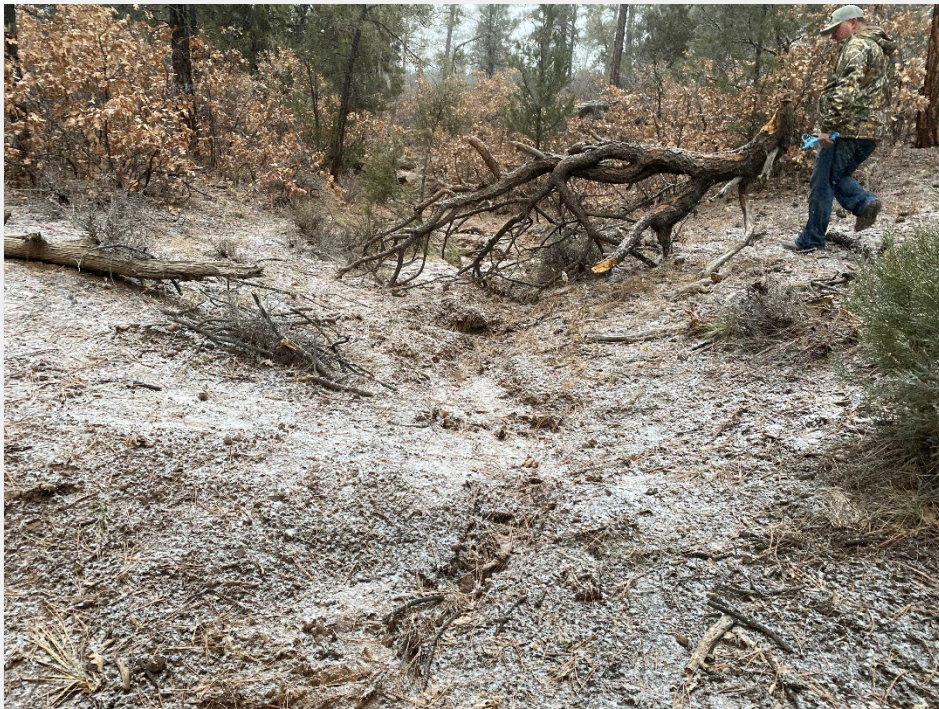
Figure 10. Flow Path After Cleanup

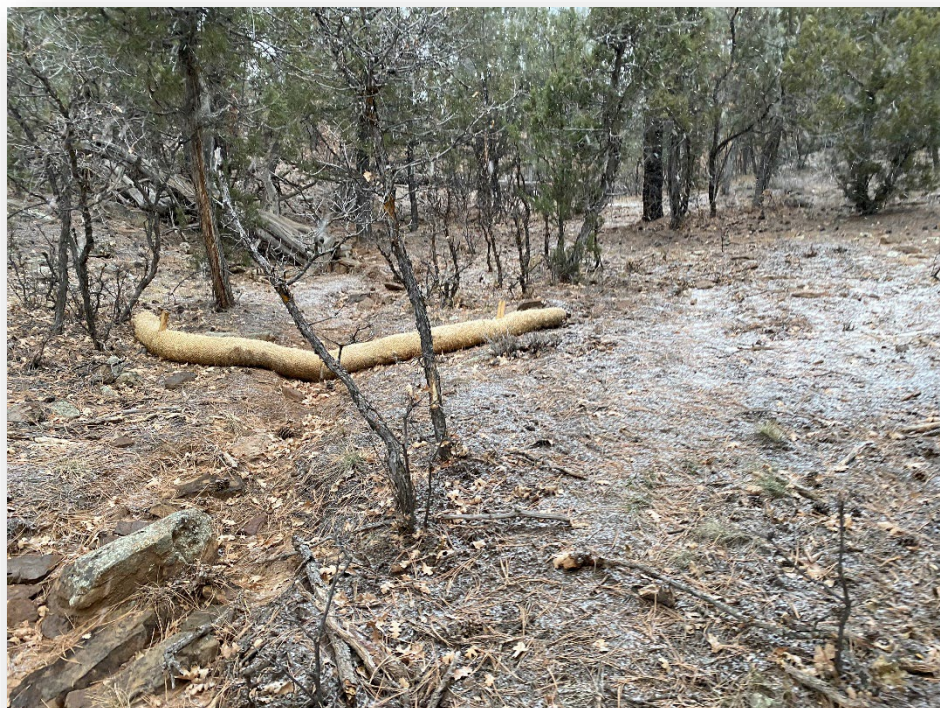
Figure 11. Flow Path After Cleanup

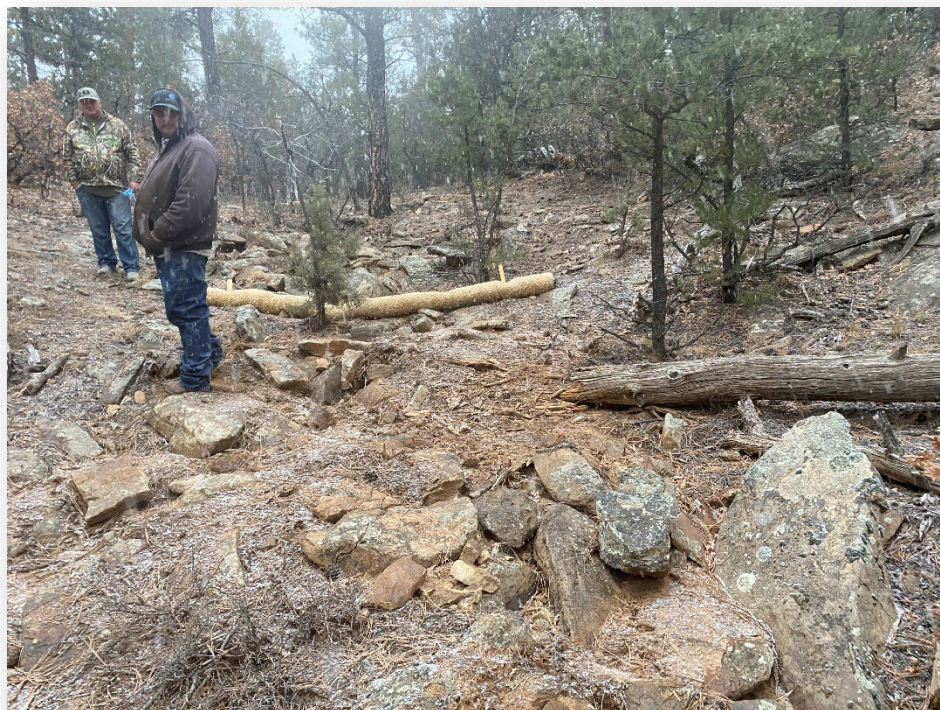
Figure 12. Flow Path After Cleanup

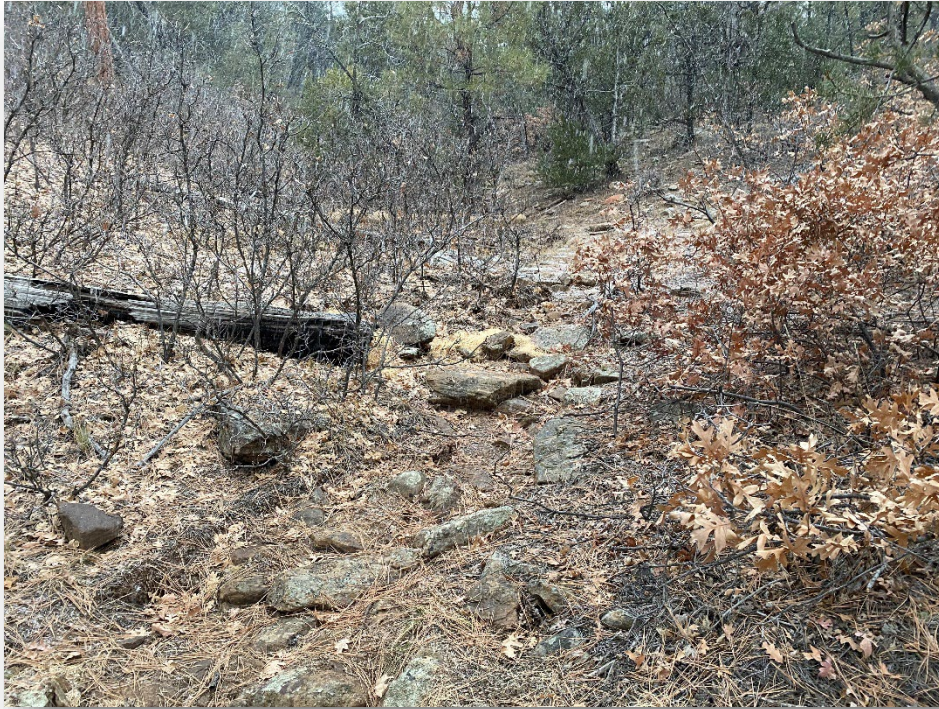
Figure 17. Flow Path After Cleanup

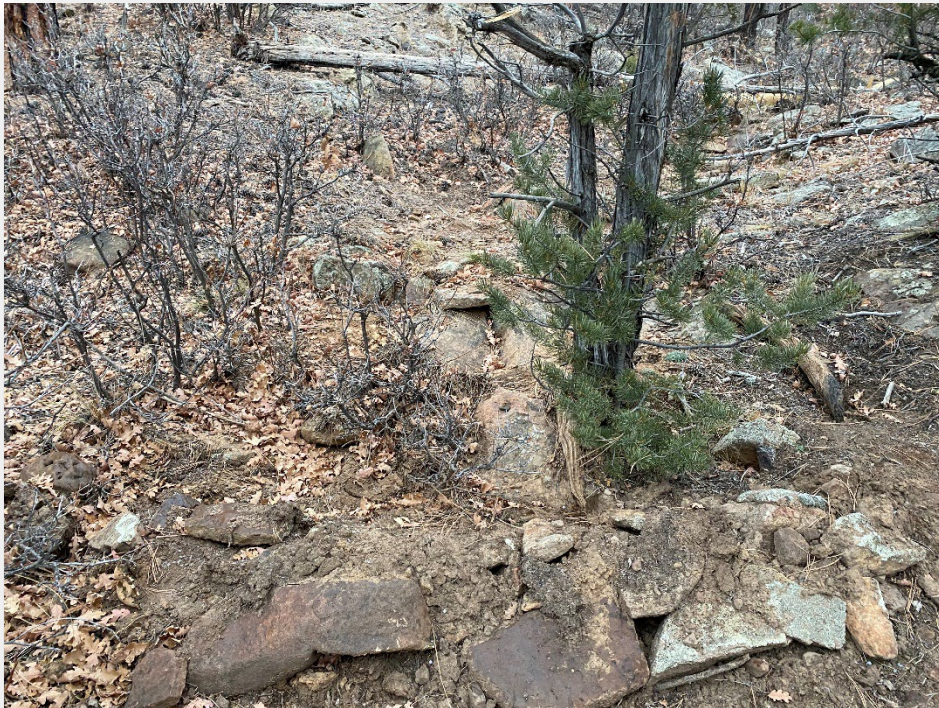
Figure 18. Flow Path After Cleanup

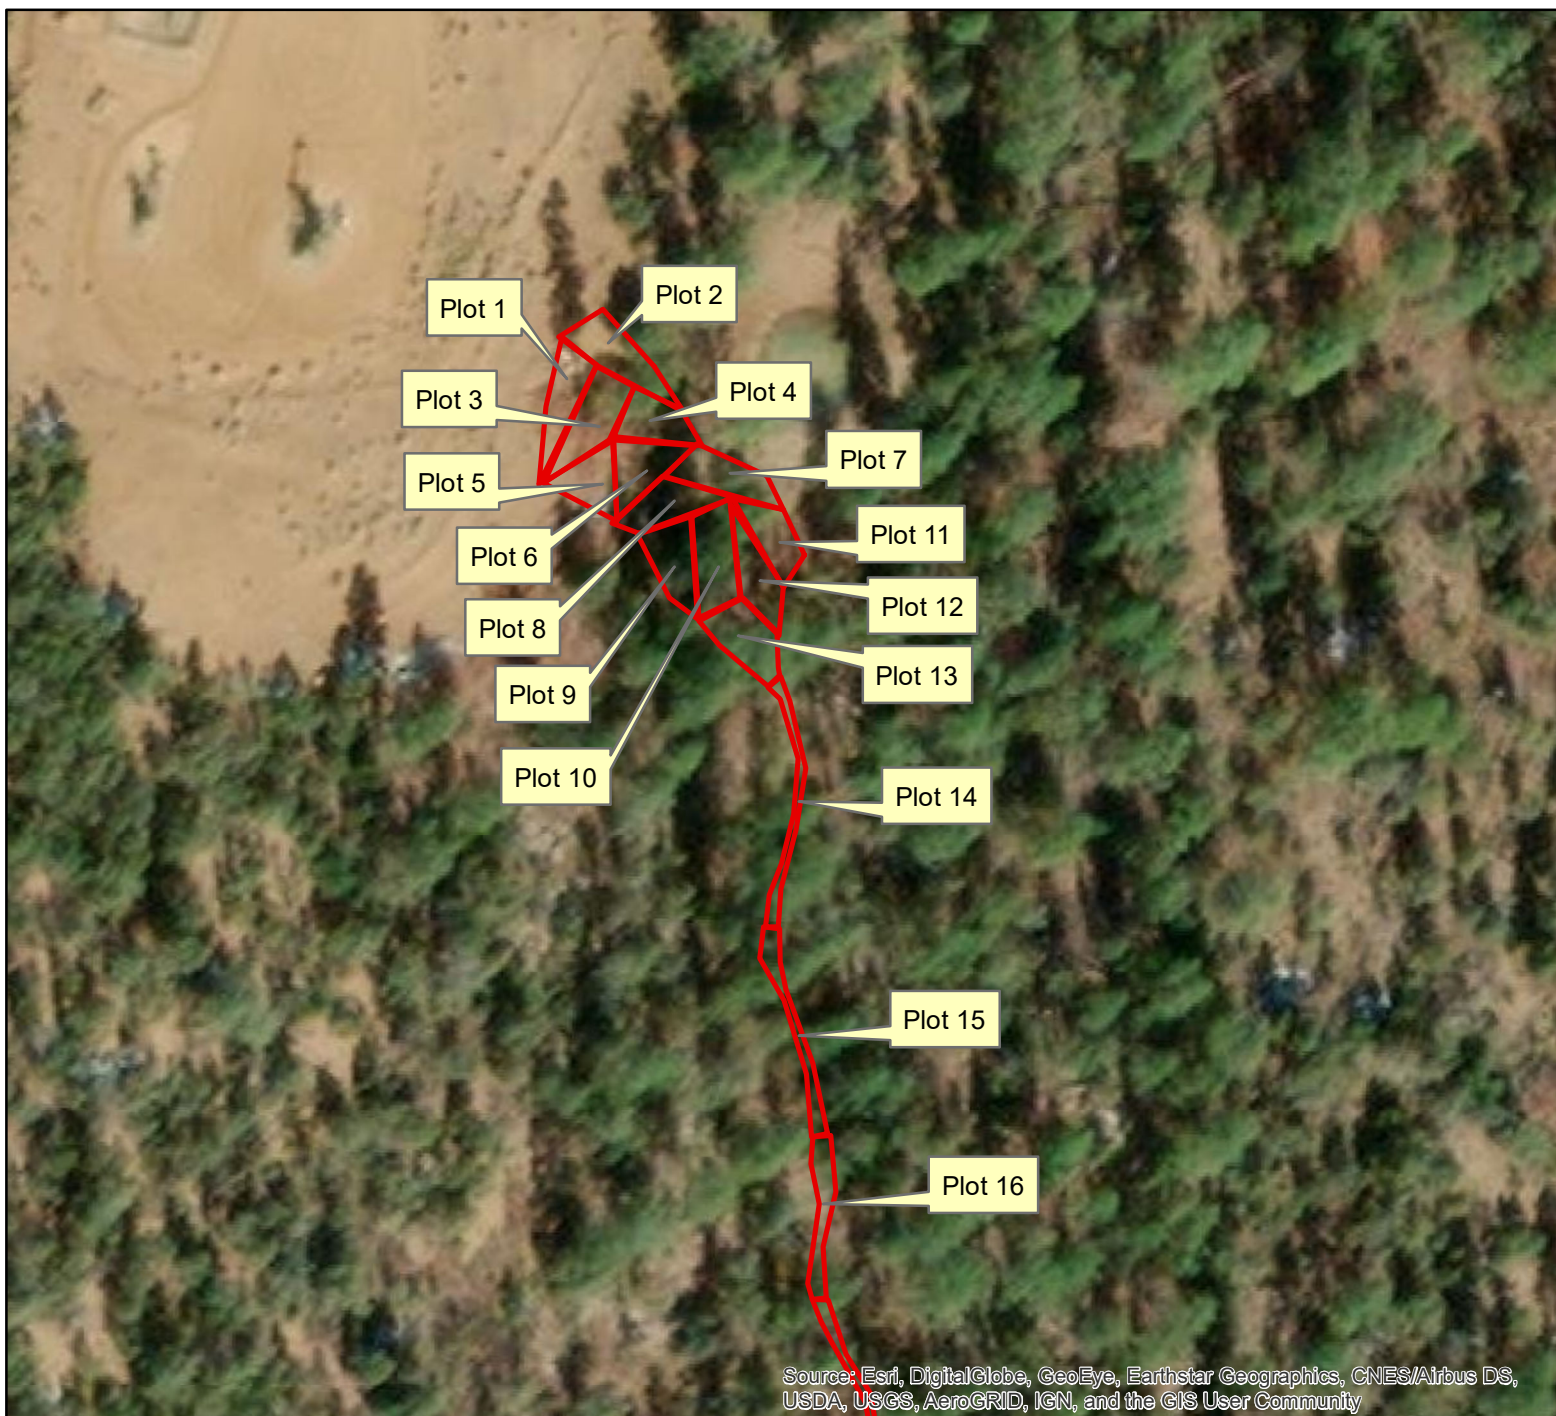
Carracus 23A #004 Soil Sampling Plots

Flow Path with 400 sq. ft Sampling Sections

EIS Environmental, on behalf of MorningStar, proposes a sampling methodology of collecting a discreet sample every 400 square feet within the release flow path (22 samples in total) along with four background samples upgradient of the impacted area (See Attachment II) utilizing ~~NMAC Table I~~ **Closure Criteria for Soils Impacted by a Release** (See Attachment I). All samples will be hand augured to a depth of 1 foot or to a restrictive layer. All samples will be transported via ice and analyzed utilizing EPA 300 approved series.

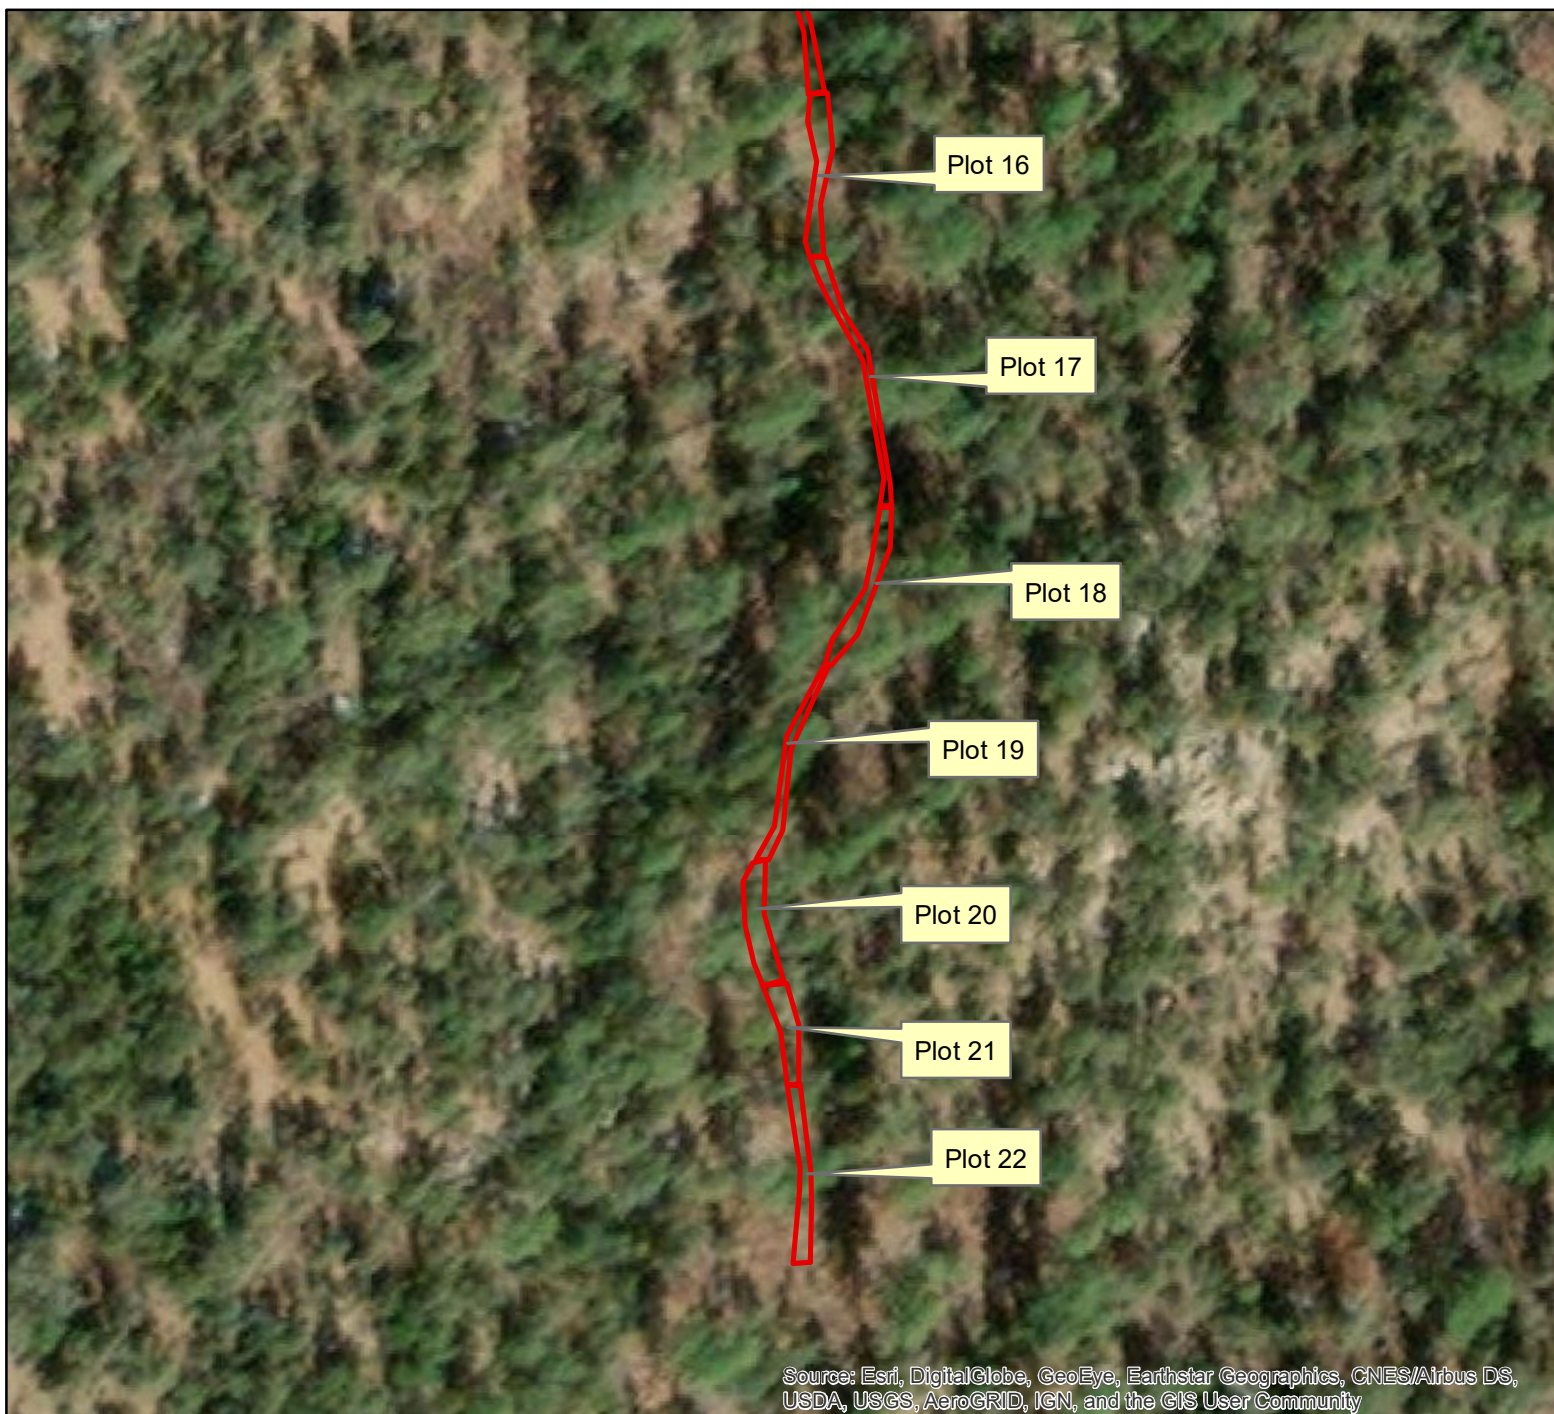
Carracus 23A #004 Soil Sampling Plots

Flow Path with 400 sq. ft. Sampling Sections

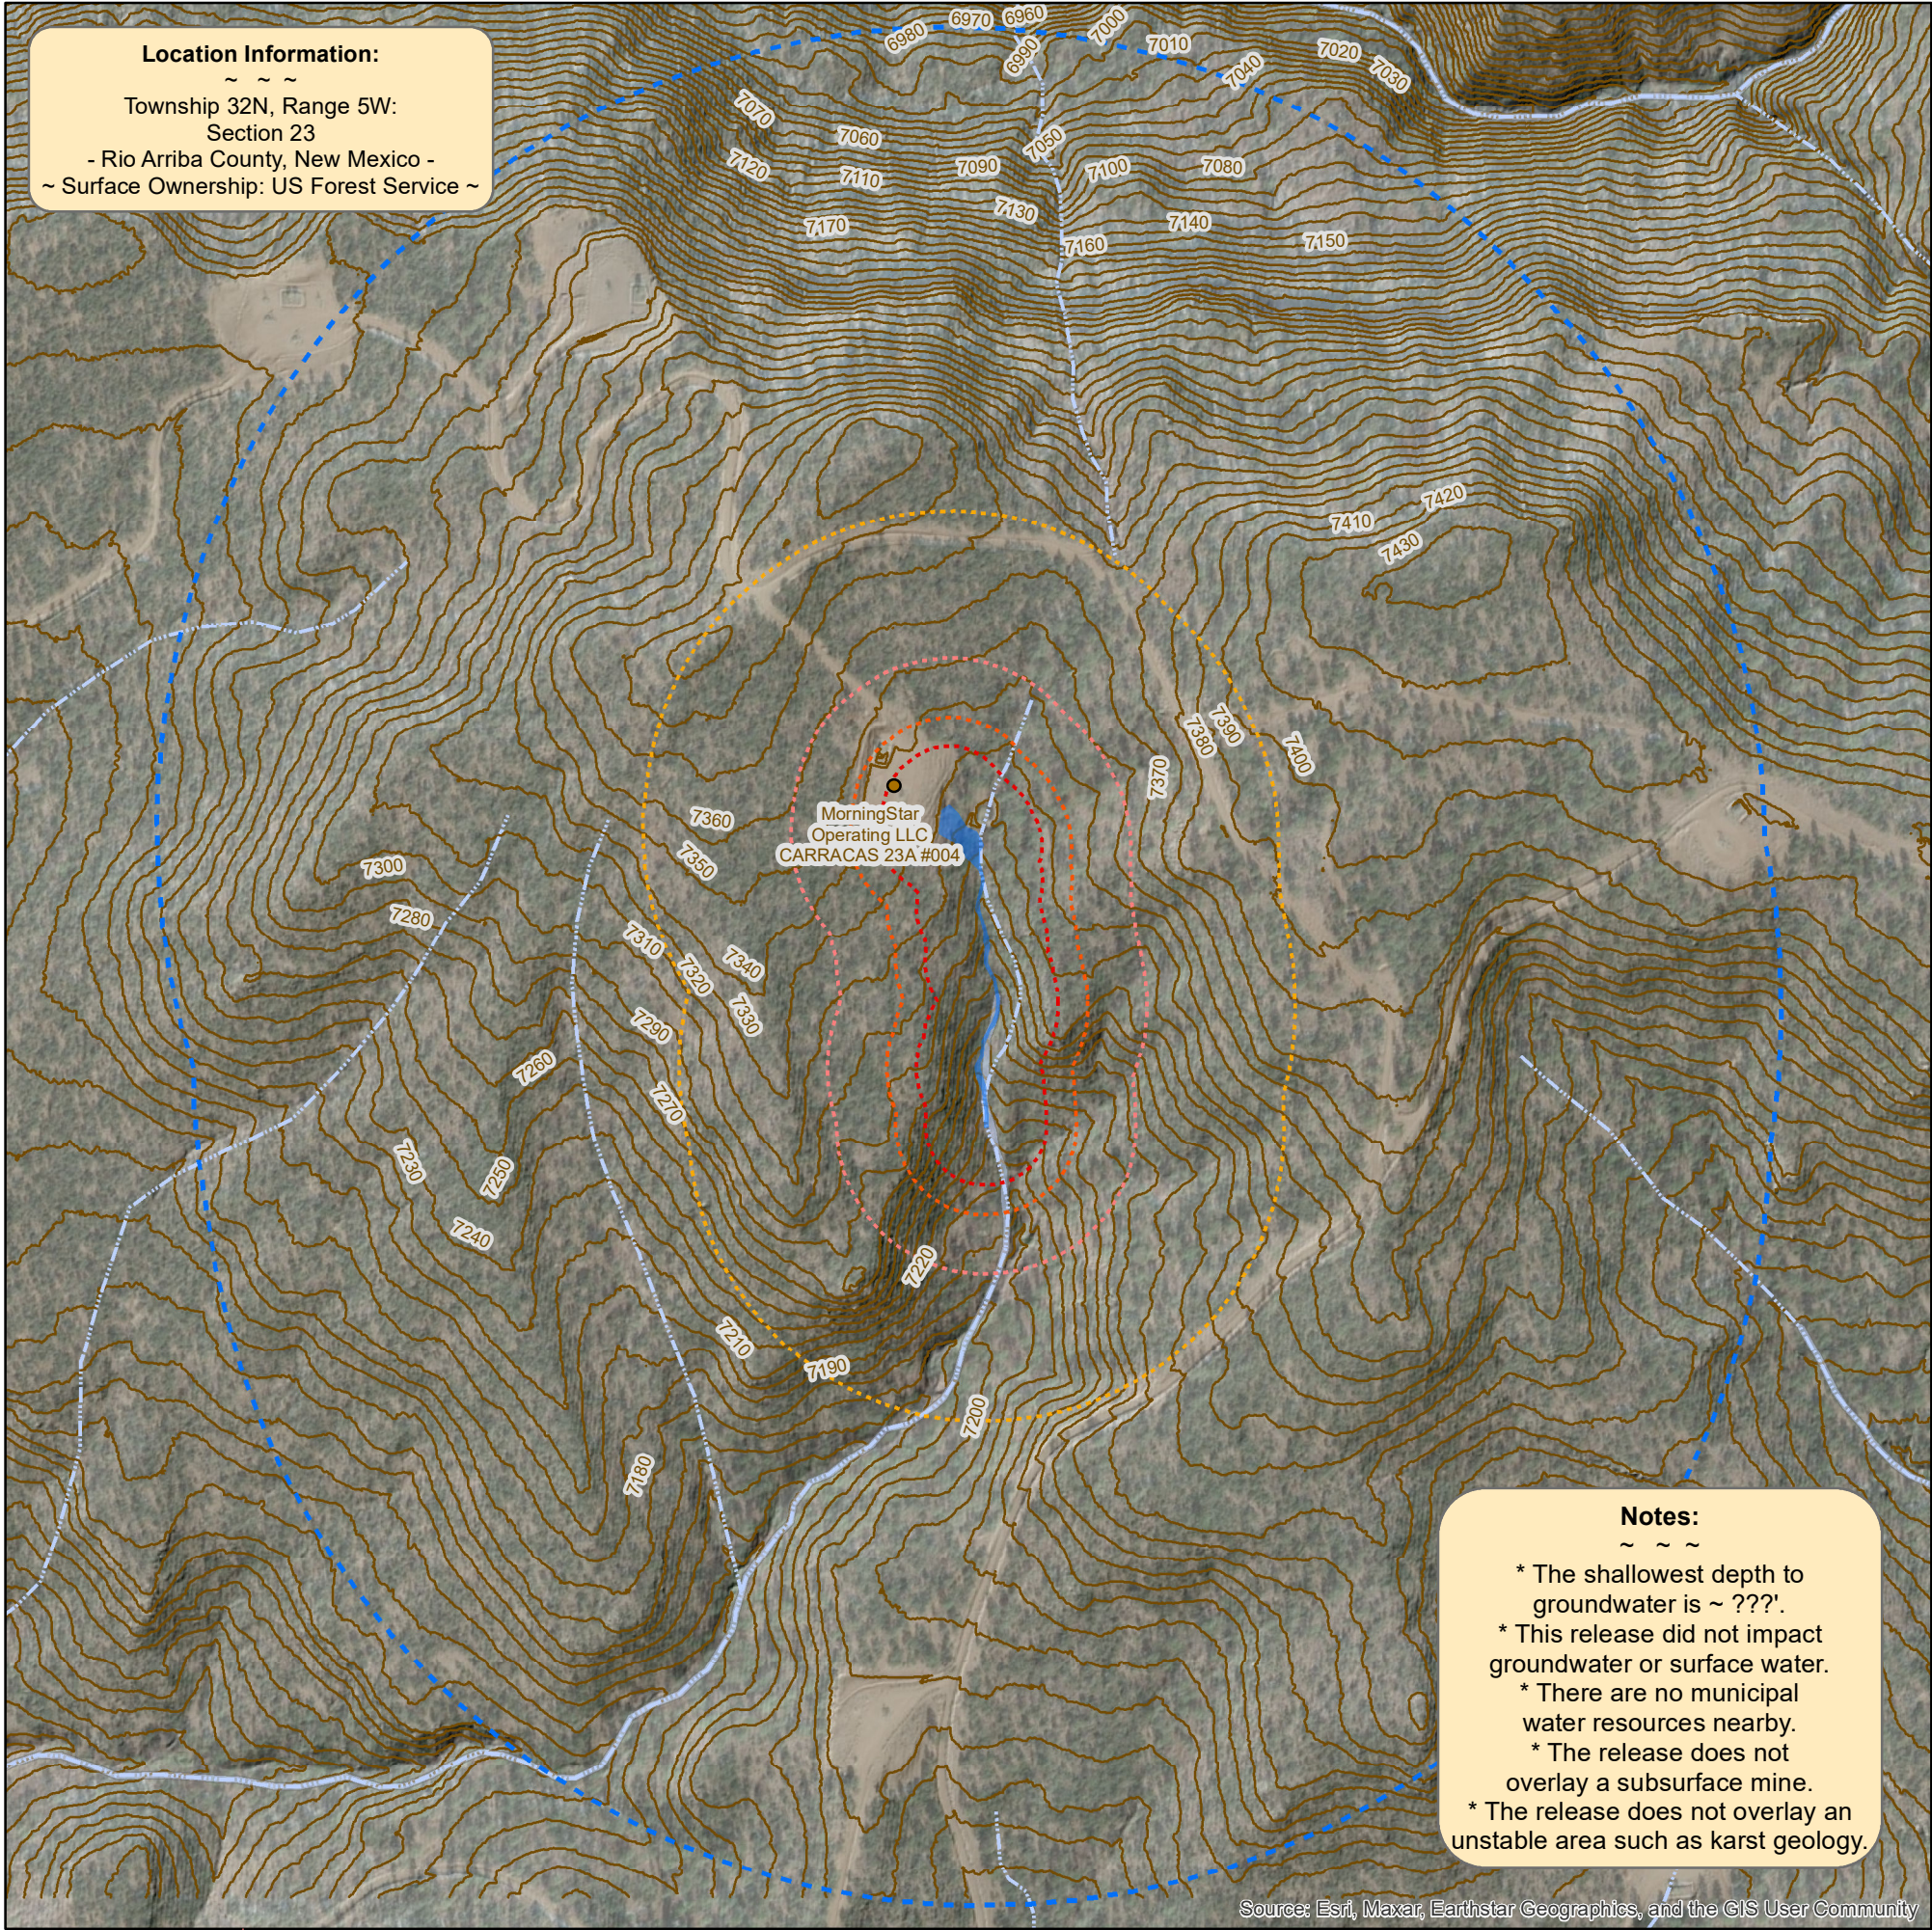
-- Spill Area Map --

- @ 36.970097, -107.336662
- Carracas 23A #004 Spill Flow Path
- ~ Ephemeral Stream (NHD)

- ~ None Within 300'

- ~ None Within 200'
- Riverine Area (NWI)

- ~ None Within Spill Area

- None Within 500'

- None Within 1000'

The nearest Point of Diversion (POD) indicating a domestic water well is approximately 14,500' to the east and is at a depth of 800'. Looking at the NMOCD's data on the Carracas 23A #004, the top of the Ojo Alamo formation is 3,264 feet. Looking at a cathodic well that was drilled near the Carracas 18B #003 well, which is approximately 2.12 miles to the NE, water was found at a depth of 230'. As a result, we have concluded that depth to groundwater (DTGW) is estimated to be greater than 100 feet. As such, the closure criteria of soils in Table I >100 feet will be utilized.
