Release Notification

The spill site is located in the Broadside 13 battery containment. The release occurred due to a truck drivers' failure to disconnect his load line from the battery. Approximately 436 barrels of produce water was lost with 420 barrels recovered. Figures were calculated based off containment measurements and are attached to the incident report.

Delineation Map
NAPP2208741123

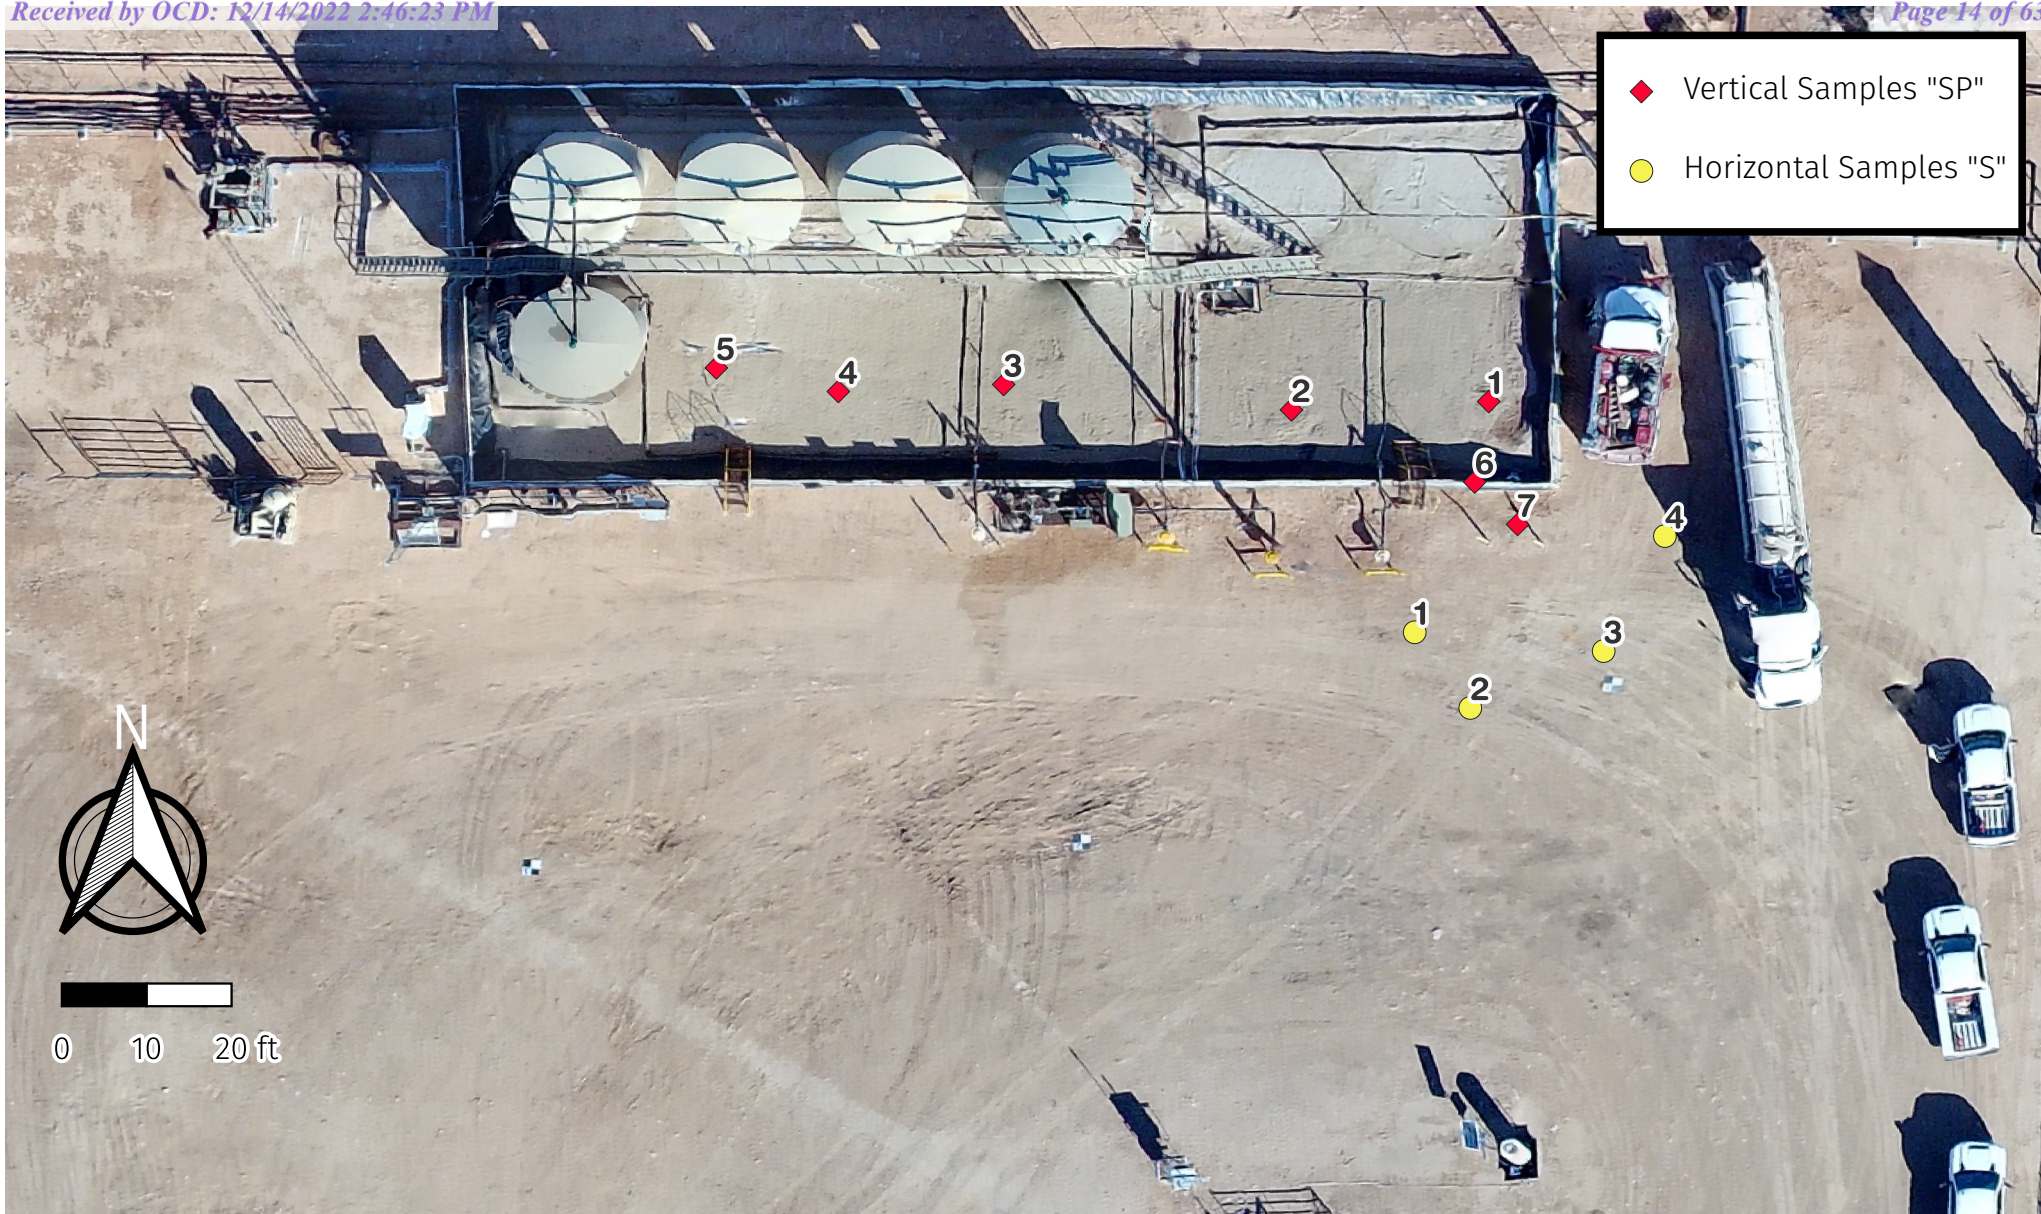
Upon review of analytical, all containment area samples (1-5) proved to be below table 1 RRAL's for site closure and meet reclamation criteria, indicating no breach occurred. At locations below the containment failure and outside the containment, sample results (6-7) indicate they are below RRAL's for site closure but exceed reclamation criteria.

On August 2nd, 2022, Diamondback arrived on site to delineate the site. The existing liner was inspected for integrity. Only one area was found to be ripped due to incident but seemed to be above fluid levels upon visual inspection. Small penetrations were cut in liner to gain access with hand auger to collect underlying soils. Samples were taken below the containment area, below the tear in the containment and one outside the containment area, packaged and delivered to a third-party lab, with chain of custody for testing as per regulatory standards. (See attached analytical). After sample collection the containment liner was repaired in a manner that prevent future penetration of liquids.

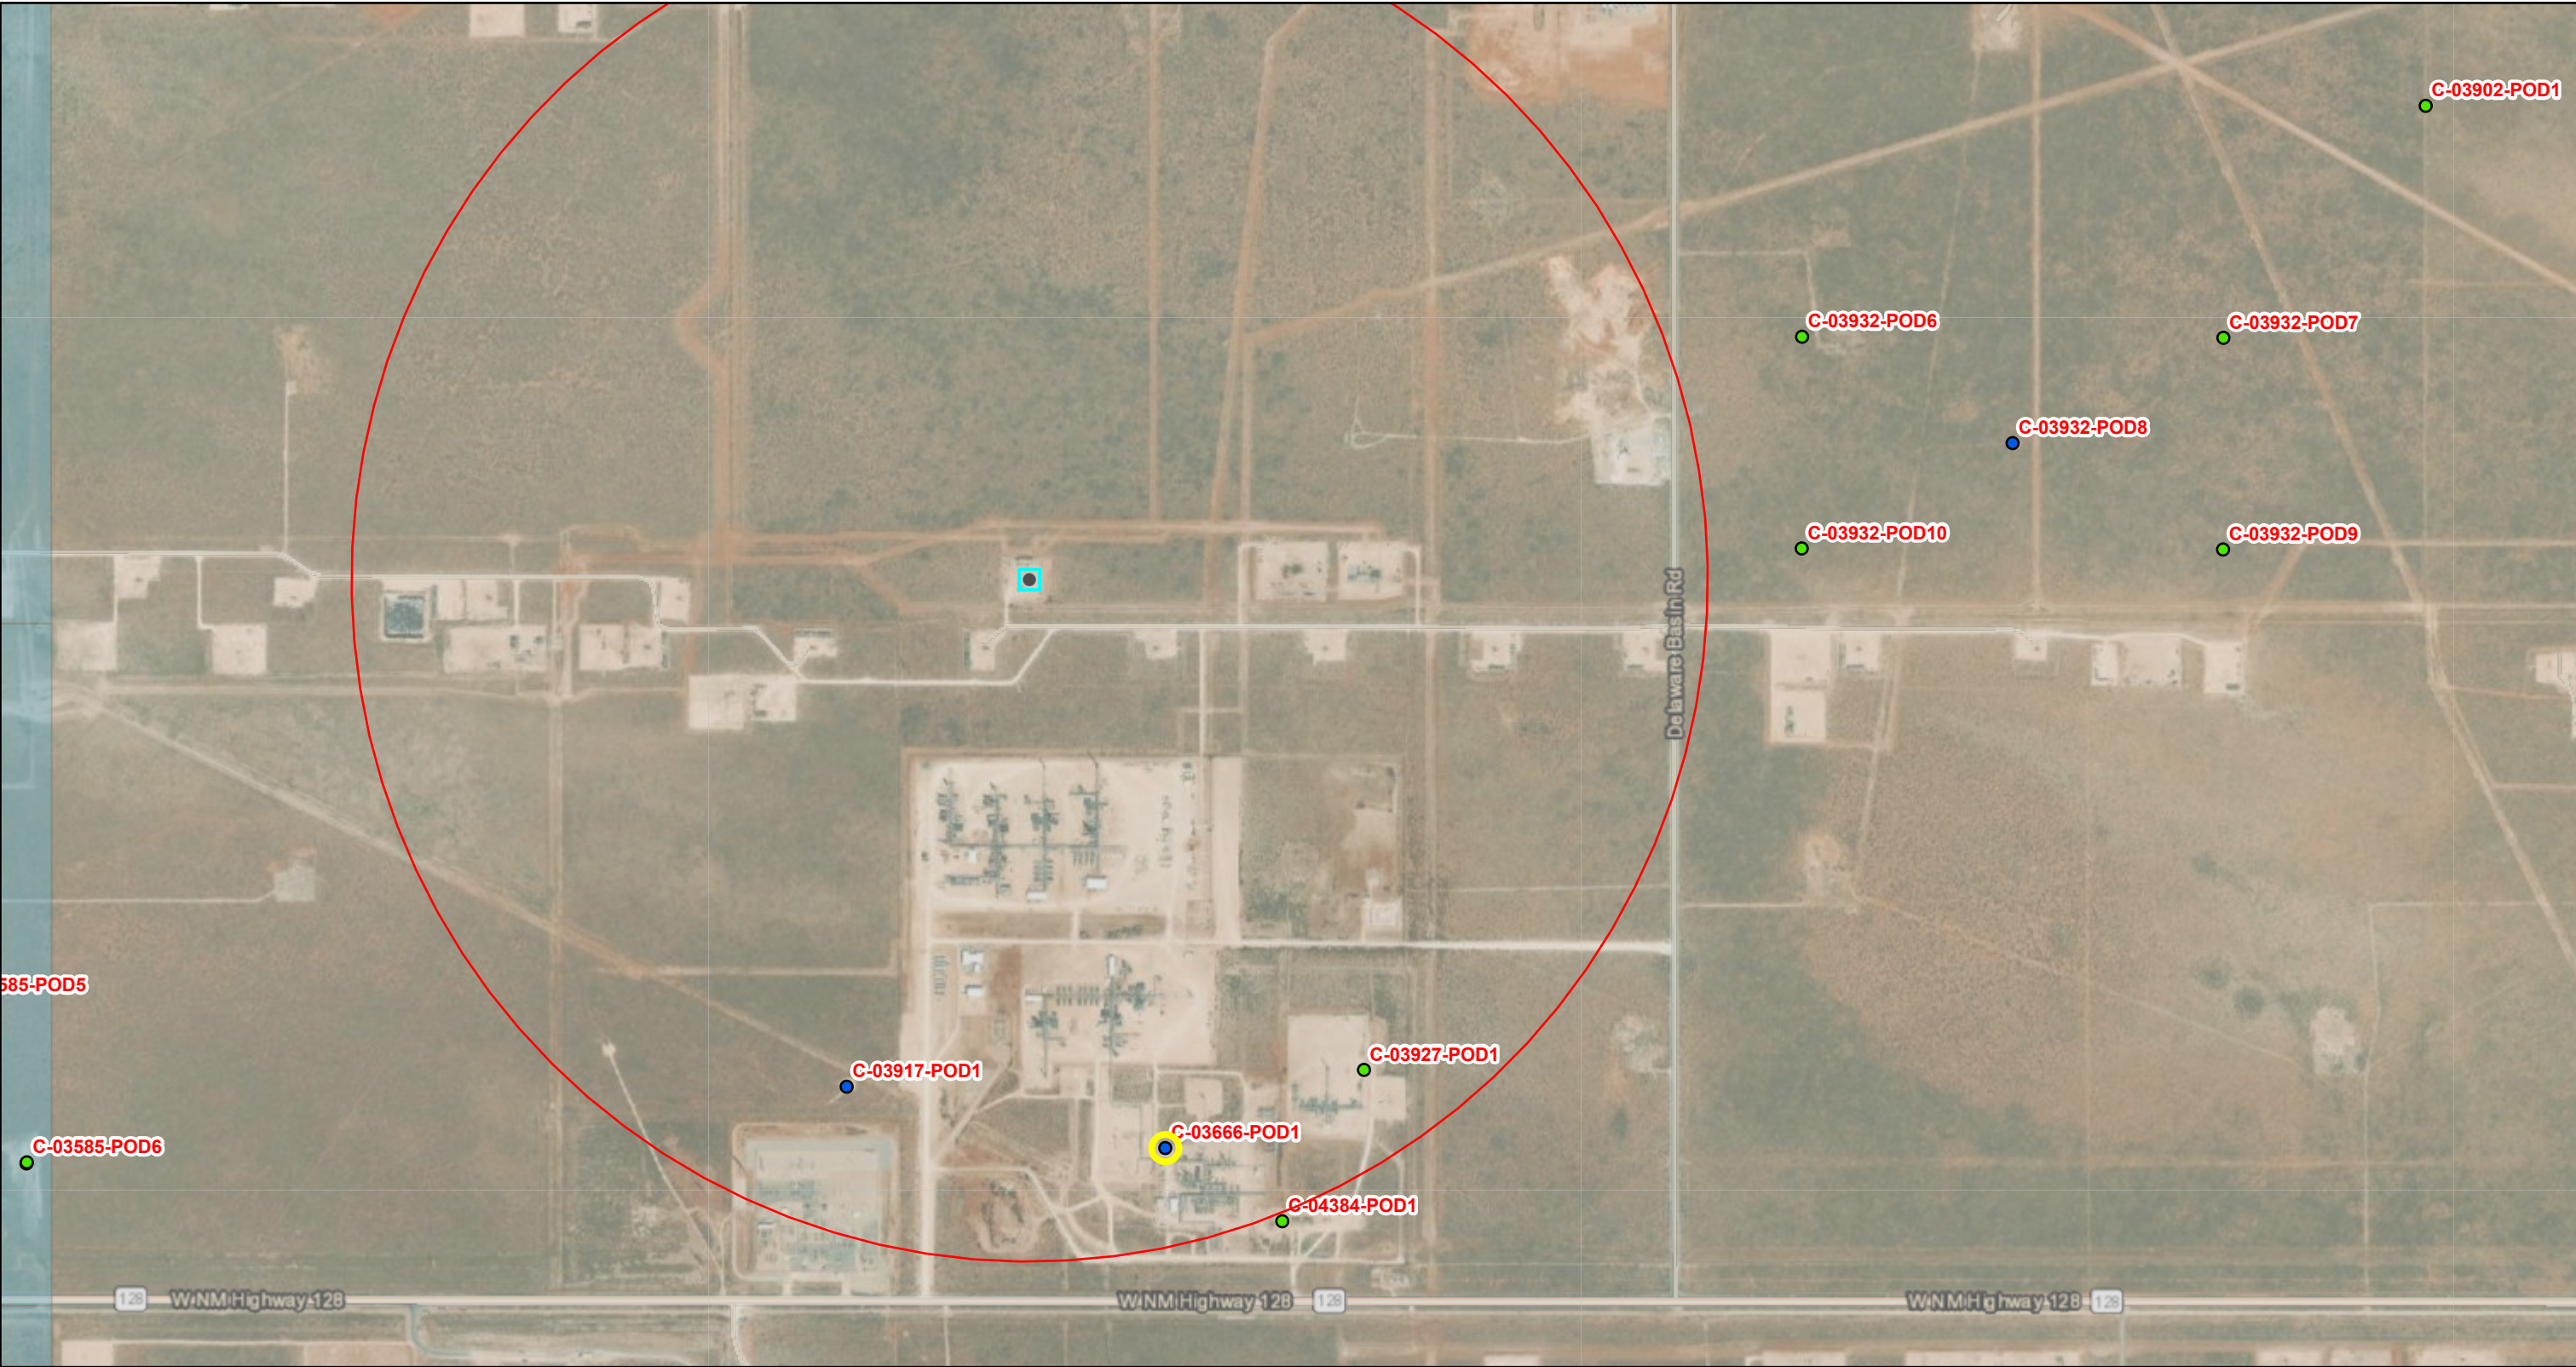
OSE POD Locations Map

NM OSE POD data for Broadside 13 W Fed Com 001H
