Incident ID	nMLB1128636288
District RP	
Facility ID	30-015-31381
Application ID

State of New Mexico  
Oil Conservation Division

## Devon Energy Cotton Draw Unit #89 SWD

### Photo Documentation

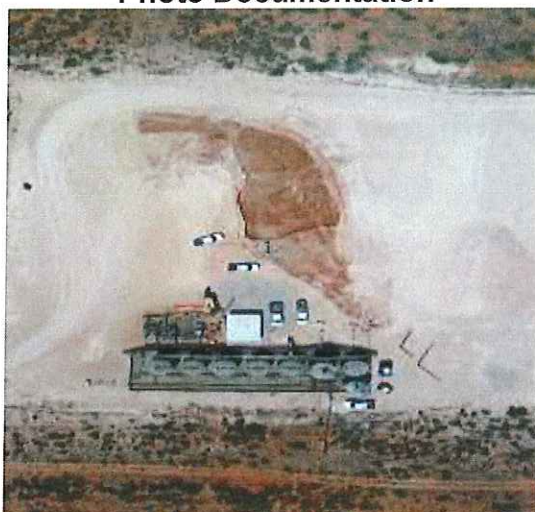
Excavation 2RP-3198/2RP-3728

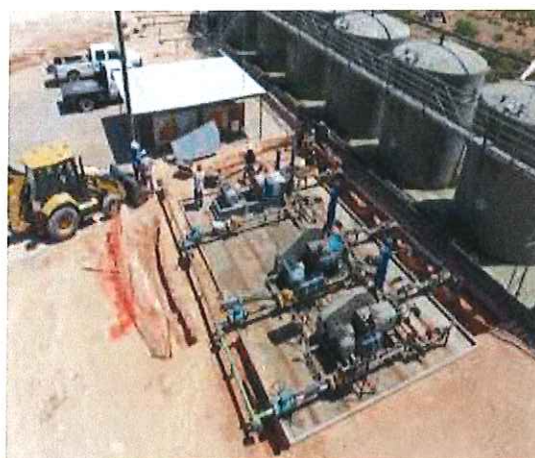
2RP-4186

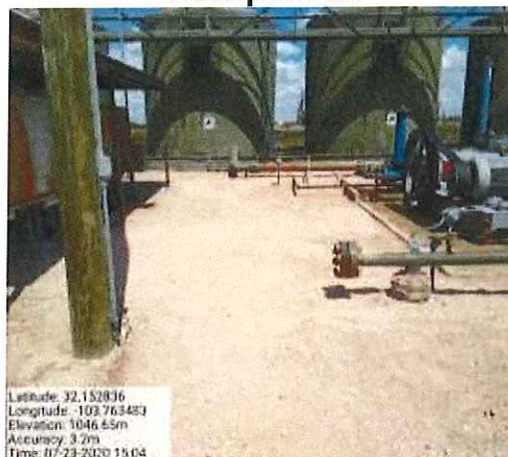
Completion 2RP-4186

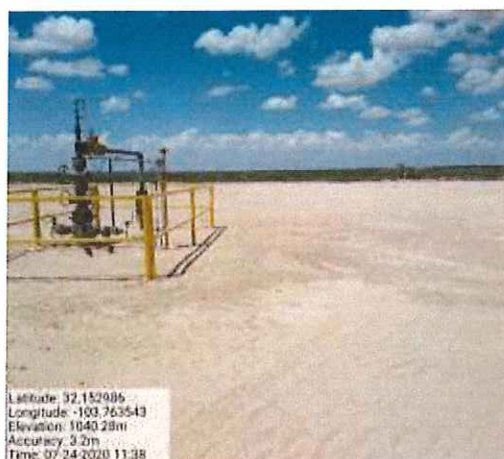
2RP-3198/2RP-3728
