**Dayton FP Battery**

**Closure Report**

**30-015-21738**

**nJMW1317739925**

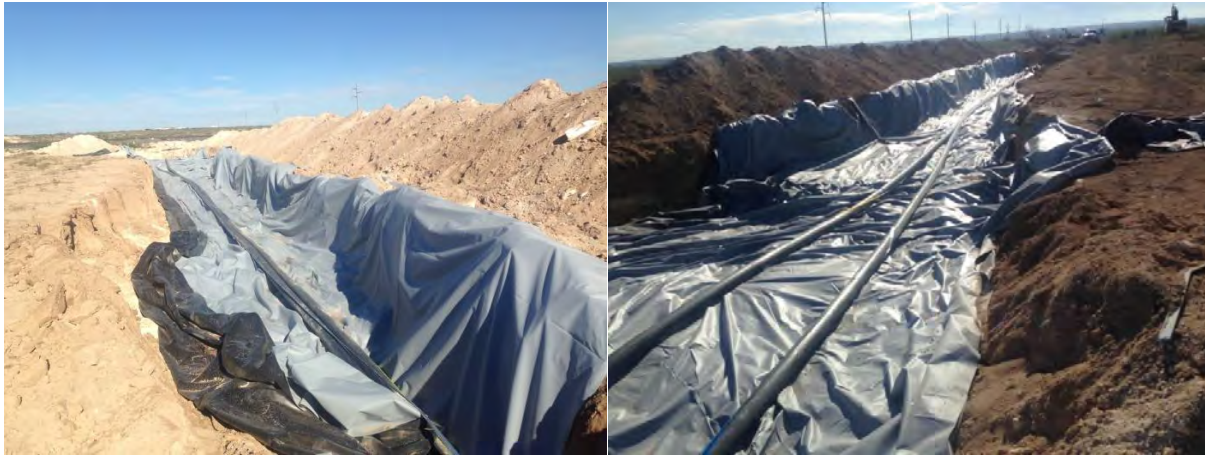
Above- 2015 photos of pipeline replacement with excavation and installation of liner.

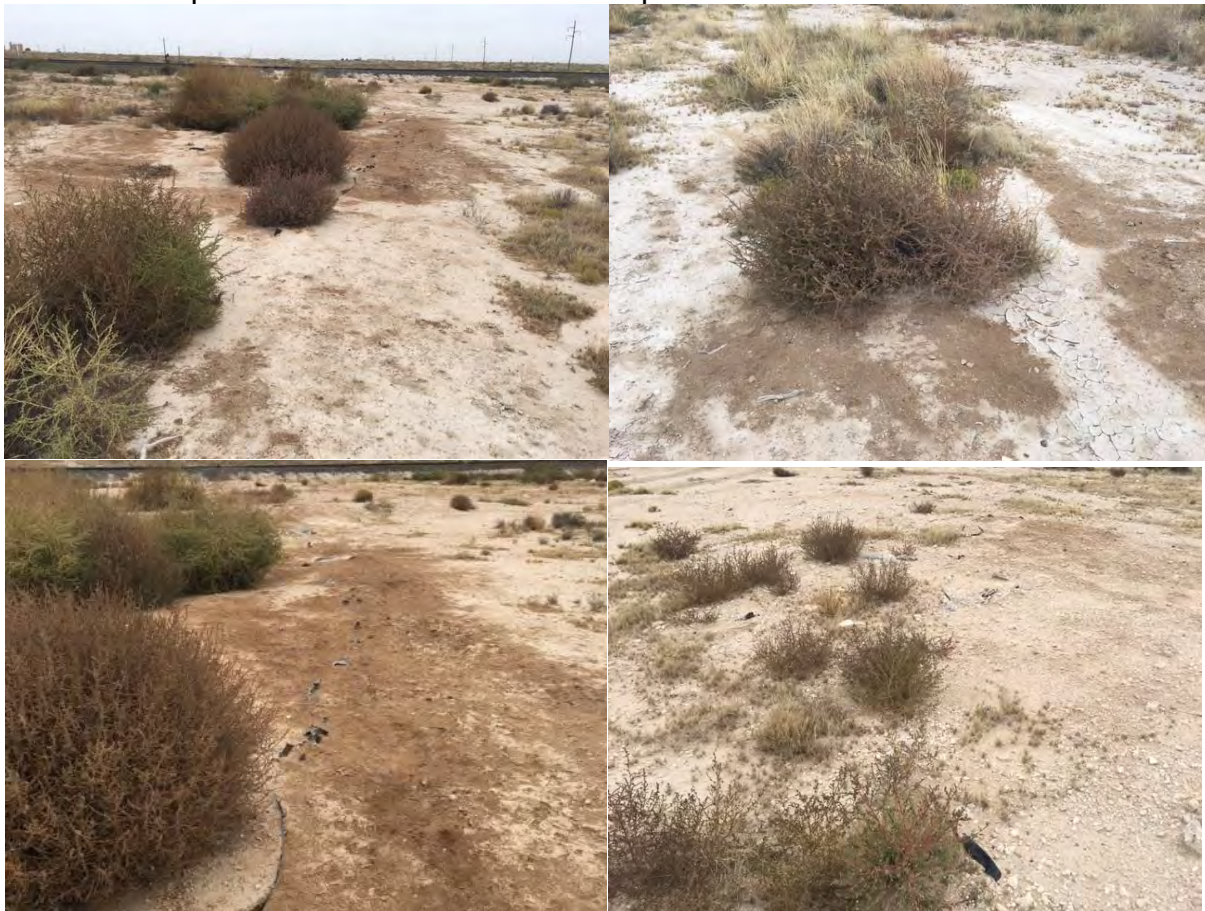
After a denial of the original Closure Report by NMOCD on October 6, 2021, a site visit was conducted to get new photos of the remediation area. During this site visit, it became evident that the portion of the release addressed during 2015 had been improperly lined. The 20-ml liner had surfaced on both the north and south sides of the pipeline Right of Way, indicating that the liner had not only been installed underneath the poly pipelines, but also up the sidewalls. Pictures of this are included in the Site Photos section.

Below- 2021 photos of remediation area completed in 2015.

Based on the need to correct the liner installation in this portion of the remediation area, EOG retained Vertex Resource Services Inc. (Vertex) to supervise the liner repairs and properly complete the remediation of this section of the release area.

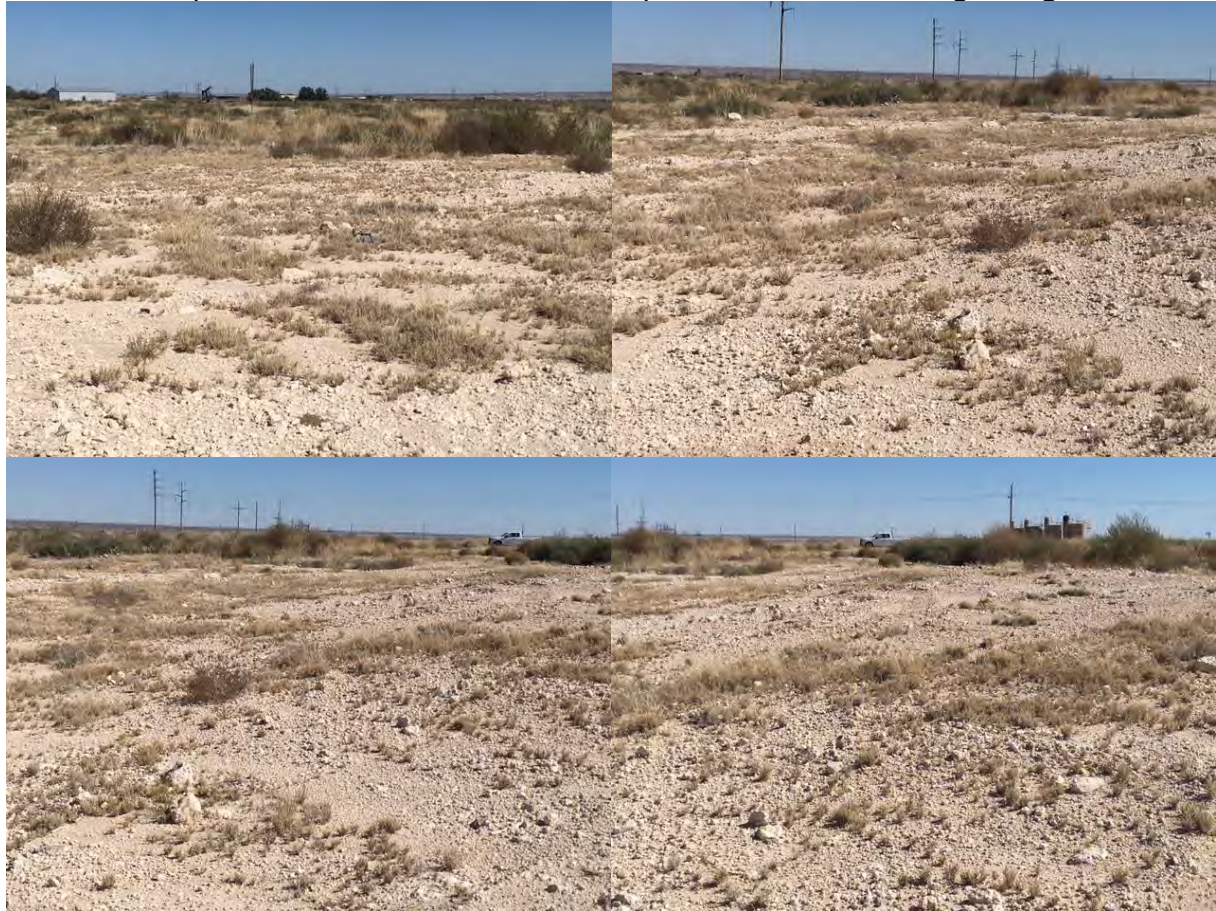
Below- 2021 photos of remediation area completed in 2016 showing revegetation.

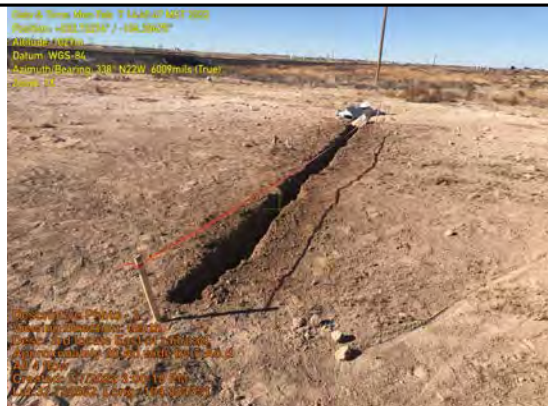
## Viewing Direction: North

Hydrovac Line Locating  
All 4 Lines Located, Lines Appear To Be 4'  
Below Surface.

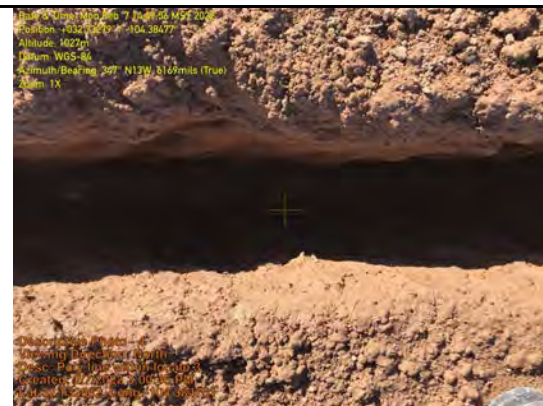
## Viewing Direction: North

Hydrovac Line Locating

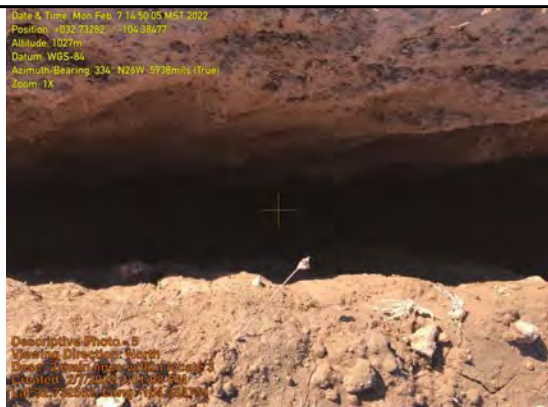
## Viewing Direction: North

Hydrovac Line Locating

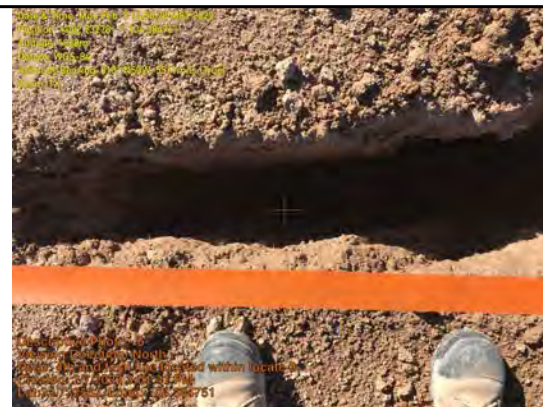
## Viewing Direction: North

Hydrovac Line Locating

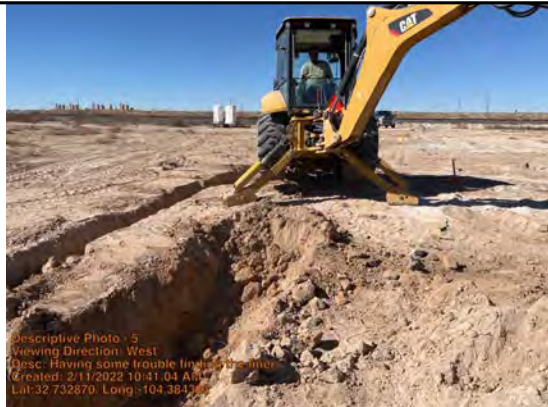
Viewing Direction: West

Beginning Excavation

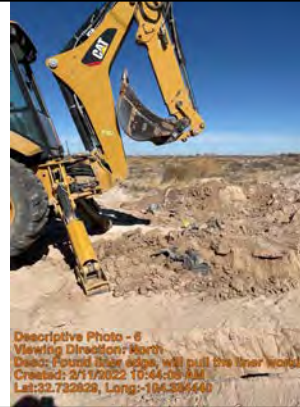
Viewing Direction: North

Found Liner Edge, Working West

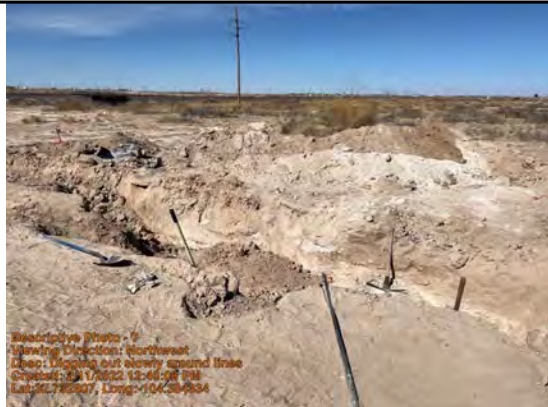
Viewing Direction: Northwest

Shovel Work Around Pipelines

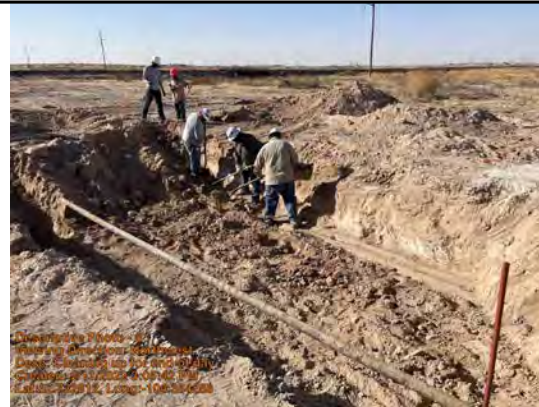
Viewing Direction: Northwest

Shovel Work Around Pipelines

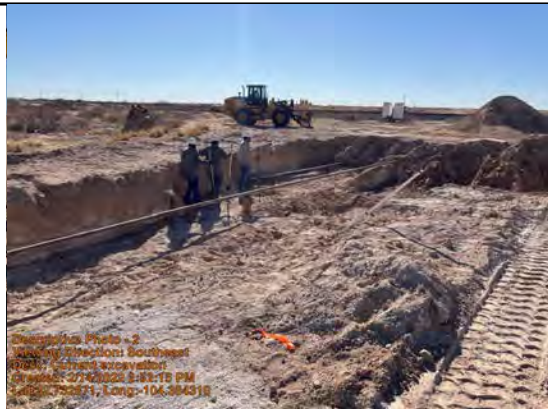
Viewing Direction: Southwest

Current Excavation

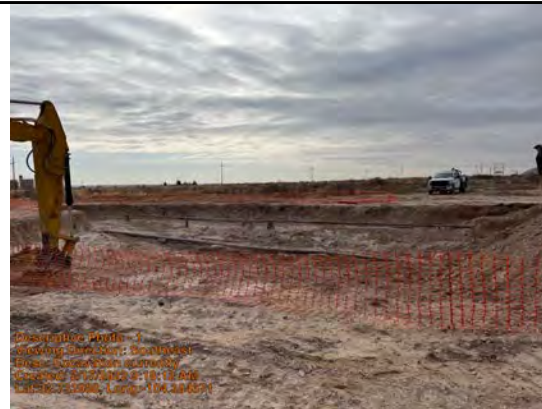
Viewing Direction: Southeast

Current Excavation

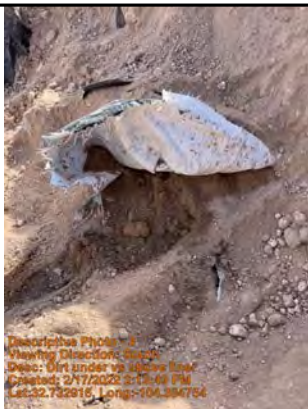
Viewing Direction: South

North Portion Liner

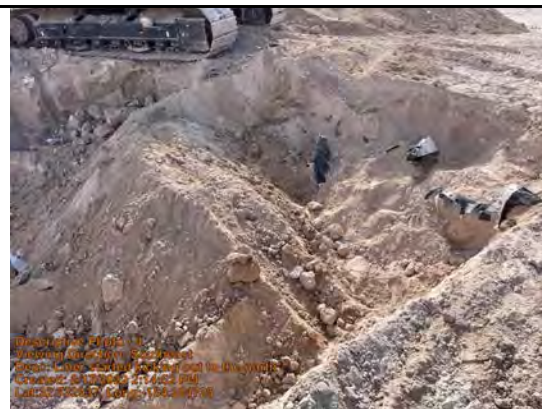
Viewing Direction: Southeast

North Portion Liner Found

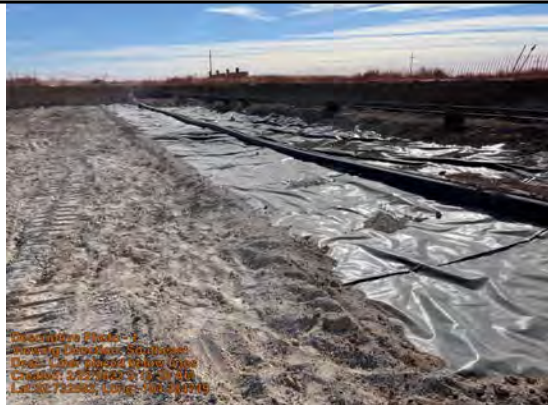
Viewing Direction: Southeast

Liner Replacement

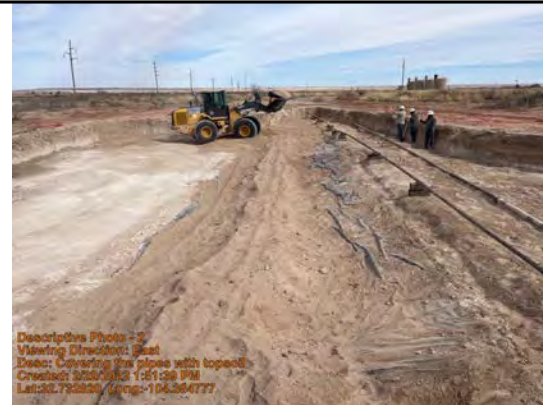
Viewing Direction: East

Backfill

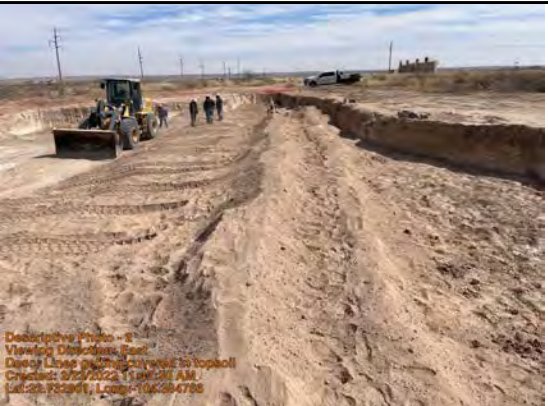
Viewing Direction: East

Backfill

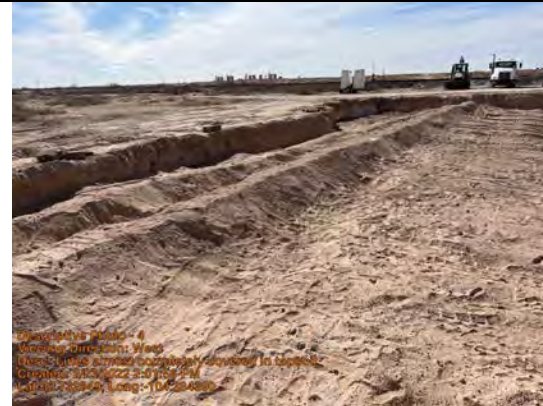
Viewing Direction: West

Backfill
