Remediation Summary and Closure Request

Great Western Drilling Co.

South Carter SA Unit #303

NMOCD Incident # nJXK1613932012

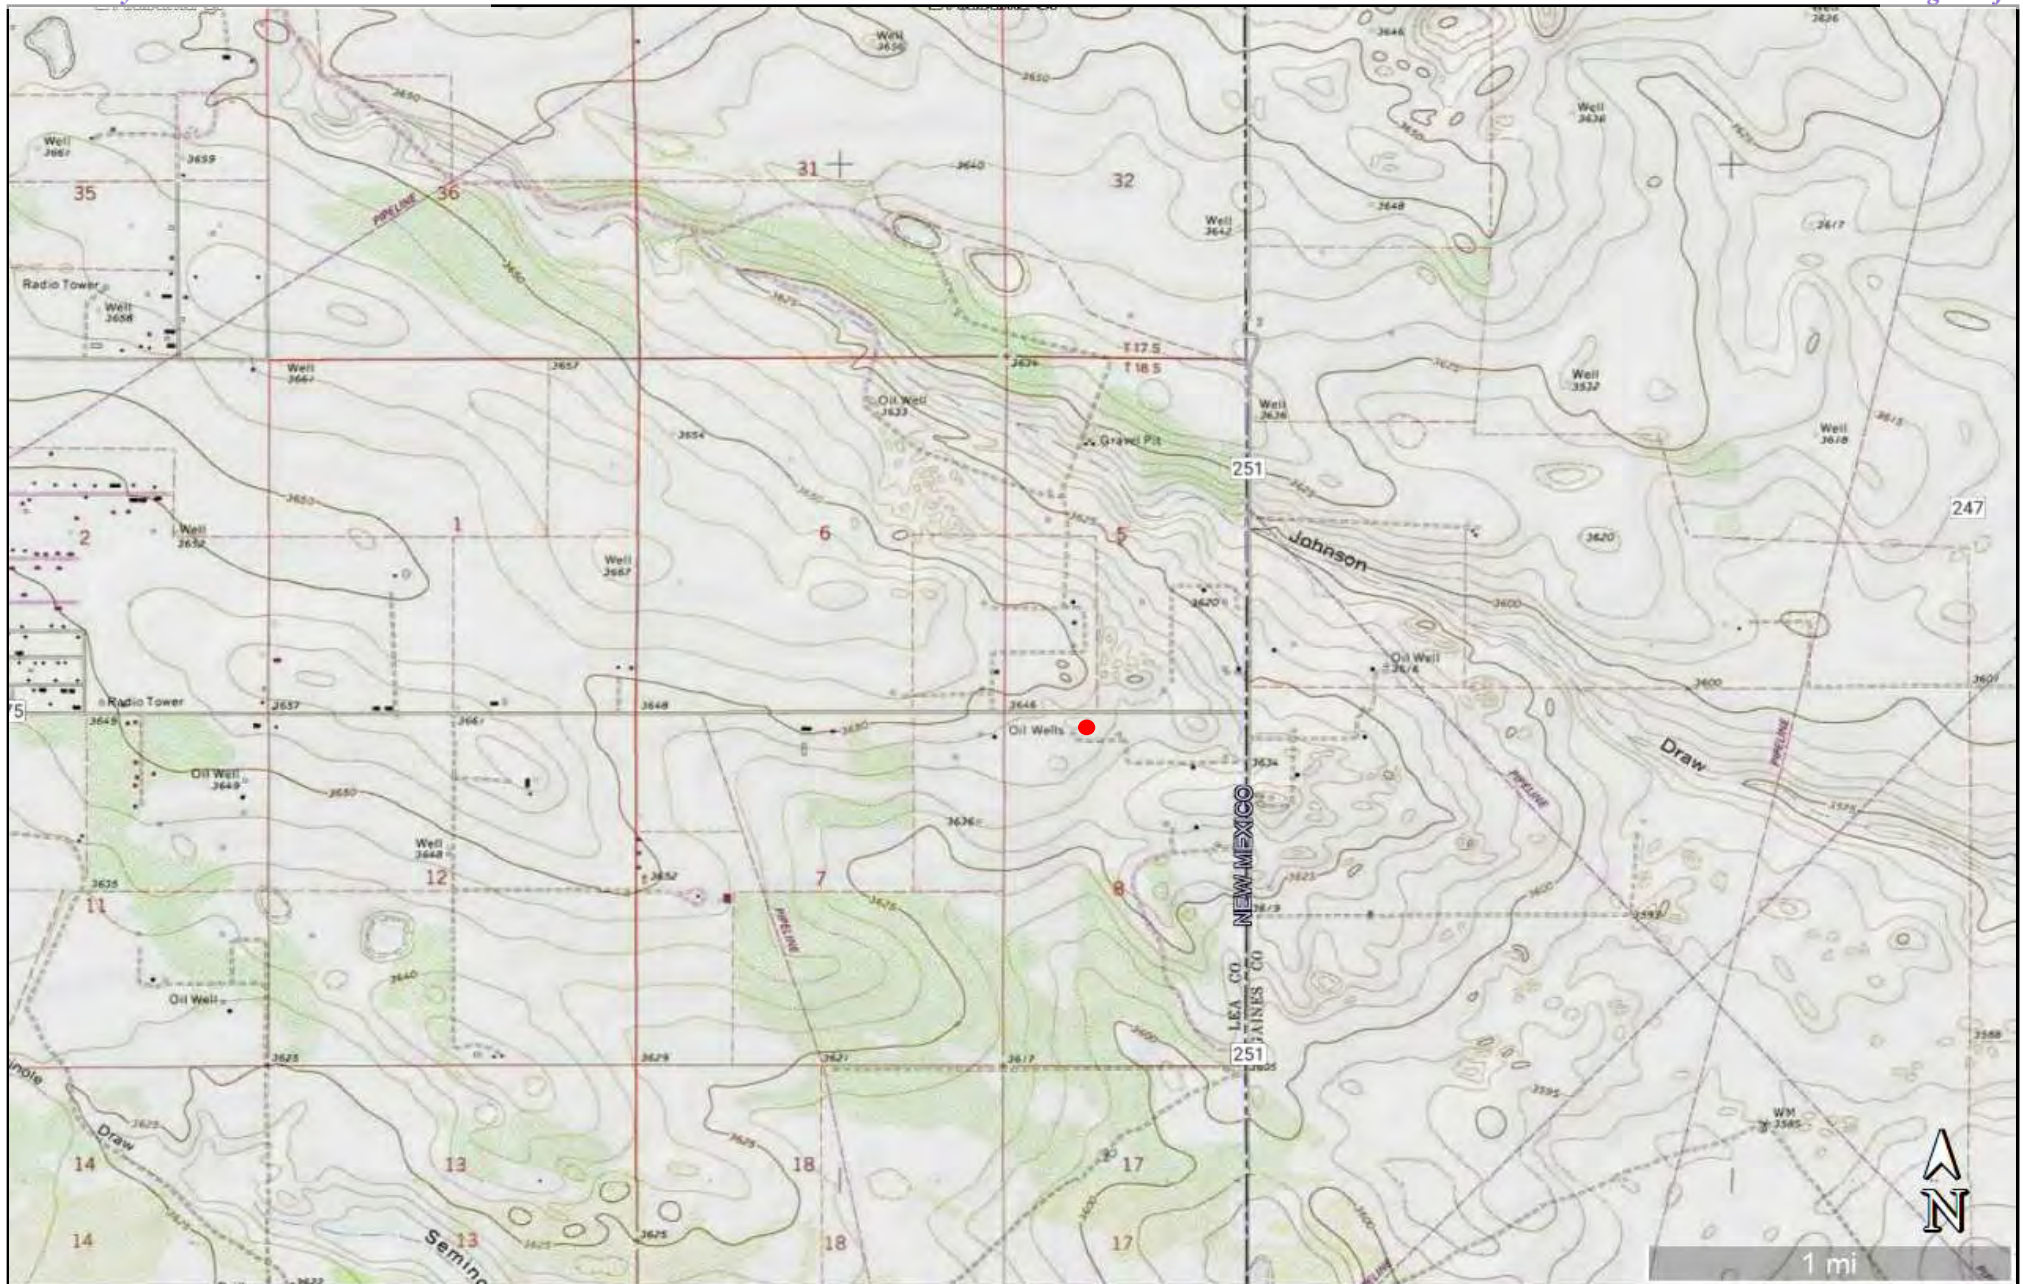
Figure 1

Topographic Map
Great Western Drilling
South Carter SA Unit #303
GPS: 32.768603, -103.072685
Lea County

The site is located in Unit Letter D (NW/NW), Section 8, Township 18 South, Range 39 East, approximately 4.5 miles northeast of Hobbs, in Lea County, New Mexico. The property is privately owned. Topographic Map, OSE POD Locations Map, and USGS Well Locations Map are included as Figure 1, Figure 2, and Figure 3, respectively.

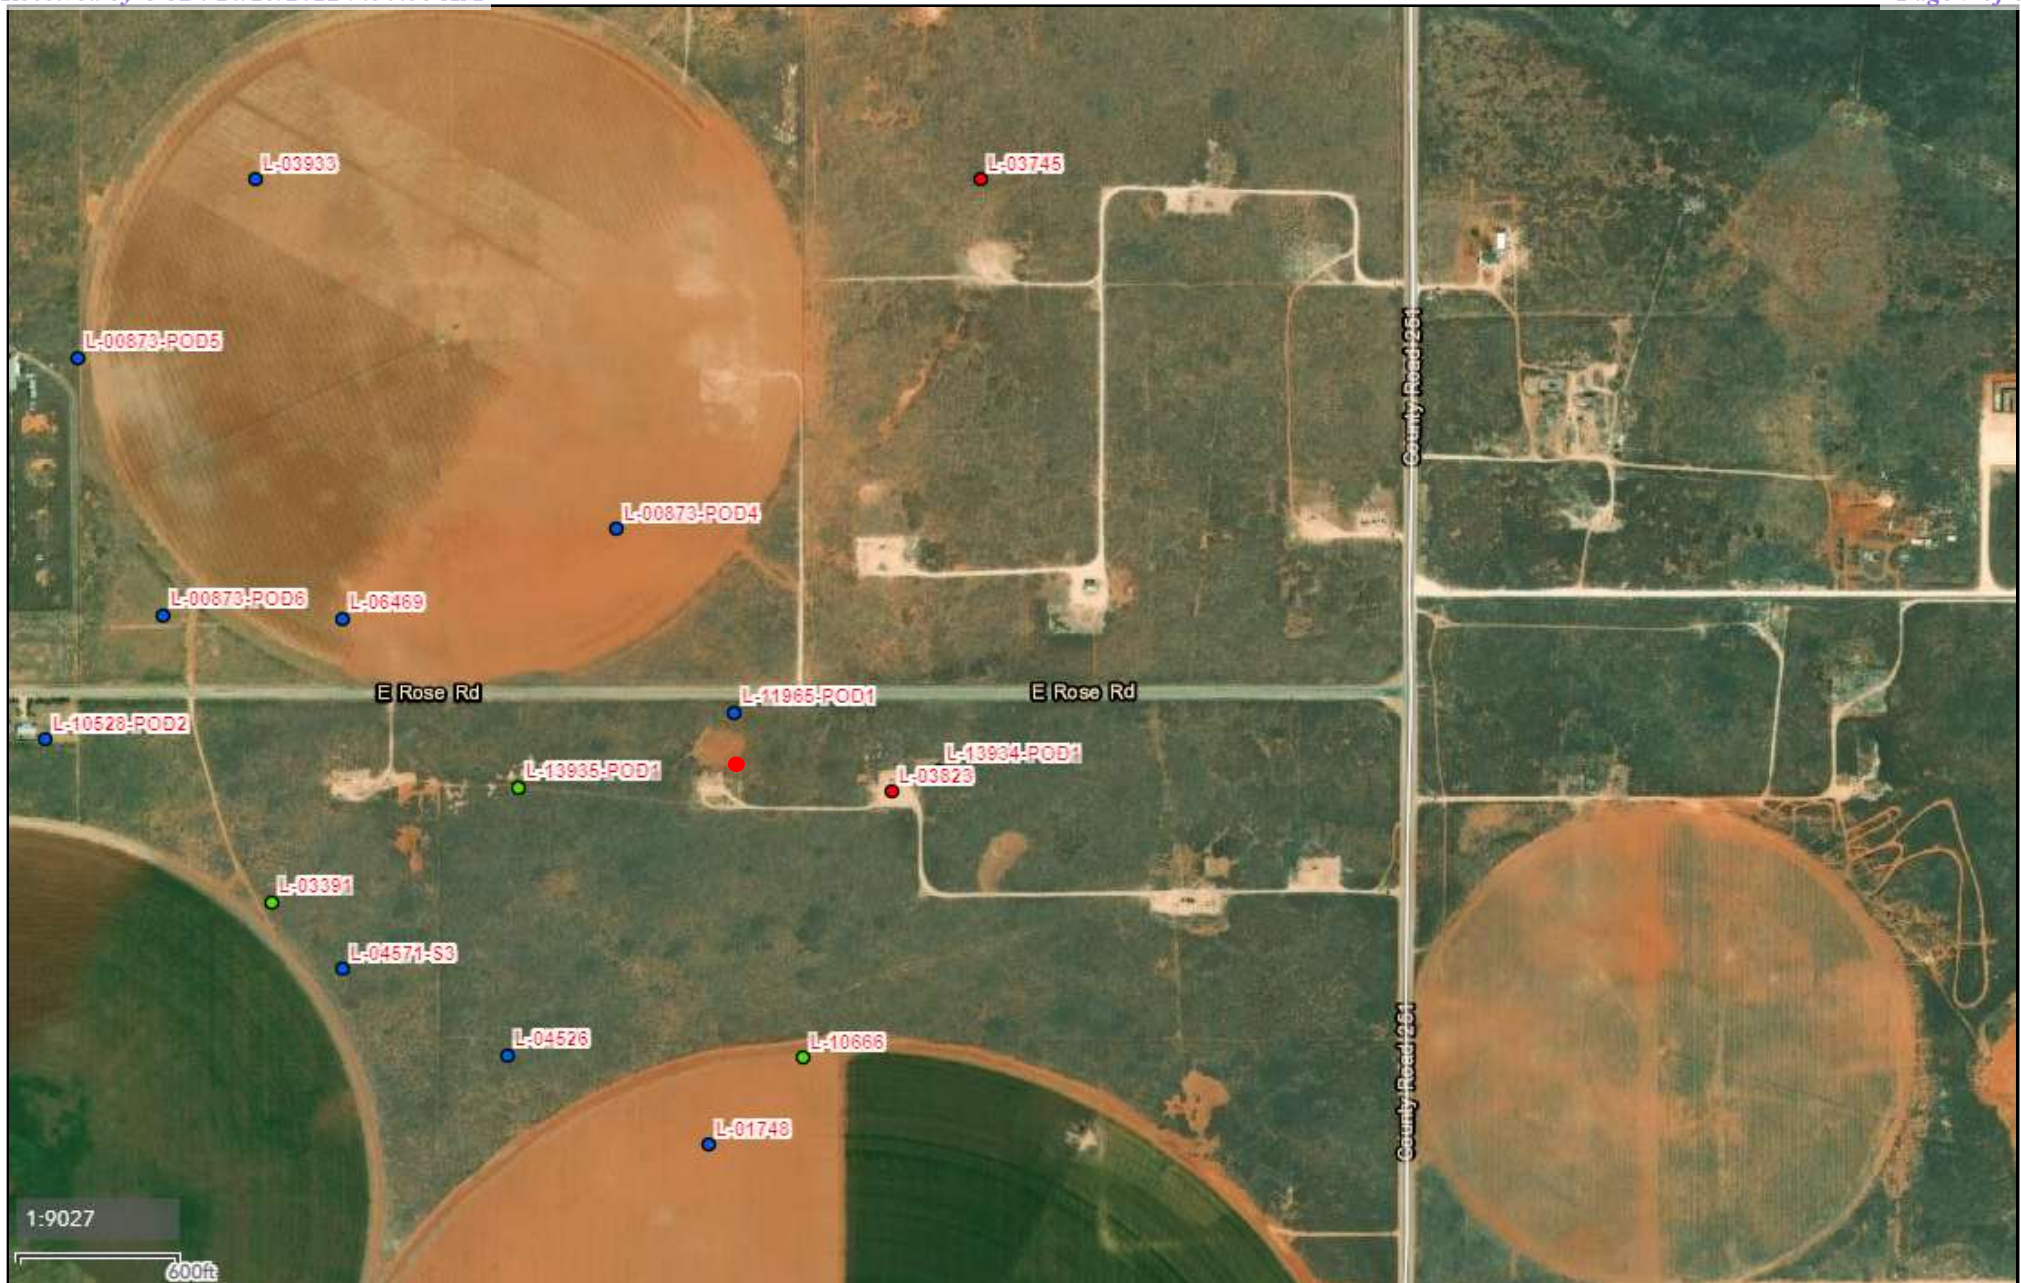
**Figure 2**

OSE POD Locations Map
 Great Western Drilling
 South Carter SA Unit #303
 GPS: 32.768603, -103.072685
 Lea County

A search of the New Mexico Office of the State Engineer (NMOSE) and United States Geological Survey (USGS) groundwater databases was completed in an effort to determine the horizontal distance to known water sources within a half mile radius of the Release Site. Approximate depth to groundwater was determined using maintained and published water well data. Karst mapping indicates the site is not located in a Karst designated area. Depth to groundwater information is provided as Attachment II and the results are depicted on Figures 2 & 3.

Twelve water wells were located within a half mile of the release area; however, only four of the wells have groundwater data less than twenty-five years old. Therefore, only these four wells, L 00873 POD4, L 04571 S3, L 00873 POD6, and L 10528 POD2, were utilized to determine depth to groundwater. However, as this location of interest is historical, the site was delineated according to the strictest NMOCD Closure Criteria. Utilizing this information, the NMOCD Closure Criteria for the site were determined as follows:

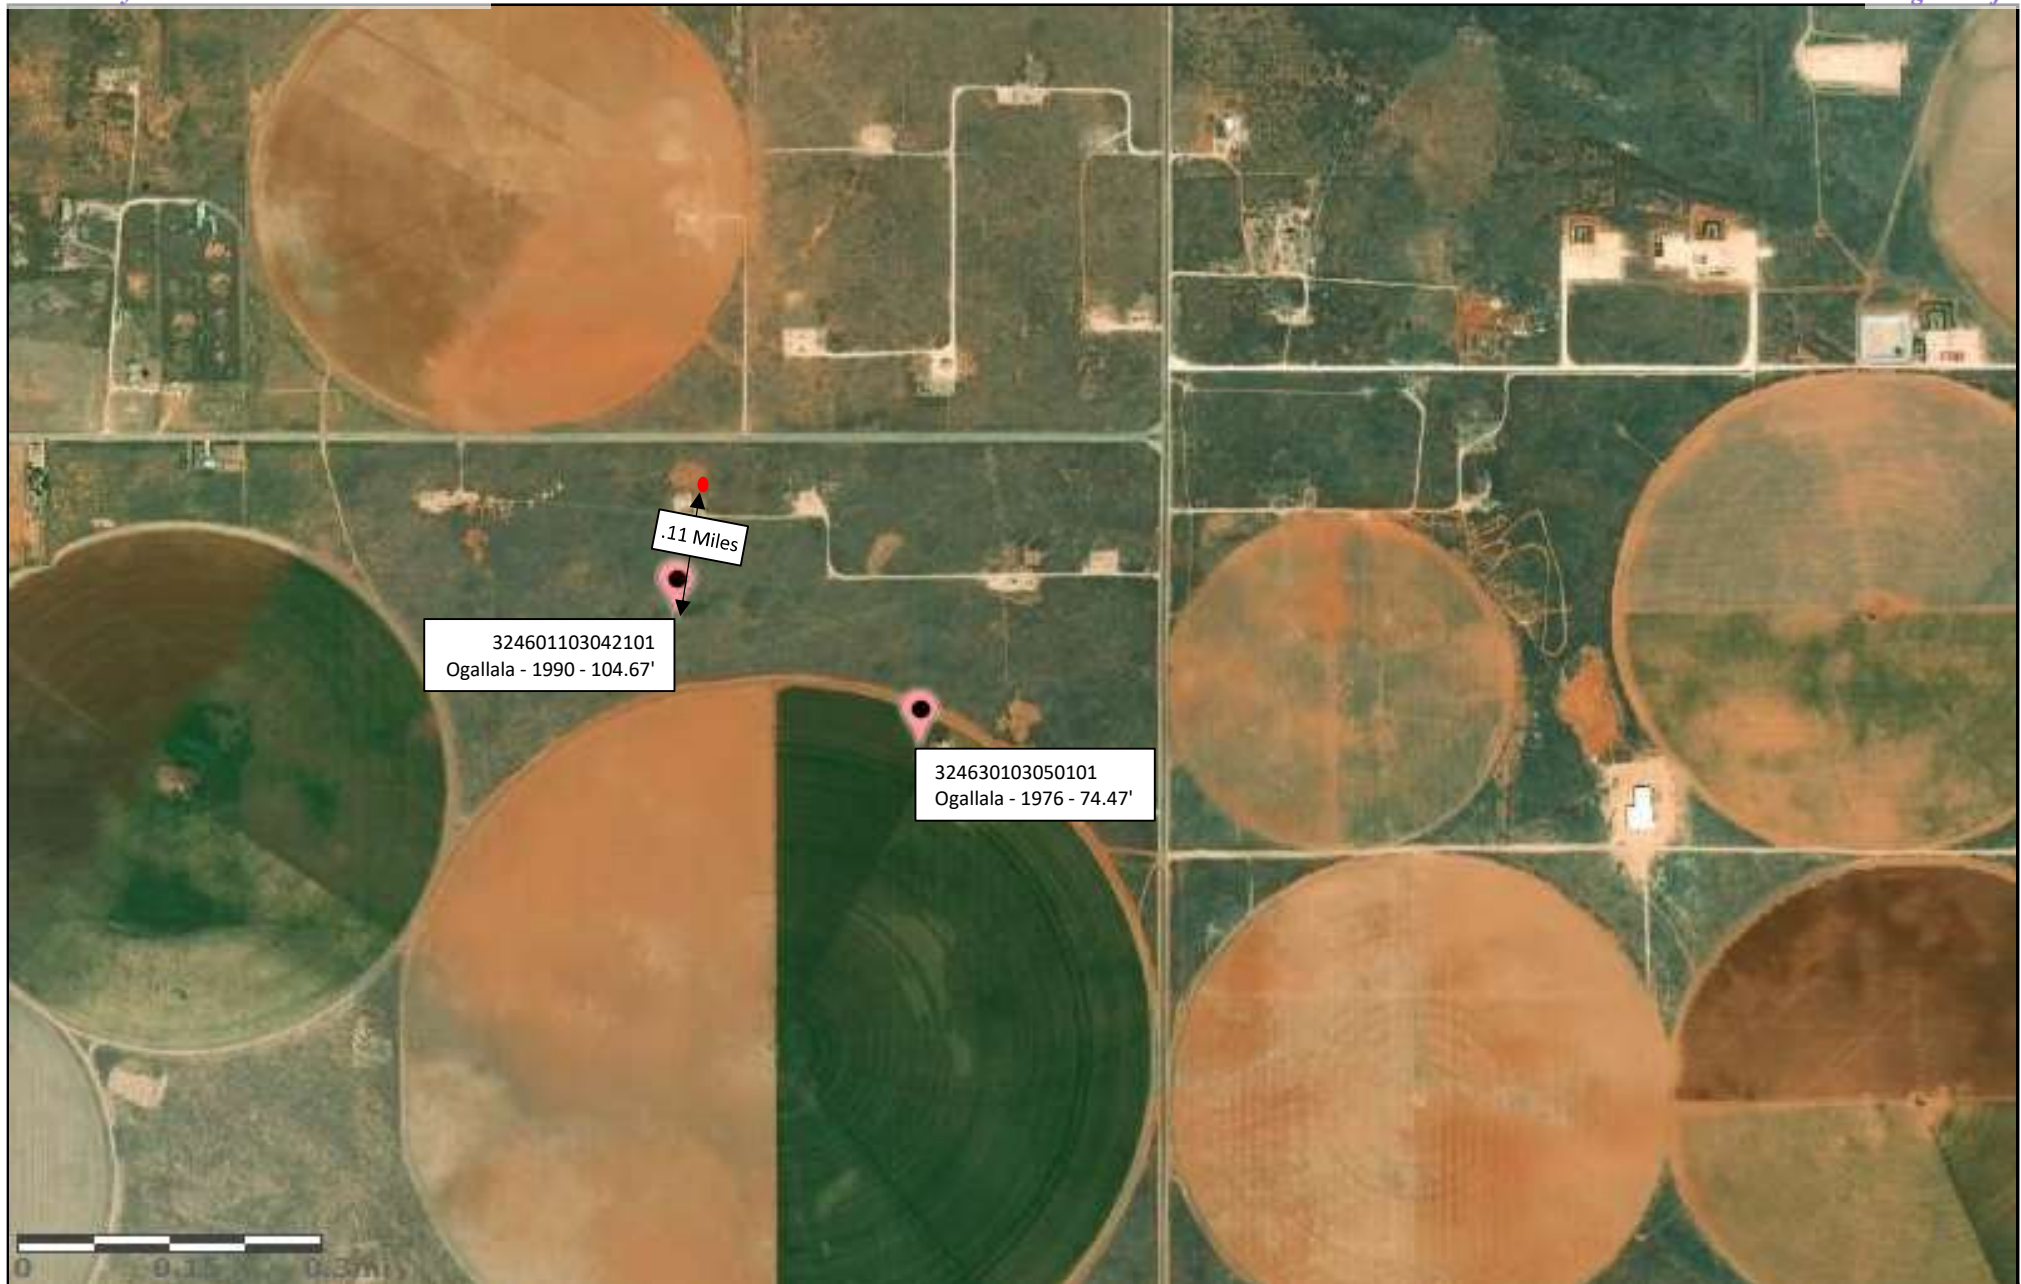
**Figure 3**

USGS Well Locations Map
Great Western Drilling
South Carter SA Unit #303
GPS: 32.768603, -103.072685
Lea County

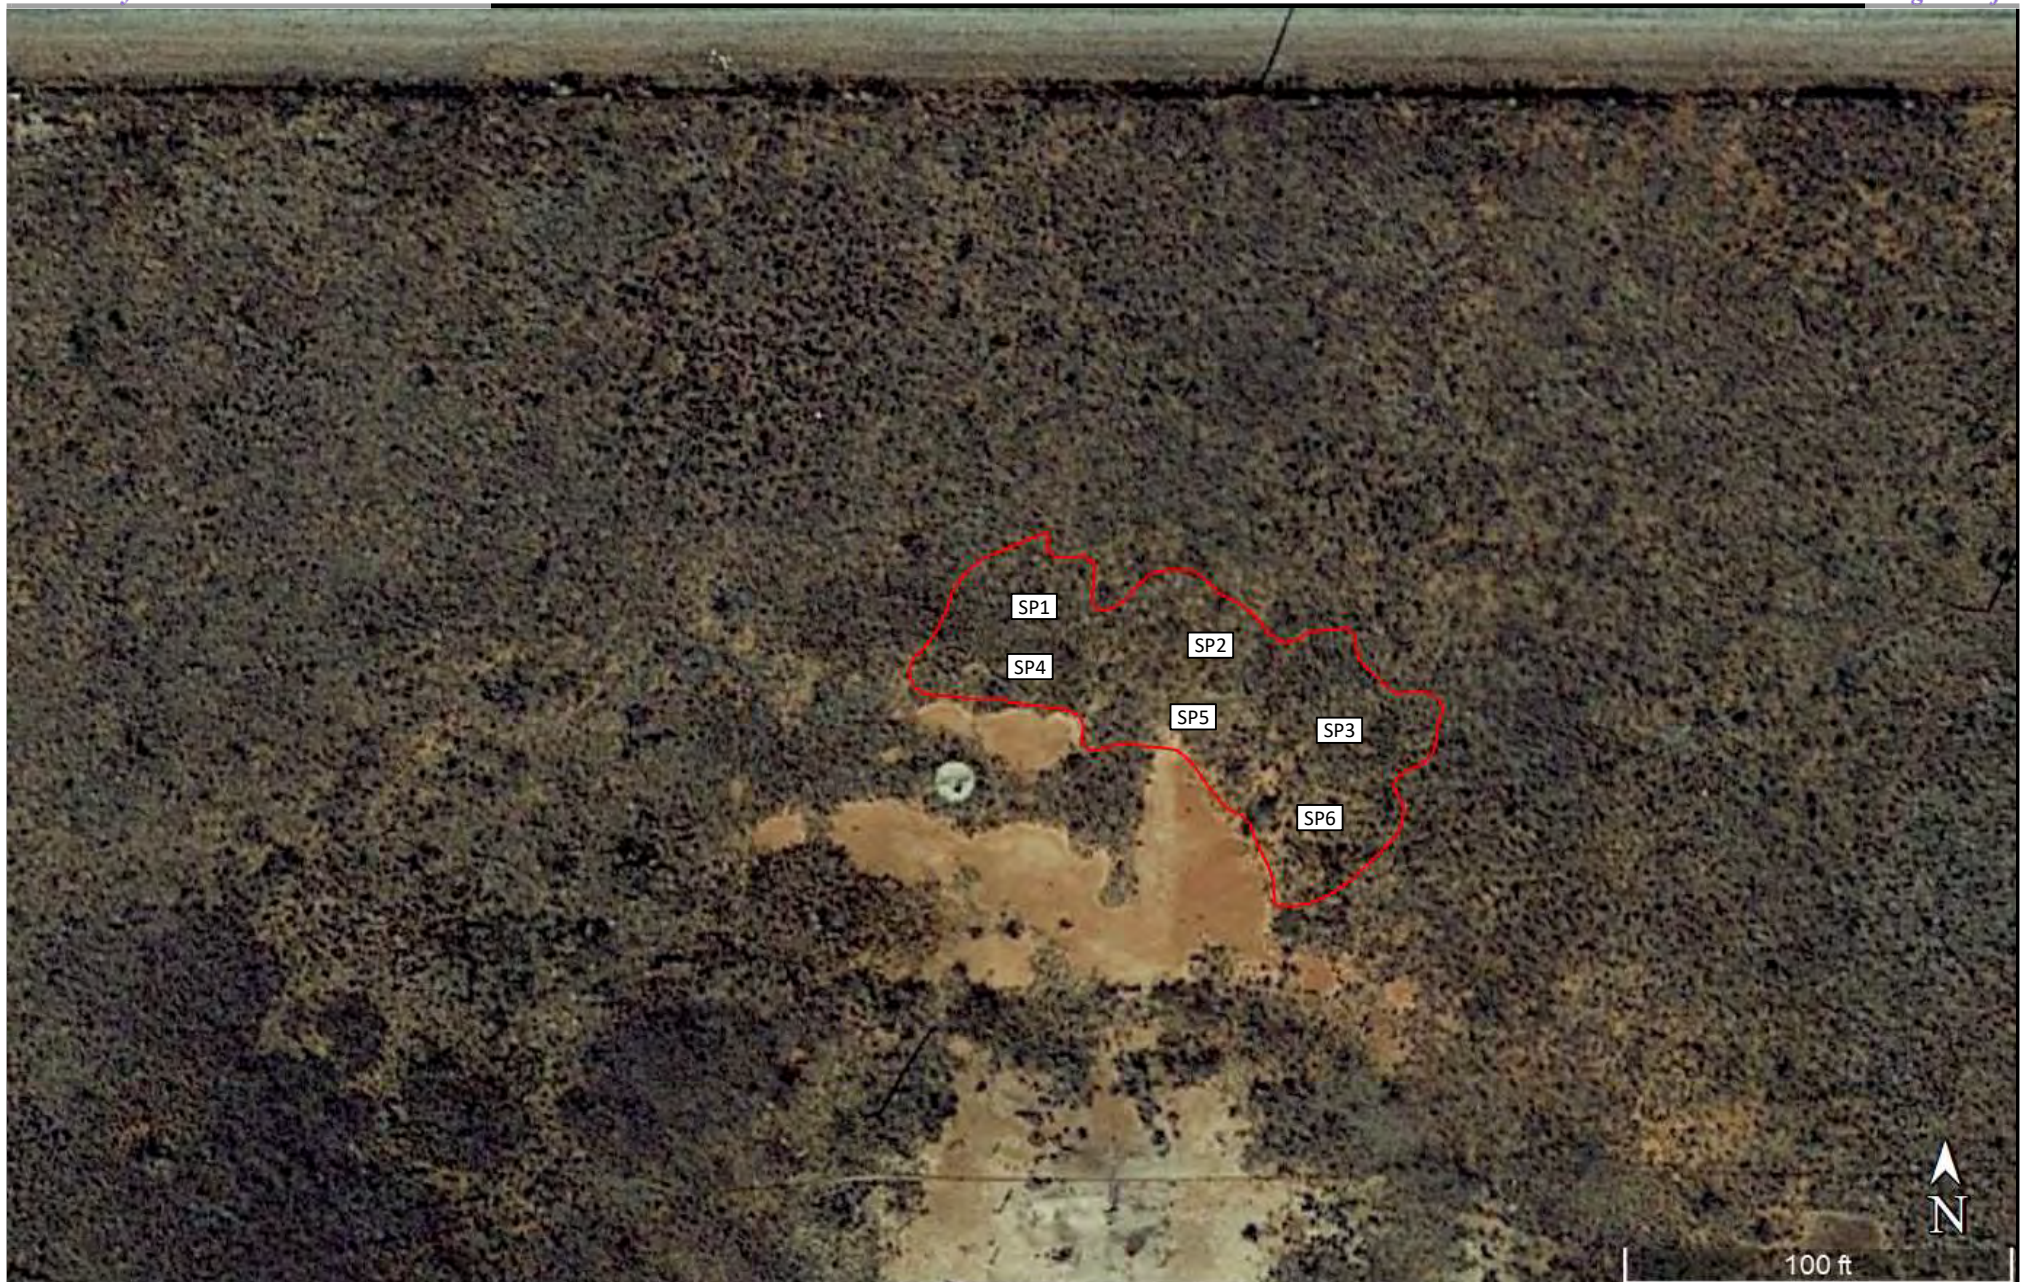
**Figure 4**

Delineation Sample Map
Great Western Drilling
South Carter SA Unit #303
GPS: 32.768603, -103.072685
Lea County

On September 29, 2022, Hungry Horse and Great Western met with NMOCD, via Teams, to discuss this location of interest regarding options to advance the site toward approved closure. NMOCD requested further sampling consisting of soil samples collected at the surface, and one through four feet bgs, from six sample locations, SP1, SP2, SP3, SP4, SP5, and SP6.

On October 4, 2022, Hungry Horse personnel arrived onsite to conduct requested sampling of the location. Thirty representative soil samples, five from each sample location, were collected, field screened for chlorides via an EC meter, then submitted for laboratory analysis. Soil samples collected from the surface through three feet bgs were submitted to the laboratory for analysis of chloride. Soil samples collected at four feet bgs were submitted to the laboratory for analysis of BTEX, TPH, and chloride. Laboratory analytical results indicated contaminant concentrations were below the NMOCD Closure Criteria in each of the submitted samples.

A Delineation Sample Map is provided as Figure 4. Field data is provided as Attachment III. A Summary of Soil Sample Laboratory Analytical Results is provided as Table 1 and Laboratory Analytical Reports are provided as Attachment IV.
