Re: Site Assessment, Remediation, and Closure Report
Fighting Okra 18 CTB 4
API No. N/A
GPS: Latitude 32.048234 Longitude -103.509606
UL -- C, 18, T23S, R34E
Lea County, NM
NMOCD Ref. No. NAPP2221026056

Fighting Okra 18 CTB 4|Devon Energy

**SITE PHOTOGRAPHS
DEVON ENERGY
FIGHTING OKRA 18 CTB 4**

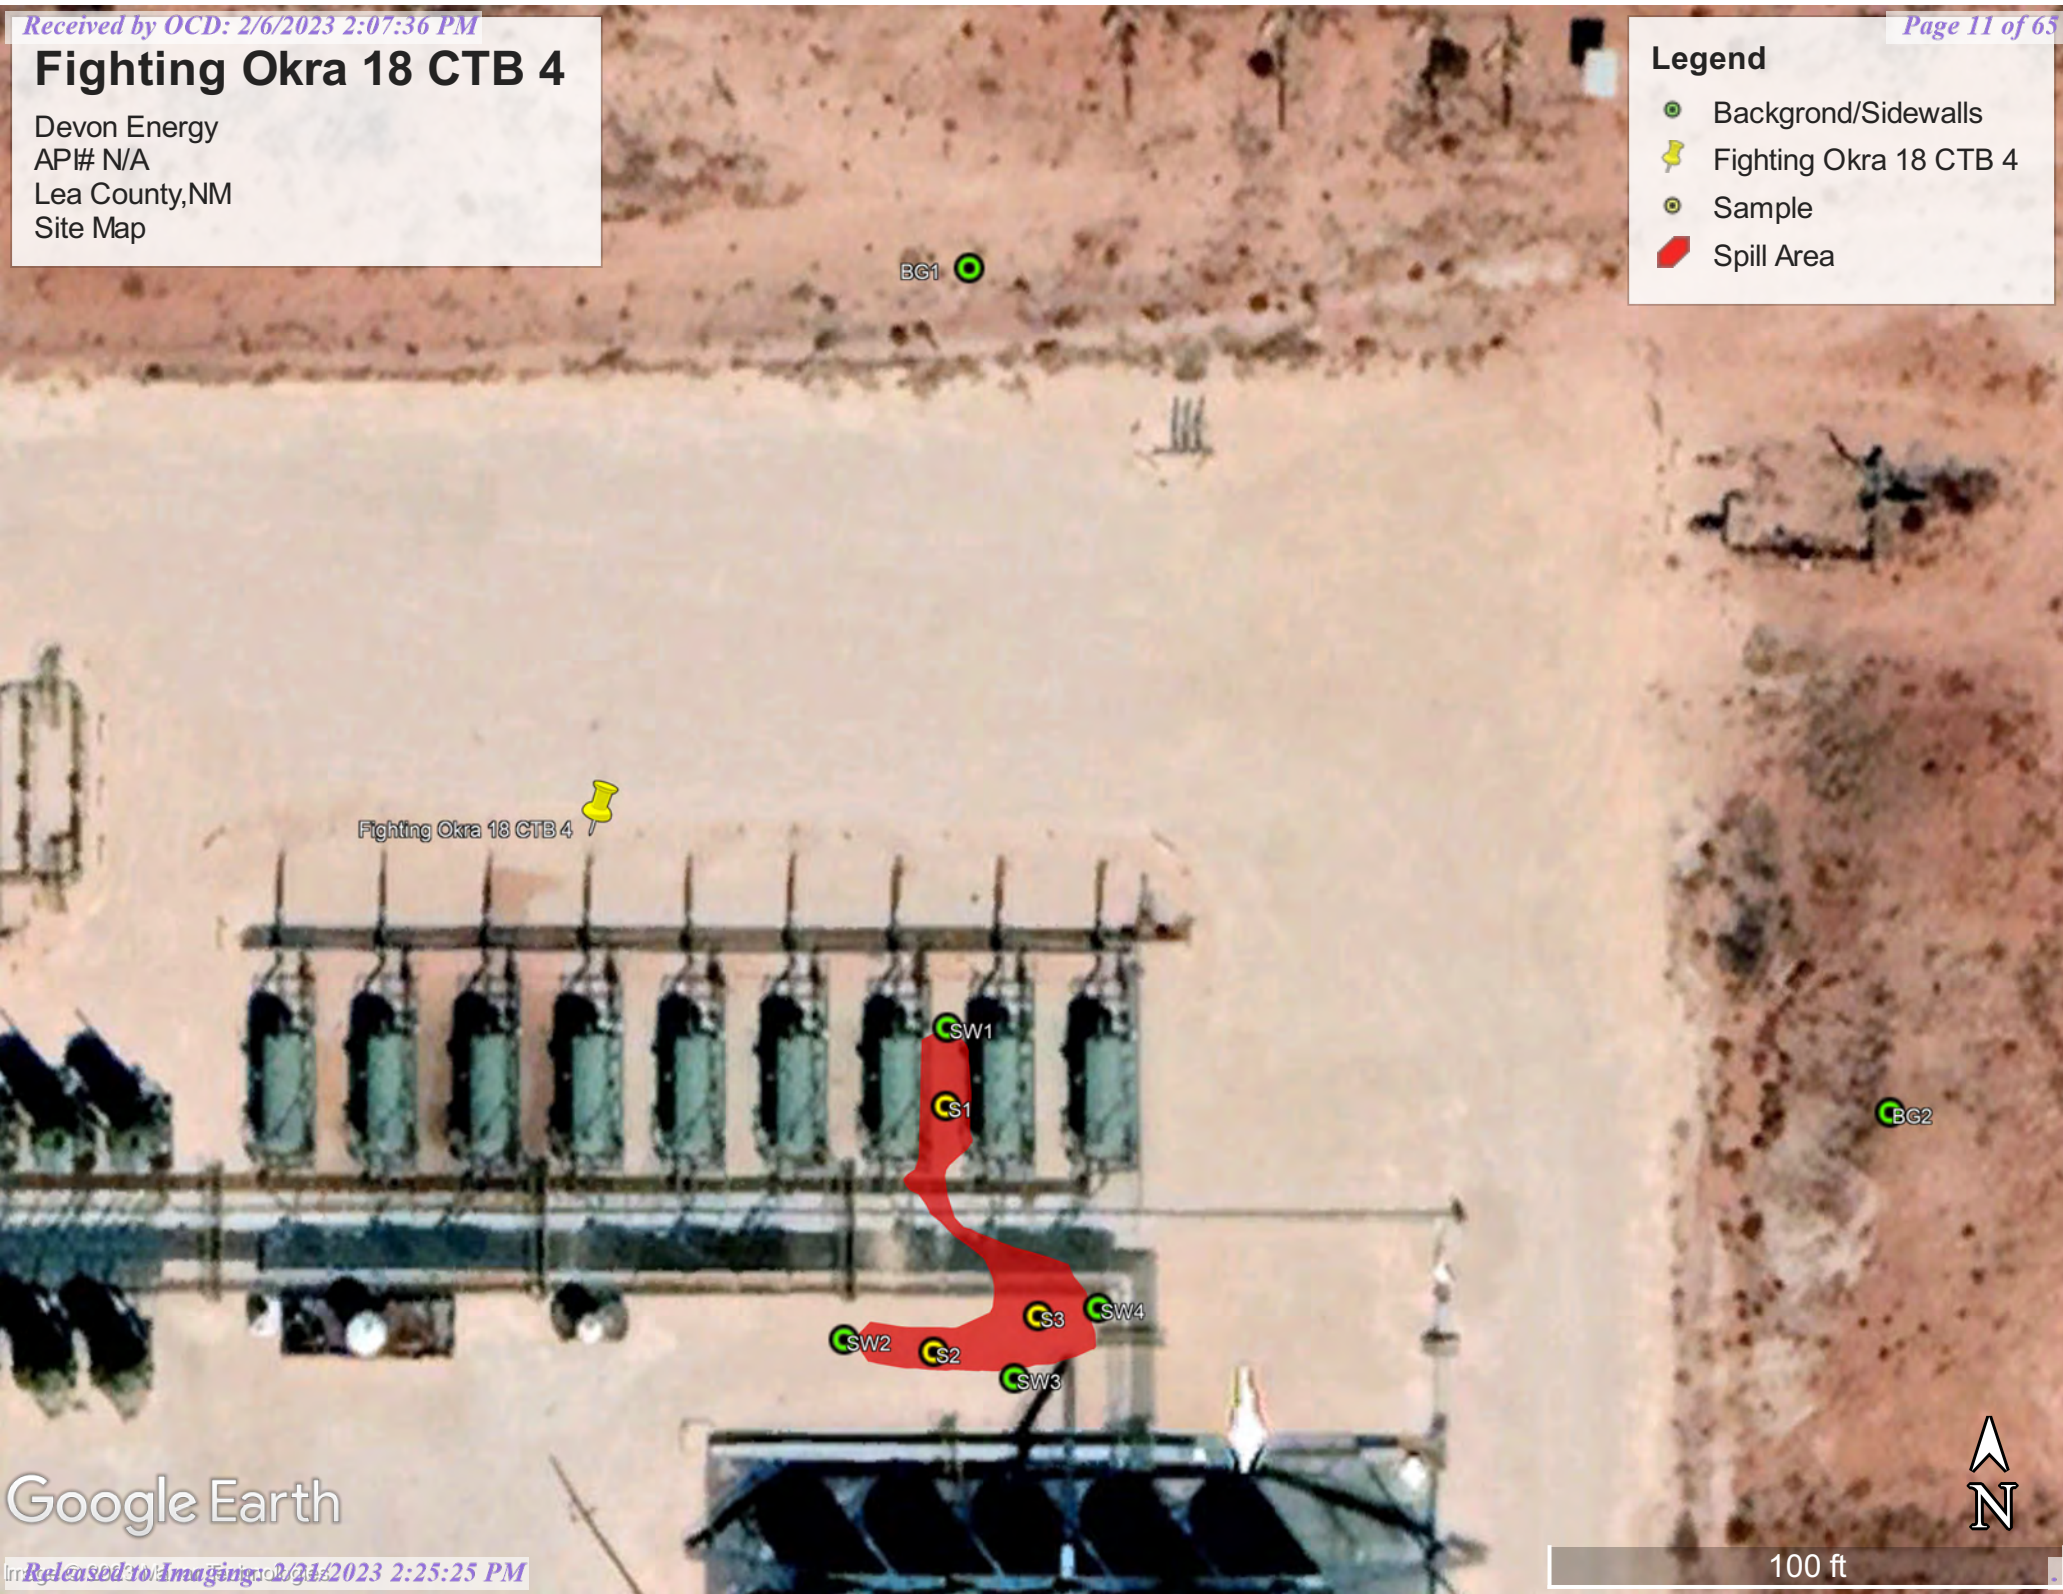
Devon Energy
API# N/A
Lea County, NM
Site Map

On September 6, 2022, Pima mobilized personnel to the site to begin collecting soil samples from spill area. The laboratory results of this sampling event can be found in the following data table. A Site Map can be found in Figure 4.

- Background/Sidewalls
- Fighting Okra 18 CTB 4
- Sample
- Spill Area

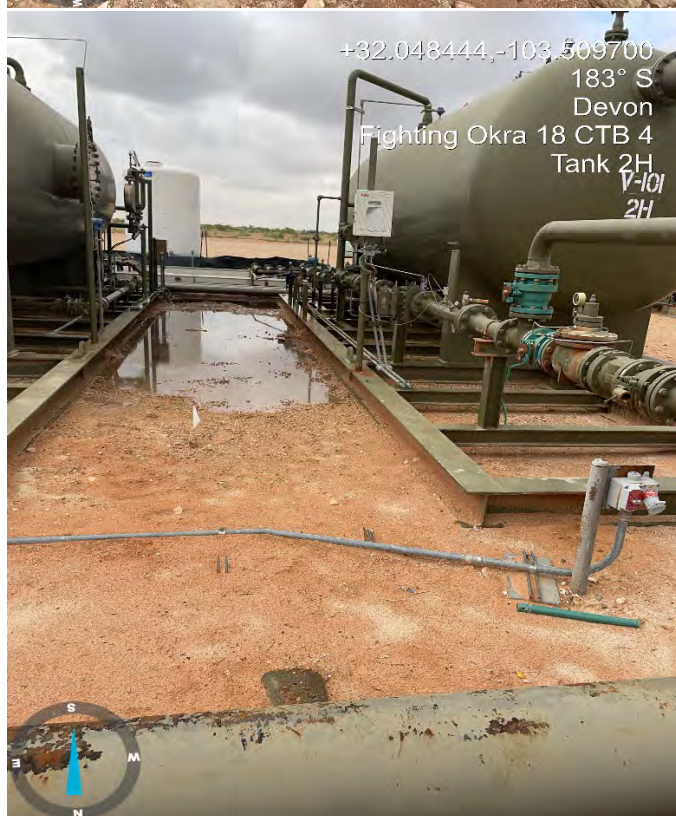
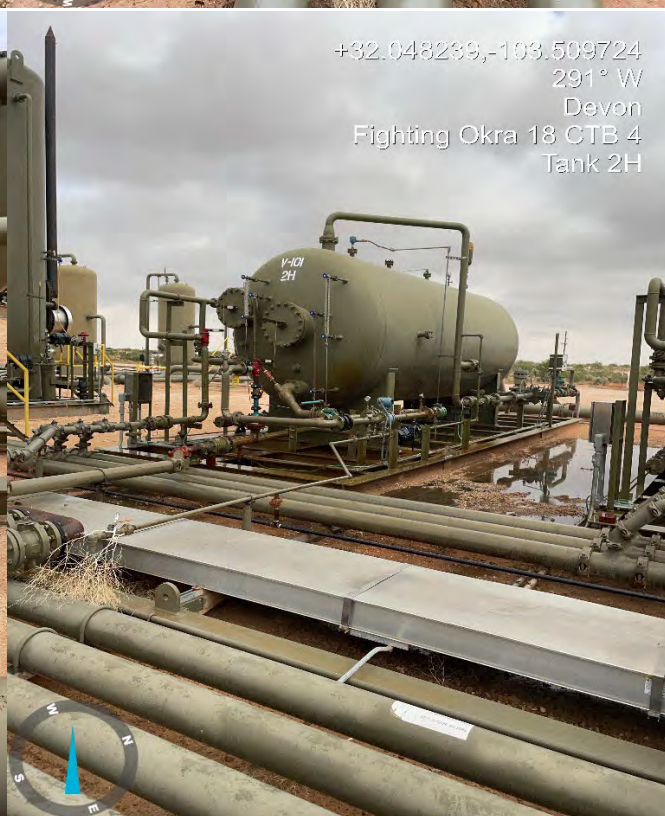
Site Assessment

Based on the sample results, the bottoms and sidewalls were below NMOCD Closure Criteria 19.15.29 NMAC. See Appendix D for Photographic Documentation.

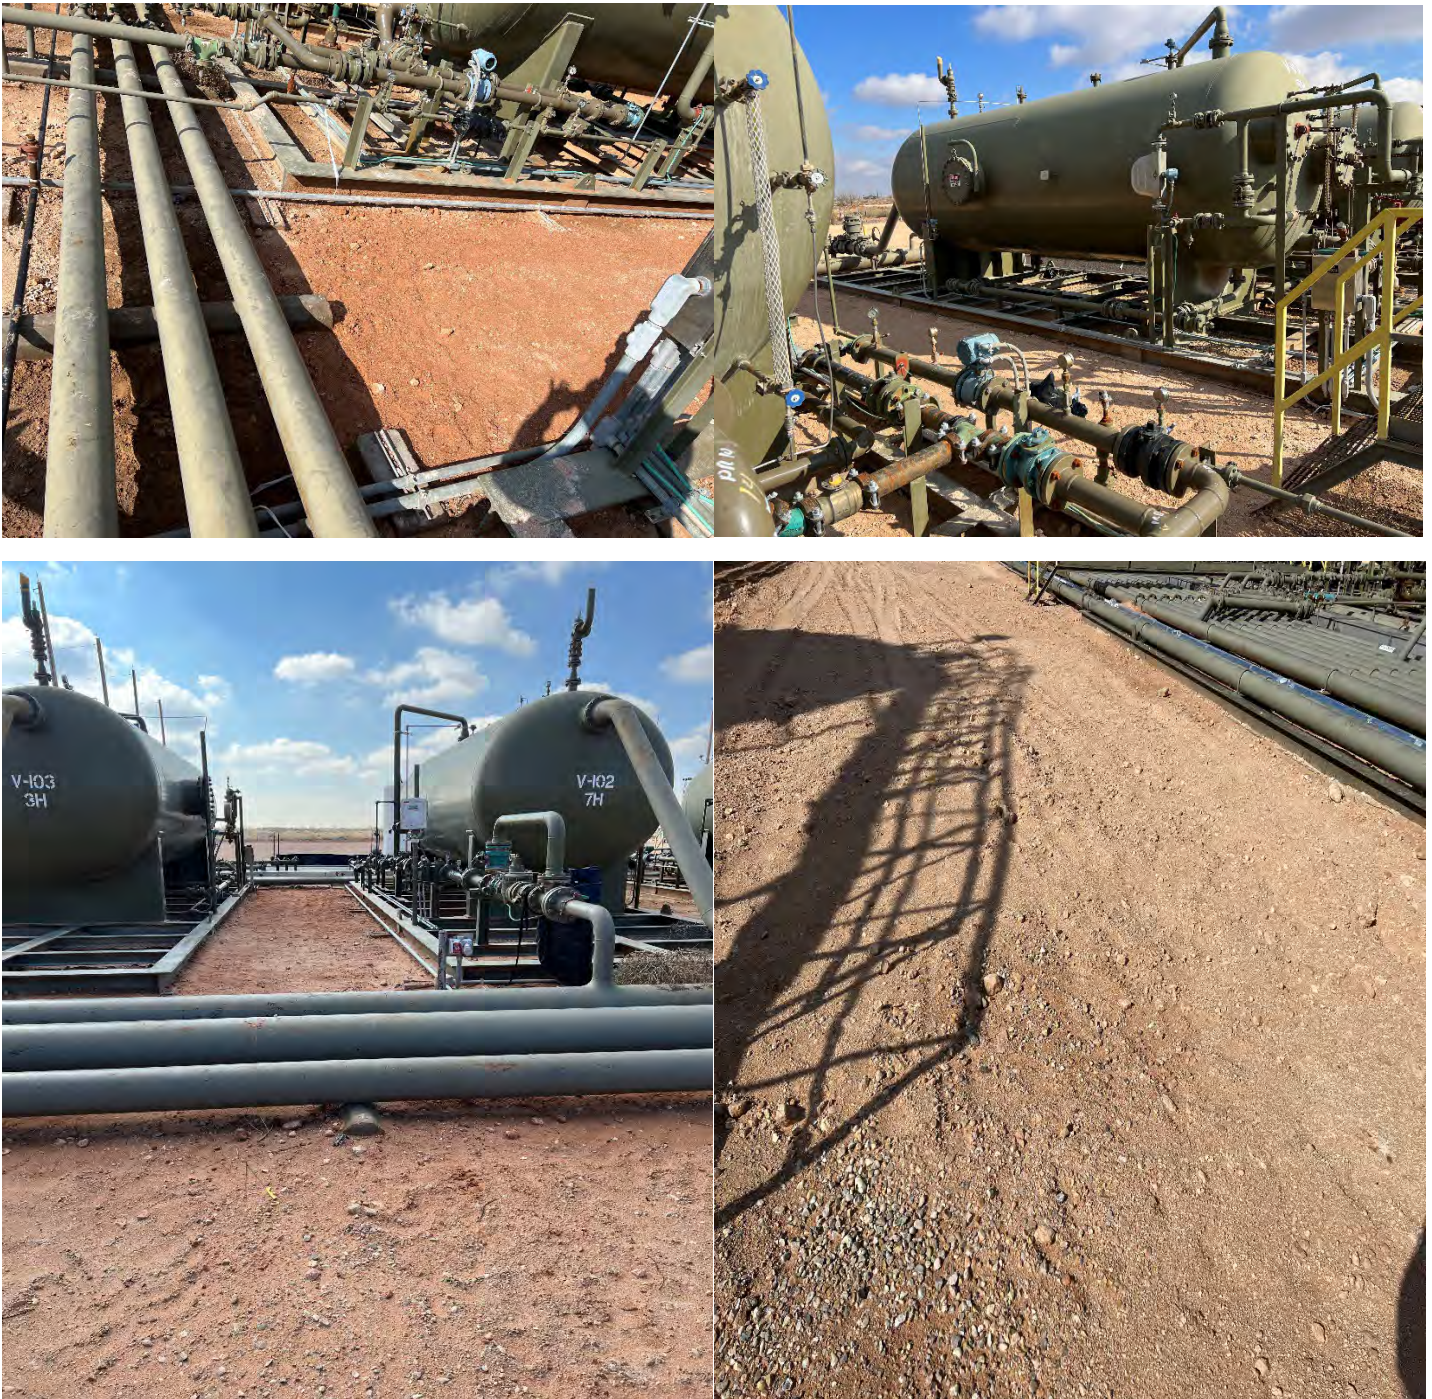
Post scrape

On January 5, 2023, Devon Construction Department personnel and equipment scraped surface staining. While conducting remediation activities for another incident on this location
