Closure Report

Site Name:	RIVERBEND B-11 BATTERY
Company:	Oxy USA, Inc.
Legal Description:	U/L E, S23,T24S, R29E
County:	EDDY
GPS Coordinates:	32.20367, -103.96233

Date of Release:	1/1/2012
Type of Release:	OIL
Source of Release:	VICATULIC CLAMP FAILURE AT CIRCULATING PUMP
Volume of Release:	151 BBLS
Volume Recovered:	73 BBLS

OXY, RIVERBEND B FEDERAL 11 BATTERY

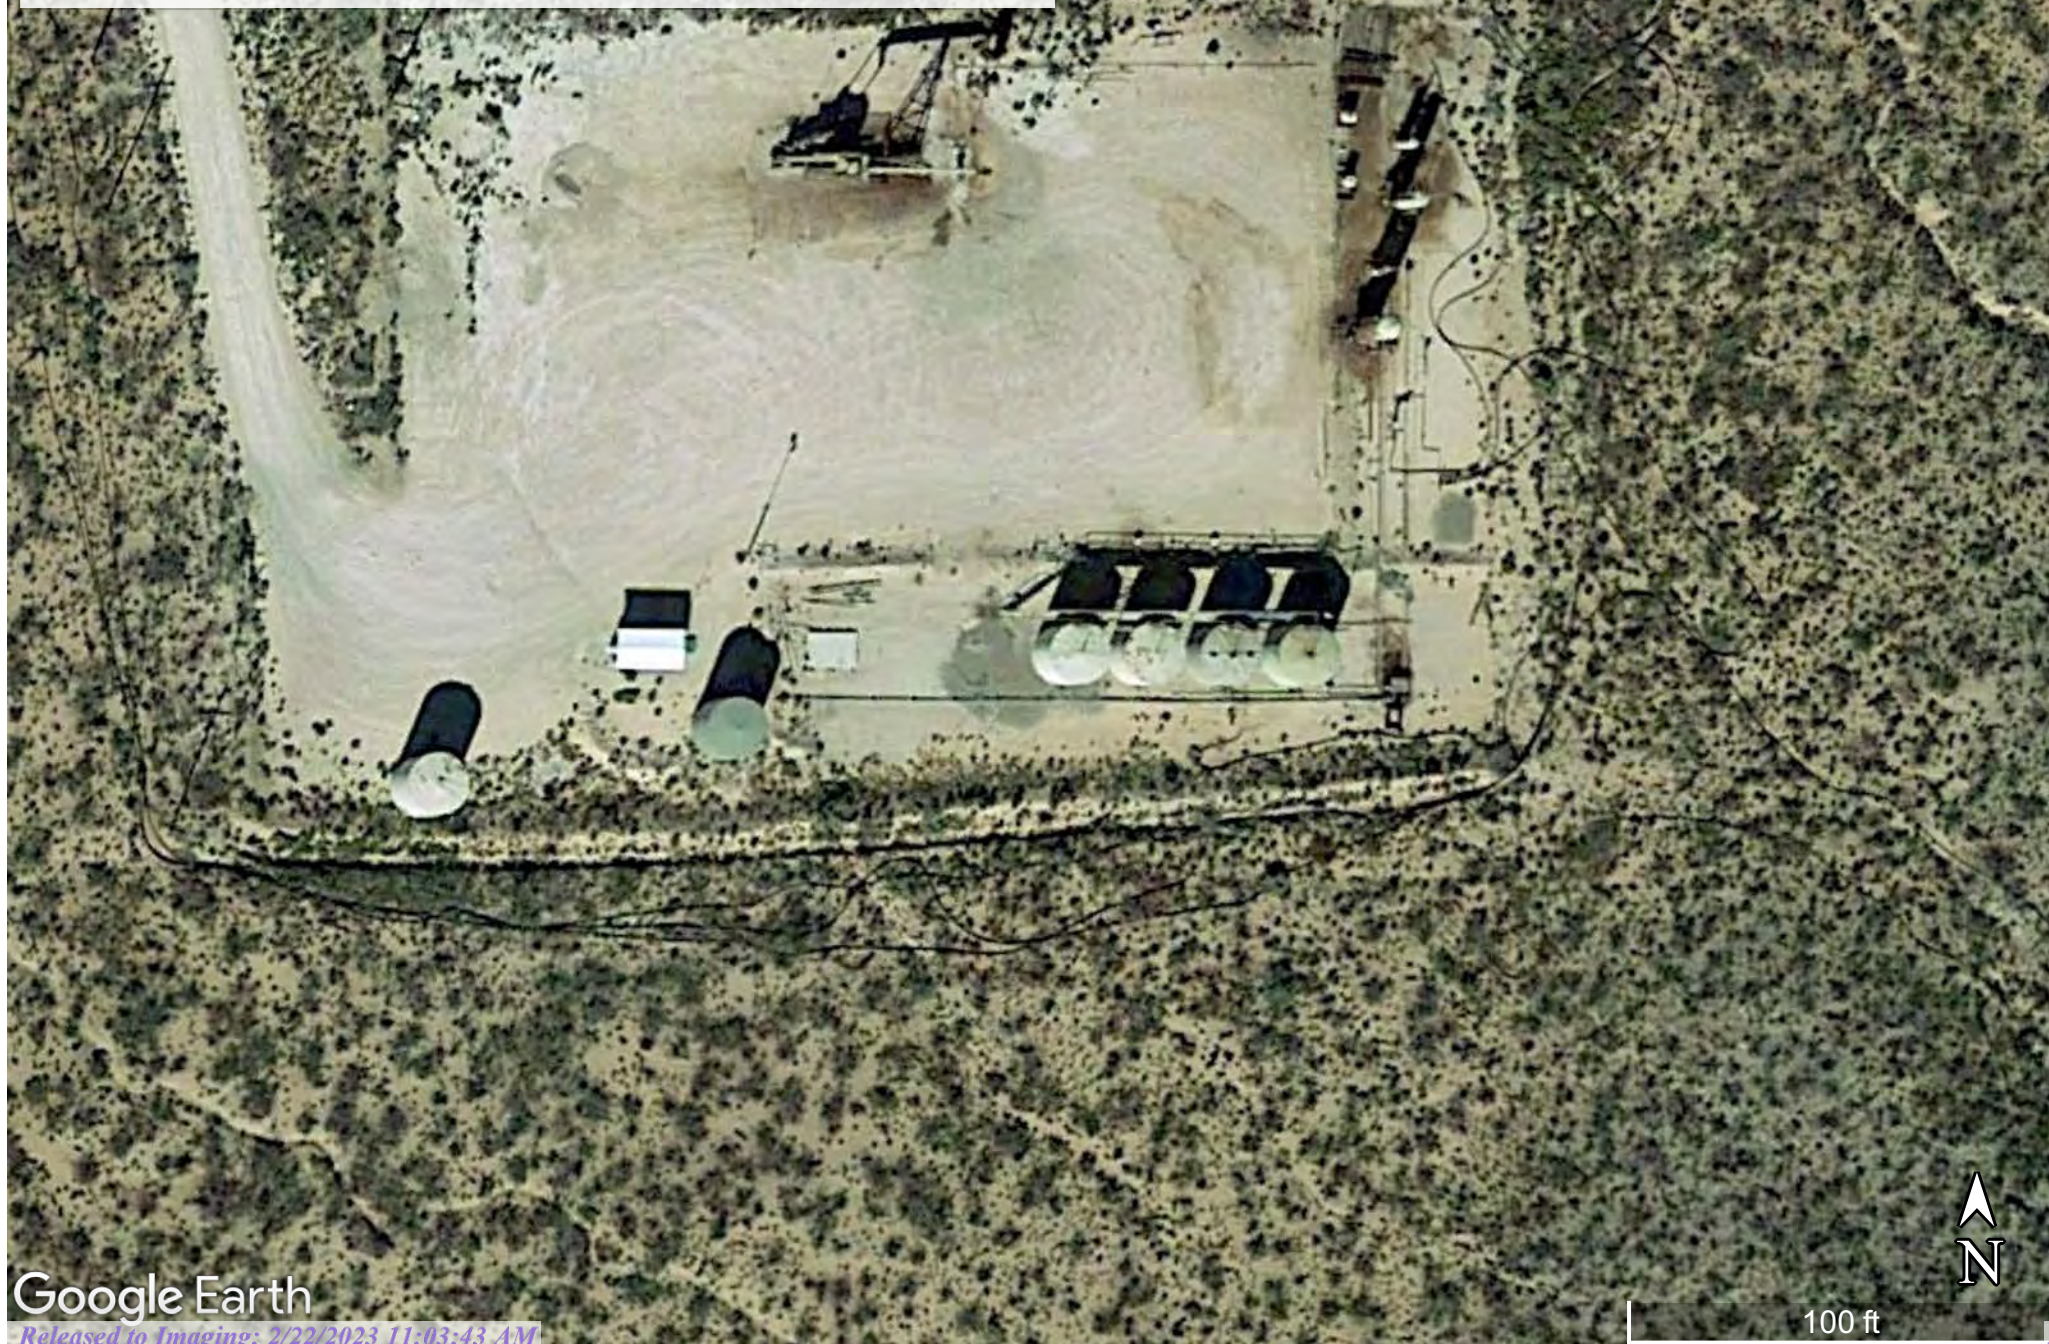
LEAK DATE: 1/1/12
INCIDENT #: nMLB1209747032
EDDY COUNTY, NM
