## Remediation Summary and Closure Request

**South Carter SA Unit #302**

**NMOCD Incident # nJXK1613929245**

**October 2022**

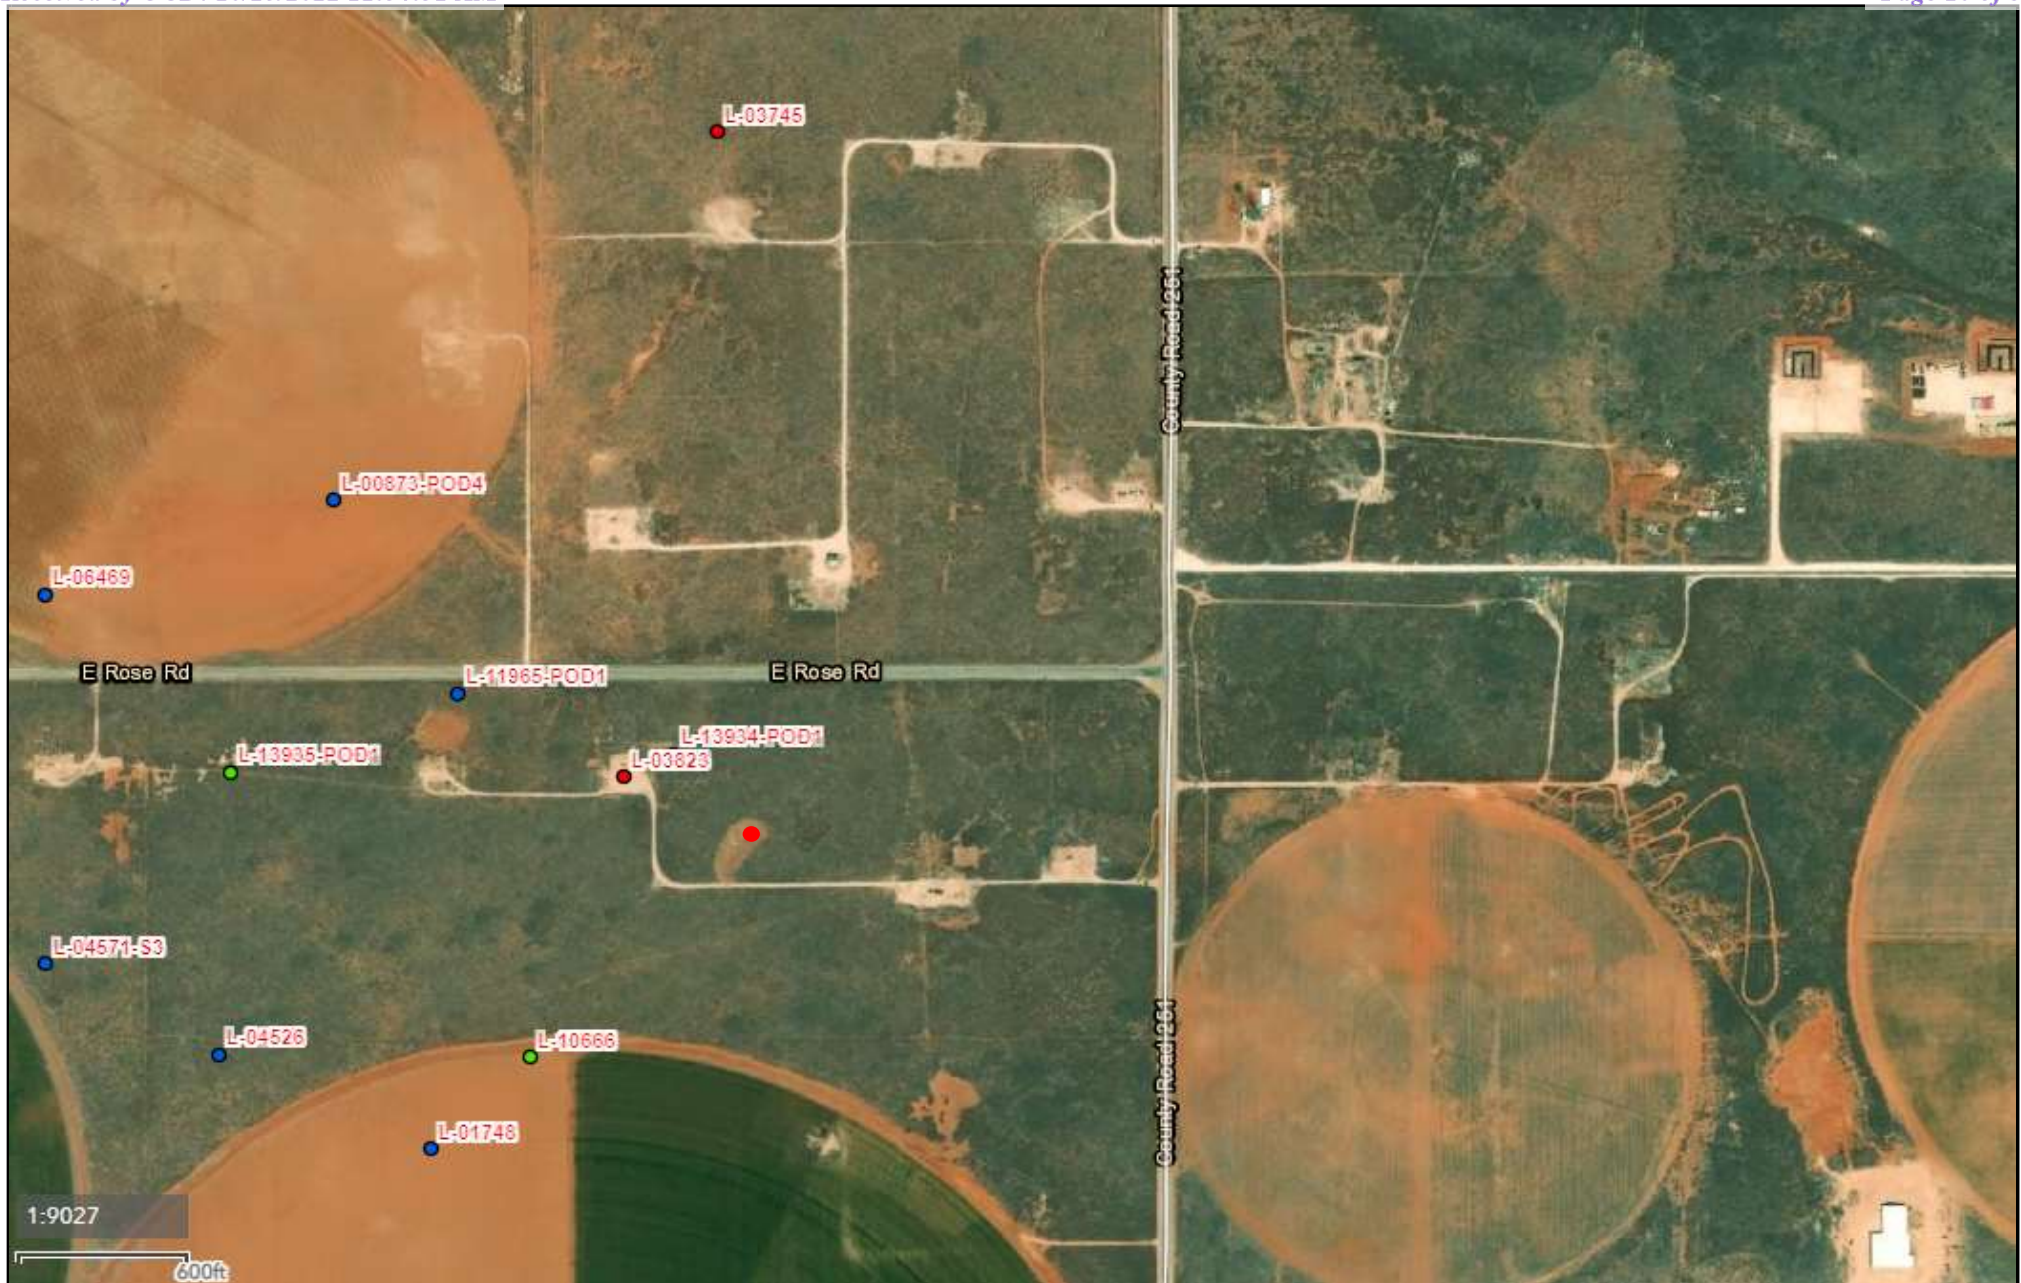
**Figure 2**

OSE POD Locations Map  
 Great Western Drilling  
 South Carter SA Unit #302  
 GPS: 32.767782, -103.069444  
 Lea County

A search of the New Mexico Office of the State Engineer (NMOSE) and United States Geological Survey (USGS) groundwater databases was completed in an effort to determine the horizontal distance to known water sources within a half mile radius of the Release Site. Approximate depth to groundwater was determined using maintained and published water well data. Karst mapping indicates the site is not located in a Karst designated area. Depth to groundwater information is provided as Attachment II and the results are depicted on Figures 2 & 3.

Ten water wells were located within a half mile of the release area; however, only two of the wells have groundwater data less than twenty-five years old. Therefore, only these two wells, L 00873 POD4 and L 04571 S3, were utilized to determine depth to groundwater. However, as this location of interest is historical, the site was delineated according to the strictest NMOCD Closure Criteria. Utilizing this information, the NMOCD Closure Criteria for the site were determined as follows:

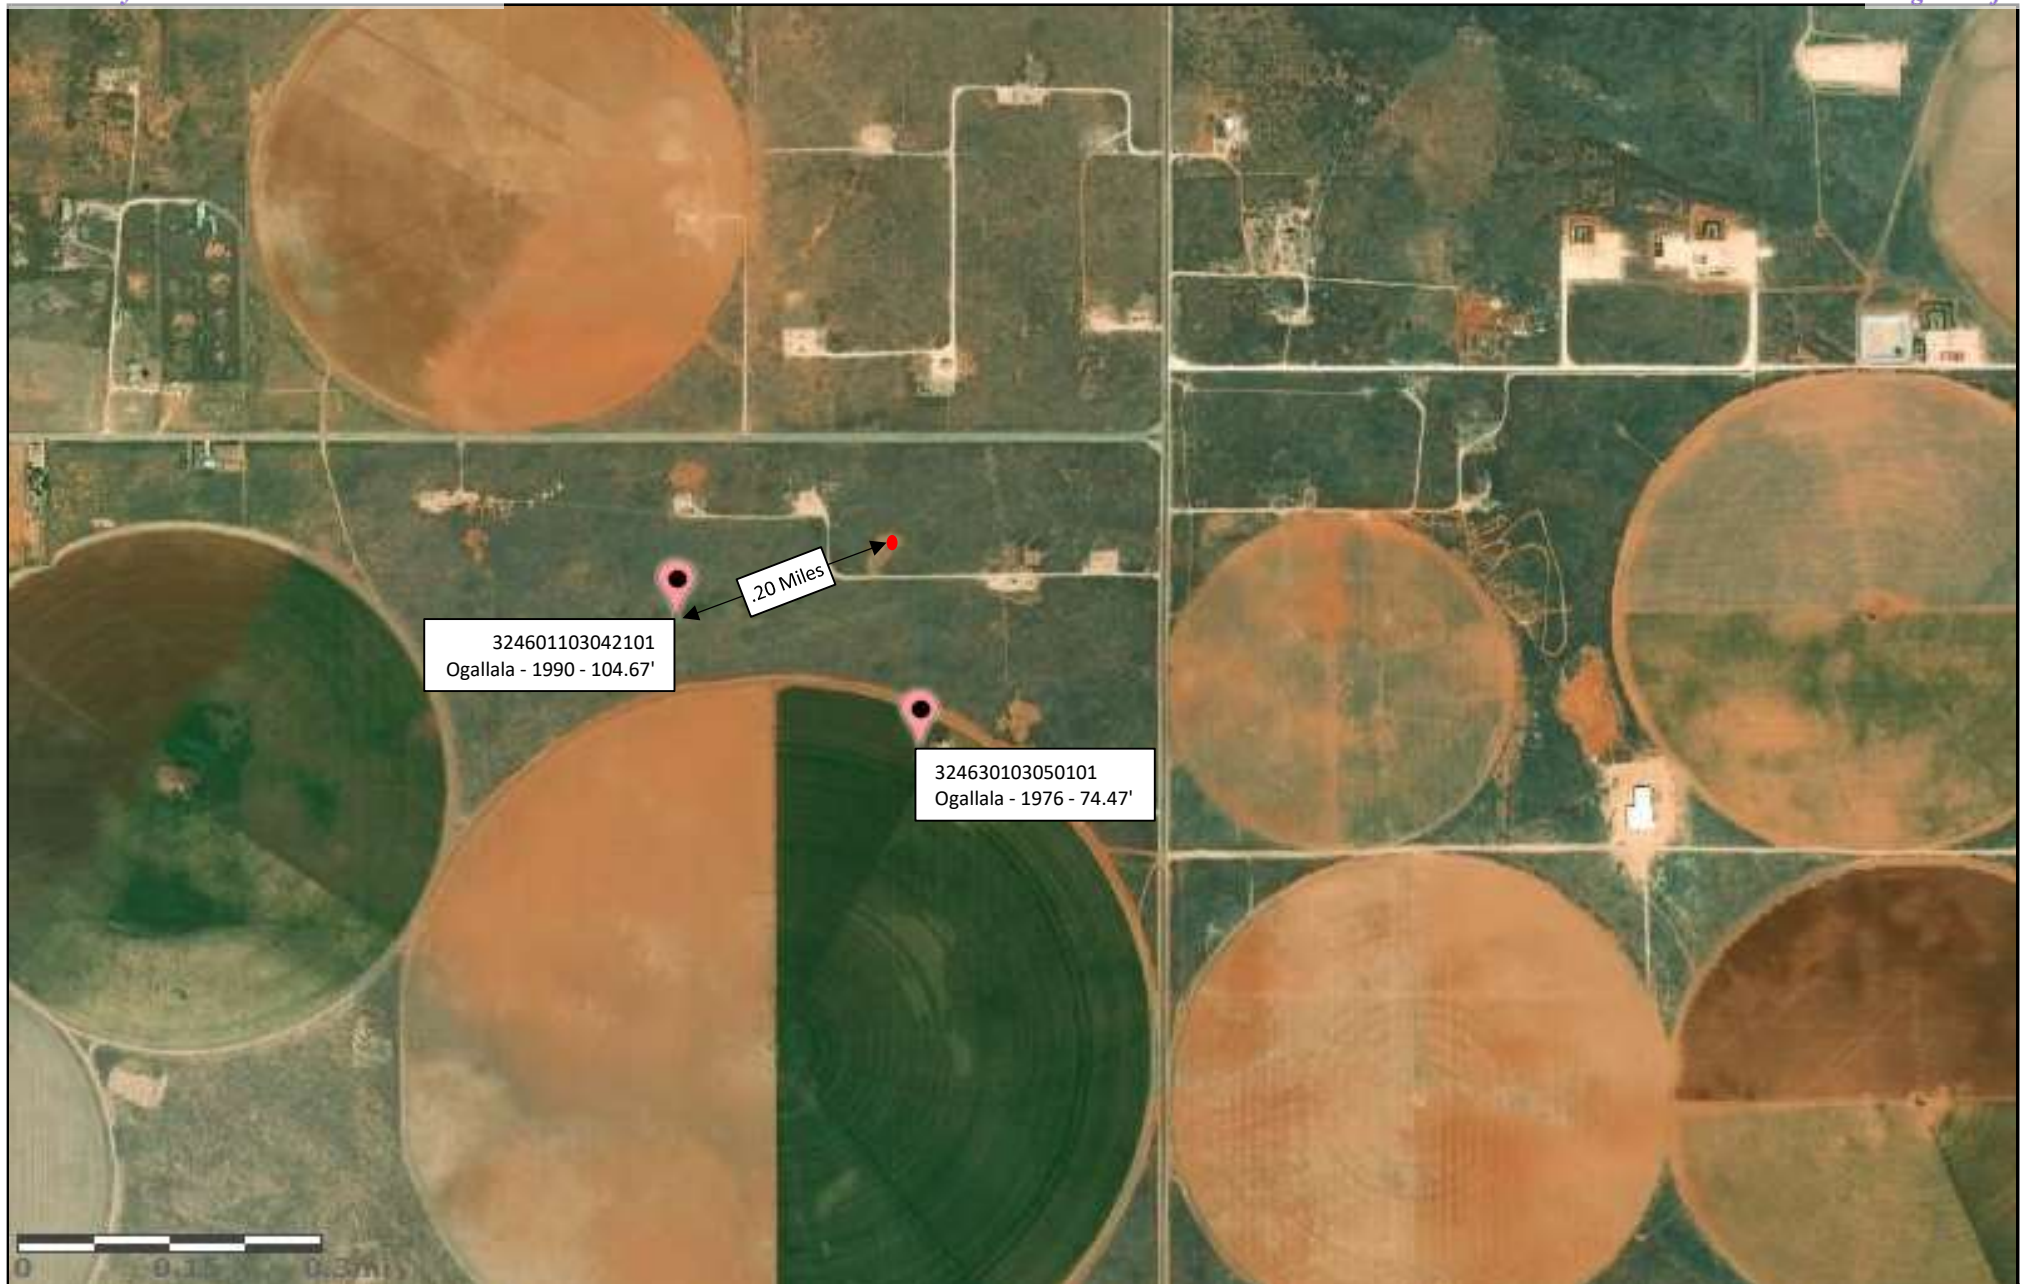
**Figure 3**

USGS Well Locations Map  
Great Western Drilling  
South Carter SA Unit #302  
GPS: 32.767782, -103.069444  
Lea County

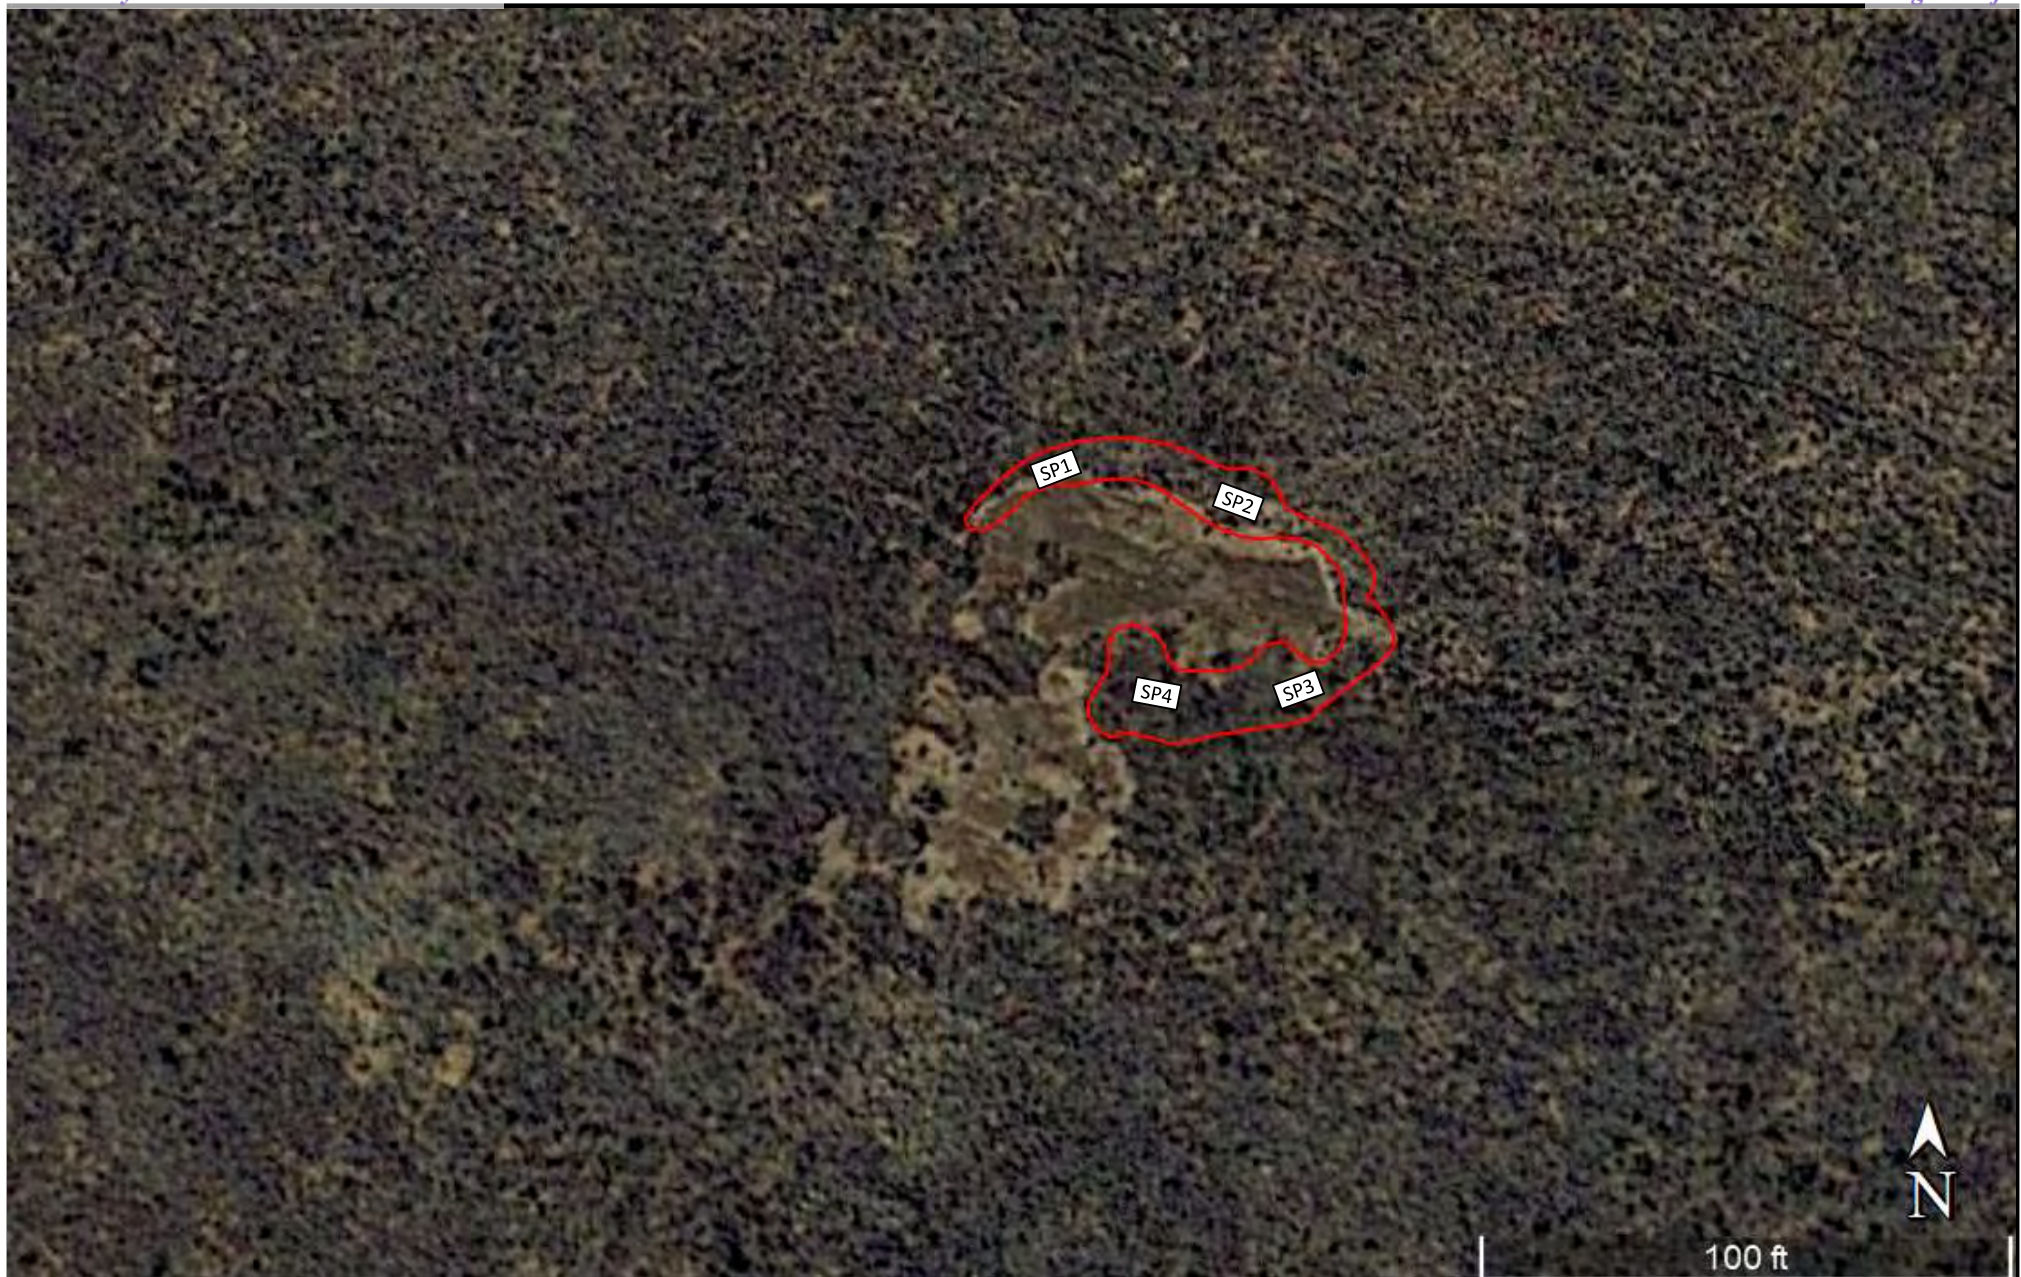
**Figure 4**

Delineation Sample Map  
Great Western Drilling  
South Carter SA Unit #302  
GPS: 32.767782, -103.069444  
Lea County

Based on field observations and field test data, two representative composite soil samples were selected for laboratory analysis. Surface soil samples SP1 and SP2 were submitted to the laboratory for analysis of BTEX, TPH, and chloride. Laboratory analytical results indicated contaminant concentrations were below the NMOCD Closure Criteria in each of the submitted samples.

On October 4, 2022, Hungry Horse personnel arrived onsite to conduct requested sampling of the location. Twenty representative soil samples, five from each sample location, were collected, field screened for chlorides via an EC meter, and sent for laboratory analysis. Soil samples collected from the surface through three feet bgs were submitted to the laboratory for analysis of chloride. Soil samples collected at four feet bgs were submitted to the laboratory for analysis of BTEX, TPH, and chloride. Laboratory analytical results indicated contaminant concentrations were below the NMOCD Closure Criteria in each of the submitted samples.

A Delineation Sample Map is provided as Figure 4. Field data is provided as Attachment III. A Summary of Soil Sample Laboratory Analytical Results is provided as Table 1 and Laboratory Analytical Reports are provided as Attachment IV.
