**Re: Release Characterization and Closure Request  
ConocoPhillips  
Heritage Concho  
RJ Unit 110 Release  
Unit Letter P & O, Section 27, Township 17 South, Range 29 East  
Eddy County, New Mexico  
Incident ID# NMLB1022357667  
2RP-427**

Release Characterization and Closure Request  
January 31, 2022

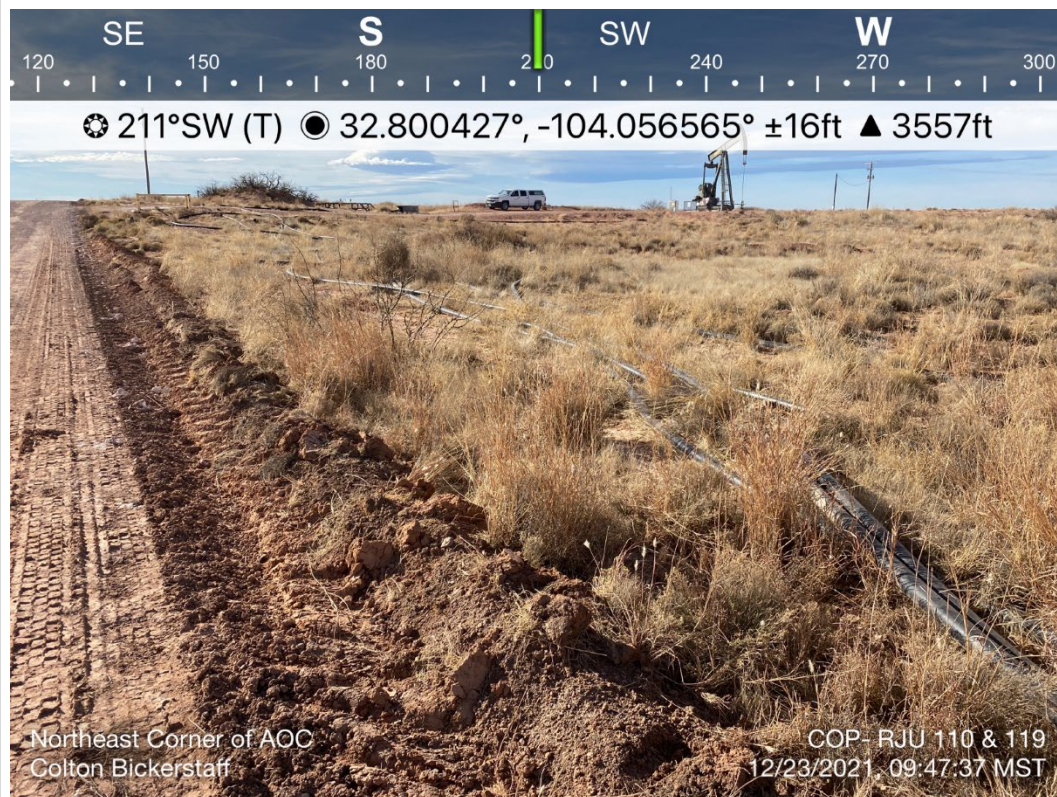
TETRA TECH, INC. PROJECT NO. 212C-MD-02619	DESCRIPTION	View south-southwest of northeast corner of visual inspection area from lease road.	2
	SITE NAME	ConocoPhillips: RJ Units 110 & 119 Site Visit	12/23/2021

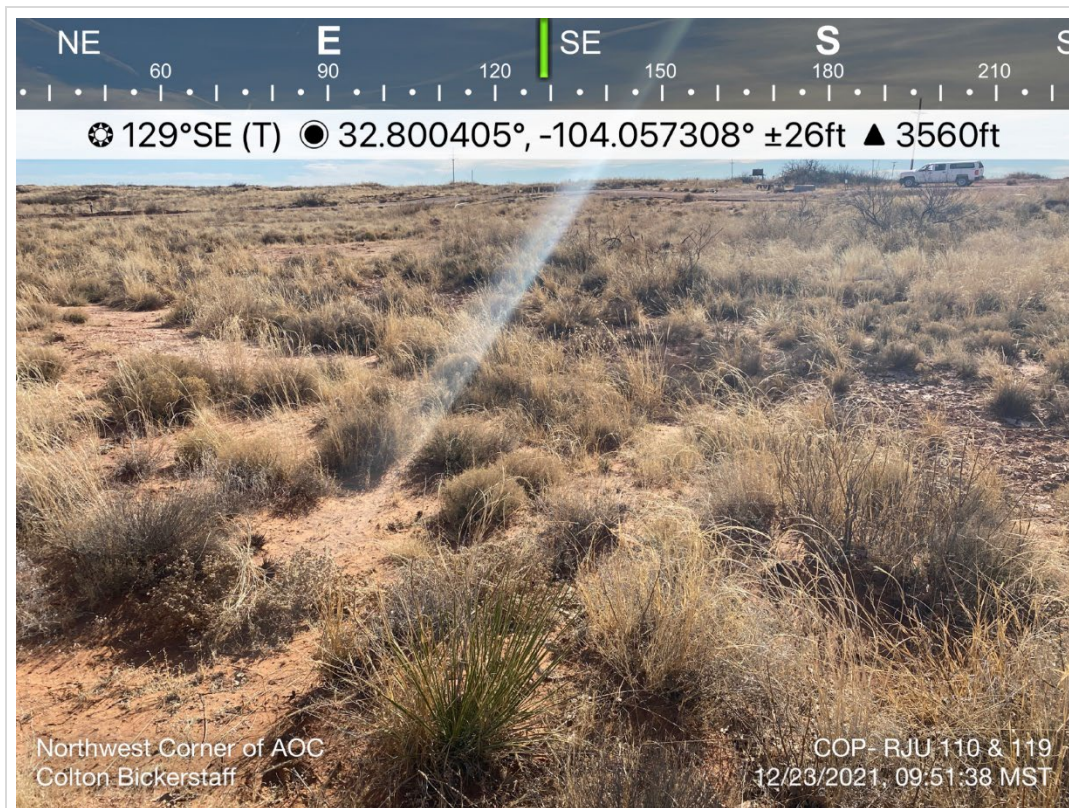
TETRA TECH, INC. PROJECT NO. 212C-MD-02619	DESCRIPTION	View southeast of northwest corner of visual inspection area.	3
	SITE NAME	ConocoPhillips: RJ Units 110 & 119 Site Visit	12/23/2021

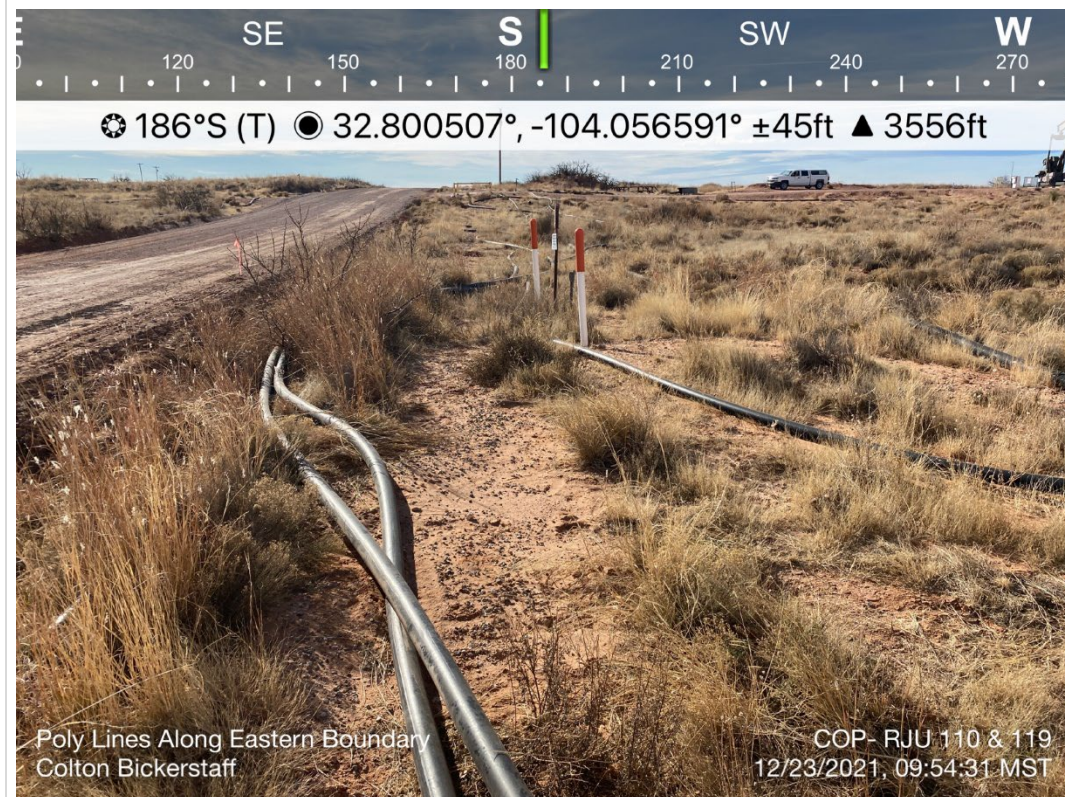
TETRA TECH, INC. PROJECT NO. 212C-MD-02619	DESCRIPTION	View south of surface flowlines along eastern boundary of visual inspection area.	4
	SITE NAME	ConocoPhillips: RJ Units 110 & 119 Site Visit	12/23/2021
