**Re: Closure Request
Rojo 22-25 Tank Battery
Incident Numbers nAPP2206753386 and nAPP2209076202
Lea County, New Mexico**

Ensolum, LLC (Ensolum), on behalf of BTA Oil Producers, LLC (BTA), has prepared this *Closure Request* to document assessment, excavation, and soil sampling activities performed at the Rojo 22-25 Tank Battery (Site). The purpose of the Site assessment, excavation, and soil sampling activities was to address impacts to soil following two release events at the Site. Based on the excavation activities completed and laboratory analytical results from the soil sampling events, BTA is submitting this *Closure Request*, describing remediation that has occurred and requesting closure for Incident Numbers nAPP2206753386 and nAPP2209076202.

BTA Oil Producers, LLC
Closure Request
Rojo 22-25 Tank Battery

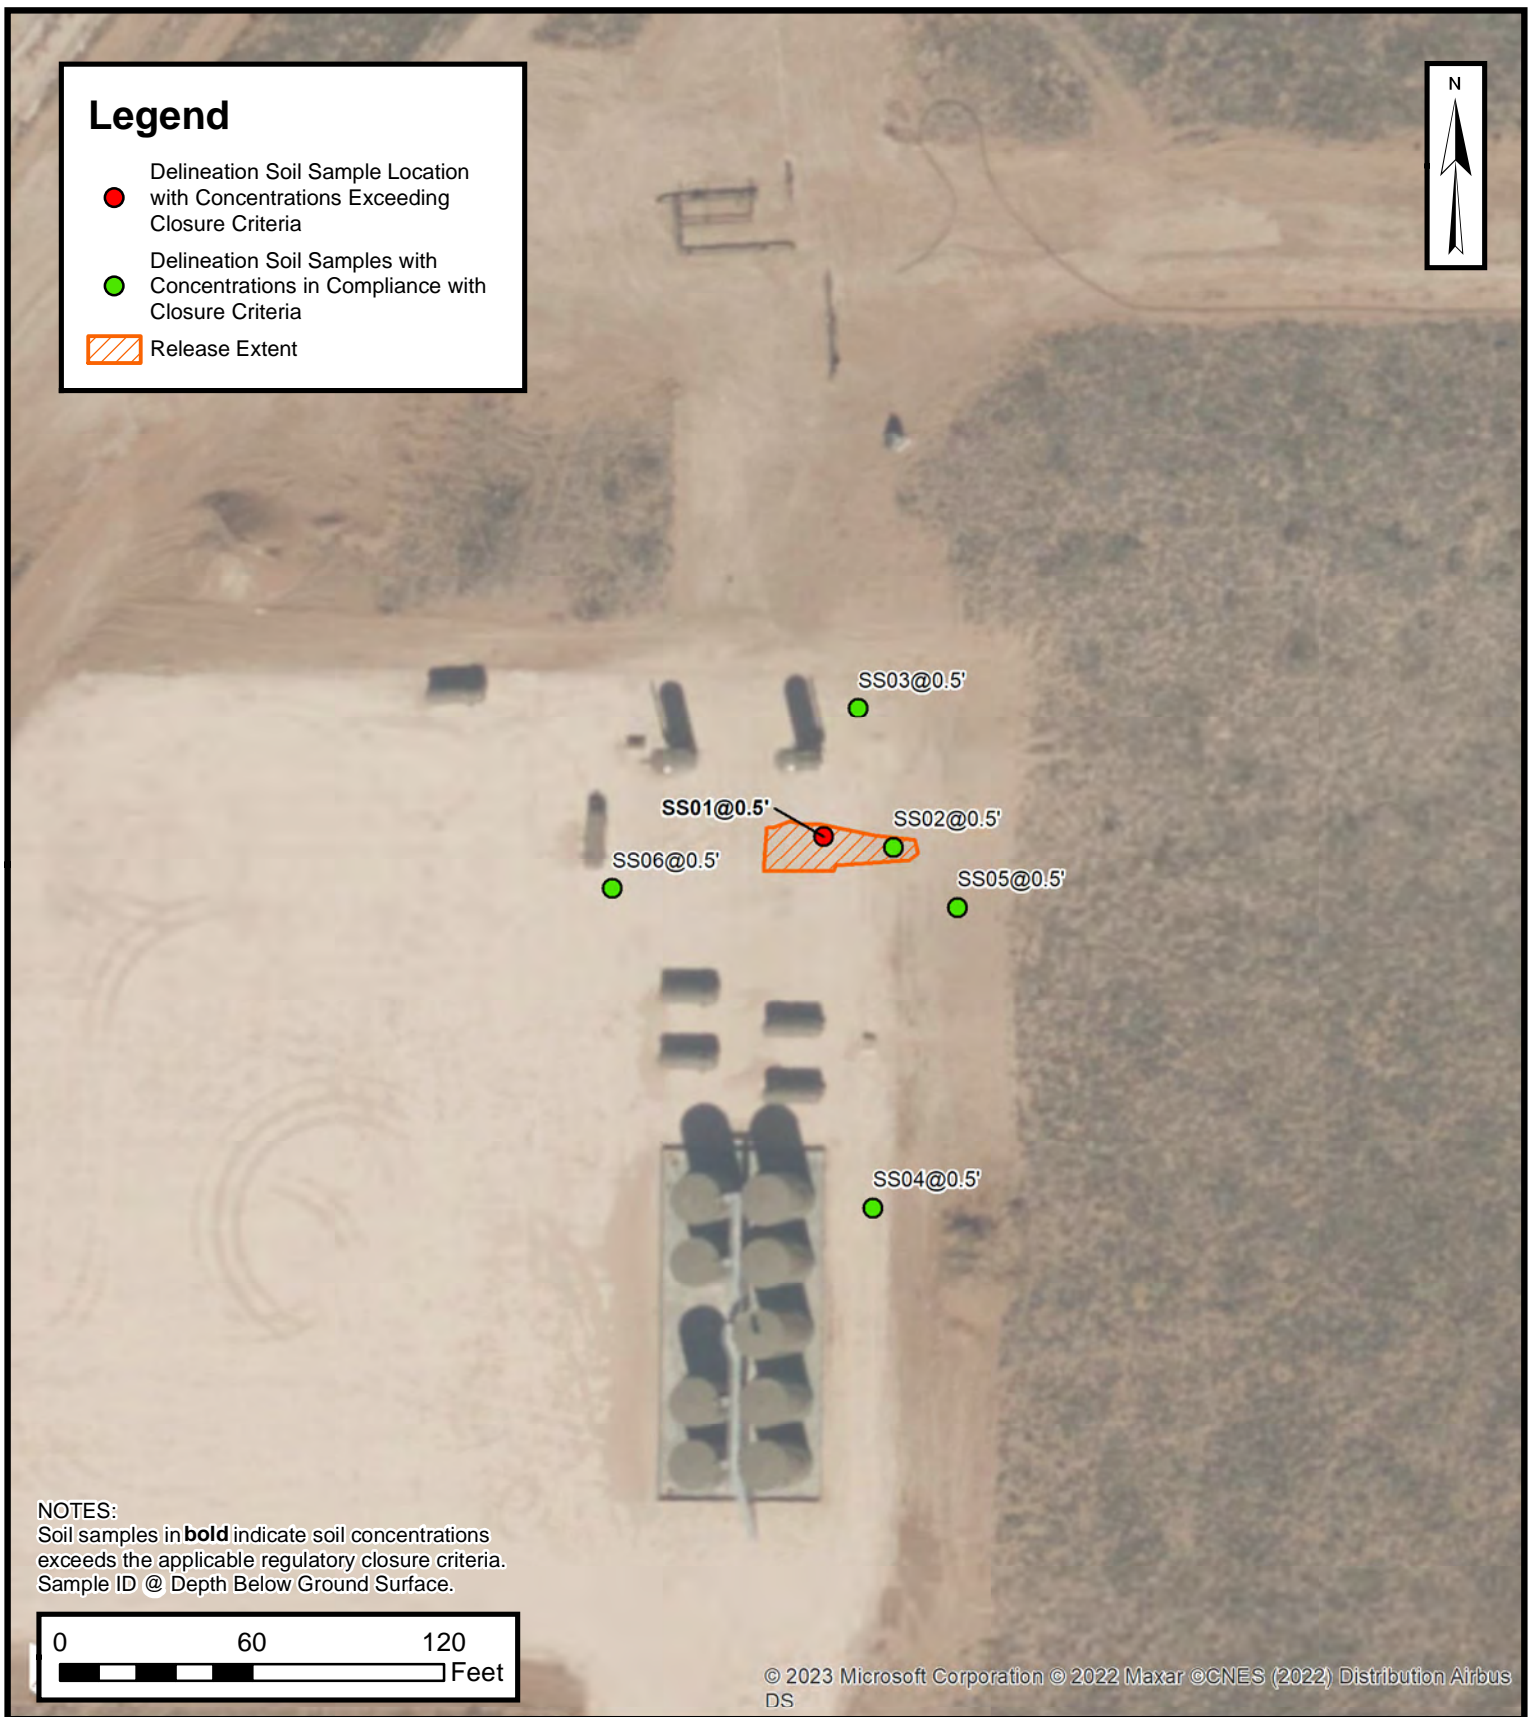
FIGURE
2

On October 17, 2022, Ensolum personnel were at the Site to evaluate the releases based on information provided on the Form C-141s and visual observations. The releases overlapped so a single release extent was mapped utilizing a handheld Global Positioning System (GPS) unit. In addition, six assessment soil samples (SS01 through SS06) were collected within and around the release extents at a depth of approximately 0.5 feet bgs to assess shallow soil for the presence or absence of impacts from the two releases. The soil samples were field screened for volatile organic compounds (VOCs) utilizing a calibrated photoionization detector (PID) and chloride utilizing Hach® chloride QuanTab® test strips. The soil sample locations were mapped utilizing a GPS unit and are depicted on Figure 2. Photographic documentation was completed during the Site visit and a photographic log is included in Appendix B.

Laboratory analytical results for soil sample SS01, collected within the release extent, indicated TPH concentrations exceeded the Closure Criteria. Laboratory analytical results for soil samples SS02 through SS06 indicated all COC concentrations were compliant with the Closure Criteria. The laboratory analytical results are summarized on Table 1 and the complete laboratory analytical reports are included as Appendix C.

Delineation Soil Sample Sample Locations

Based on visible staining in the release areas and elevated field screening results, excavation activities appeared to be warranted.

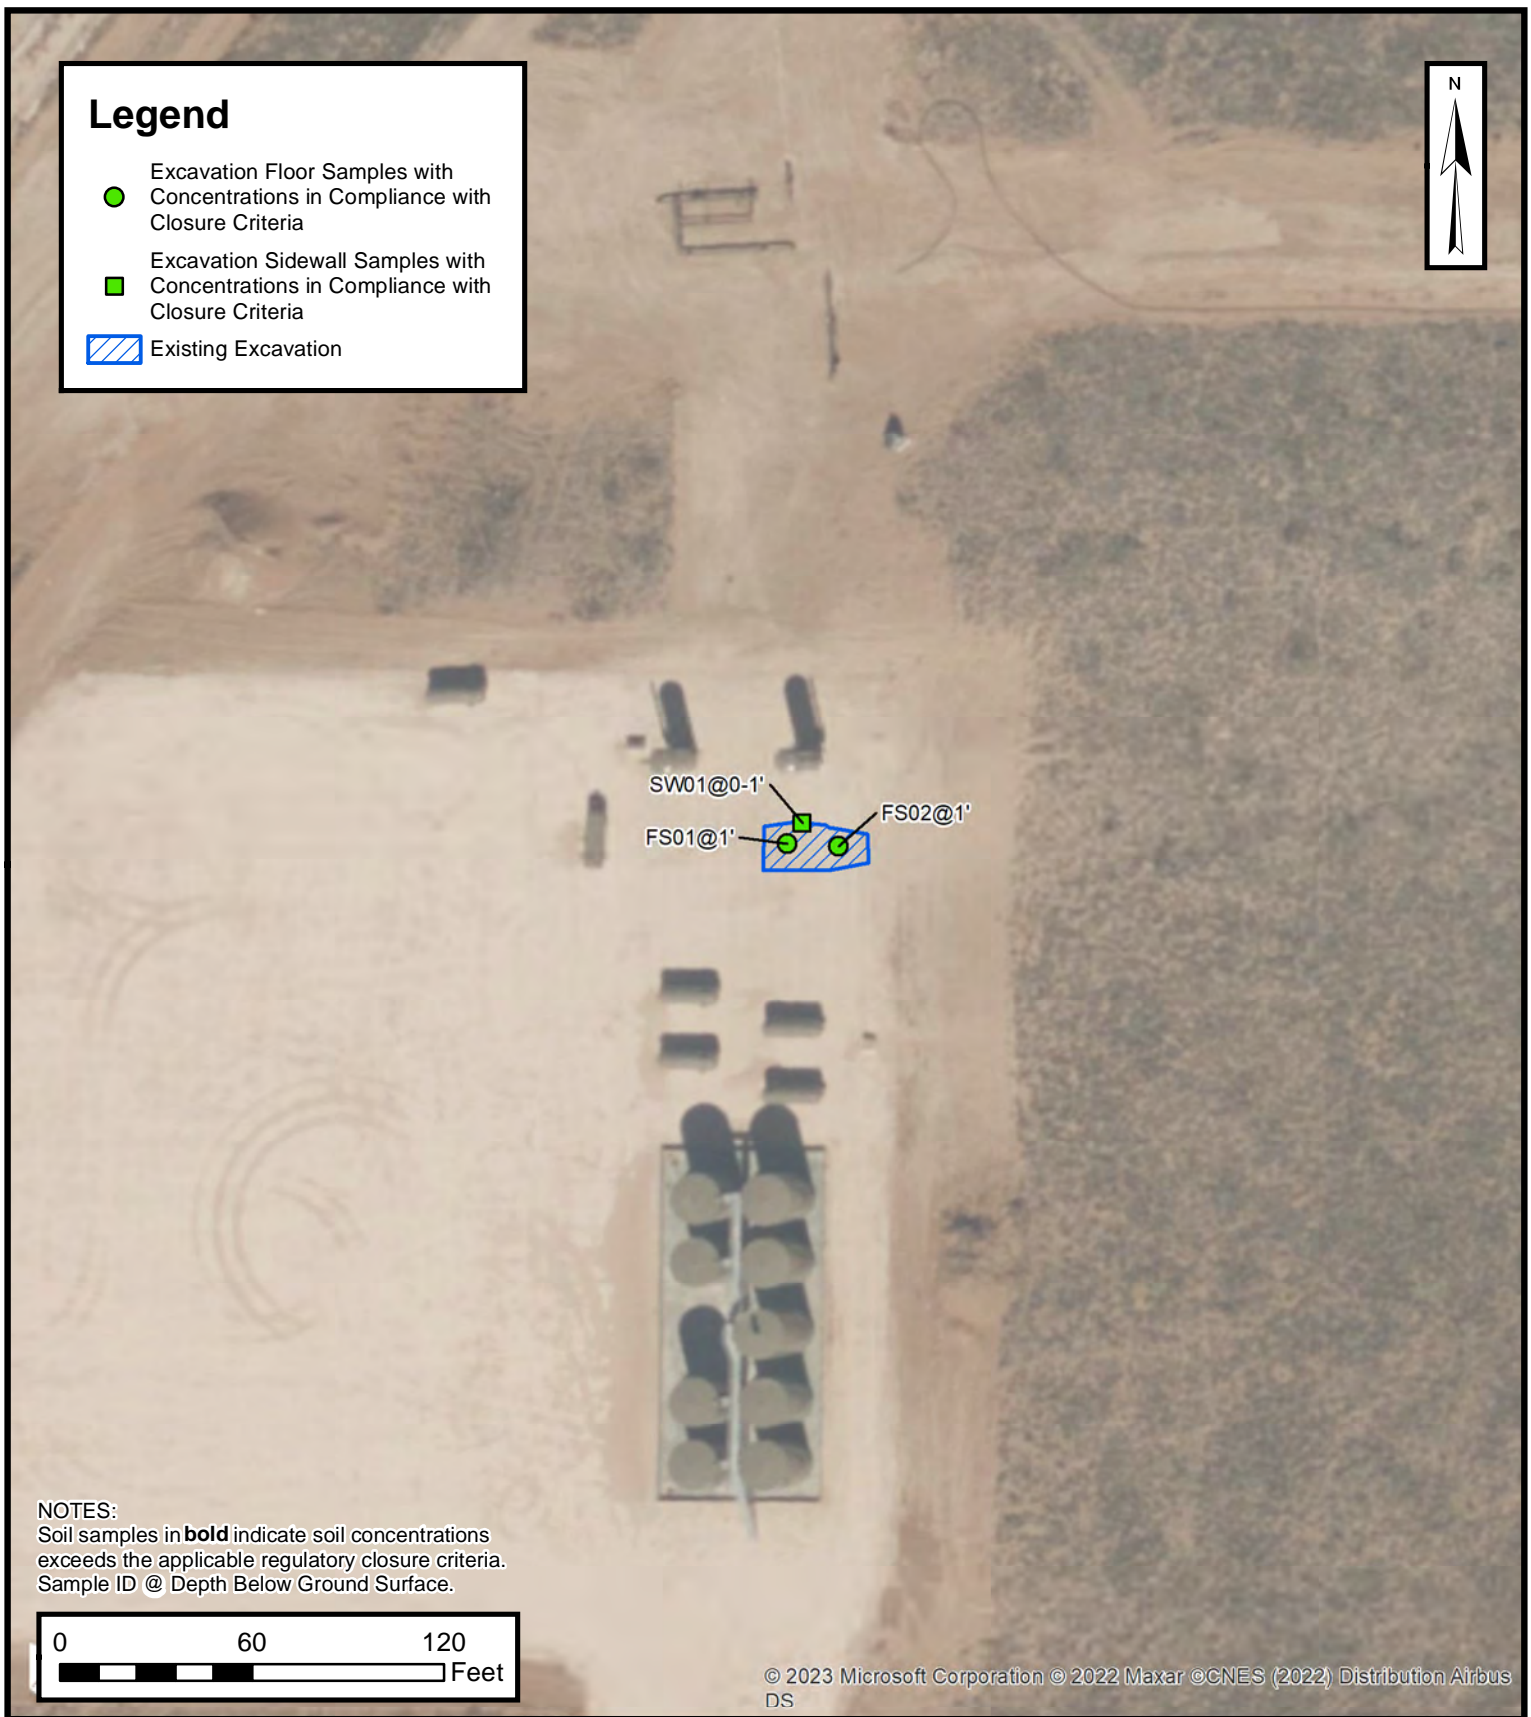
FIGURE
3

Following the excavation activities, 5-point composite samples were collected from the floor and sidewalls of the excavation. The 5-point composite samples were collected by placing five equivalent aliquots of soil into a 1-gallon, resealable plastic bag and homogenizing the samples by thoroughly mixing. Composite soil samples FS01 and FS02 were collected from the floor of the excavation at a depth of 1-foot bgs. Composite soil sample SW01 was collected from the sidewall of the excavation. Due to the shallow nature of the excavation, one sidewall sample was collected for the full parameter, which also included a portion of the floor based on the sloped sidewall configuration. The soil samples were collected, handled, and analyzed following the same procedures as described above. The excavation extent and excavation soil sample locations were mapped utilizing a handheld GPS unit and are depicted on Figure 3. A photographic log of the excavation is included as Appendix B.

Laboratory analytical results for excavation soil samples FS01, FS02, and SW01, collected from the final excavation extent, indicated all COC concentrations were compliant with the Site Closure Criteria. The laboratory analytical results are summarized on Table 1 and the complete laboratory analytical reports are included as Appendix C.

Excavation Soil Sample Locations

On December 15, 2022, Ensolum personnel were at the Site to oversee excavation activities. Impacted soil was excavated as indicated by visible staining, field screenings and laboratory analytical results. Excavation activities were performed via hand shoveling and a hydrovac truck. To direct excavation activities, soil was screened for VOCs and chloride. The excavation was completed to a depth of 1-foot bgs.

The excavation measured approximately 415 square feet in areal extent. A total of approximately 15 cubic yards of impacted soil was removed during the excavation activities. The impacted soil was transported and properly disposed of at the R360 Disposal Facility located in Hobbs, New Mexico. After completion of confirmation sampling, the excavation was secured with fencing.

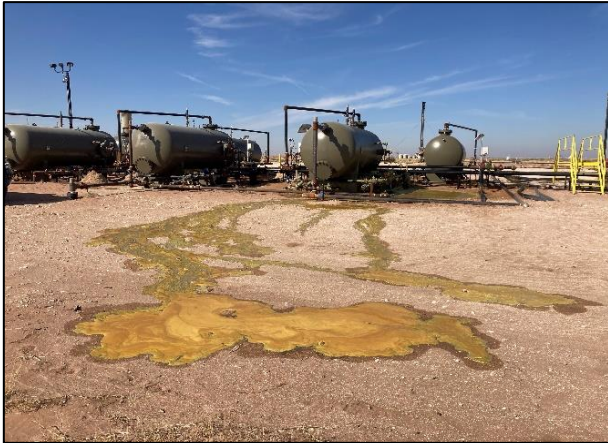
On March 7, 2022, a fitting failed on the separator, resulting in the release of approximately 7 barrels (bbls) of produced water and 5 bbls of crude oil onto the well pad. A vacuum truck was dispatched to the Site to recover free-standing fluids; approximately 6 bbls of produced water and 4 bbls of crude oil were recovered. BTA reported the release to the New Mexico Oil and Conservation Division (NMOCD) on March 8, 2022 and submitted a Release Notification Form C-141 (Form C-141). The release was assigned Incident Number nAPP2206753386.

On March 17, 2022, a valve failed on the separator, resulting in the release of approximately 10 bbls of crude oil onto the well pad. A vacuum truck was dispatched to the Site to recover free-standing fluids; approximately 3 bbls of crude oil were recovered. BTA reported the release to the NMOCD on March 31, 2022 and submitted a Form C-141. The release was assigned Incident Number nAPP2209076202.

Photograph: 1 Date: 3/7/2022
Description: Release footprint
View: West

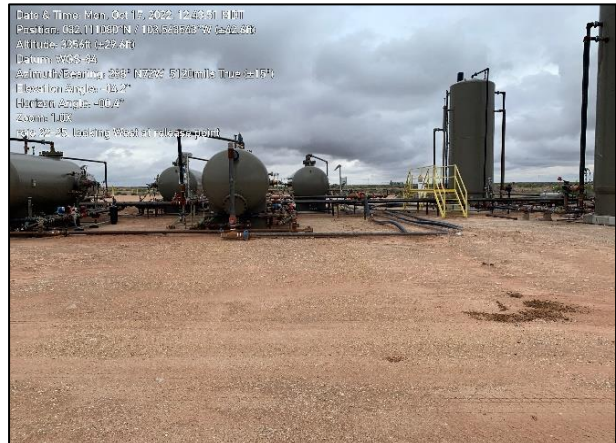
Photograph: 2 Date: 10/17/2022
Description: Initial assessment activities
View: Northwest

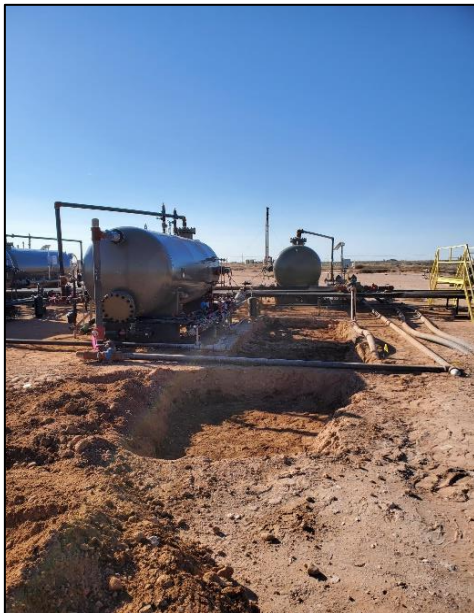
Photograph: 3 Date: 12/15/2022
Description: Excavation activities
View: West

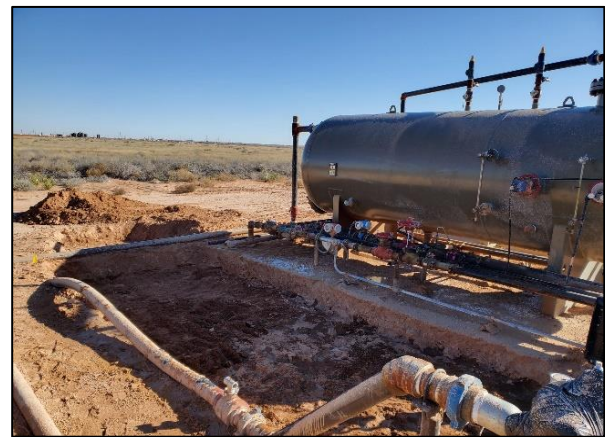
Photograph: 4 Date: 12/15/2022
Description: Excavation activities
View: Southeast
