Re: Hoffman PL Tank Battery  
30-015-23664  
E-27-18S-26E  
Eddy County, New Mexico  
2RP-58  
nKMW0736054740

**EOG Resources, Inc.**  
**Hoffman PL Tank Battery**  
**Closure Report**  
**E-27-18S-26E**  
**Eddy County, New Mexico**  
**April 12, 2022**  
**2RP-58**  
**nKMW0736054740**

### Spill Summary and Work Plan

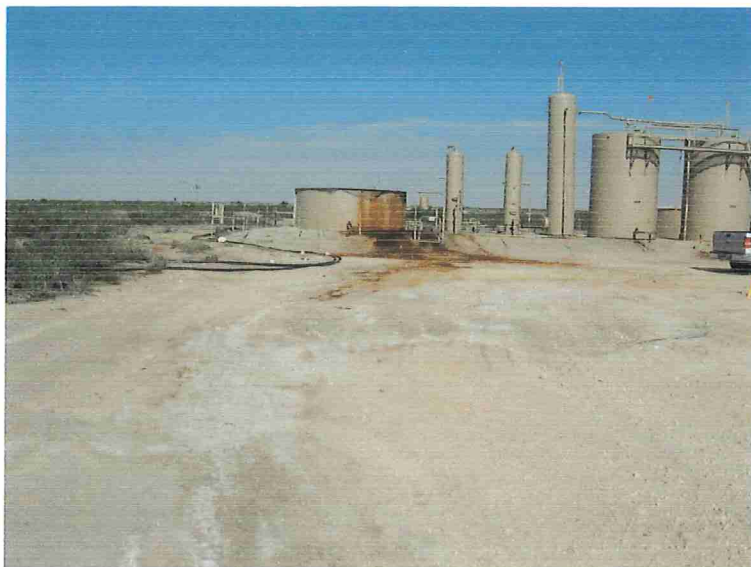
Shooting Date/Time : 7/19/2006 8:52:12 AM  
Comment : Looking west

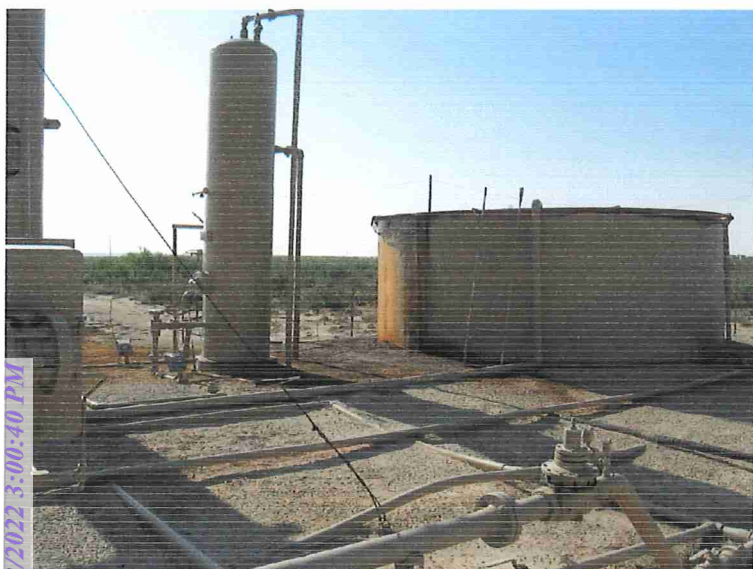
Hoffman PL Tank Battery

Shooting Date/Time : 7/19/2006 8:53:30 AM  
Comment : Looking SE
