Re: Updated Remediation Work Plan

Seymour 6 San Juan County, New Mexico

Hilcorp Energy Company
NMOCD Incident No: nAPP2224144740

Ensolum, LLC (Ensolum), on behalf of Hilcorp Energy Company (Hilcorp), presents this *Updated Remediation Work Plan* for a release at the Seymour 6 natural gas production well (Site). The Site is located on Federal land managed by the Bureau of Land Management (BLM) in rural San Juan County, New Mexico (Figure 1). This proposed Work Plan includes additional remediation of impacted soil and vegetation originating from the overtopping of oil from a below grade tank (BGT). The Site is located in Unit M, Section 14, Township 31 North, Range 9 West, in rural San Juan County, New Mexico.

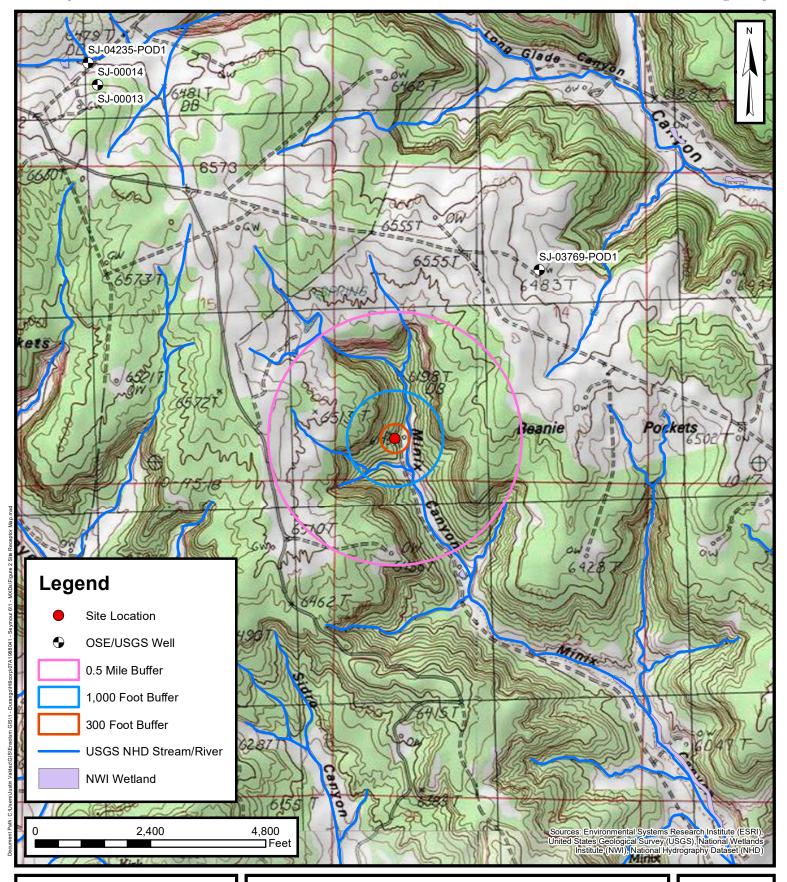
Site Receptor Map

As part of the Site investigation, local geology/hydrogeology and nearby sensitive receptors (shown on Figure 2) were assessed in accordance with Title 19, Chapter 15, Part 29, Sections 11 and 12 (19.15.29.11 and 12) of the New Mexico Administrative Code (NMAC). Based on the information presented in Ensolum's *Remediation Work Plan* and in accordance with the *Table I, Closure Criteria for Soils Impacted by a Release* (19.15.29.12 of the NMAC), the following "Closure Criteria" are applied to the Site based on the proximity to a significant watercourse:

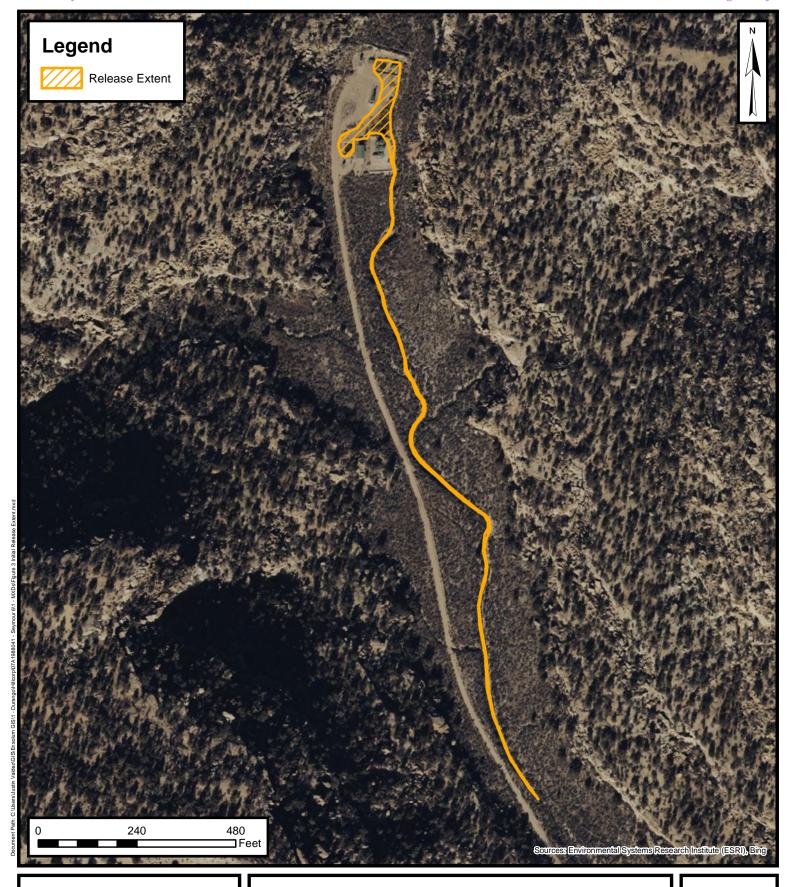
Initial Release Extent

On August 18, 2022, Hilcorp discovered a 20-barrel (bbl) release of oil at the Site. Significant precipitation at the Site caused a BGT to overflow into the secondary containment berm. A section of the earthen berm subsequently failed and released fluids outside of the containment and ultimately migrated off the facility pad into an adjacent dry wash. The volume released was determined by the operator's monthly tank gauging data. Upon discovery, Hilcorp immediately emptied the remaining fluids from the BGT and retained a vacuum truck to recover any possible standing fluids at the Site (approximately 2 bbls). On August 19, 2022, Hilcorp excavated approximately 55 yards of visibly impacted soils from the original footprint of the well pad at the Site for disposal at a permitted facility.

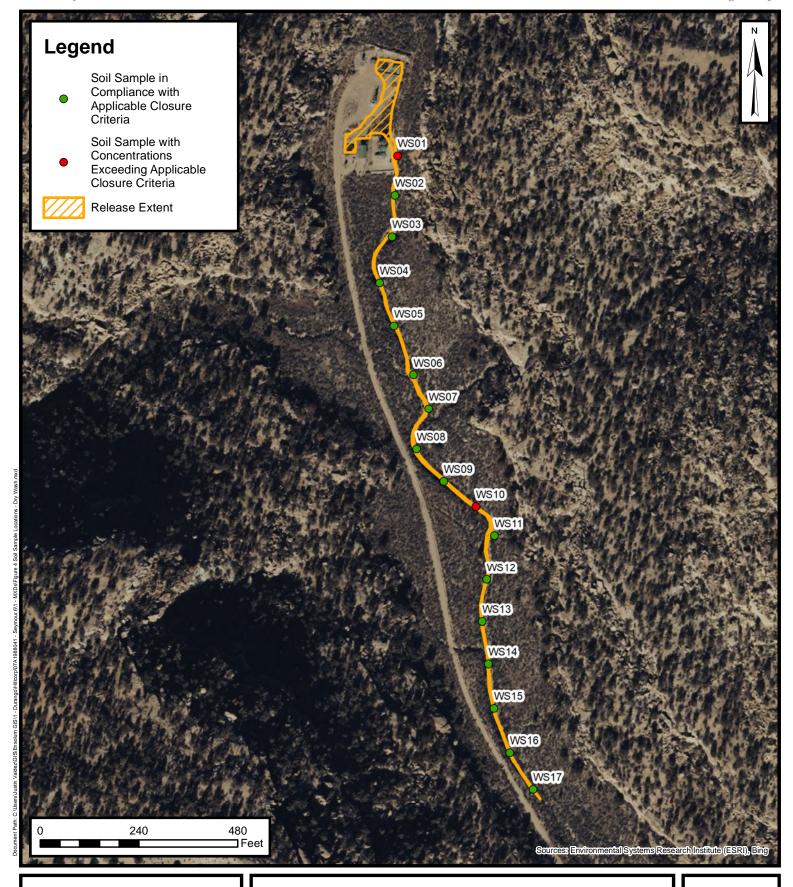
Composite Sample Location – Wash

After removing obviously impacted soil from the well pad (conducted in August 2022 and based on petroleum hydrocarbon staining and odors), and once BLM approval was received for off-pad activities, Ensolum and Hilcorp personnel collected soil samples on December 8, 2022 to assess soil conditions both on the well pad and in the dry wash. Prior to sampling, the NMOCD and the BLM were notified of the upcoming Site activities (Appendix B). Five-point composite soil samples were collected from the floor of the well pad excavation at a frequency of one sample per 500 square feet (samples SS01 through SS20). Due to the shallow nature of the excavation (less than 1 foot in depth), shallow sidewall areas were incorporated into the composite floor samples. Additionally, 5-point composite samples were collected from the dry wash at a frequency of one sample for every 100 linear feet (samples WS01 through WS17). The entire release extent is shown on Figure 3, with specific sampling locations for the wash and well pad presented on Figures 4 and 5, respectively.

Analytical results indicated two samples collected within the wash (WS01 and WS10) exceeded the applicable Closure Criteria for TPH. Concentrations of TPH also exceeded the Closure Criteria in all on-pad soil samples with the exception of samples SS02 and SS17. Additionally, concentrations of chloride exceeded the Closure Criteria in only one on-pad sample, SS08. All other COCs analyzed during the December 8, 2022 sampling event were in compliance with the applicable NMOCD Table I Closure Criteria. Analytical results collected during this event are summarized in Table 1, with complete laboratory analytical reports attached as Appendix C. Photographs taken during the sampling event are presented in Appendix D.

Based on the soil sampling results described above, Hilcorp proposes to further delineate on-pad areas using a hand auger and/or backhoe (if shallow refusal is encountered with a hand auger) to assess the vertical extent of soil impacts at the Site. Once delineated, Hilcorp will continue excavating TPH impacted soil in on-pad areas of the Site. Hilcorp will also remove TPH-impacted soil in in the vicinity of samples WS01 and WS10 (located within the adjacent wash) using hand equipment (i.e., shovel). Additionally, Hilcorp will remove by hand any vegetation impacted by the release, as indicated by the presence of an oily film on the vegetation and/or vegetation exhibiting stress caused by the release (e.g., browning or staining). Once impacted soil is removed, Hilcorp will collect additional 5-point composite samples from the excavation floors and sidewalls at the frequency approved by the NMOCD. The samples will be collected in the manner described above and submitted to Hall for laboratory analysis. Based on the results from the December 2022 sampling event, Hilcorp is requesting that future samples only be analyzed for TPH and chloride.

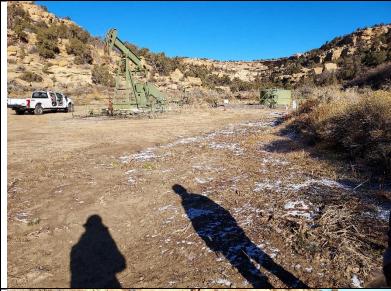
Photograph 1

View looking north at the impacted area on the well pad. Photo taken December 8, 2022.

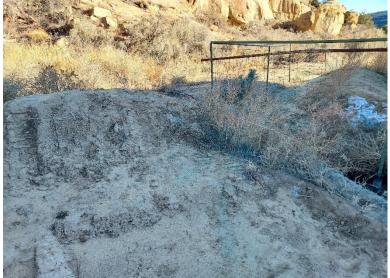
Photograph 2

View looking east at the eastern edge of the Seymour 6 well pad. Photo taken December 8, 2022.
