**RE: Deferral Request  
Hat Mesa 31-32 Tank Battery  
Remediation Permit Number 1RP-3143, 1RP-3726, and 1RP-4072  
Lea County, New Mexico**

LT Environmental, Inc. (LTE), on behalf of XTO Energy, Inc. (XTO), presents the following report detailing excavation of impacted soil and confirmation soil sampling activities at the Hat Mesa 31-32 Tank Battery (Site) located in Unit Letter B, Section 31, Township 20 South, Range 33 East, in Lea County, New Mexico (Figure 1). The purpose of the soil sampling and excavation activities was to address impact to soil after three separate releases occurred in two locations on the same well pad.

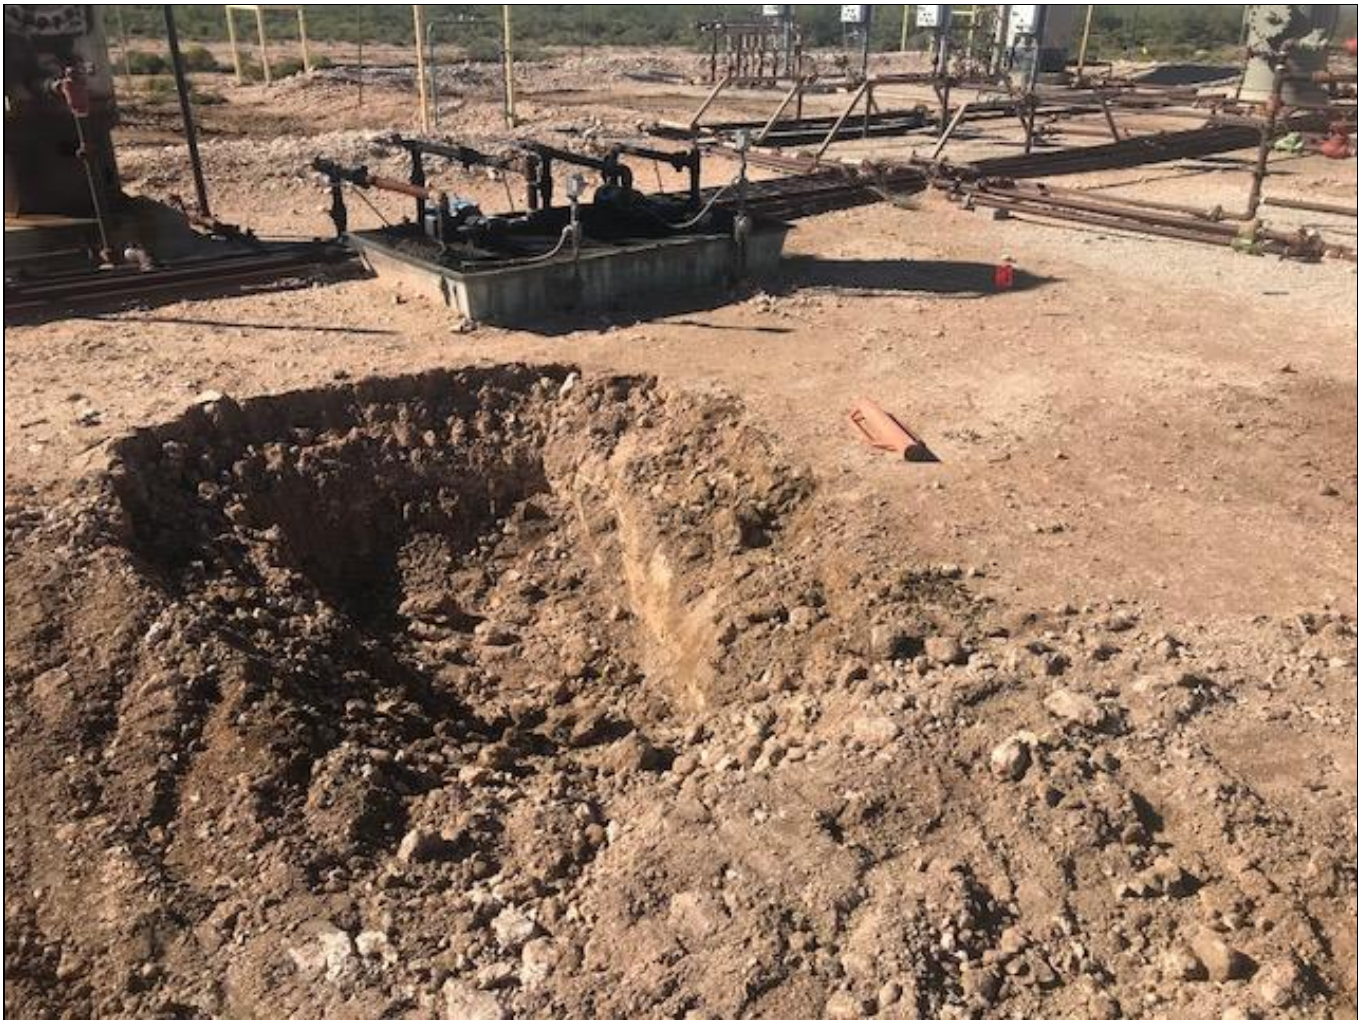
3D X-Section of the northern excavation
