**TETRA TECH**

March 27, 2020

Re: Closure Report for the EOG Resources, David Ross SWD #1, Section 35, Township 22 South, Range 31 East, Eddy County, New Mexico.

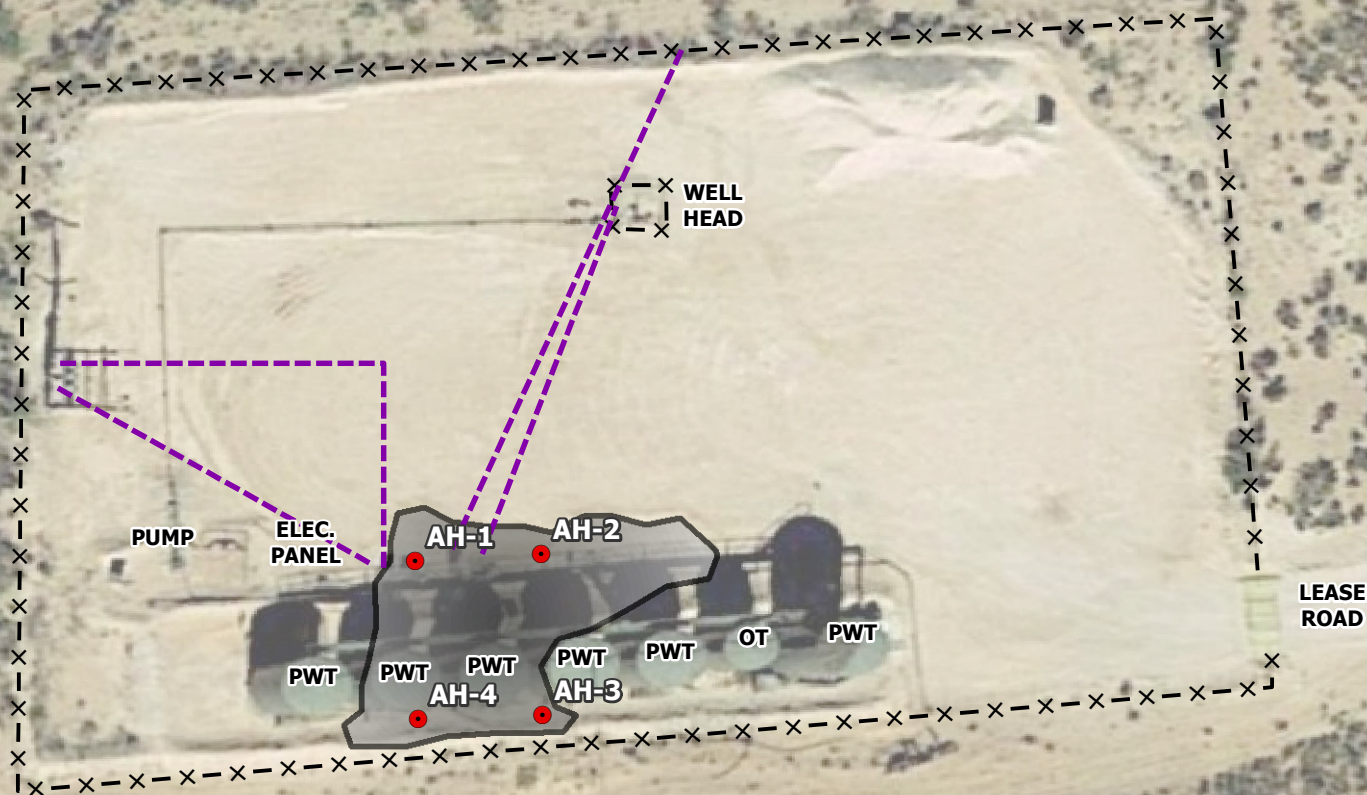
● AUGERHOLE SAMPLE LOCATIONS

--- BURIED PIPE

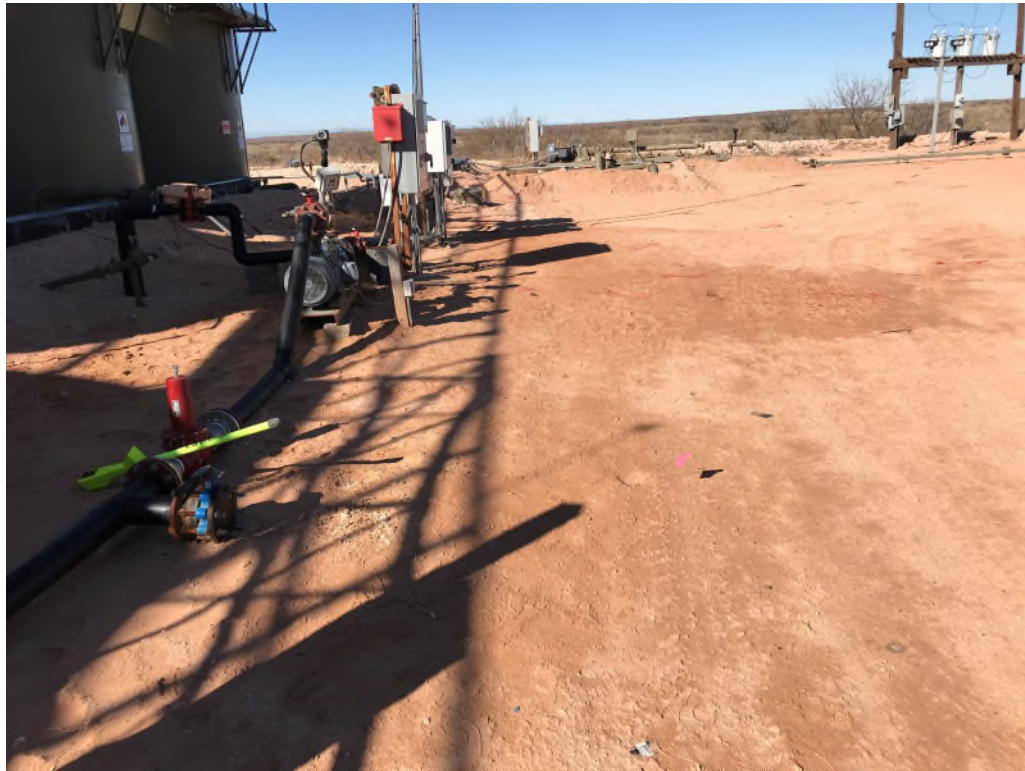
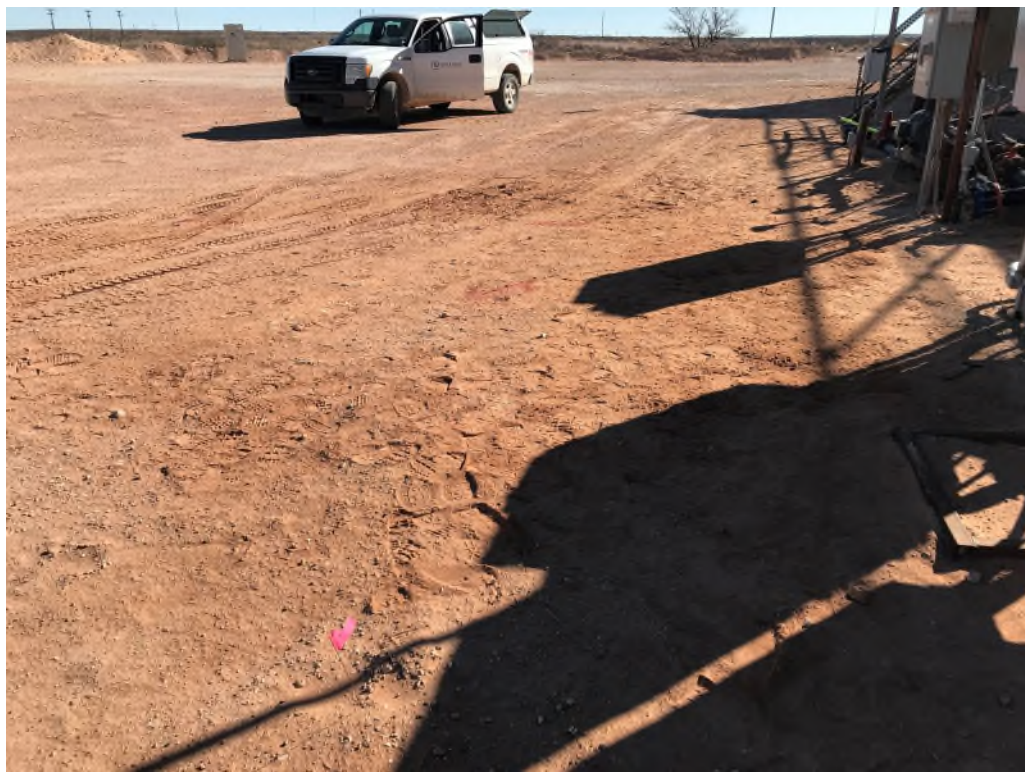
View of Release, North of Tank Battery

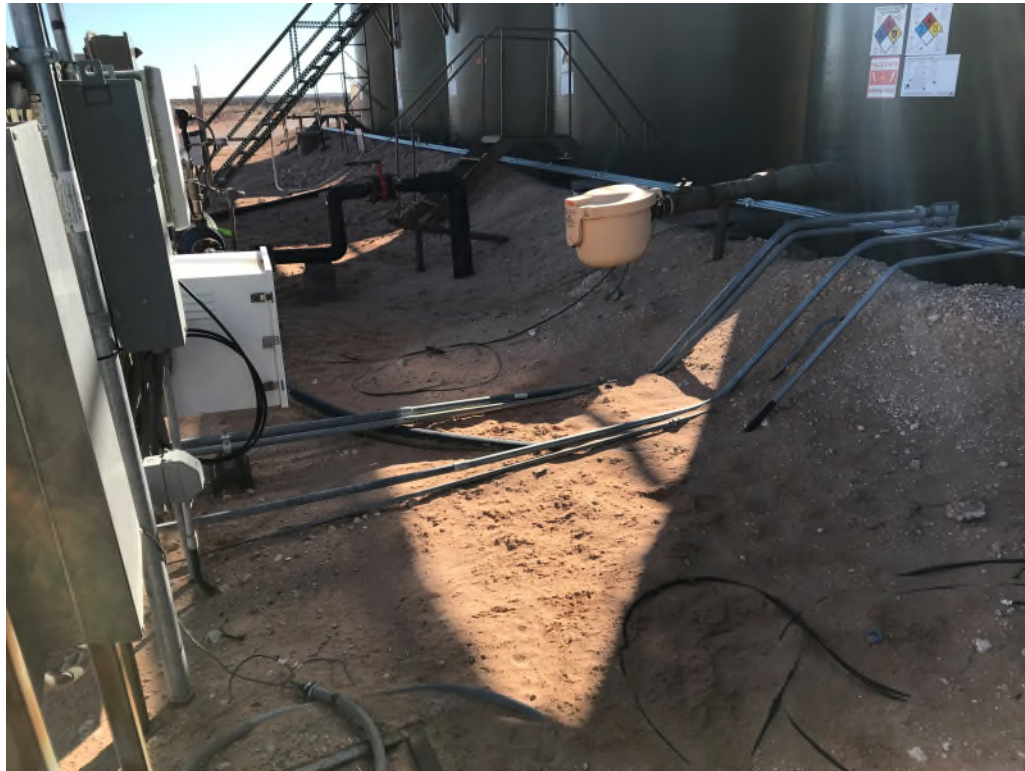
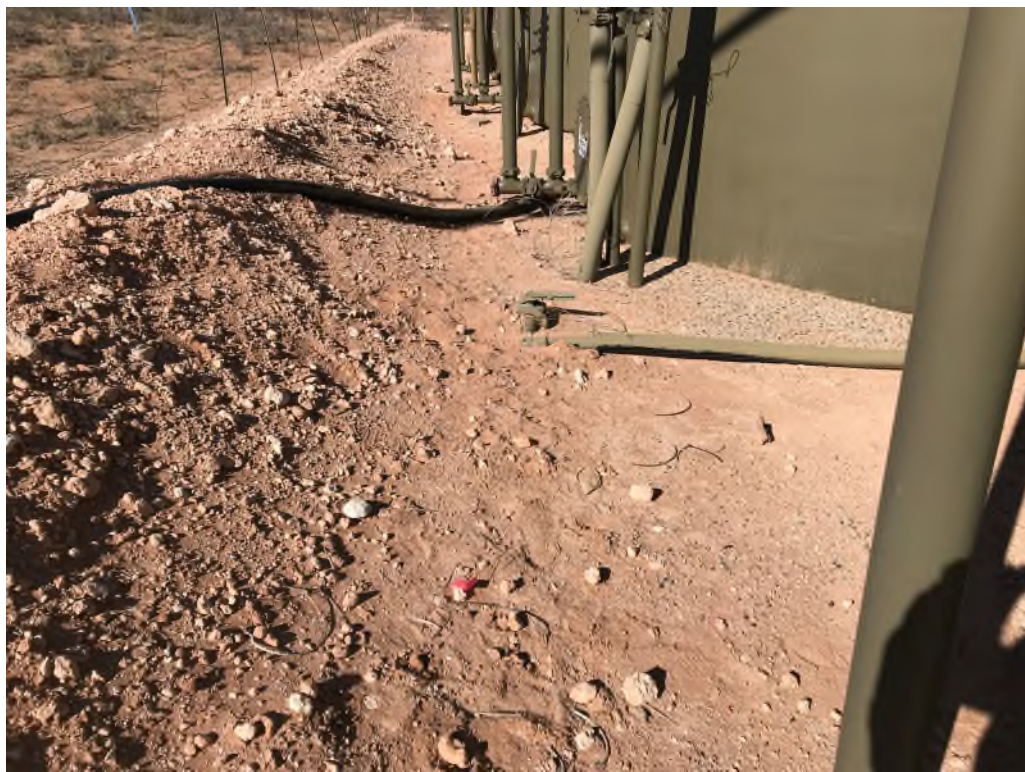
View of Release, South of Tank Battery

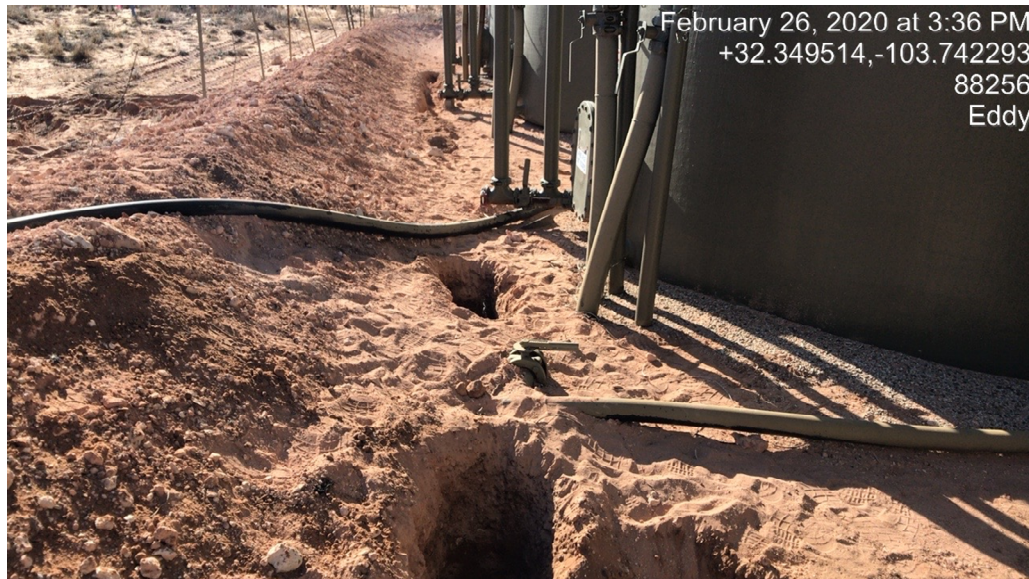
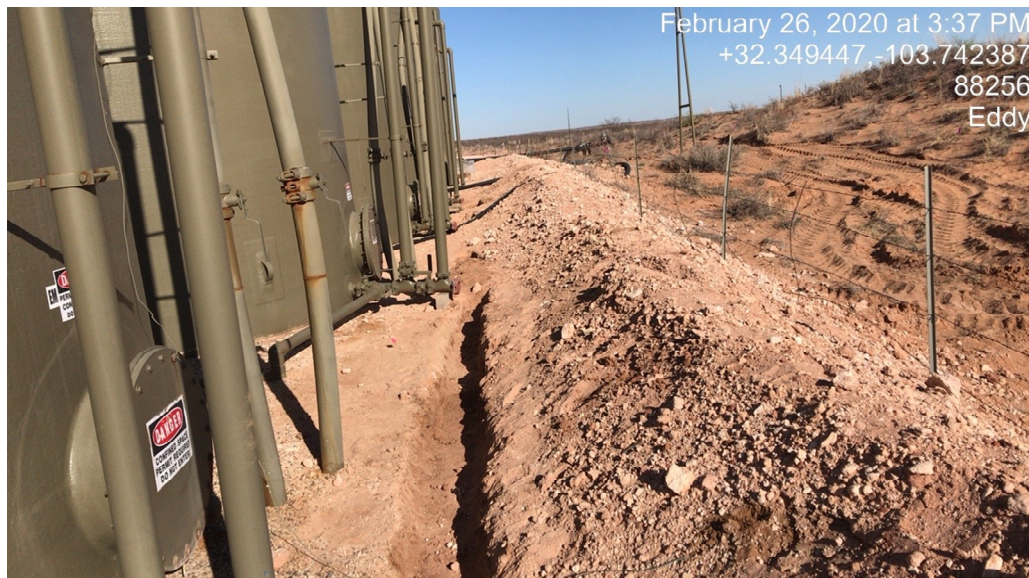
View of Remediation, South of Tank Battery

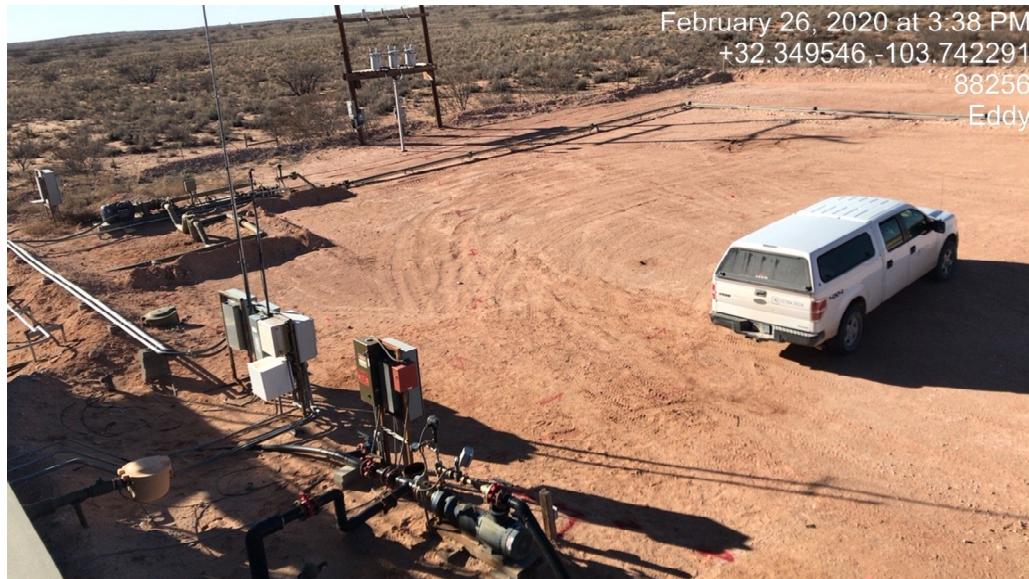
View of Release and Remediation, North of Tank Battery

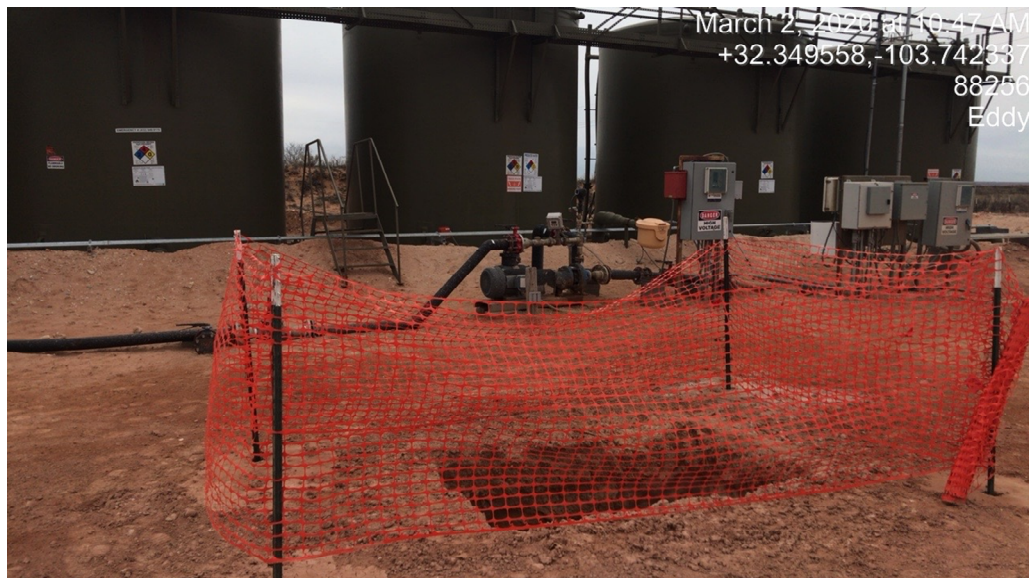
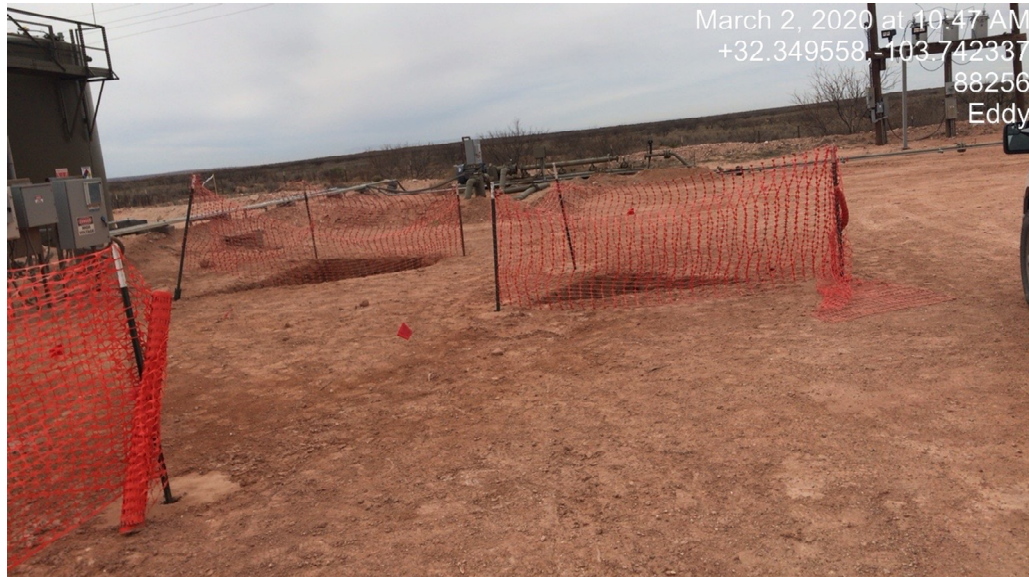
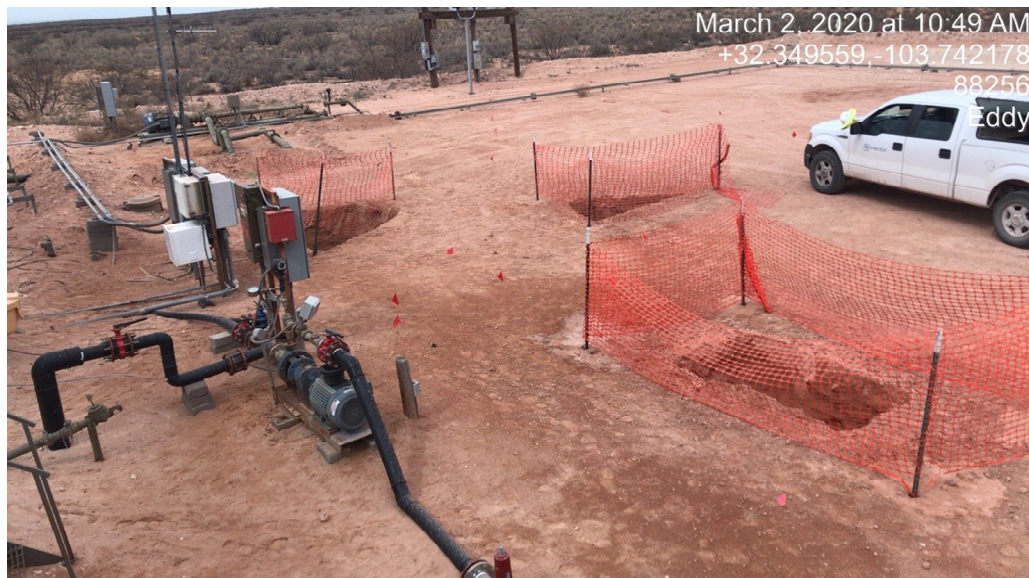
View of Remediation, North of Tank Battery
