Re: Closure Report for the EOG Resources, Ohkay SWD #3, Section 6, Township 25 South, Range 30 East, Eddy County, New Mexico.

Tetra Tech, Inc. (Tetra Tech) was contacted by EOG Resources (EOG) to assess and remediate a release that occurred at the EOG Resources, Ohkay SWD #3, Section 6, Township 25 South, Range 30 East, Eddy County, New Mexico (Site). The site coordinates are 32.13240°, -104.13323°. The site location is shown on Figures 1 and 2.

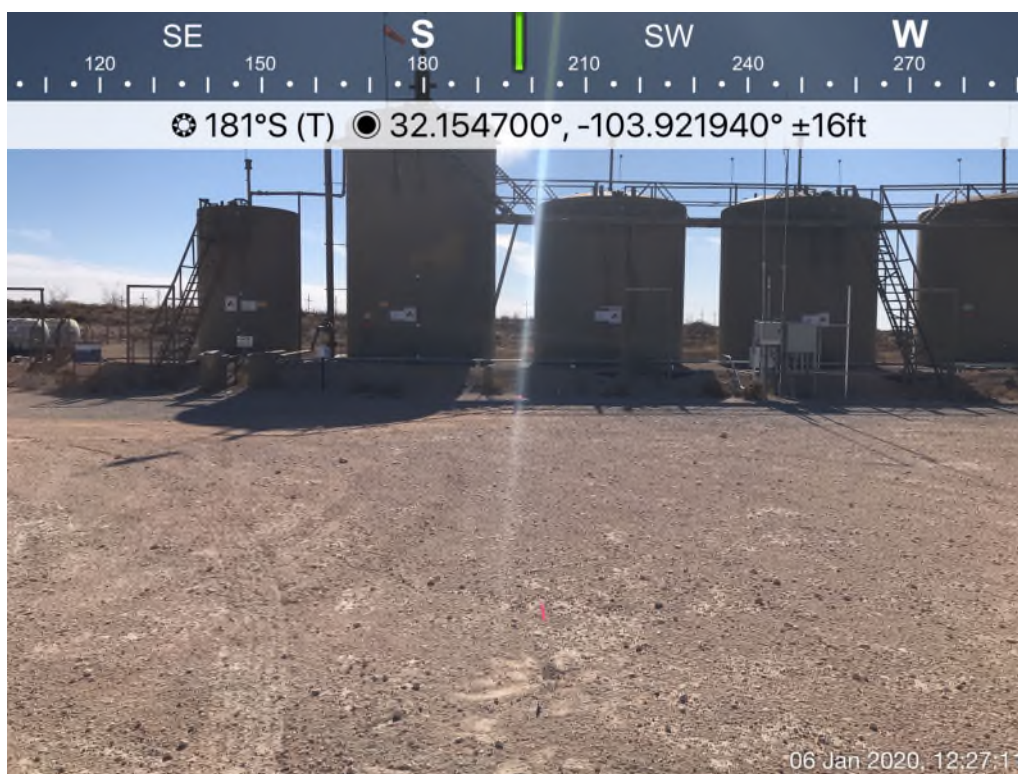
View of Release – View South

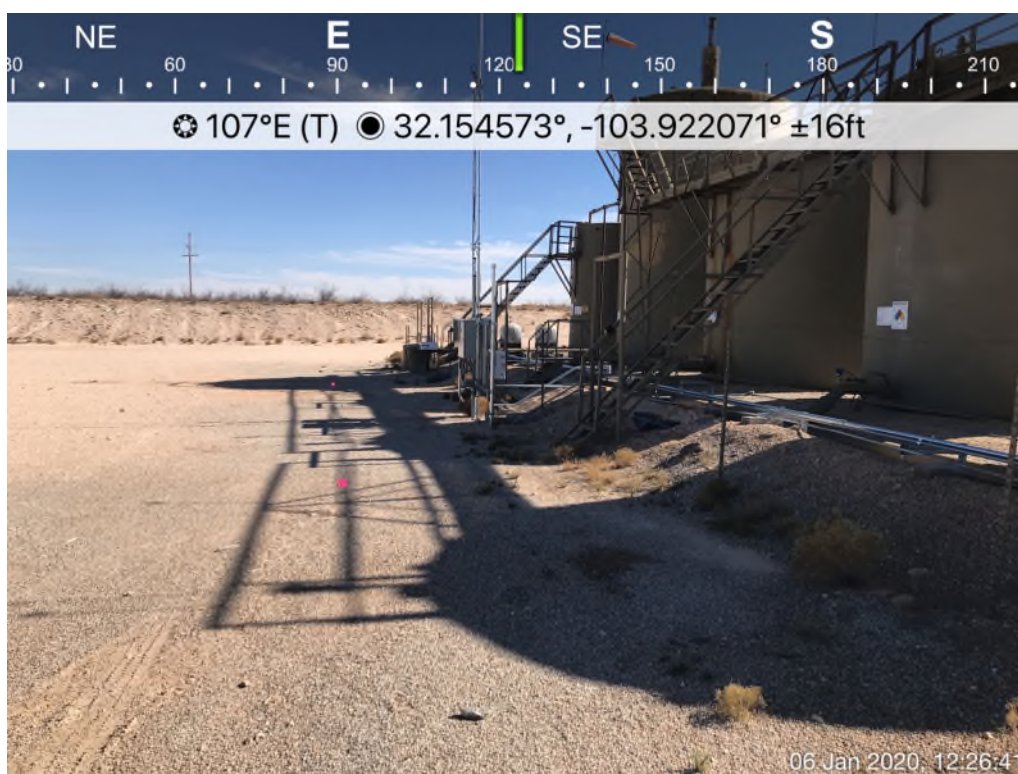
View of Release – View Southeast

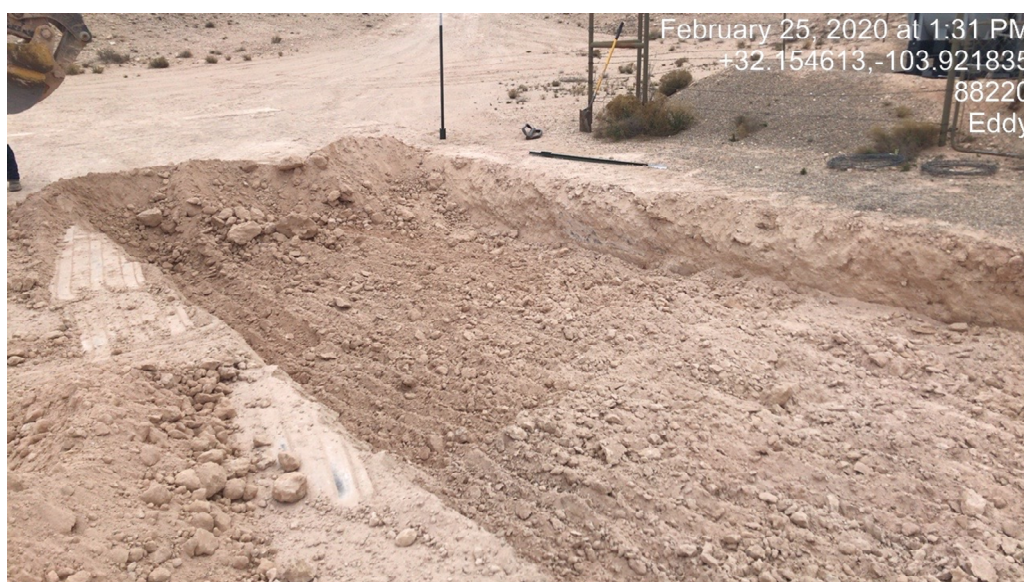
View of Remediation Activities

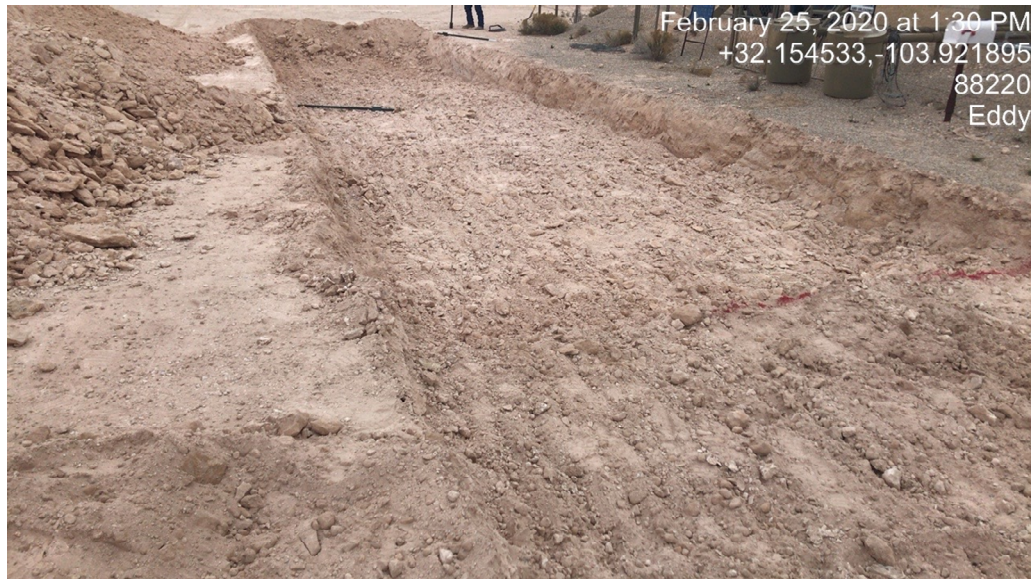
View of Remediation Activities

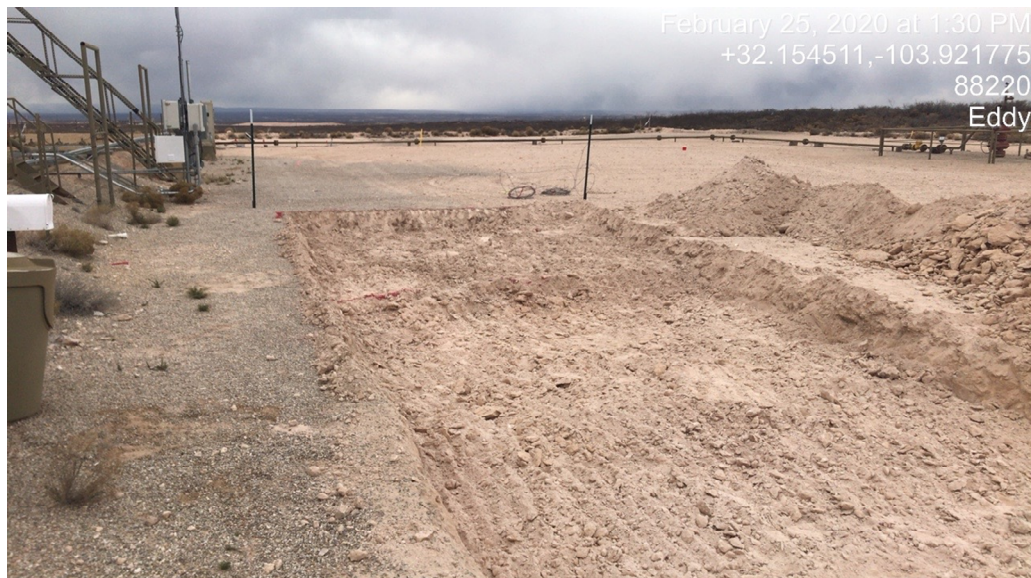
View of Remediation Activities
