**Release Notification and Corrective Action****OPERATOR**

Name of Company Roddy Production Company  
 Address P.O. Box 1222, Farmington, NM 87499  
 Facility Name Yockey #2

Site Name: <b>Yockey #2</b>	Site Type: <b>Well Site</b>
Date Release Discovered: <b>9/13/2000</b>	API# (if applicable) <b>30-045-06408</b>

## ON-SITE FORM

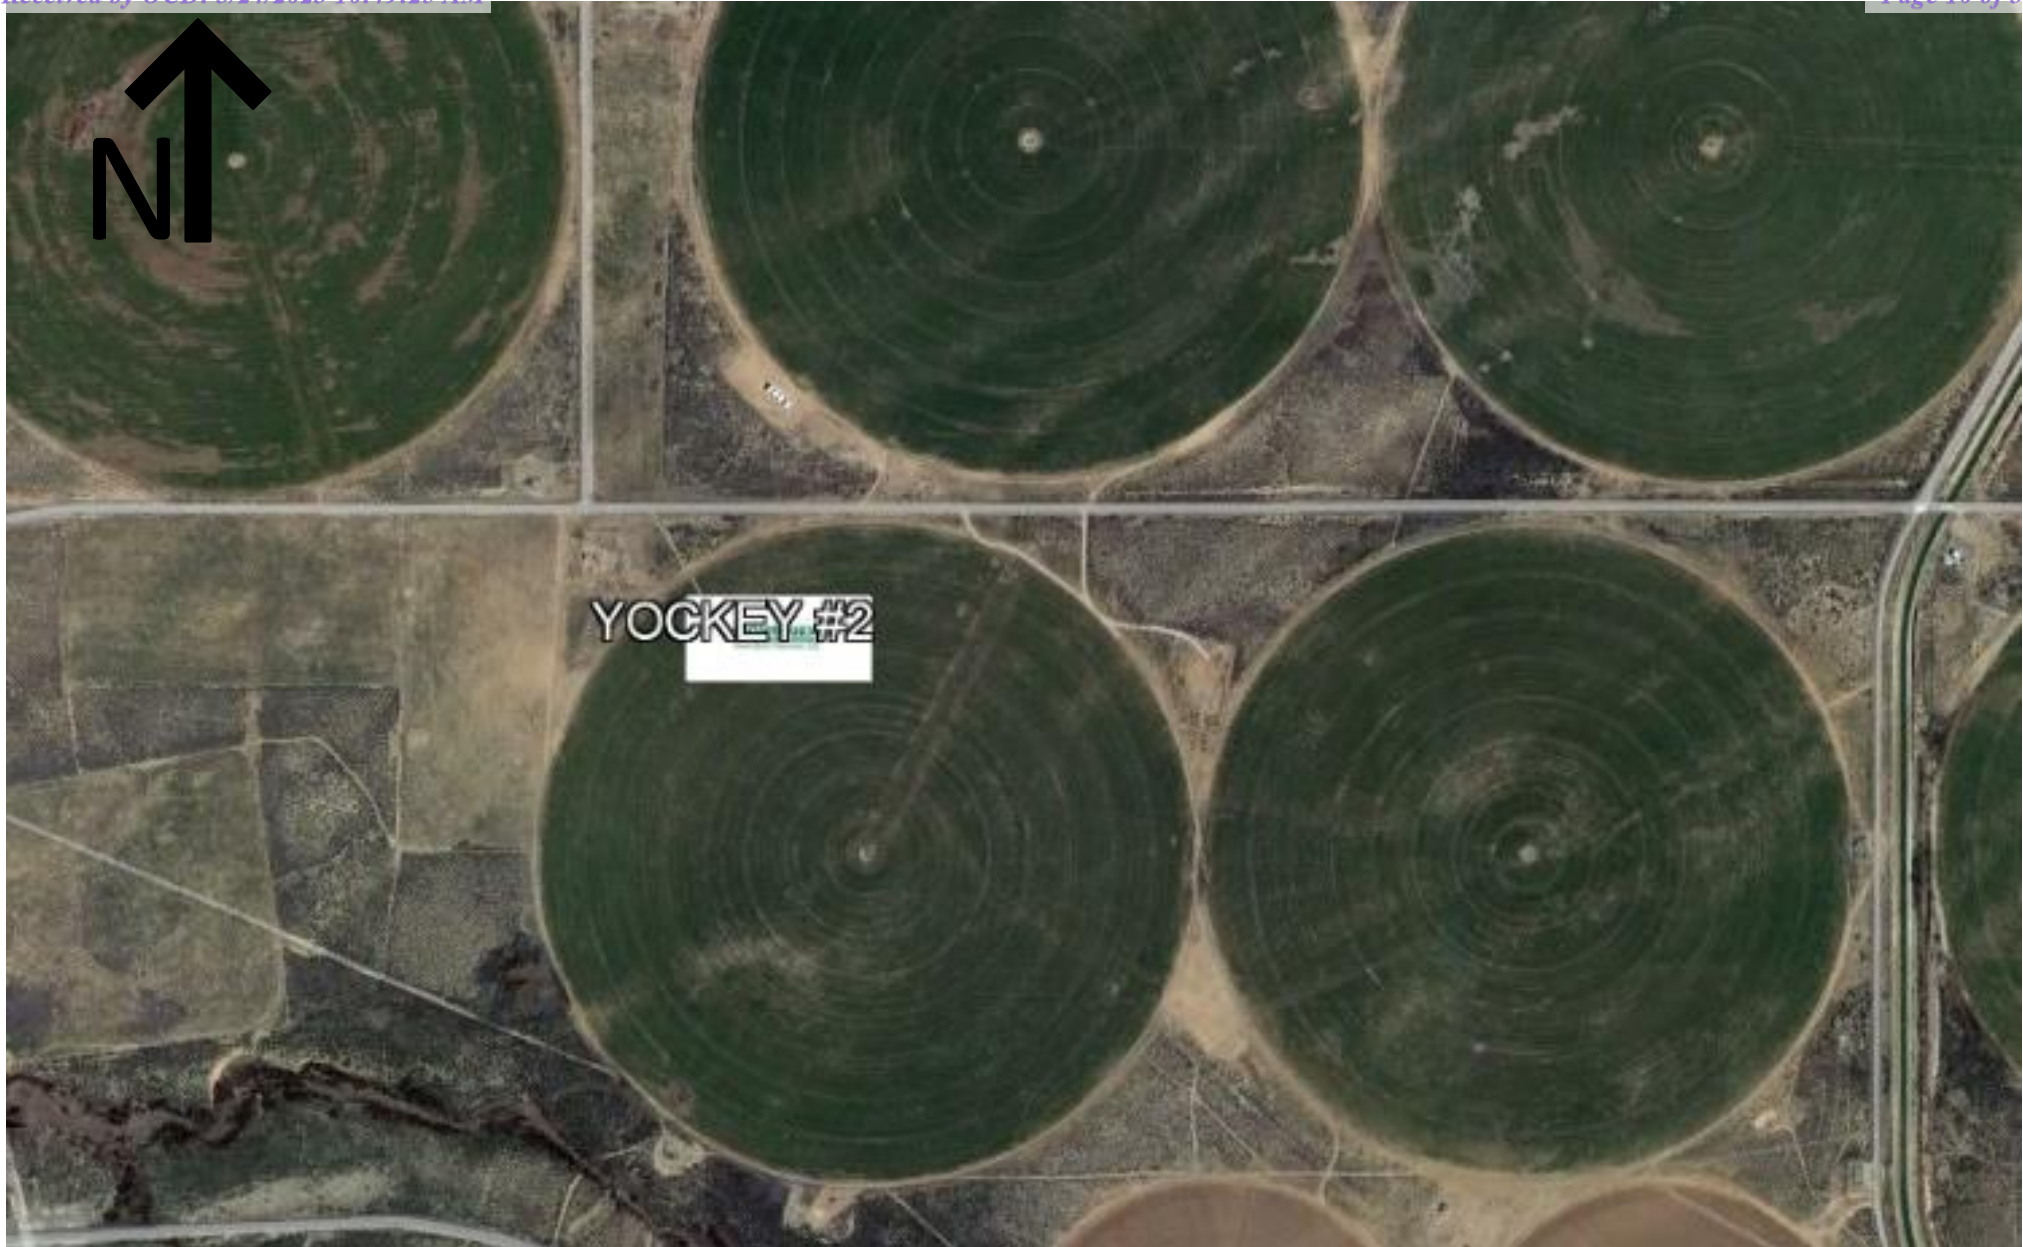
### AERIAL MAP

Company: **Roddy Production**  
Well Name: **Yockey #2**  
API: **30-045-06408**  
Sec **20**, Twn **27N**, Rge **11W**  
San Juan County, New Mexico  
Lease: **NM-020496**  
Lat: **36.563934** Long: **-108.031242**

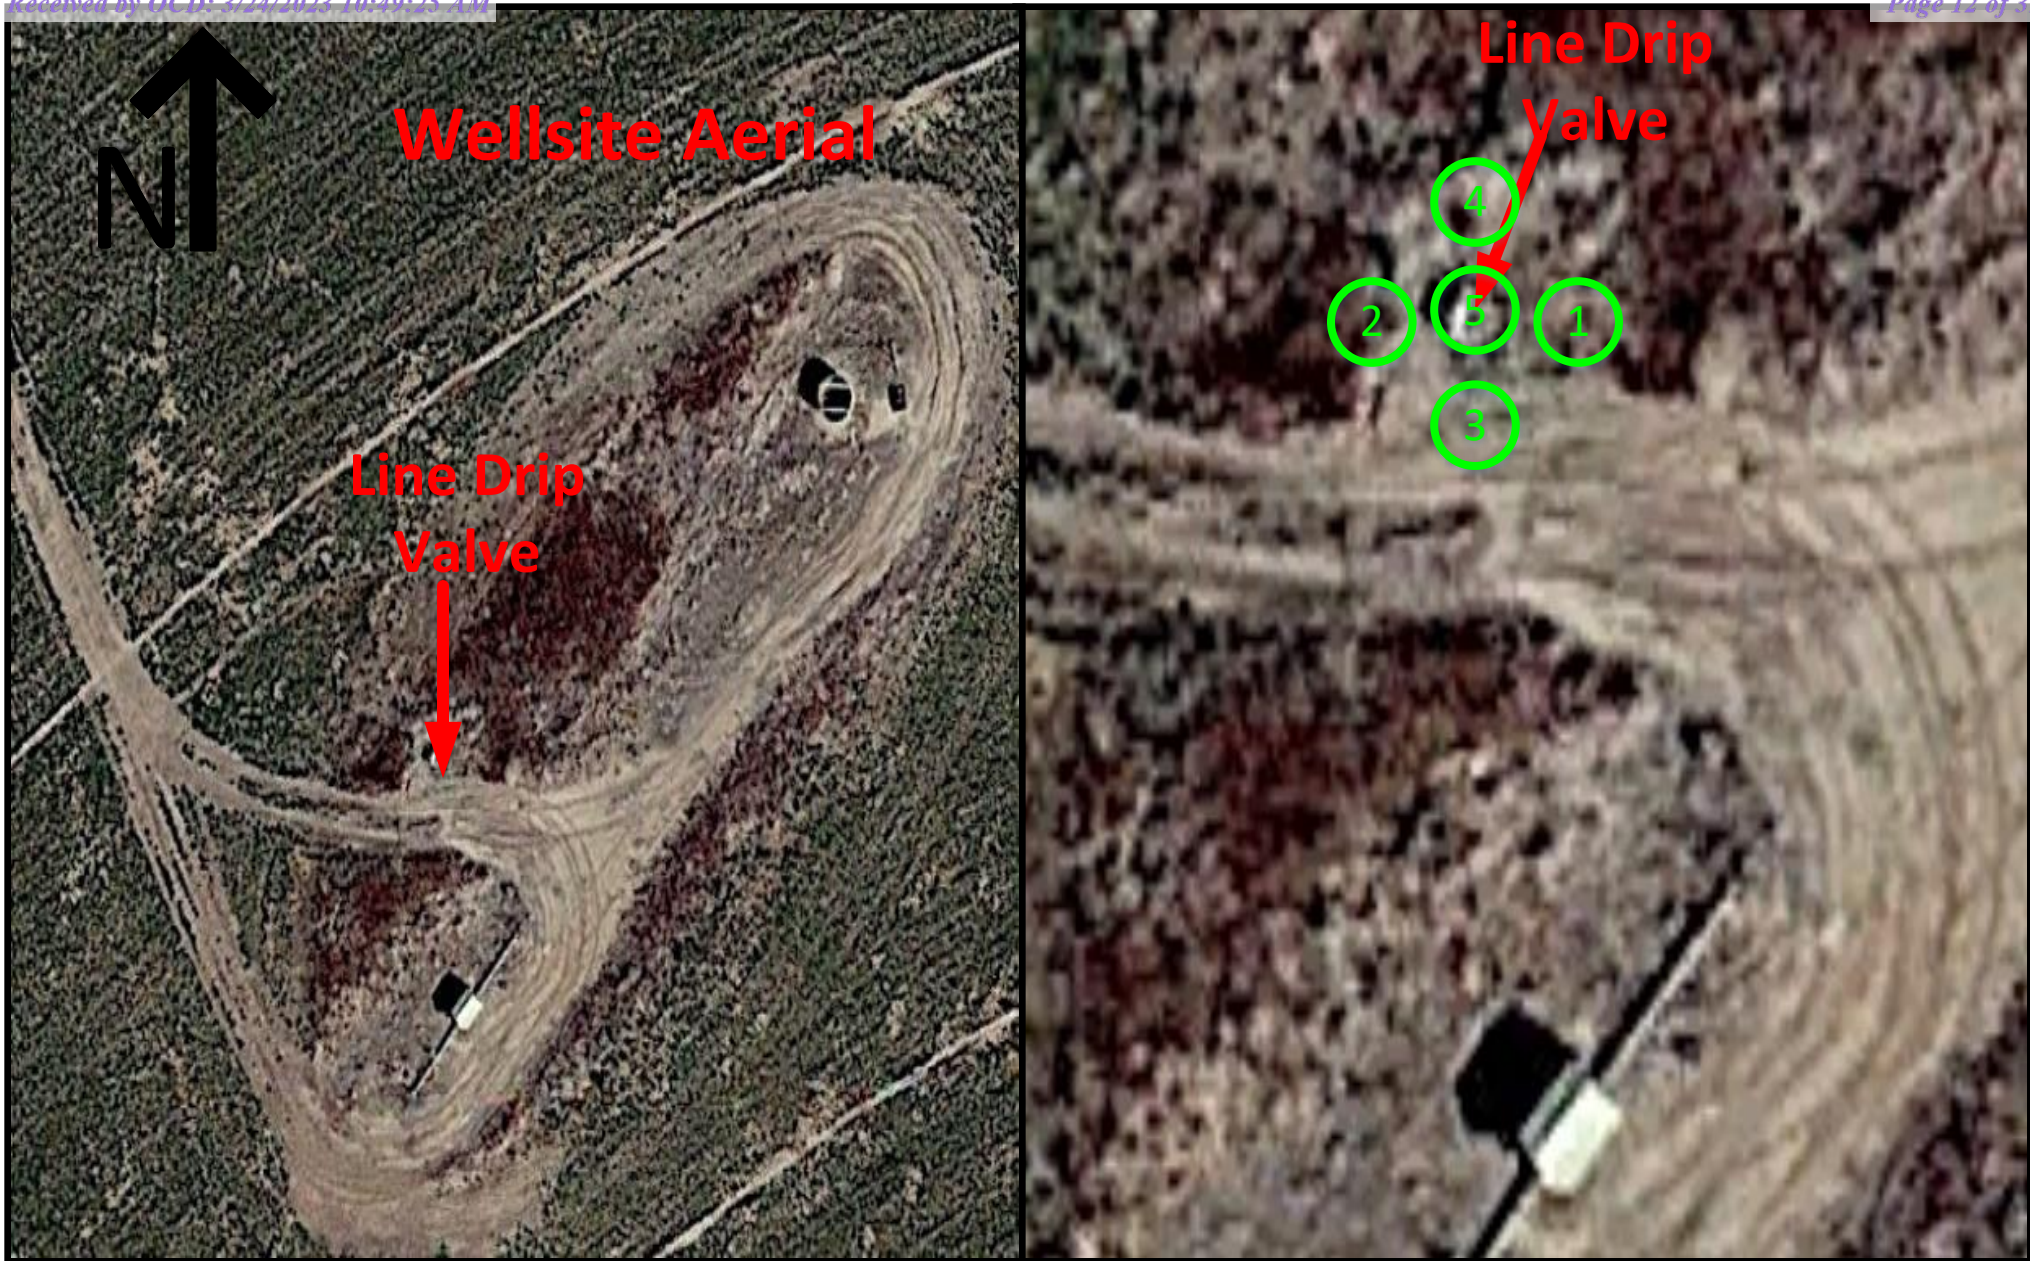
### SAMPLING MAP

Time	Sample #	Sample Description	Characteristics	OVM (ppm)	Analysis Requested
	NA	100 Standard	NA	—	NA
7:00 AM	1	BH #1 @ 6"	Brown sandy loam, no odor	—	8015, 8021, CI
7:30 AM	2	BH #2 @ 6"	↓	—	↓
7:40 AM	3	BH #3 @ 6"		—	
7:50 AM	4	BH #4 @ 6"		—	
7:10 AM	5	BH #5 @ 1.5'		—

① Borehole Locations

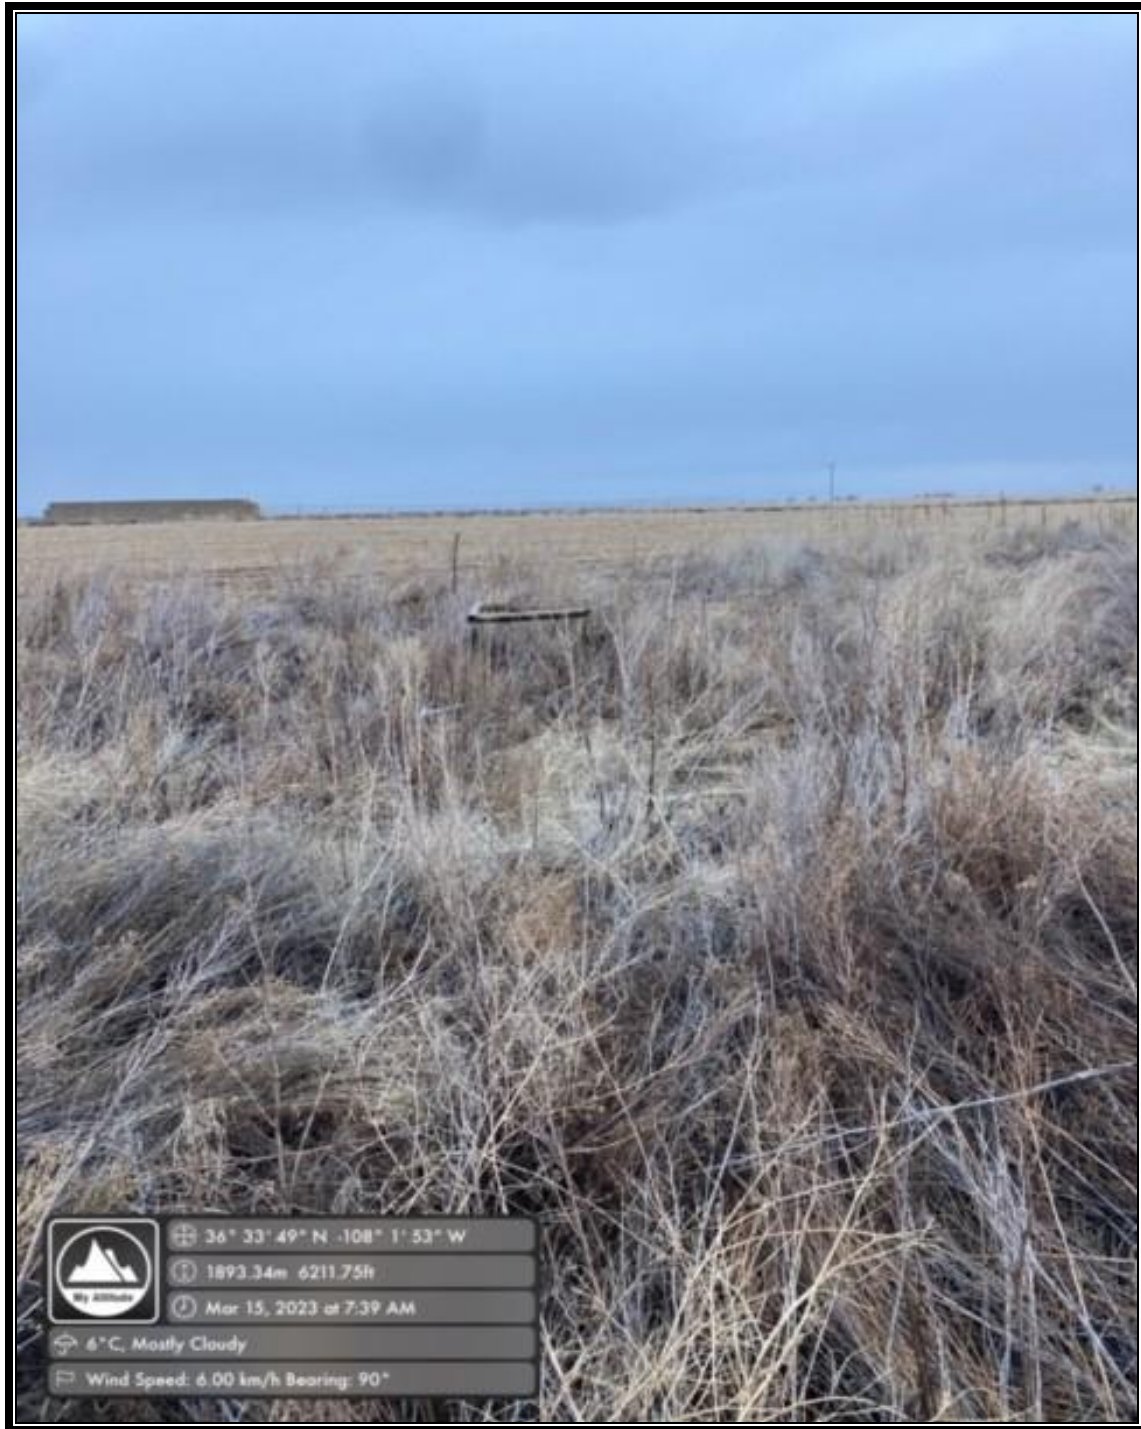
Photo 2: Line Drip Surface Valve

**Key truck ran over line drip riser on the Yockey #2. A small amount of condensate was released onto the surface but evaporated. The broken valve was replaced, and a steel barricade was erected to prevent the incident from occurring again in the future. Verification samples were collected on 3/15/2023.**

A damaged above ground line drip riser was discovered at this location on 9/13/2000. A water truck had struck the riser causing the damage. A small amount of condensate was discovered on the surface but evaporated. The riser was repaired, and a barricade was installed to prevent future incidents.
