Mr. Bradford Billings  
New Mexico Oil Conservation Division  
1220 S St Francis Dr # 3,  
Santa Fe, NM 87505**RE: Request for Closure  
WPX Energy Permian, Inc.  
Remediation Permit Number 2RP-3676  
Longview Federal 12-4H  
Eddy County, New Mexico**

LT Environmental, Inc. (LTE), on behalf of WPX Energy Permian, Inc. (WPX), is pleased to present the following letter report detailing characterization soil sampling activities at the Longview Federal 12-4H well pad (Site) located in Unit A, Section 12, Township 23 South, Range 28 East, Eddy County, New Mexico, as depicted on Figure 1. Soil sampling activities were conducted in response to a release of approximately 30 barrels (bbls) of produced water due to an equipment malfunction on the tank battery. The release was discovered on May 4, 2016. Approximately 28 bbls of produced water were recovered using a vacuum truck. The release affected approximately 1,600 square feet of the well pad surface. The release footprint was mapped, and the impacted soil was excavated and transported off site for disposal. WPX reported the release to the New Mexico Oil Conservation Division (NMOCD) on a Release Notification and Corrective Action Form C

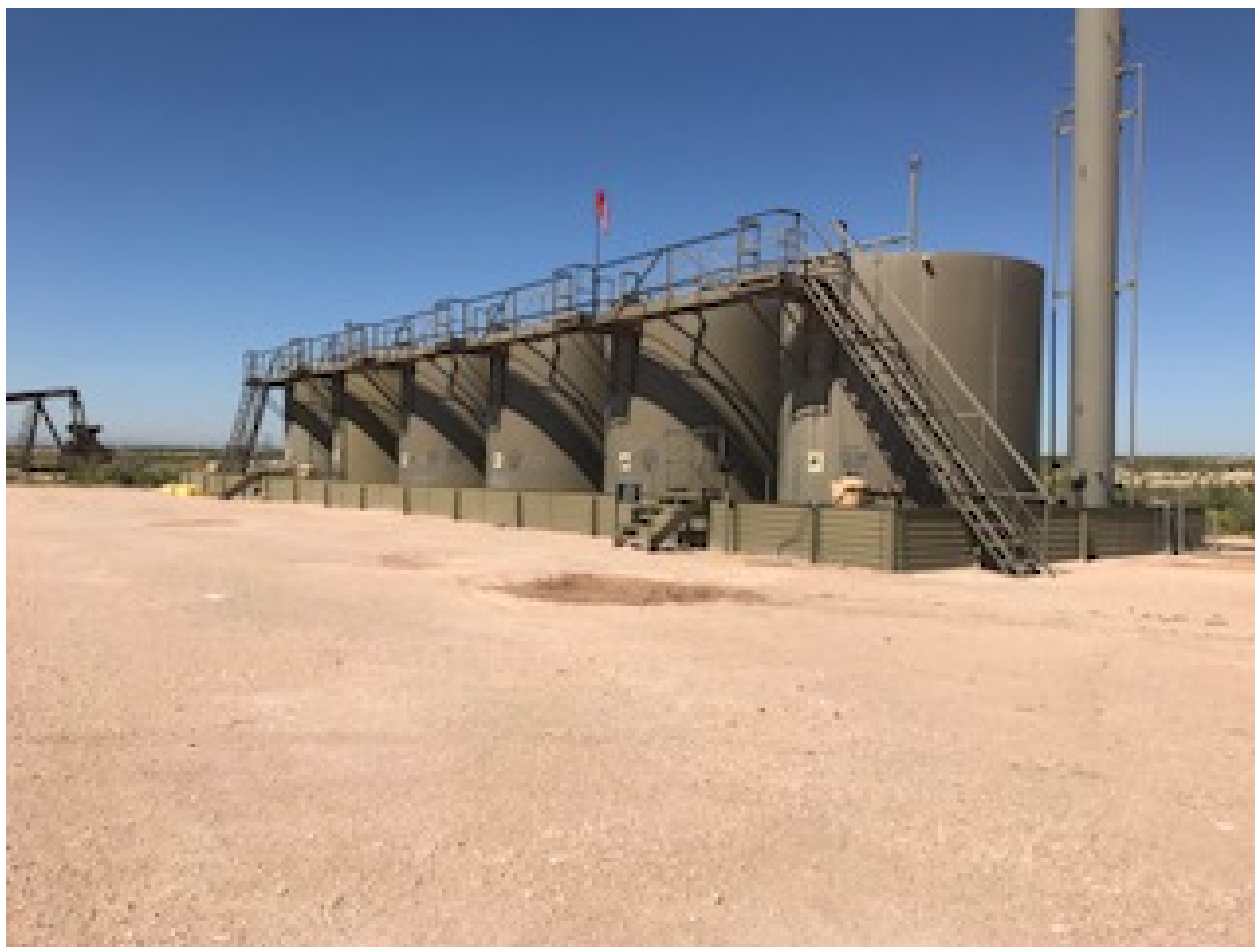
**Release footprint on pad surface before excavation– view northwest.**

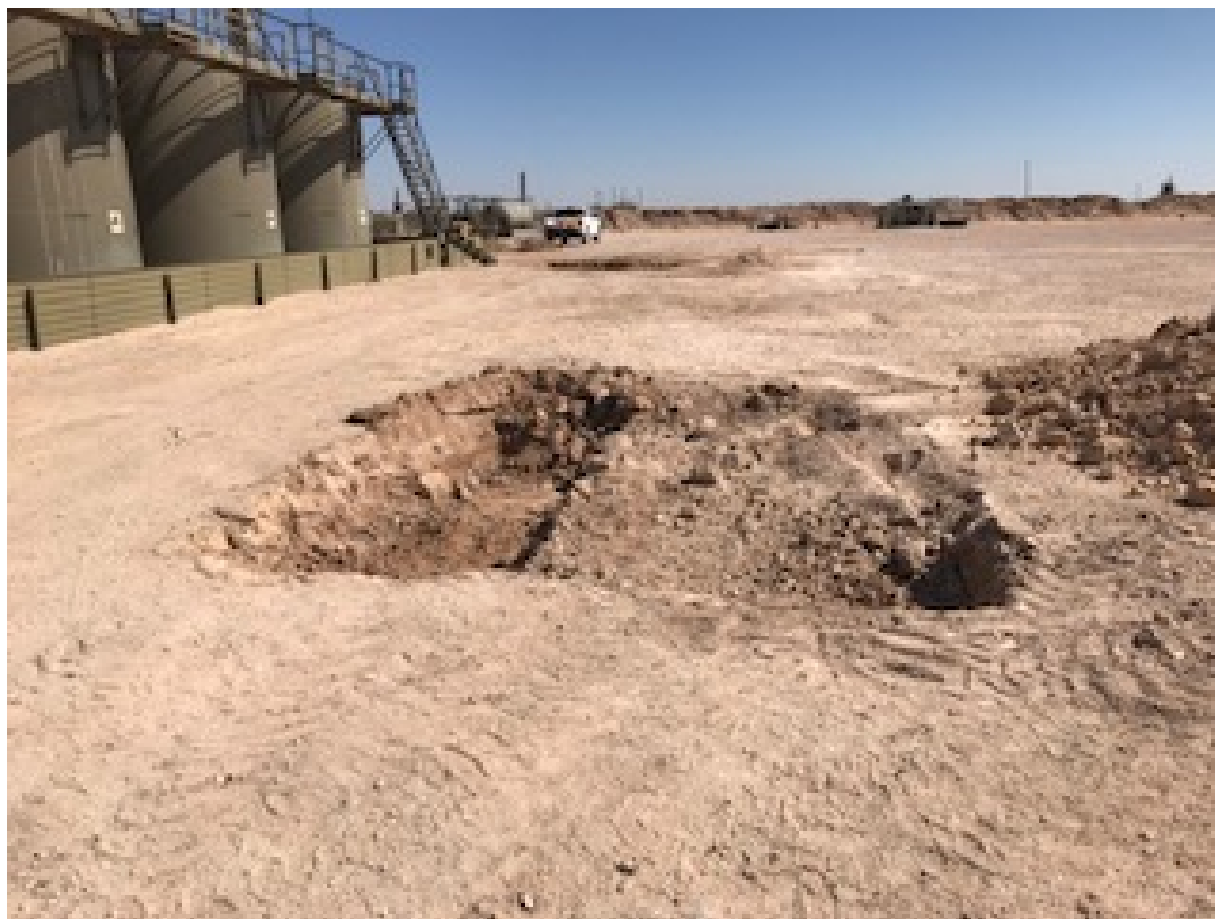
**Excavation in area of SS01 – view northeast**

On March 5, 2019, LTE directed excavation activities to address TPH concentrations in soil sample locations SS01 and SS02. The excavation in the area of SS01 measured approximately 238 square feet in area and 1.5 feet bgs in depth. The excavation in the area of SS02 measured approximately 210 square feet in area and 2.0 feet bgs in depth.

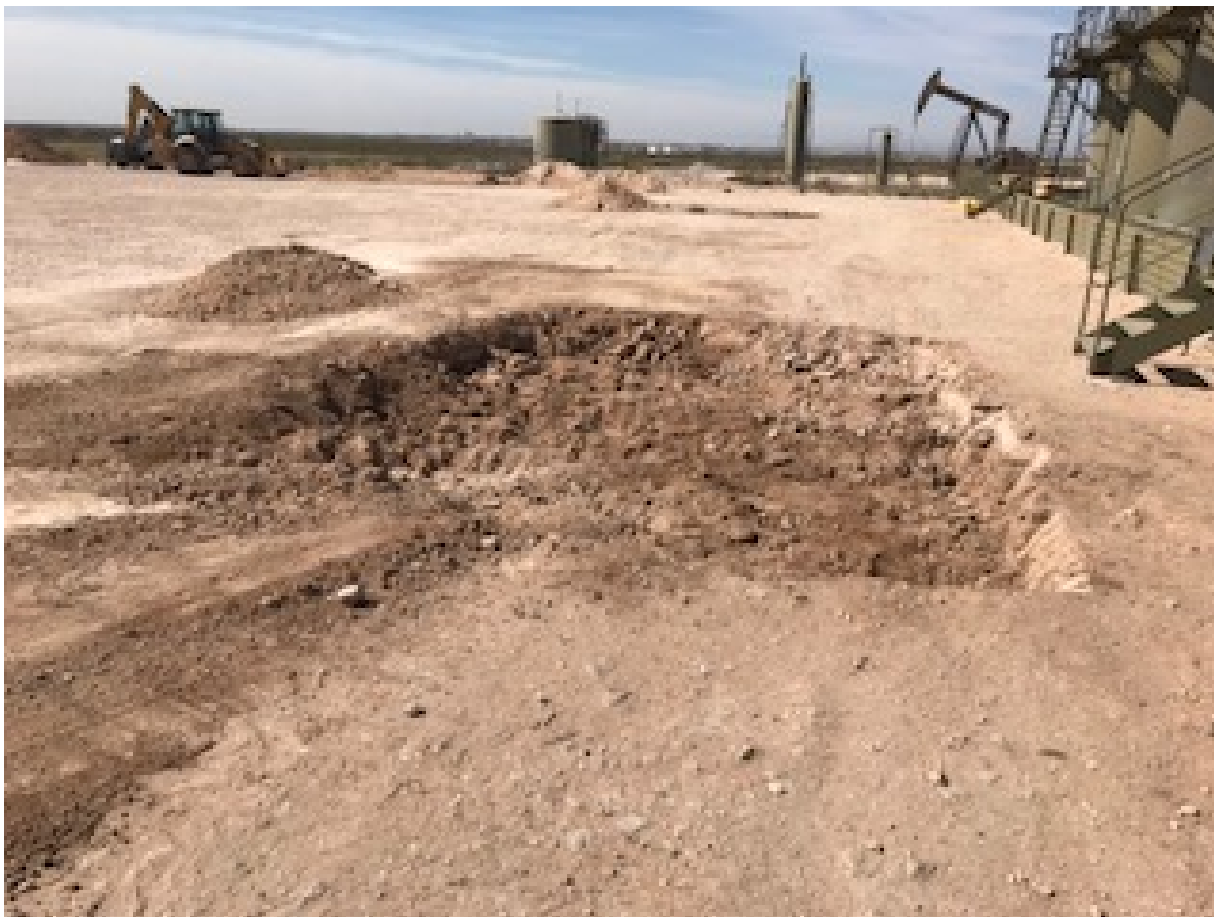
**Excavation in area of SS02 – view west**

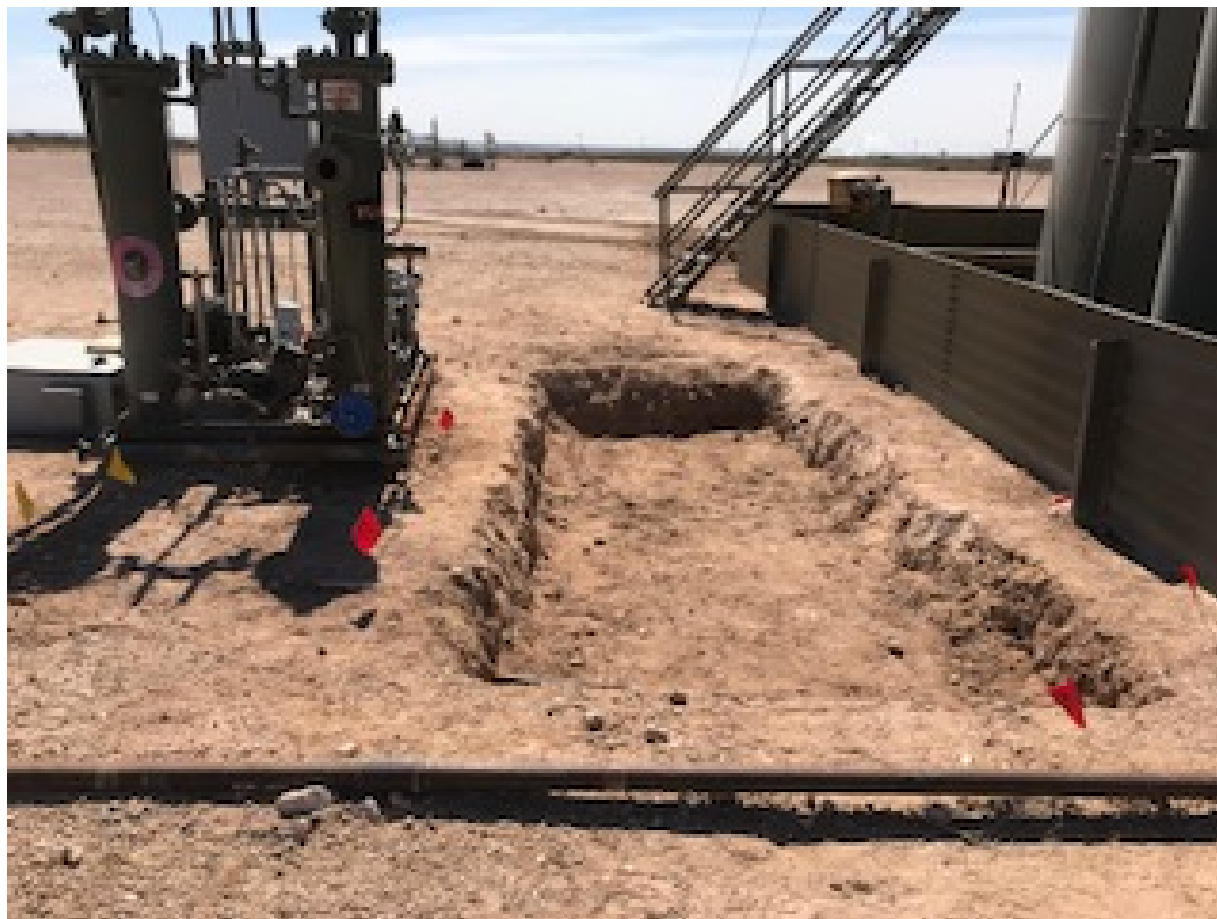
Excavation in area of SS03 – view south

On April 26, 2019, LTE directed excavation activities to address TPH concentrations in soil sample locations SS03 and SS04. The excavation in the area of SS03 measured approximately 290 square feet in area and 3.0 feet bgs in depth. The excavation in the area of SS04 measured approximately 165 square feet in area and 2.5 feet bgs in depth.

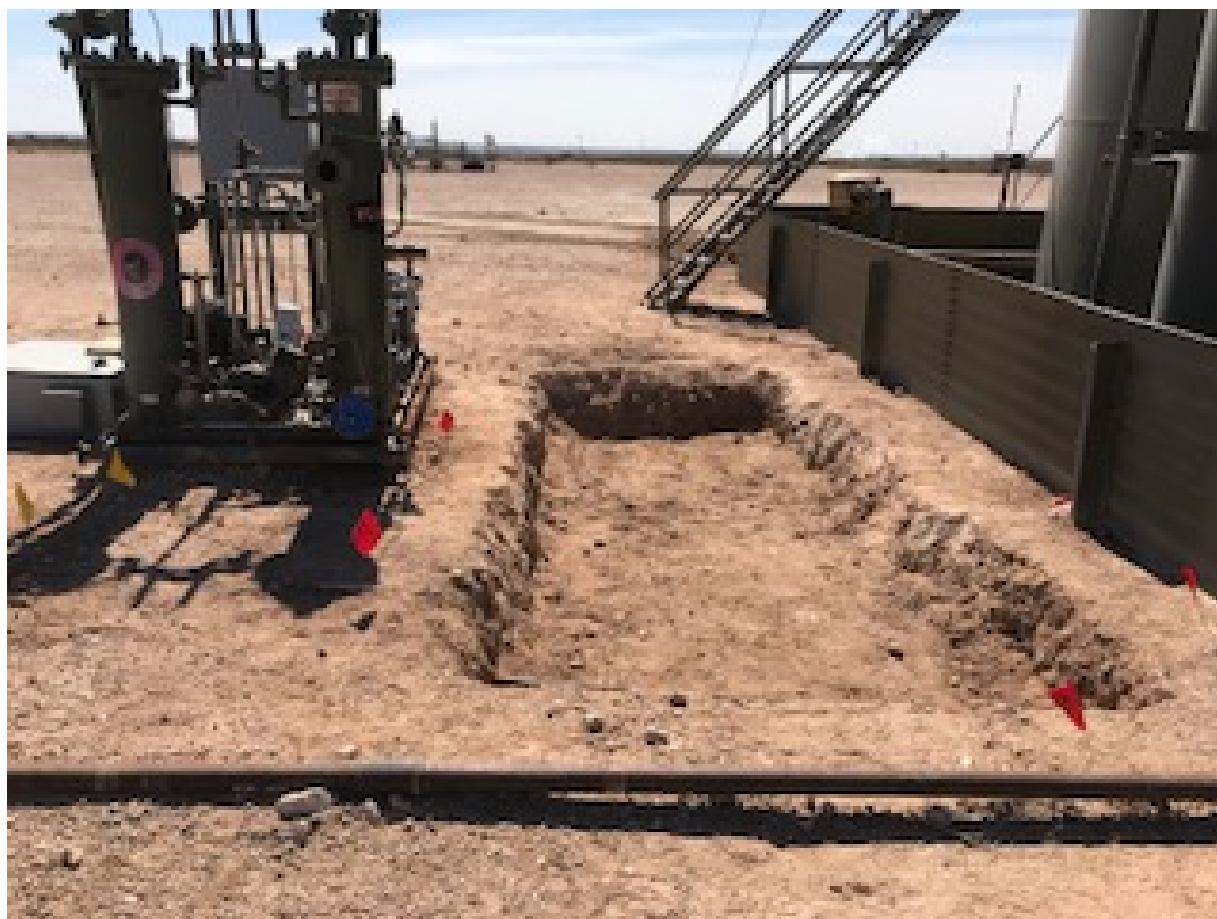
Excavation in area of SS03 – view south
