Release Notification and Corrective Action

| Facility Name | Darr Angell #1 | Facility Type | Groundwater Remediation Site |

Darr Angell No. 1  
Lea County, New Mexico  
NMOCD 1RP-4796

Plains All American  
Pipeline, L.P.

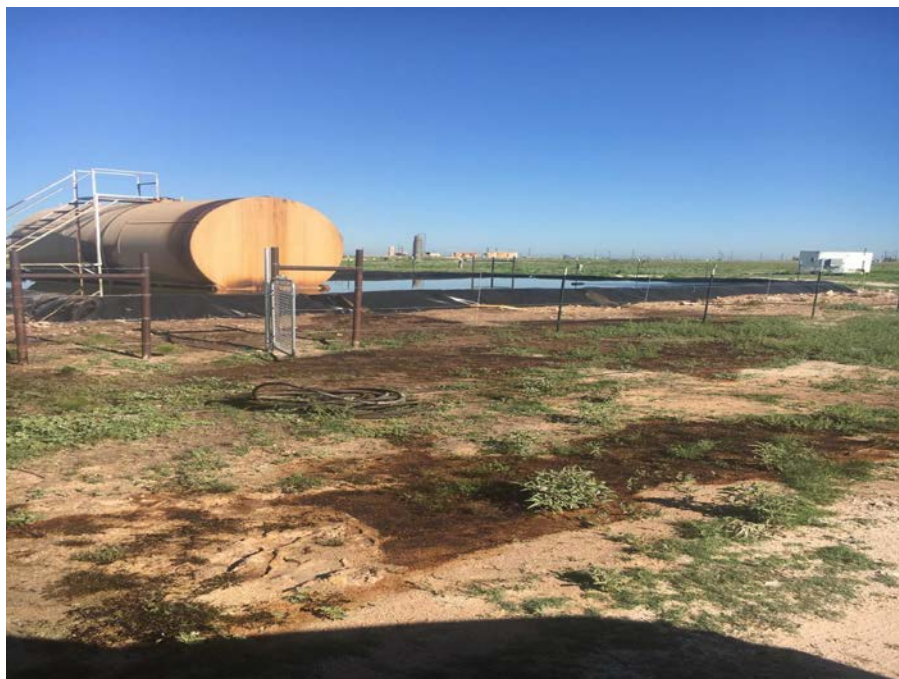
Photo 1 – View of stained and impacted soil east of containment facing northwest

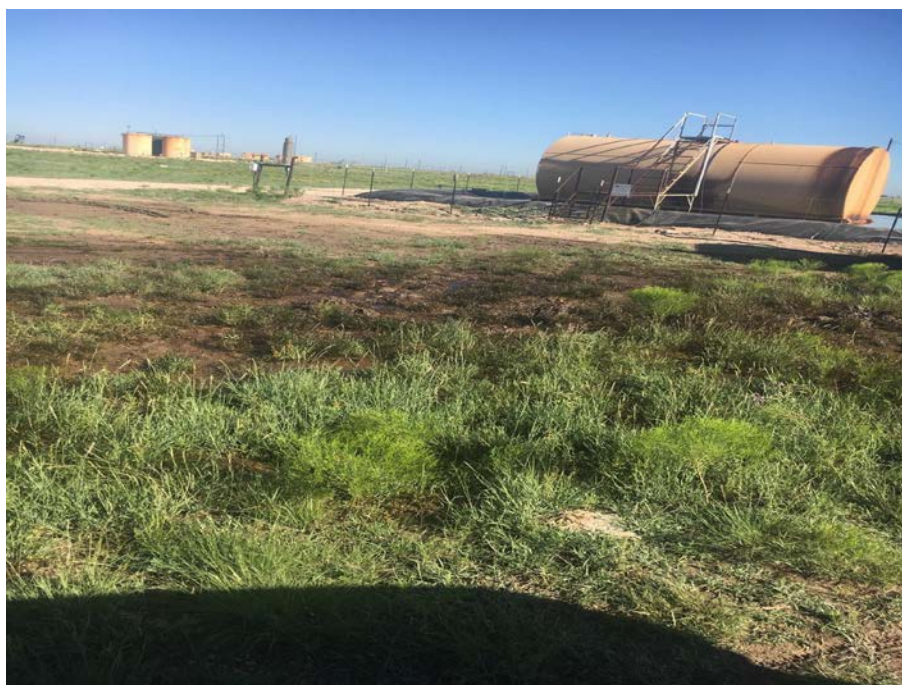
Photo 2 – View of stained and impacted soil south of containment facing northwest

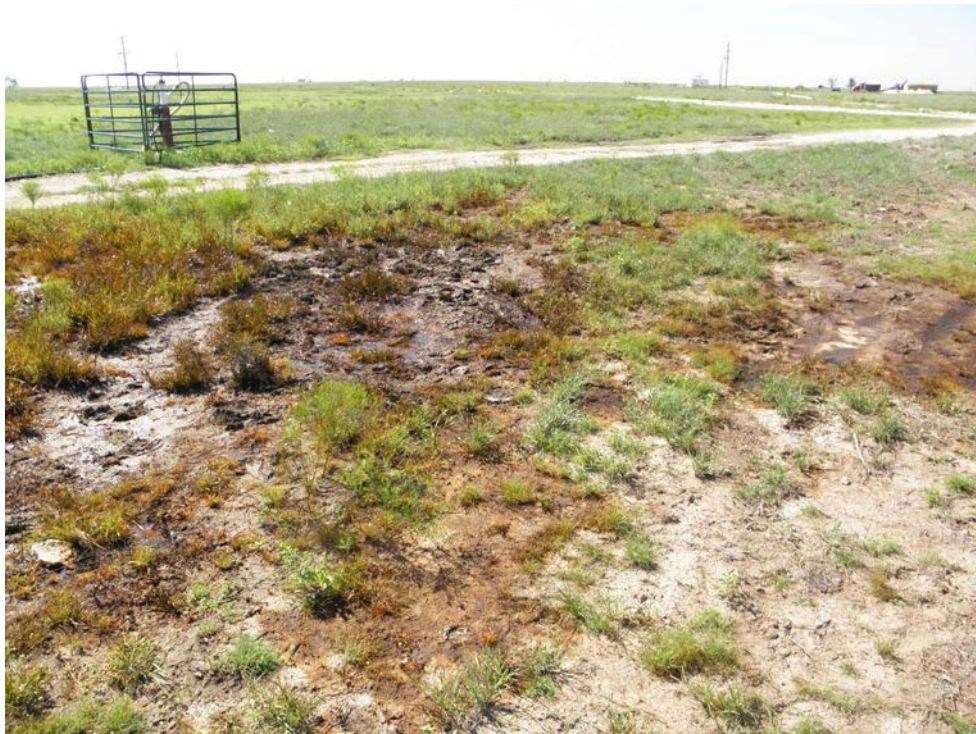
Photo 3 – View of stained and impacted soil south of compressor building facing south

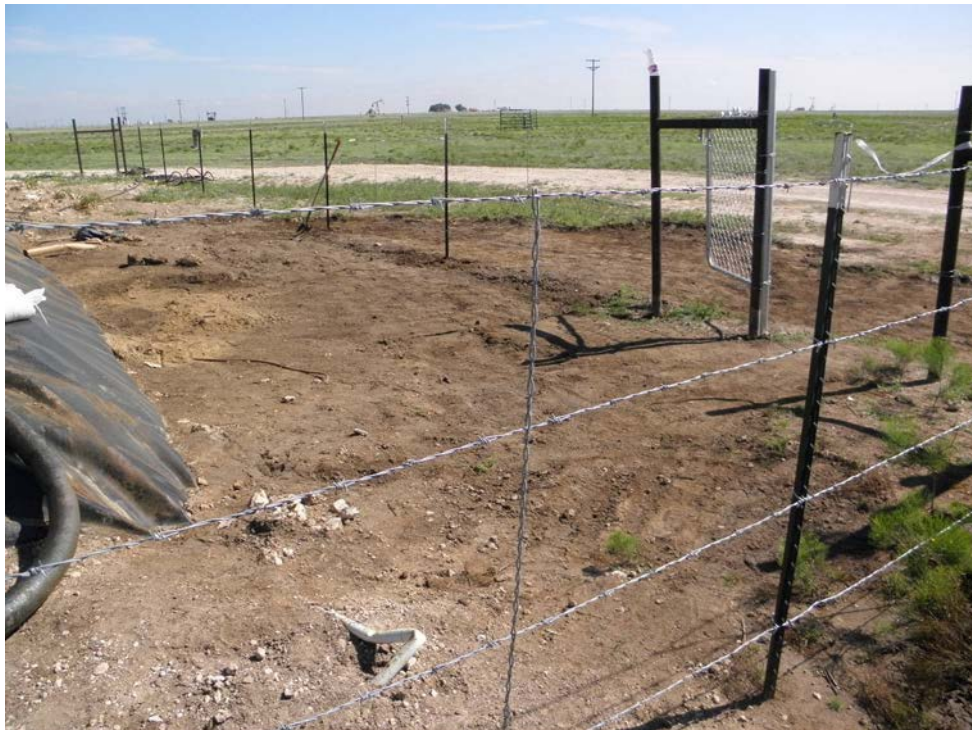
Photo 4 – View of impacted soil remediation activity facing north-northeast

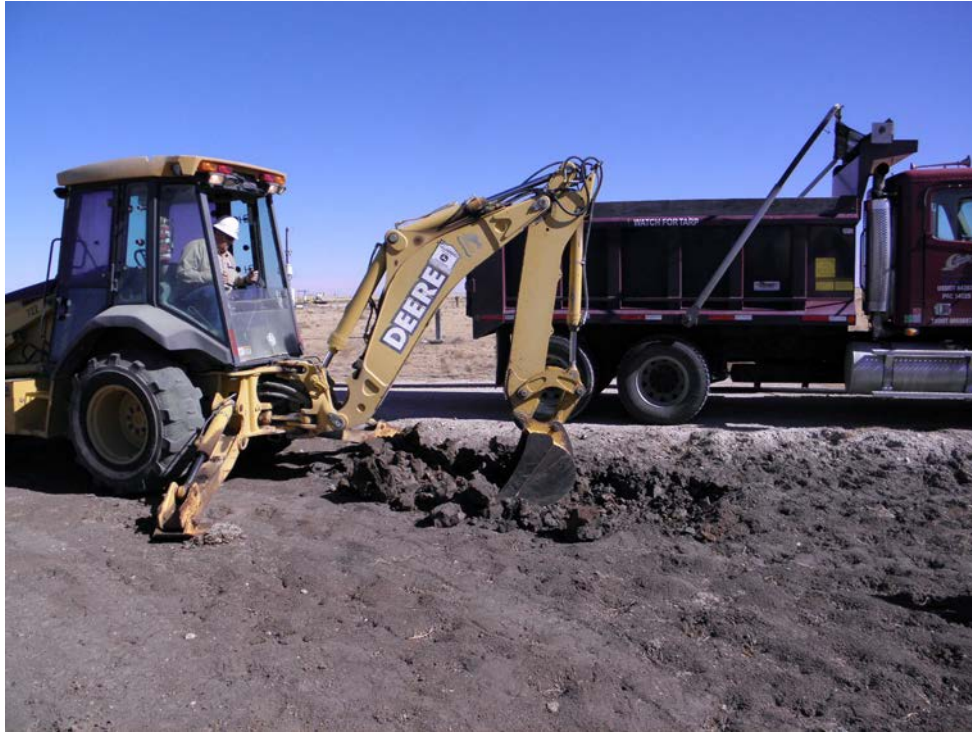
Photo 5 – View of impacted soil being excavated facing east

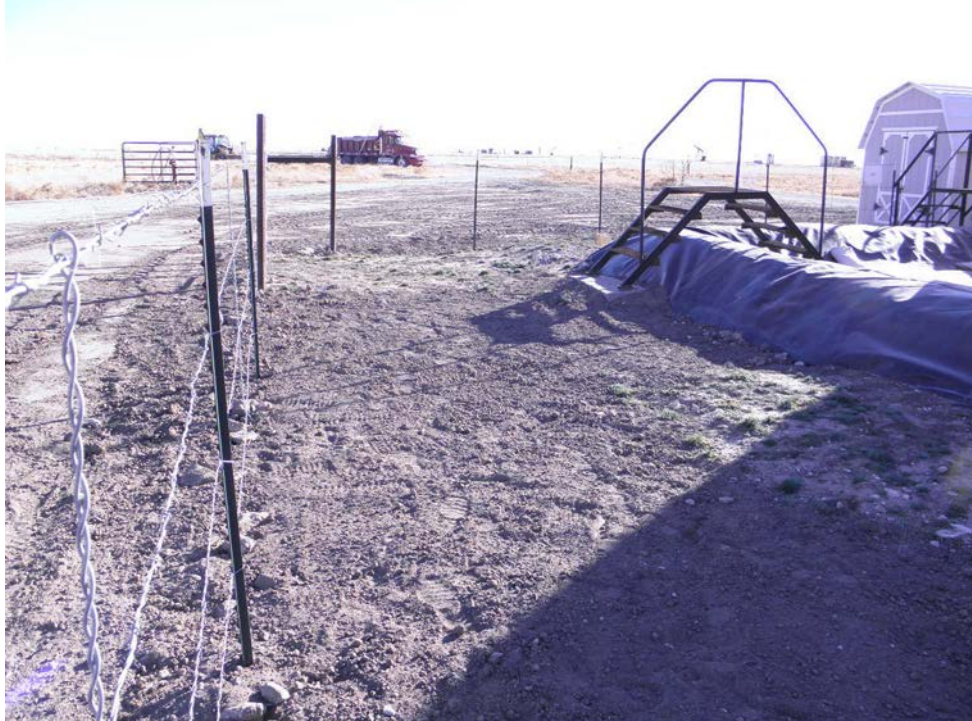
Photo 6 – View of backfilled hand dug area east of AST facing south

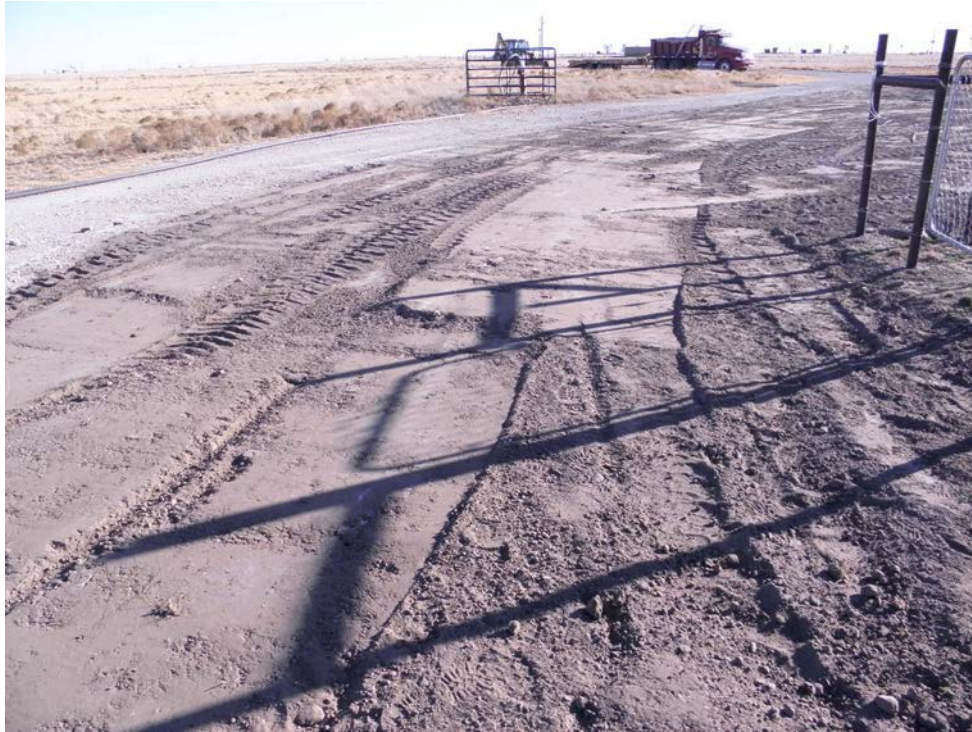
Photo 7 – View of backfilled excavated area southeast of AST fencing facing south

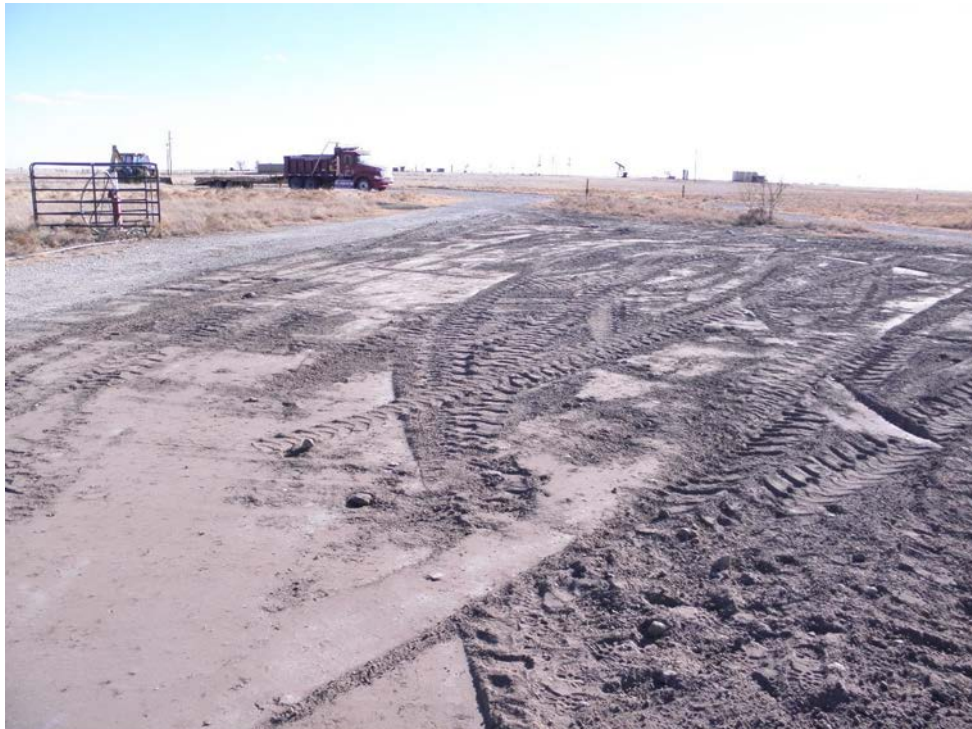
Photo 8 – View of backfilled excavated area south of AST facing south
