## Release Notification

**Re: Closure Request  
James Ranch Unit 106  
Incident Number NAPP2212344322  
Eddy County, New Mexico**

James Ranch Unit 106  
 XTO ENERGY, INC  
 Incident Number: nAPP2212344322  
 Unit K Sec 36 T22S R30E  
 Eddy County, New Mexico

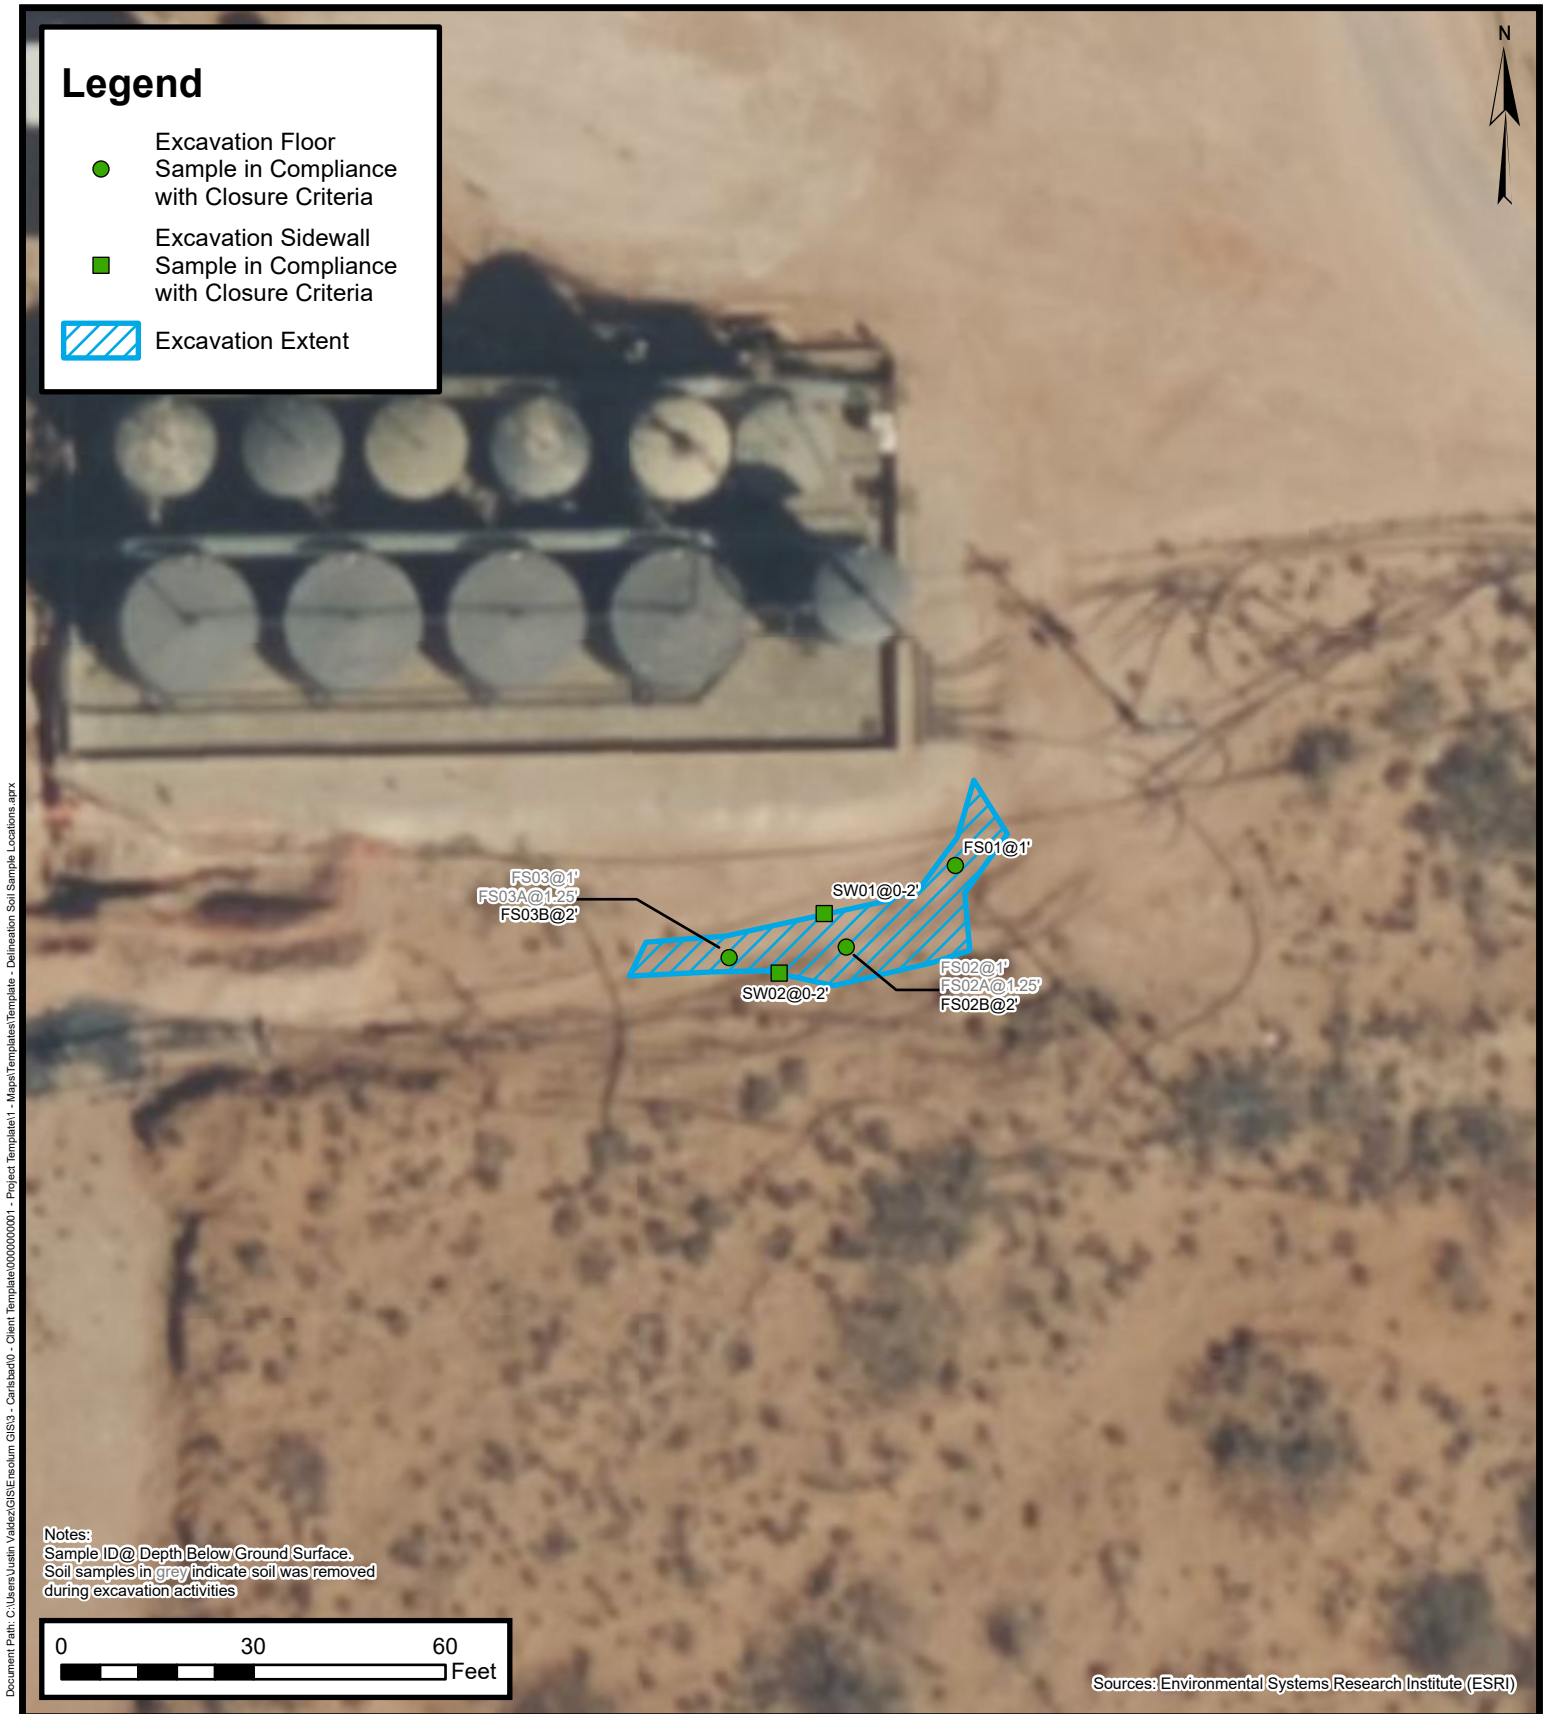
FIGURE  
 1

## Excavation Soil Sample Locations

Following removal of the impacted soil, 5-point composite soil samples were collected at least every 200 square feet from the floor of the excavation. The 5-point composite samples were collected by placing five equivalent aliquots of soil into a 1-gallon, resealable plastic bag and homogenizing the samples by thoroughly mixing. Composite floor samples FS02B and FS03B were collected from the floor of the excavation at a depth of 2 feet bgs. Composite sidewall samples SW01 and SW02 were collected from depths ranging from ground surface to 2 feet bgs. The confirmation soil samples were placed directly into pre-cleaned glass jars, labeled with the location, date, time, sampler name, method of analysis, and immediately placed on ice. The soil samples were transported under strict chain-of-custody procedures to Eurofins Laboratories (Eurofins) in Carlsbad, New Mexico, for analysis of the following contaminants of concern (COC) BTEX following United States Environmental Protection Agency (EPA) Method 8021B; TPH- GRO, TPH- DRO, and TPH-oil range organics (ORO) following EPA Method 8015M/D; and chloride following EPA Method 300.0. The excavation extent and excavation soil sample locations are presented on Figure 1.

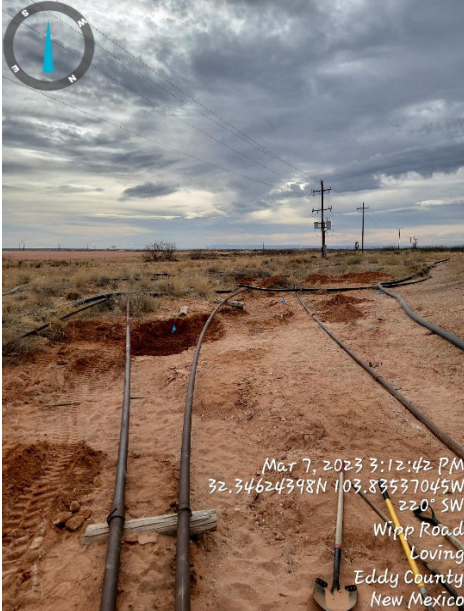
Photograph 1

Description: Ongoing excavation facing southwest

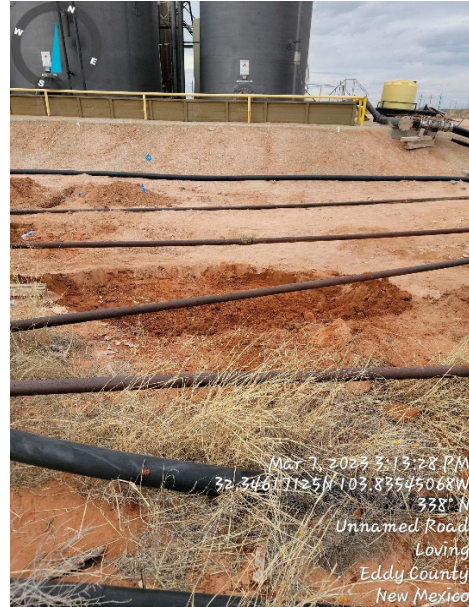
Photograph 2

Description: Ongoing excavation facing north

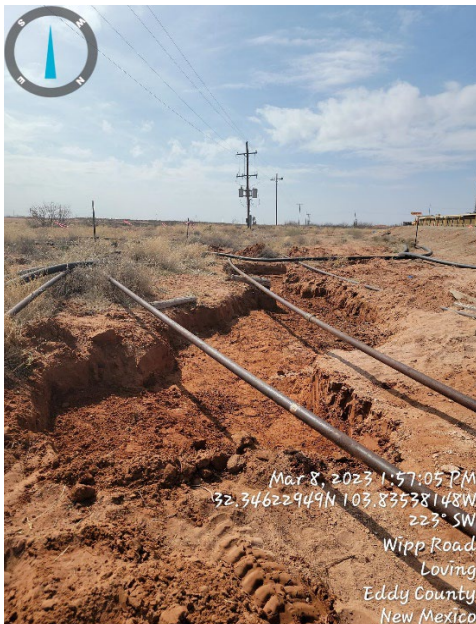
Photograph 3

Description: Final excavation facing southwest

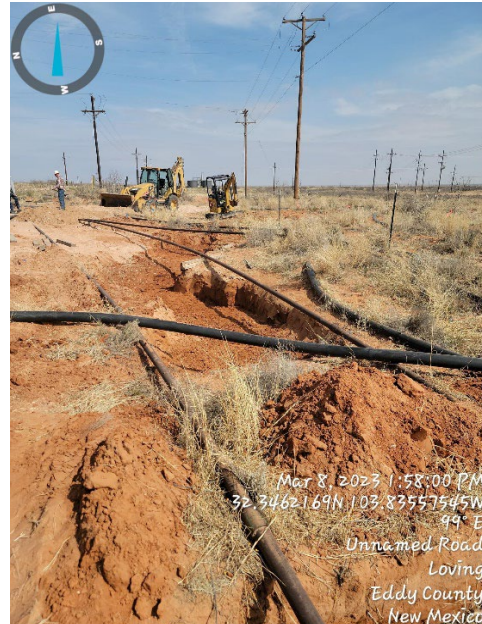
Photograph 4

Description: Final excavation facing east
