Remediation Summary and Closure Request

Frontier Field Services, LLC

6" Sand Tank Line

NMOCD Incident # nAPP2229740011

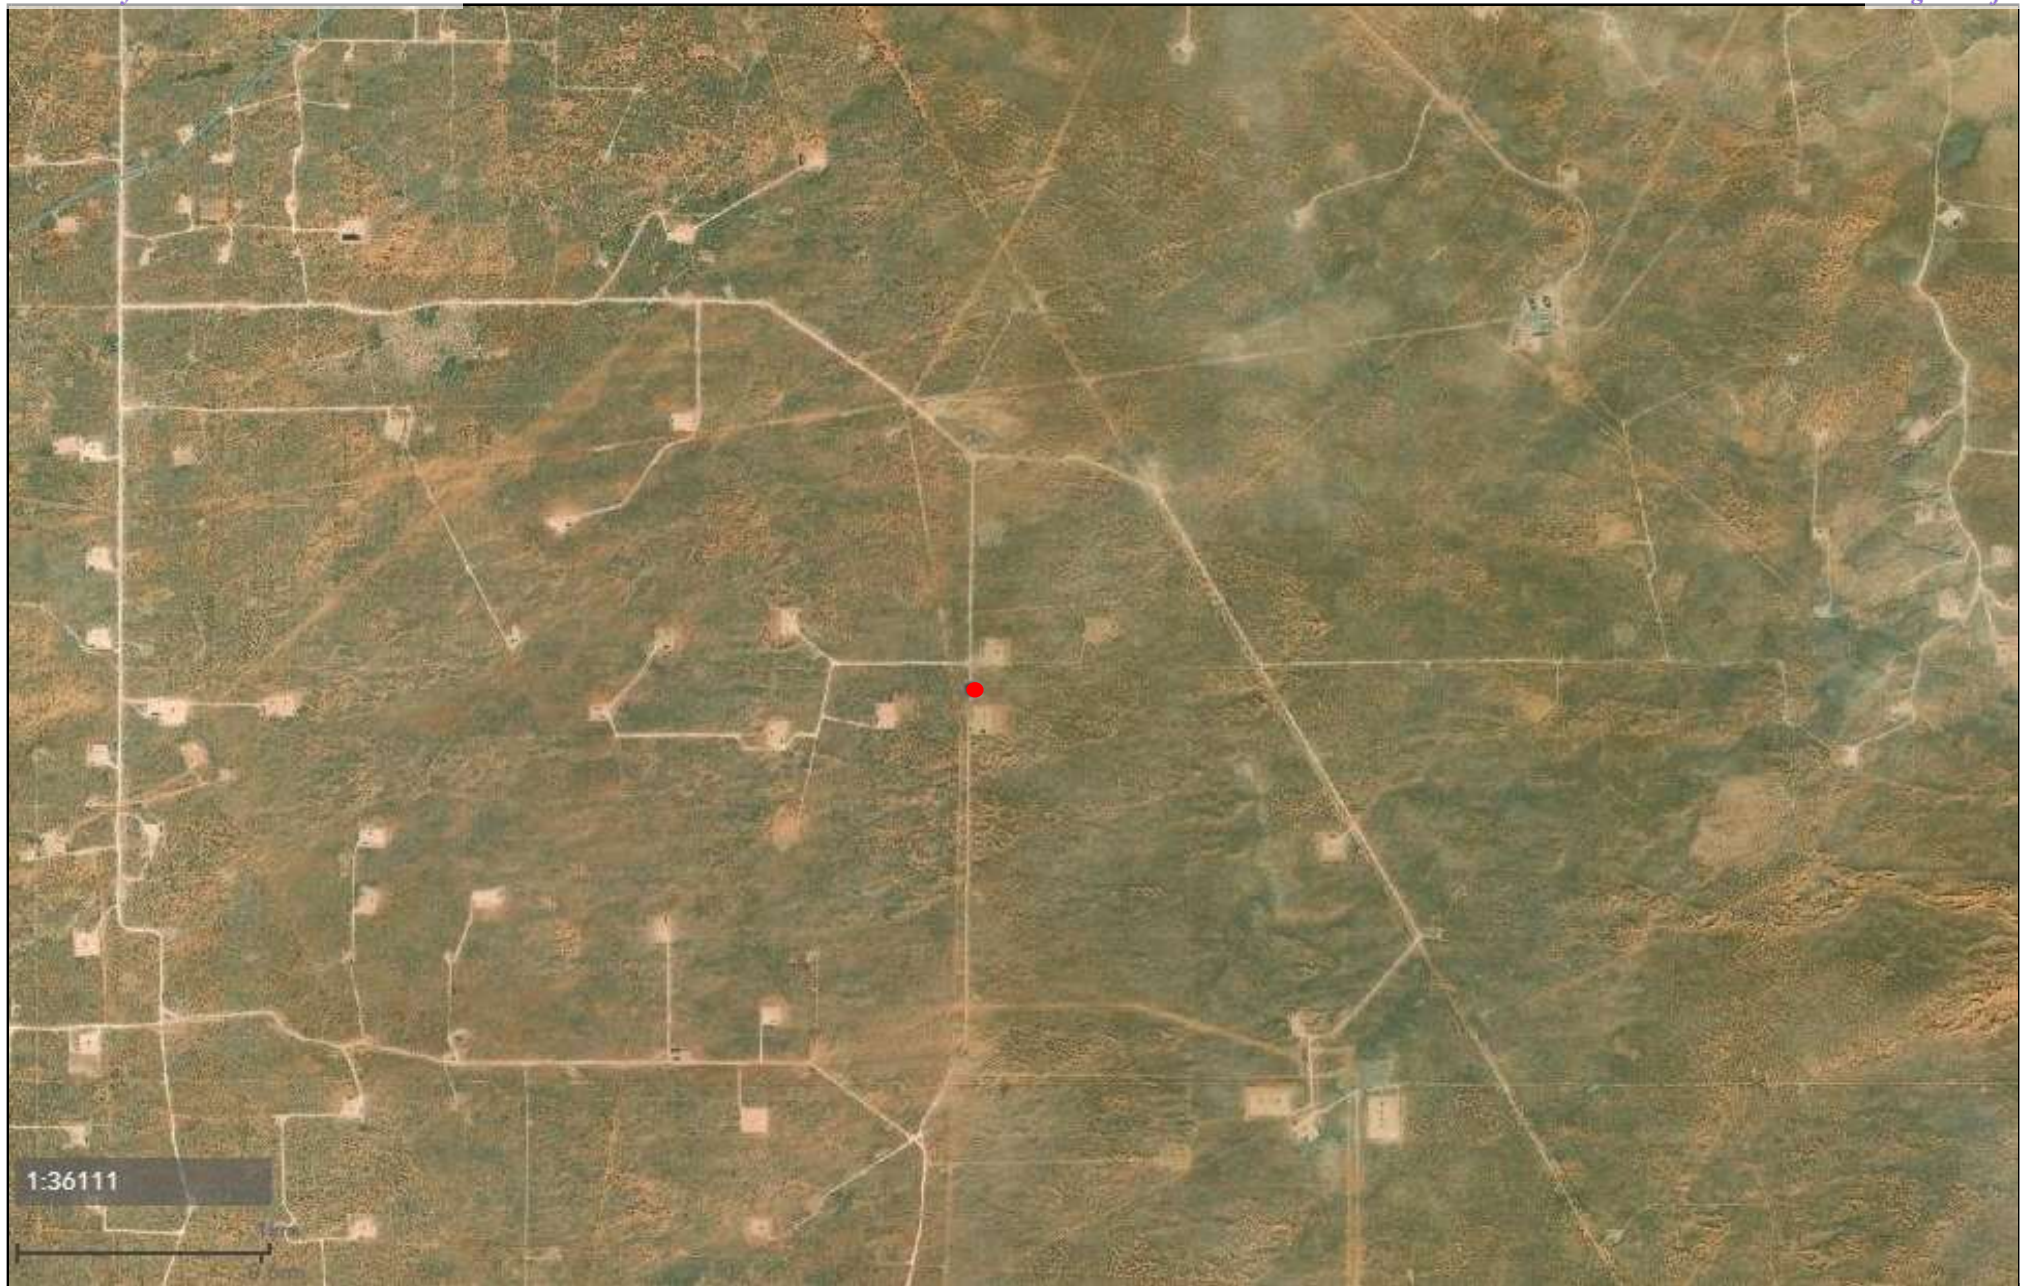
**Figure 2**

A search of the New Mexico Office of the State Engineer (NMOSE) and United States Geological Survey (USGS) groundwater databases was completed in an effort to determine the horizontal distance to known water sources within a half mile radius of the Release Site. Approximate depth to groundwater was determined using maintained and published water well data. Karst mapping indicates the site is not located in a Karst designated area. Karst and Wetland Maps are provided as Attachment I. Depth to groundwater information is provided as Attachment IV and the results are depicted on Figures 2 & 3.

OSE POD Locations Map
Frontier Field Services, LLC
6" Sand Tank Line
GPS: 32.768874, -103.984302
Eddy County

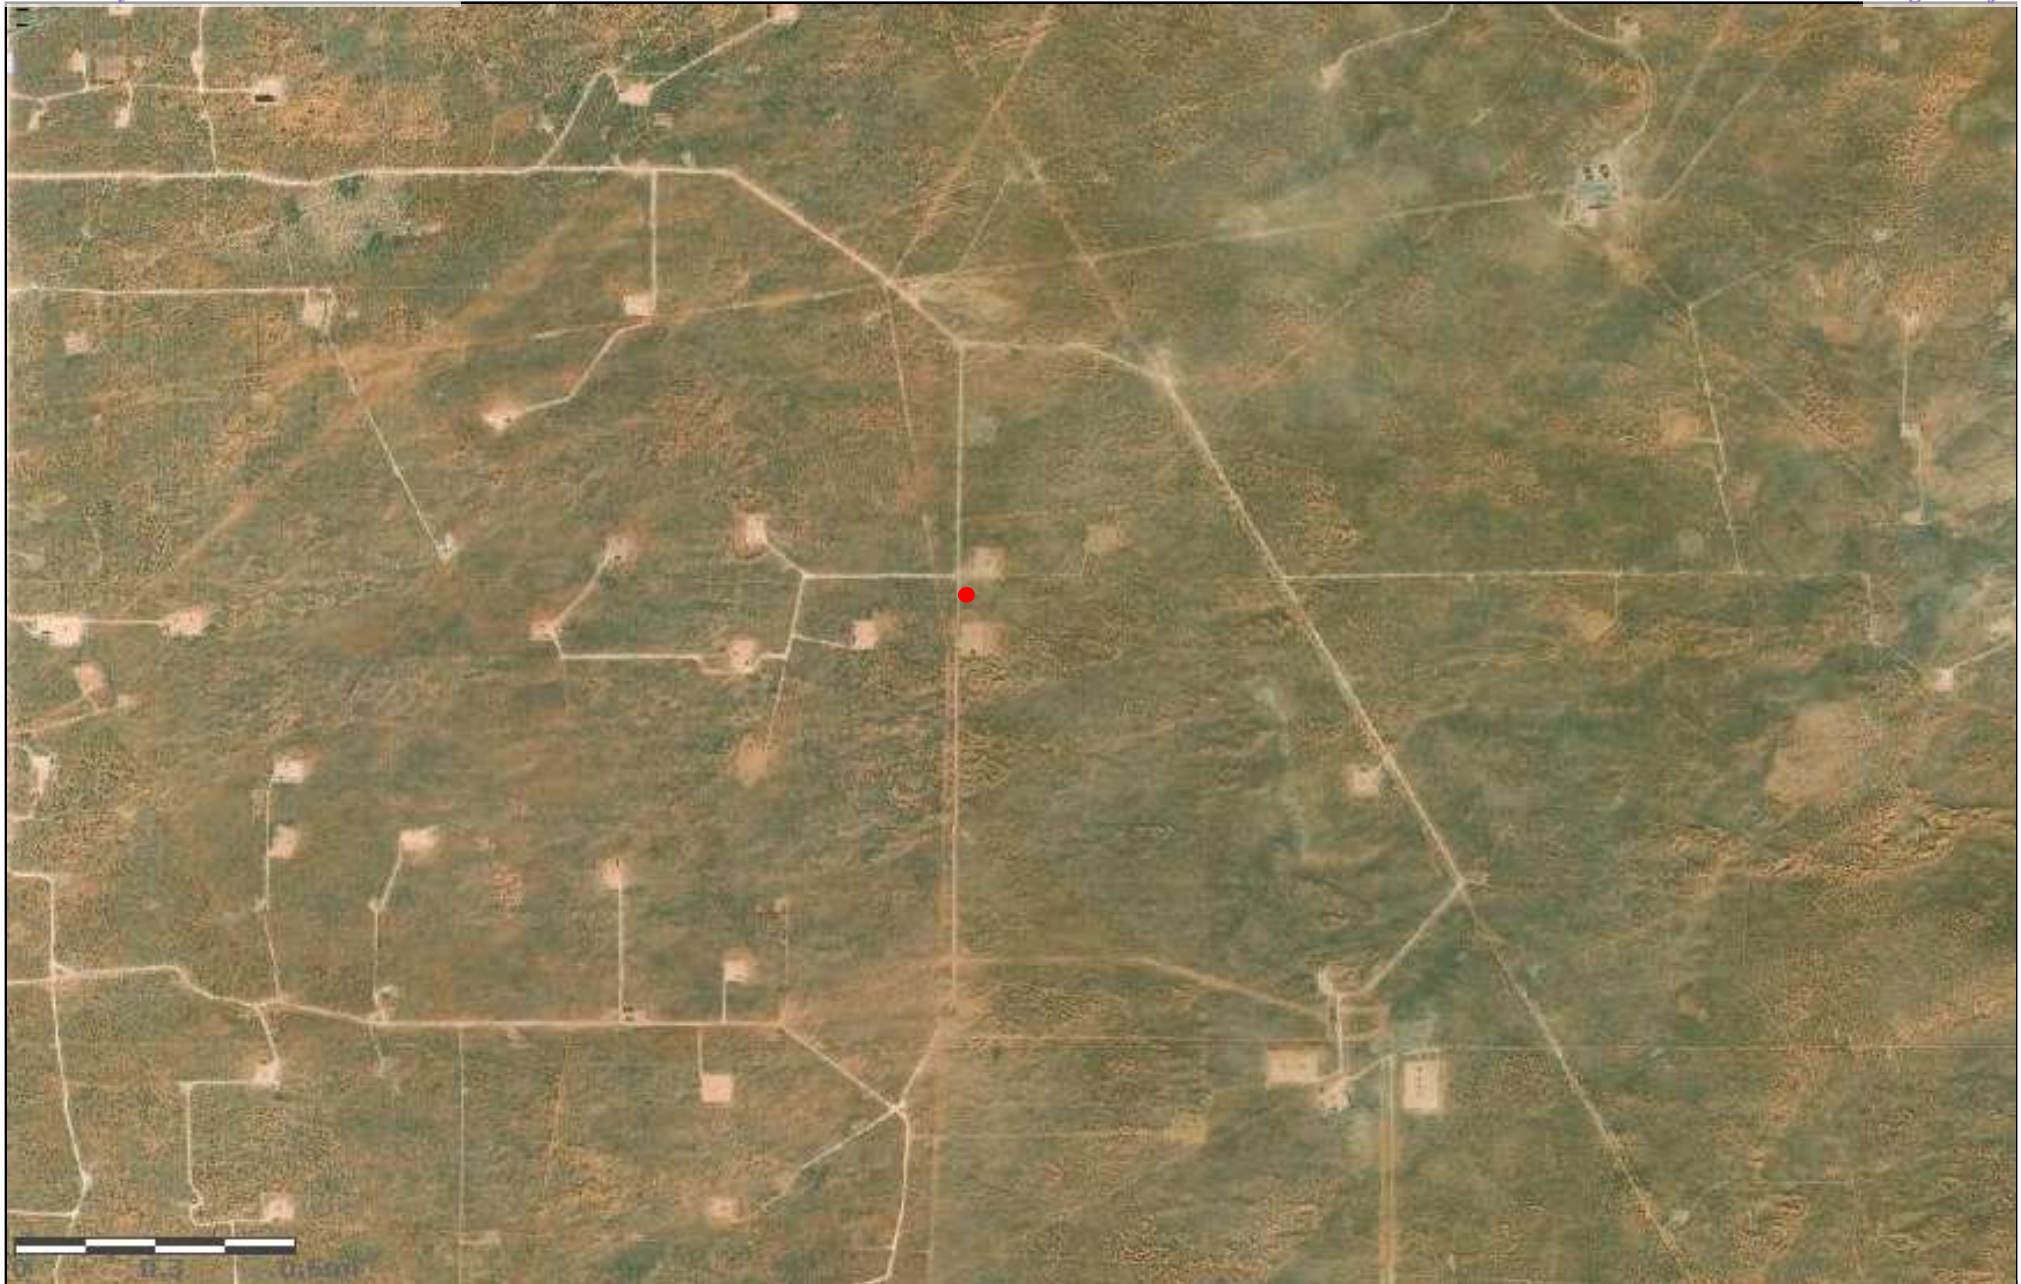
**Figure 3**

USGS Well Locations Map
Frontier Field Services, LLC
6" Sand Tank Line
GPS: 32.768874, -103.984302
Eddy County

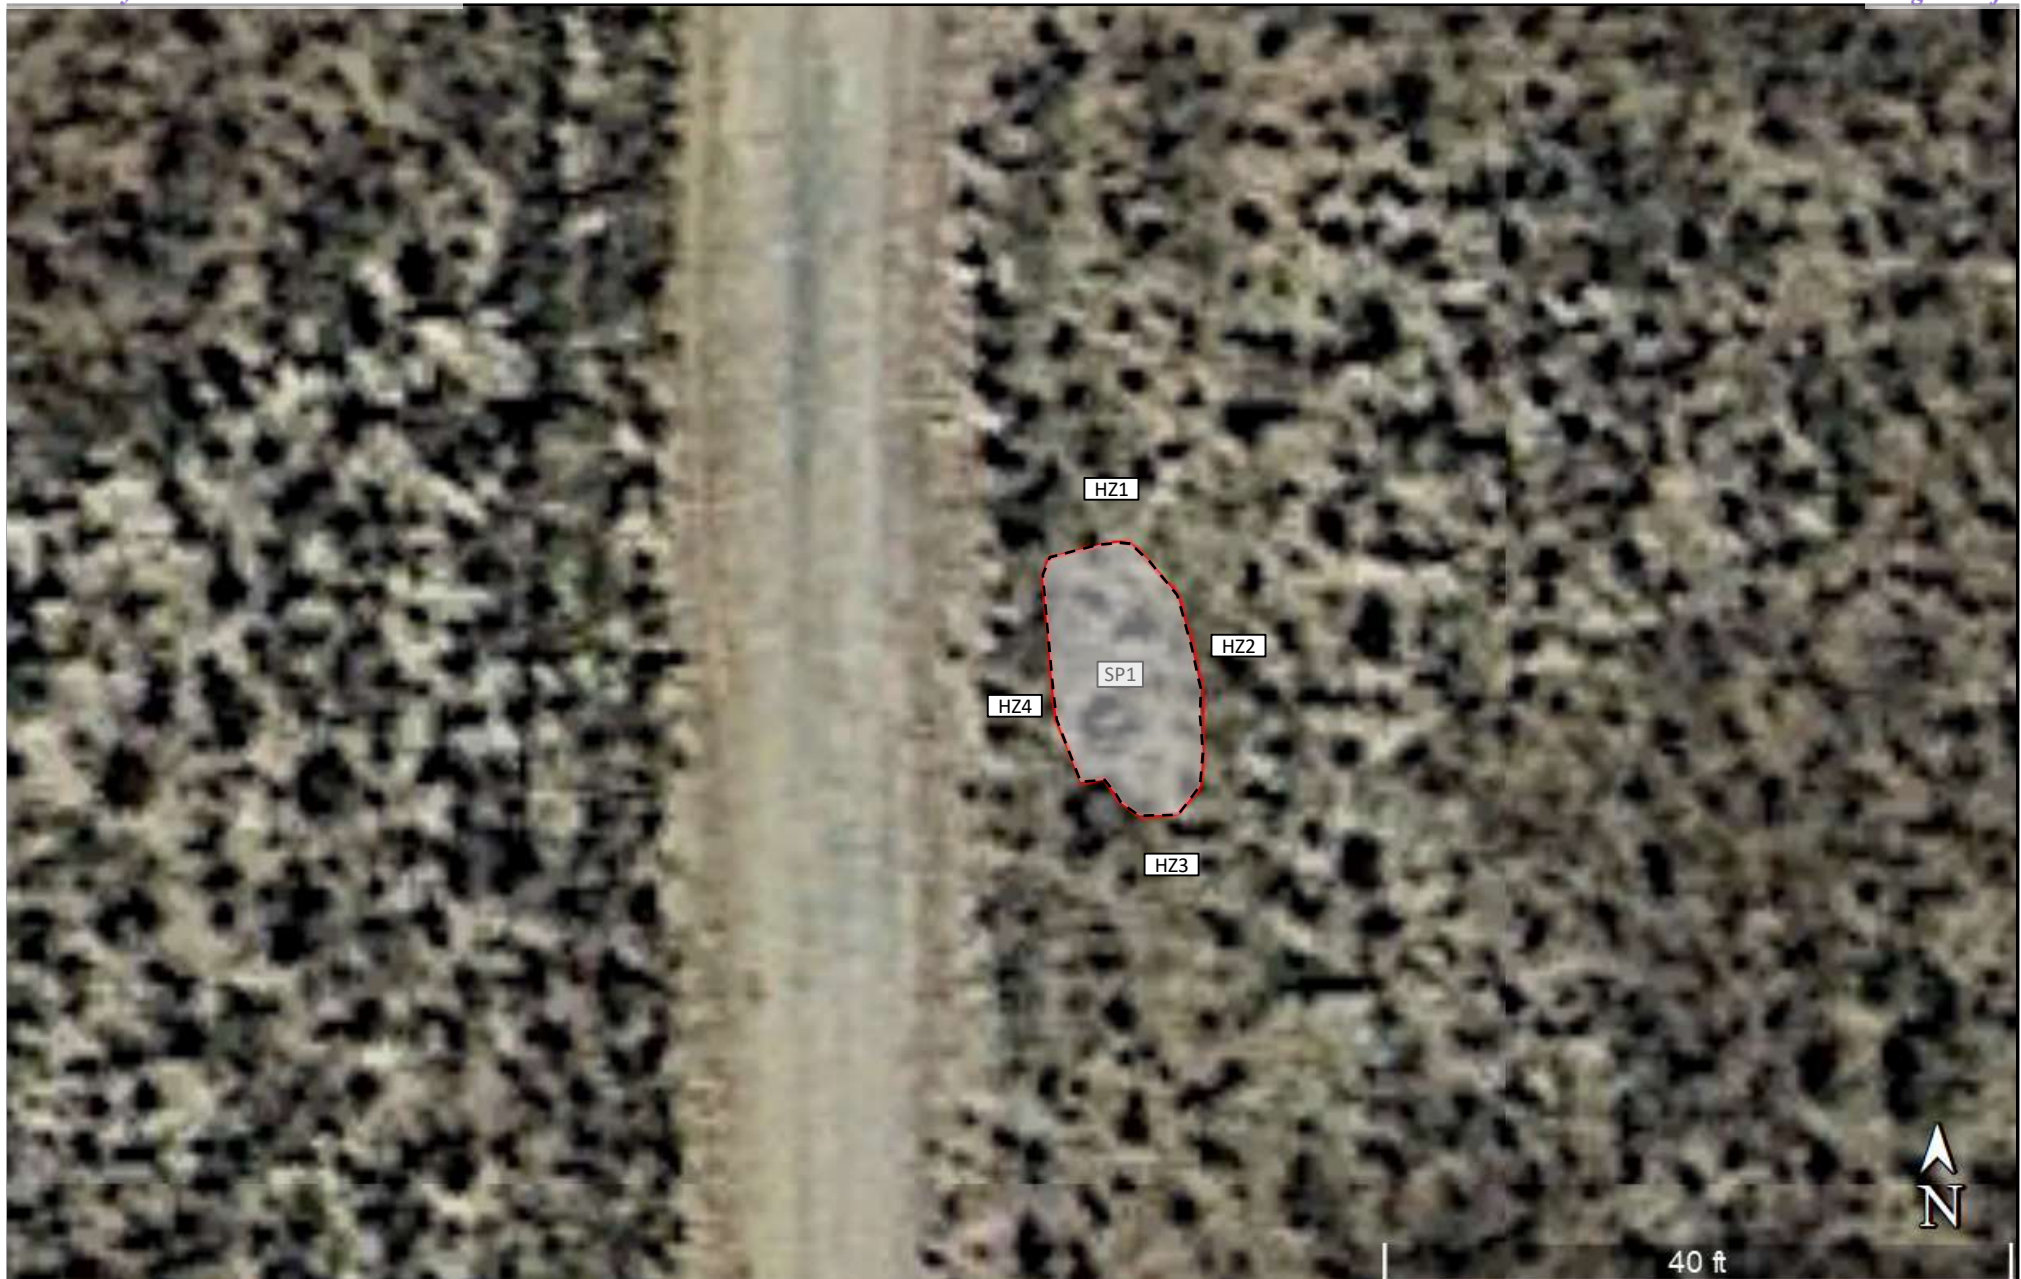
**Figure 4**

Based on field observations and field test data noted above and provided in Attachment V, ten representative soil samples, two from each sample location, were selected for laboratory analysis. Delineation soil samples SP1, and HZ1 through HZ4, were submitted to the laboratory for analysis of BTEX, TPH, and chloride. Laboratory analytical results indicated contaminant concentrations were below the NMOCD Closure Criteria in each of the submitted samples, with the exception of SP1 at Surface, which exhibited TPH concentrations in excess of NMOCD Closure Criteria.

Delineation Sample Map
Frontier Field Services, LLC
6" Sand Tank Line
GPS: 32.768874, -103.984302
Eddy County

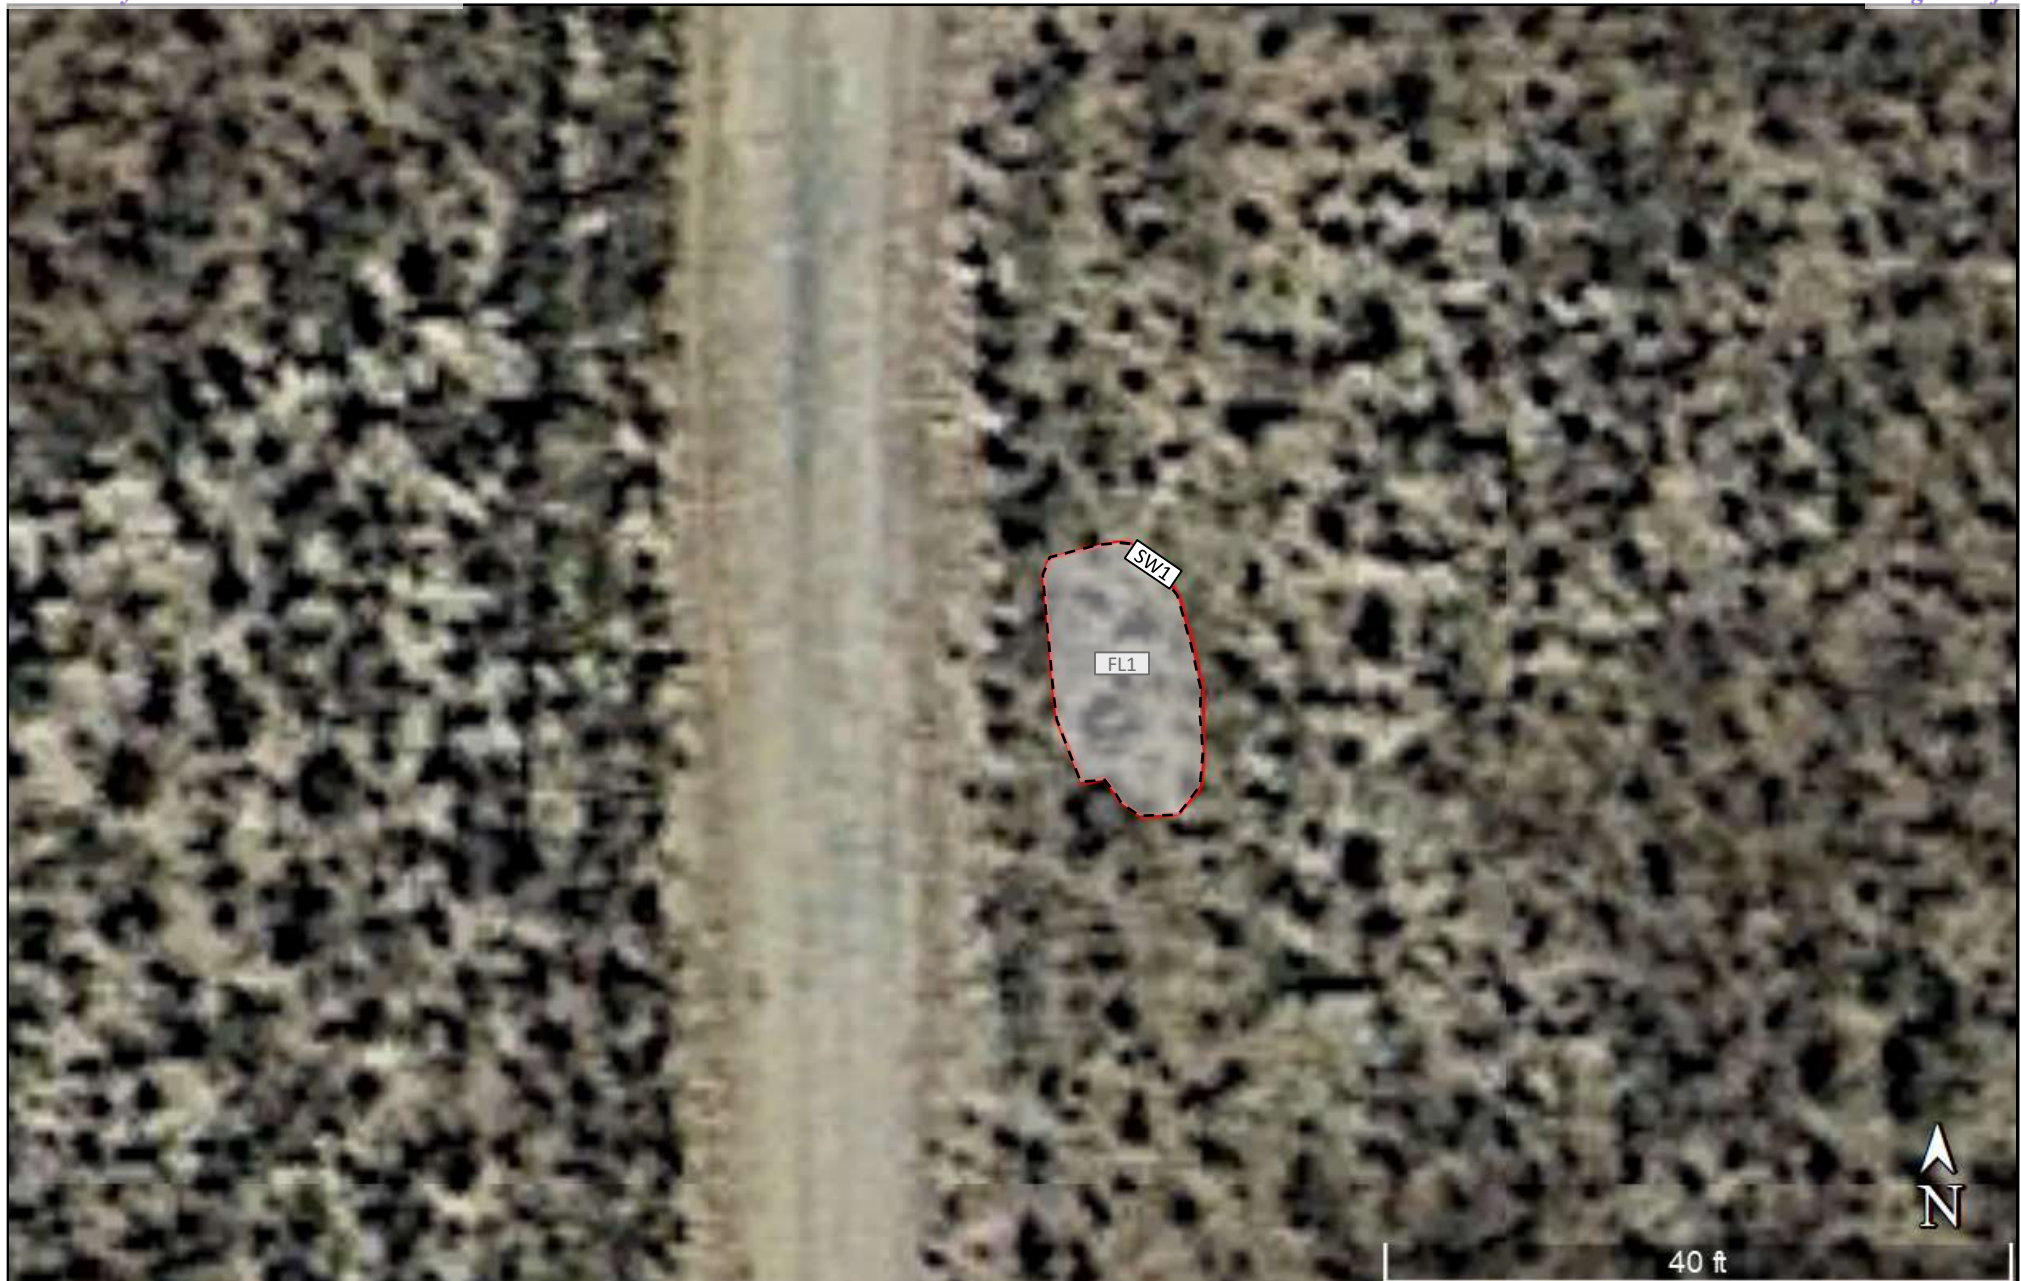
**Figure 5**

Excavation Sample Map
Frontier Field Services, LLC
6" Sand Tank Line
GPS: 32.768874, -103.984302
Eddy County
