## Remediation Summary and Closure Request

**Frontier Field Services, LLC**

**Gissler B2 4"**

**NMOCD Incident # nAPP2230130314**

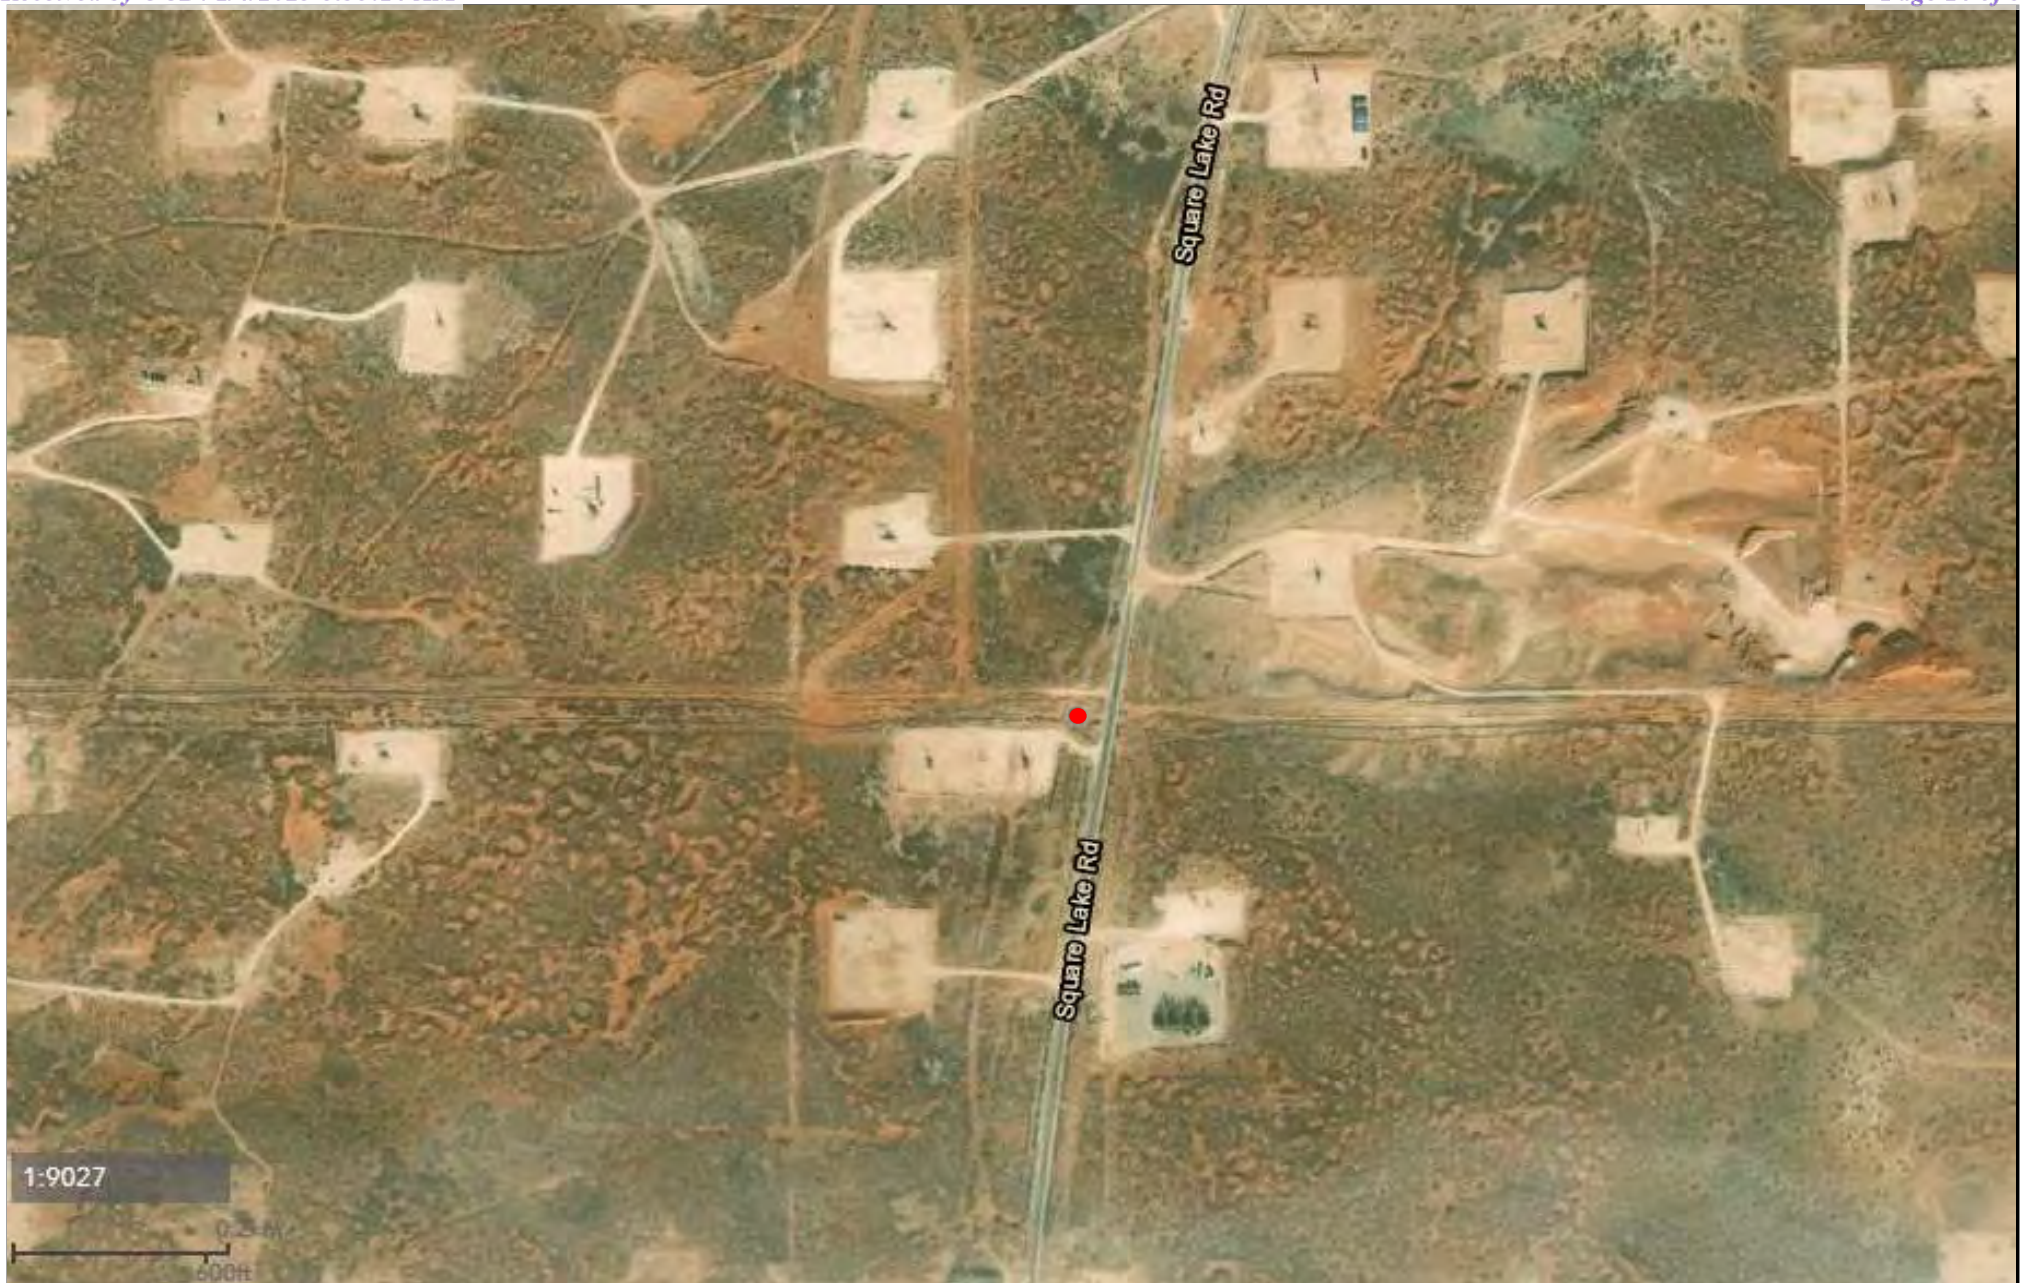
**Figure 2**

A search of the New Mexico Office of the State Engineer (NMOSE) and United States Geological Survey (USGS) groundwater databases was completed in an effort to determine the horizontal distance to known water sources within a half mile radius of the Release Site. Approximate depth to groundwater was determined using maintained and published water well data. Karst mapping indicates the site is not located in a Karst designated area. Karst and Wetland Maps are provided as Attachment I. Depth to groundwater information is provided as Attachment IV and the results are depicted on Figures 2 & 3.

OSE POD Locations Map  
Frontier Field Services, LLC  
Gissler B2 4"  
GPS: 32.822994, -103.937443  
Eddy County

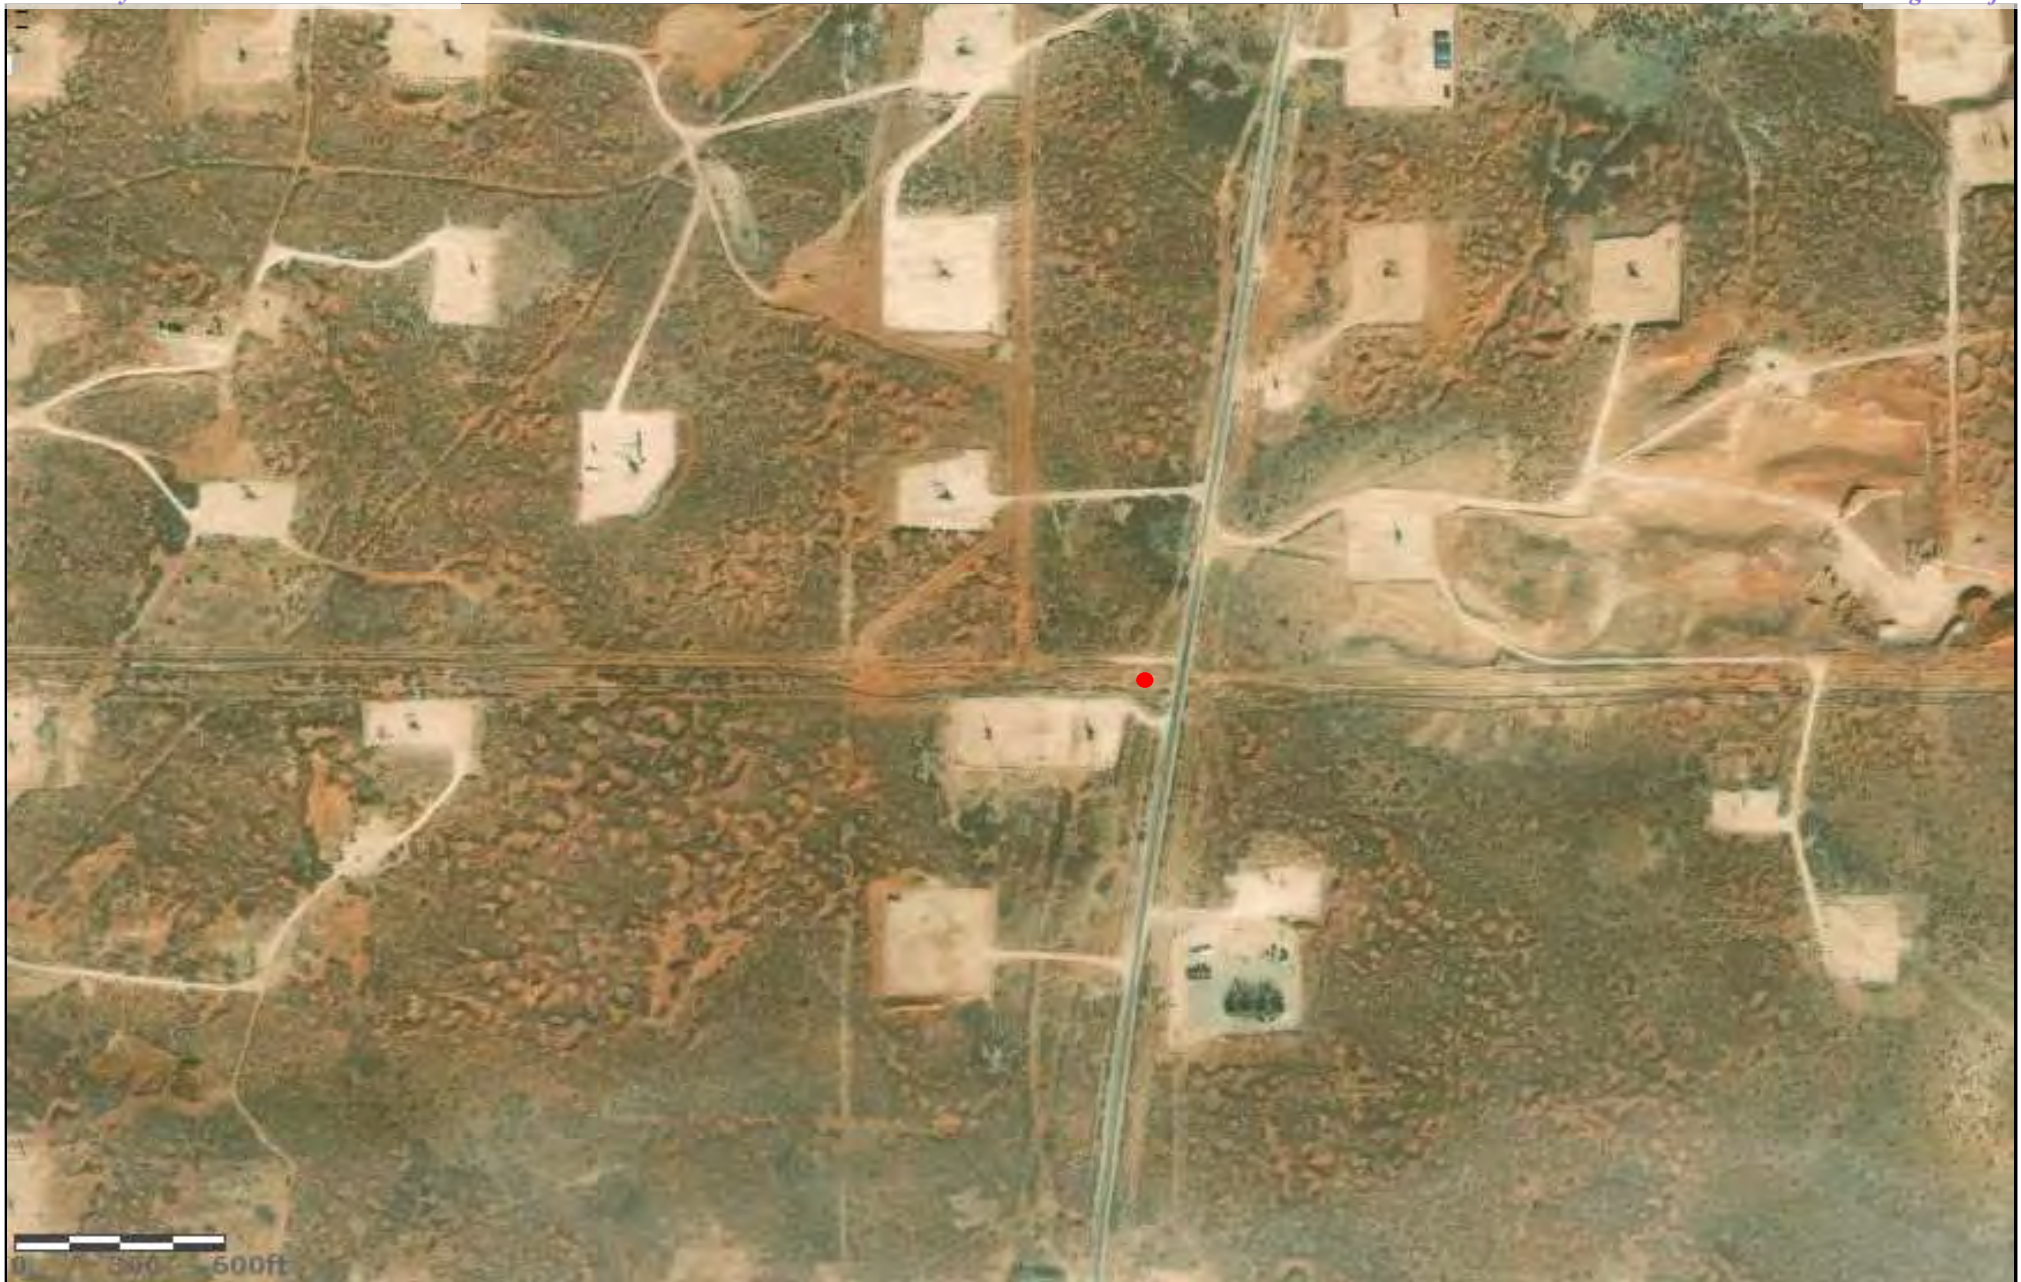
**Figure 3**

USGS Well Locations Map  
Frontier Field Services, LLC  
Gissler B2 4"  
GPS: 32.822994, -103.937443  
Eddy County

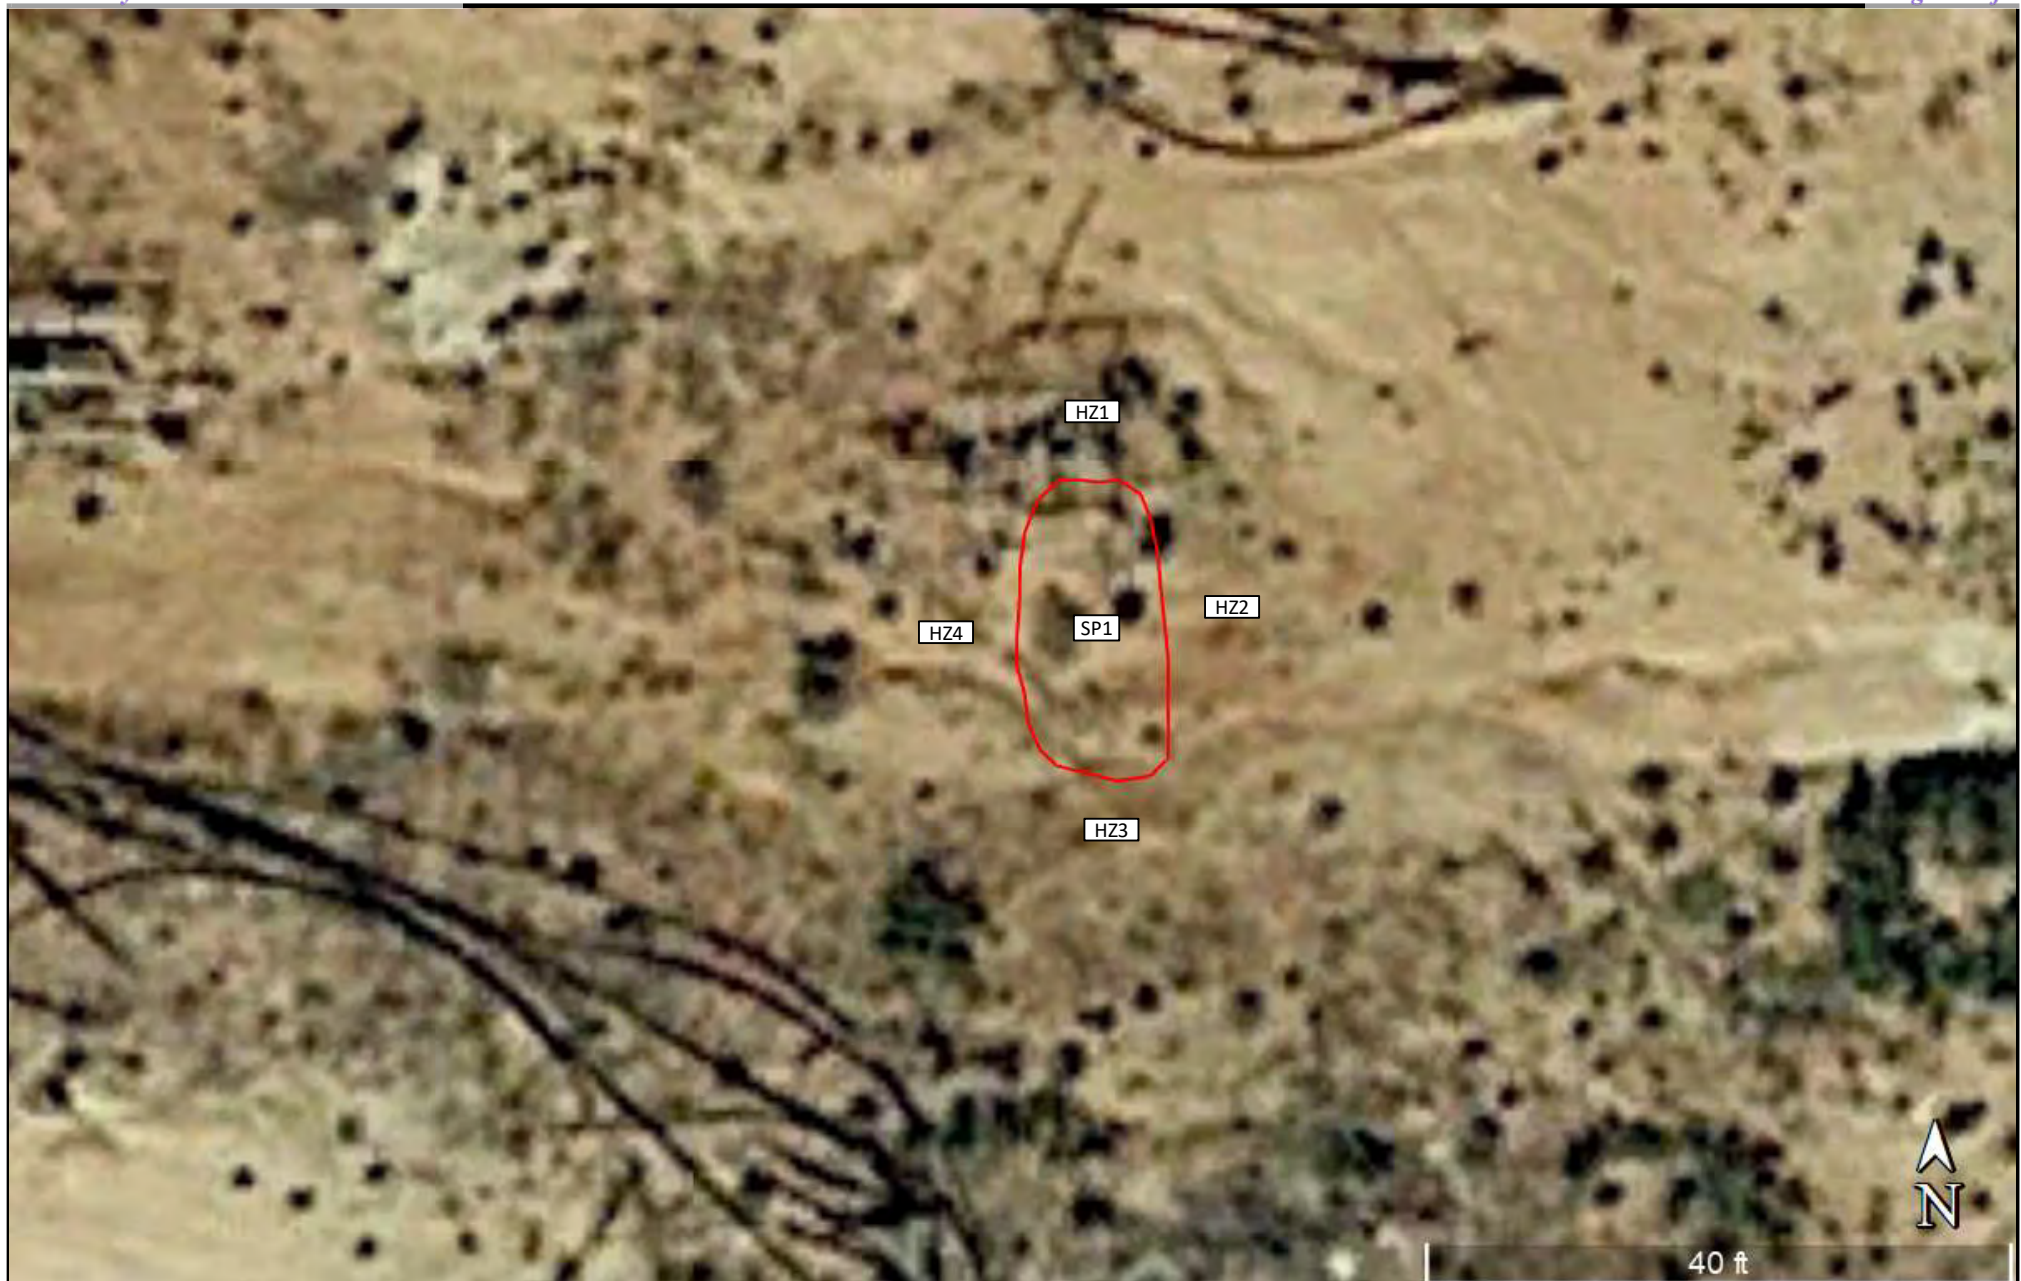
**Figure 4**

Based on field observations and field test data noted above and provided in Attachment V, ten representative soil samples, two from each sample location, were selected for laboratory analysis. Delineation soil samples SP1, and HZ1 through HZ4, were submitted to the laboratory for analysis of BTEX, TPH, and chloride. Laboratory analytical results indicated contaminant concentrations were below the NMOCD Closure Criteria in each of the submitted samples.

Delineation Sample Map  
Frontier Field Services, LLC  
Gissler B2 4"  
GPS: 32.822994, -103.937443  
Eddy County

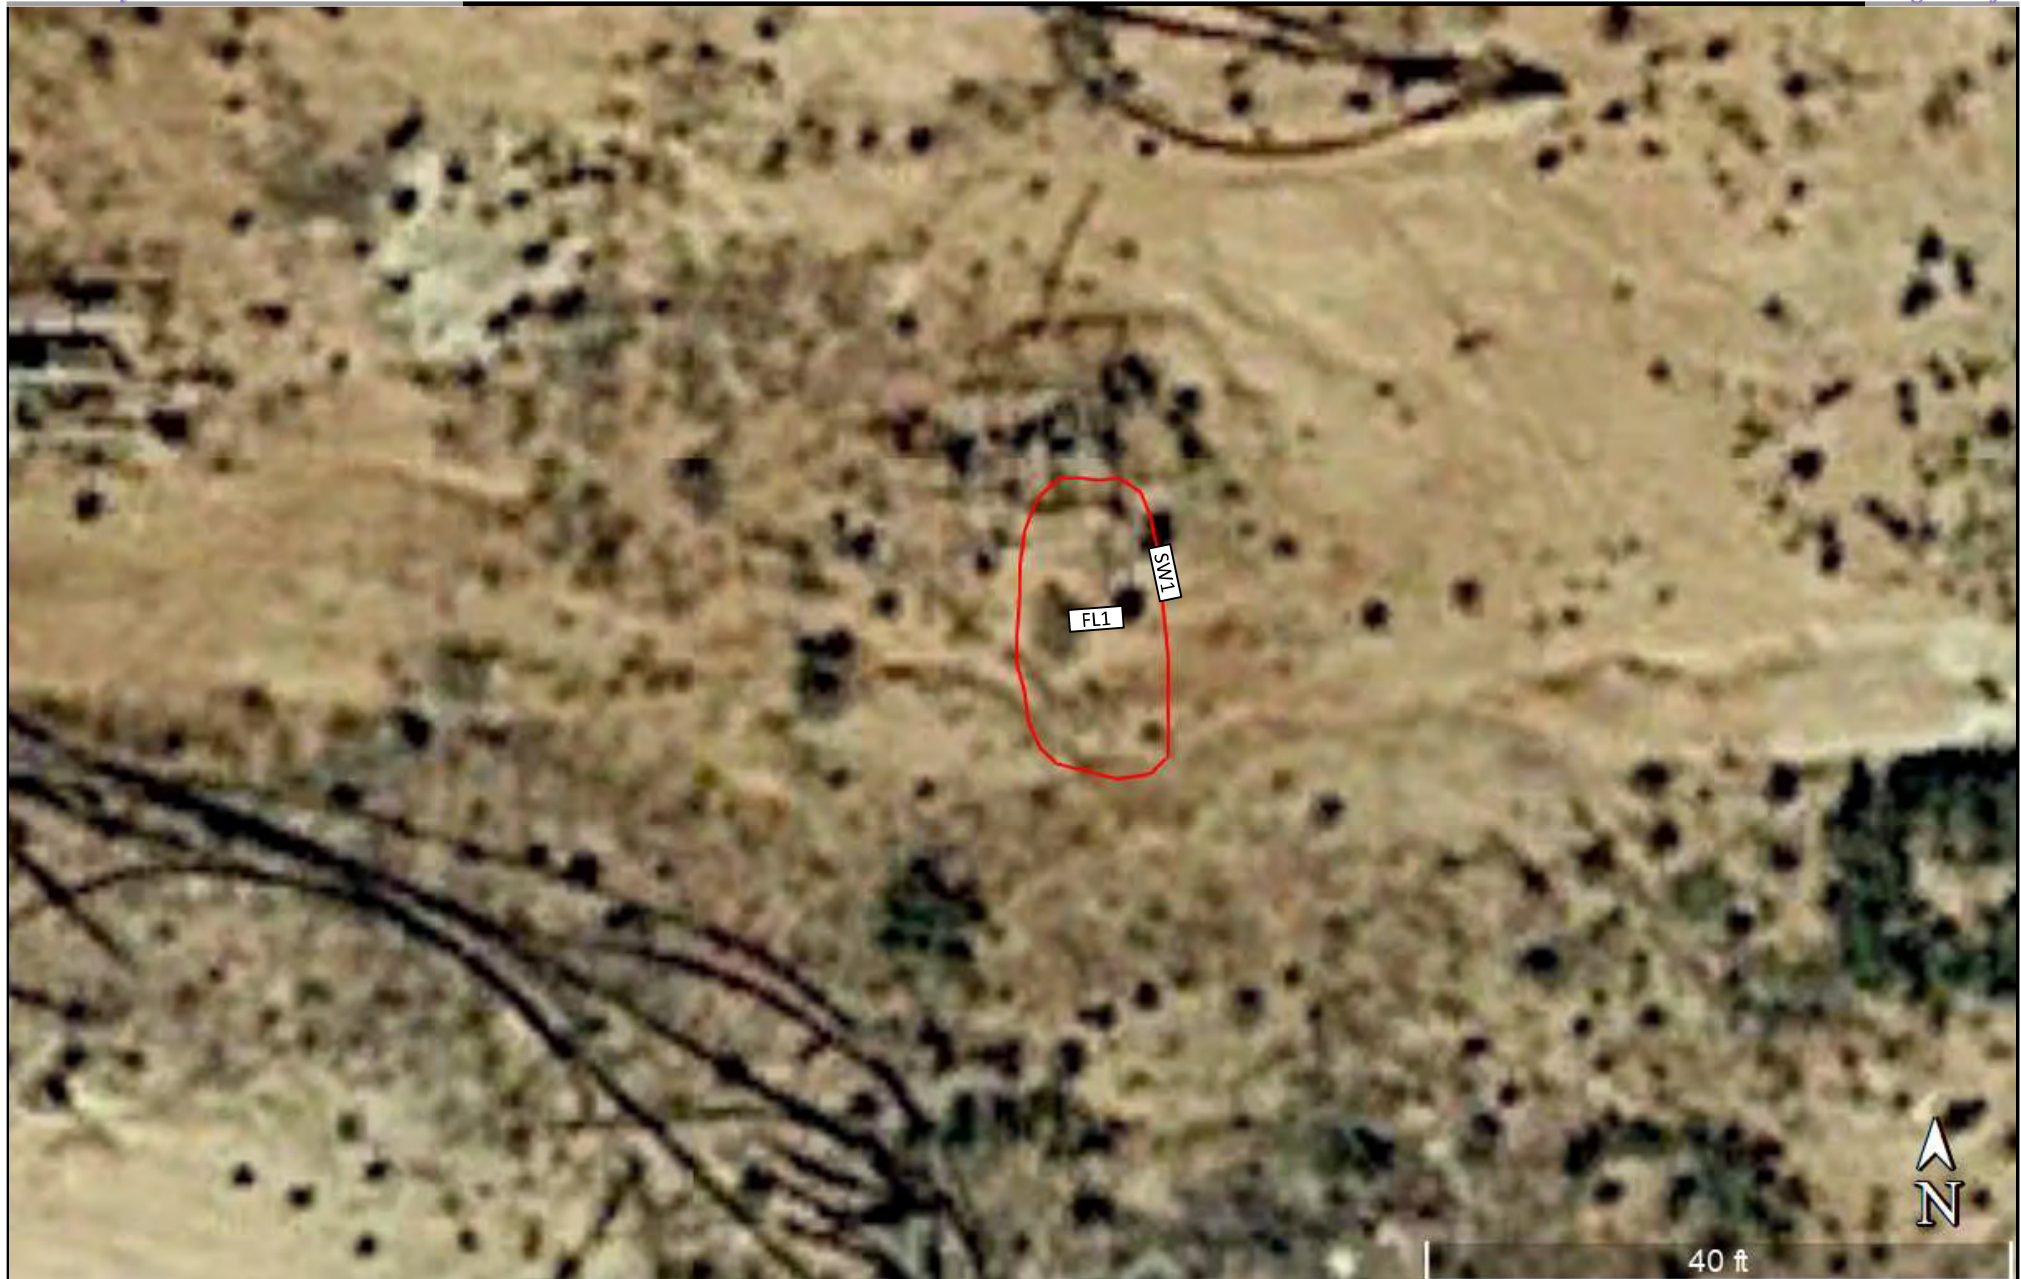
**Figure 5**

Excavation Sample Map  
Frontier Field Services, LLC  
Gissler B2 4"  
GPS: 32.822994, -103.937443  
Eddy County

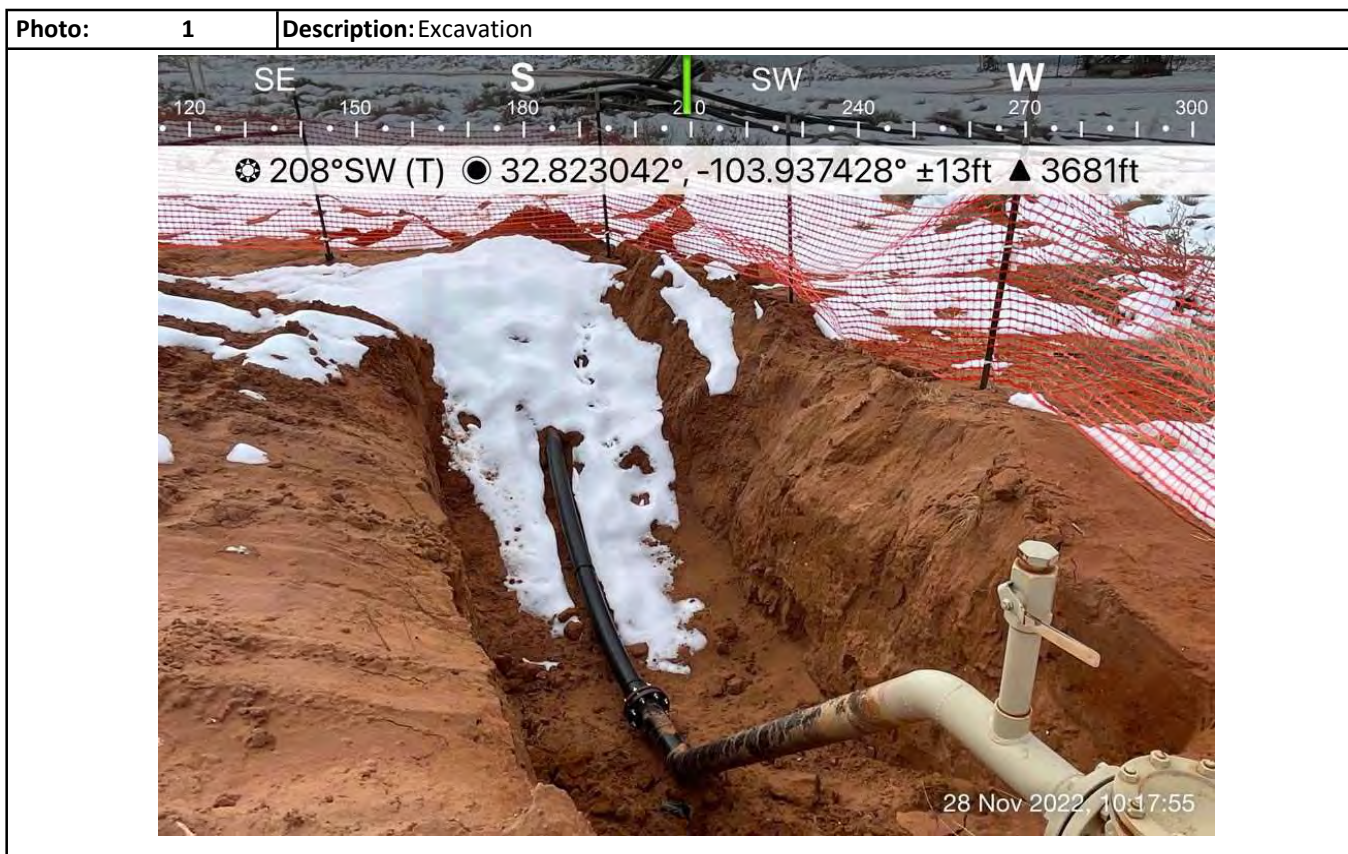
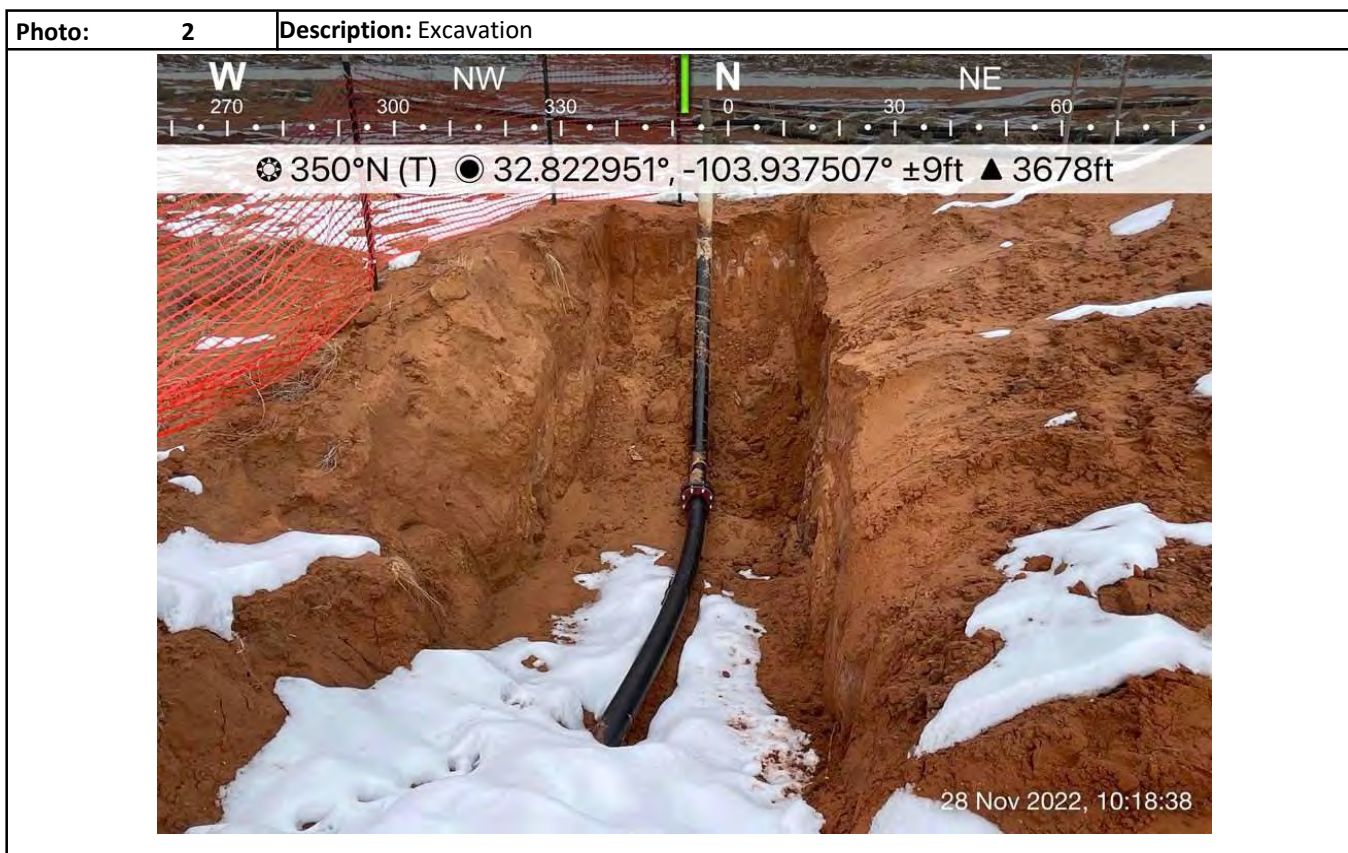
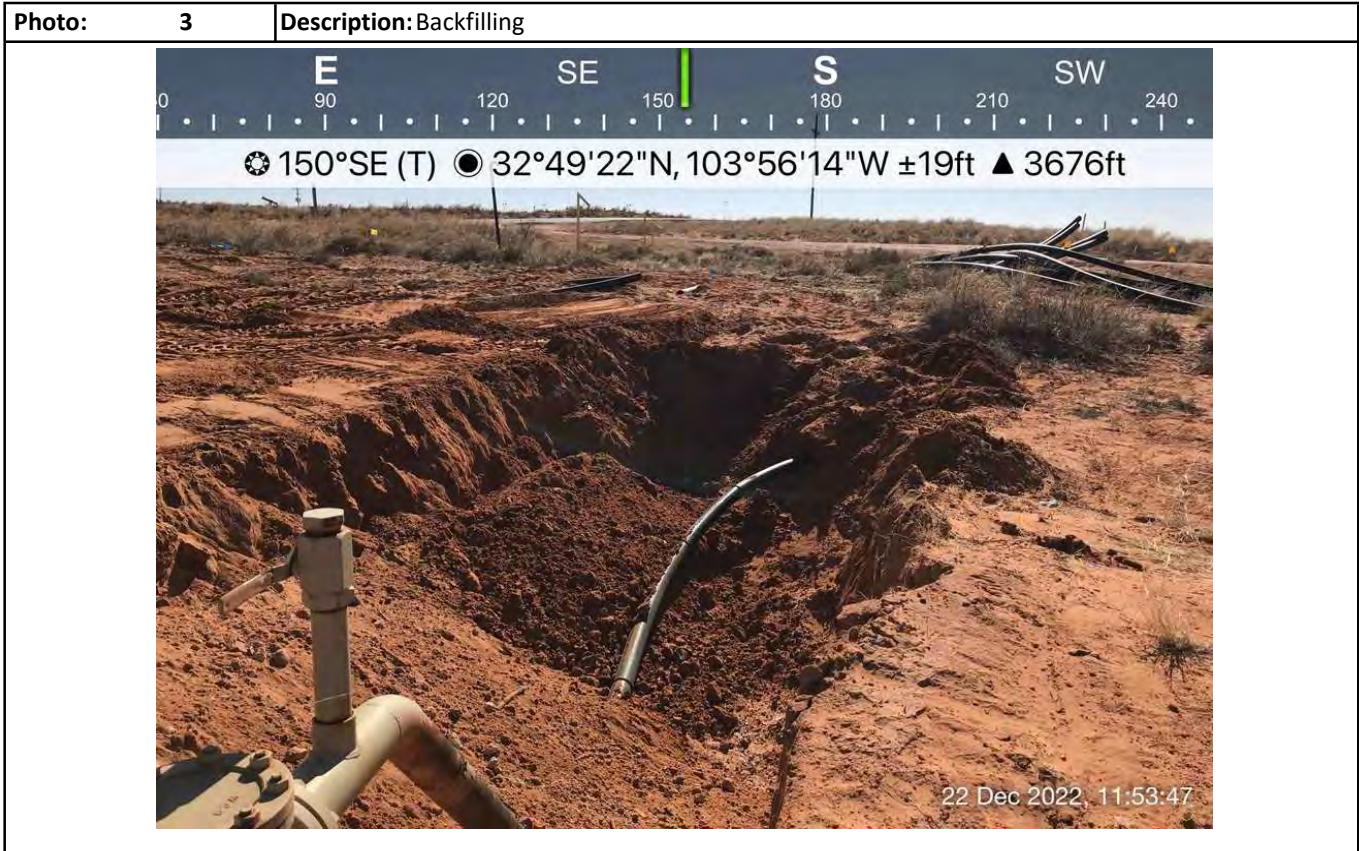
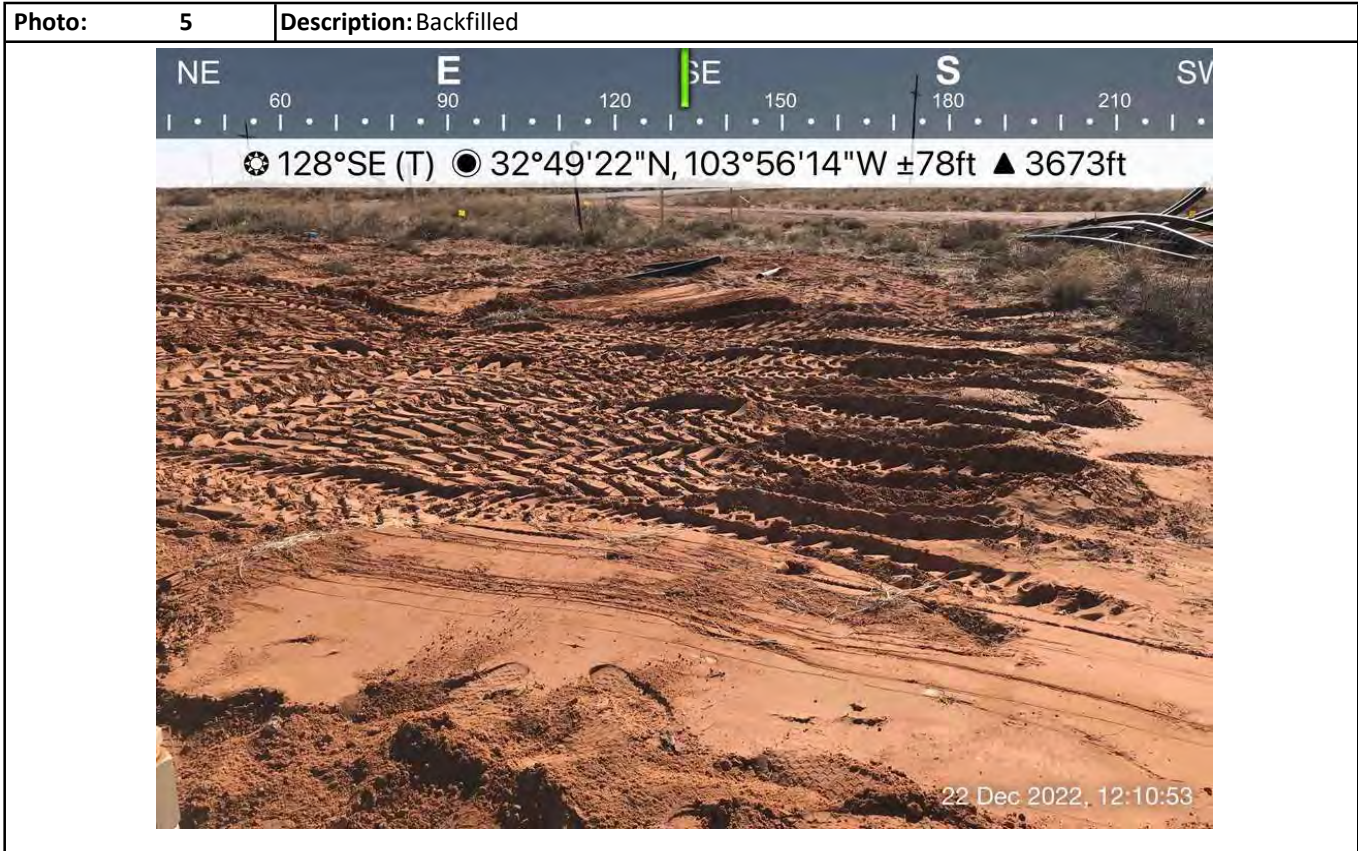
## Photographs

On December 8, 2022, Hungry Horse conducted an initial site assessment consisting of photographing and mapping the excavated area, and a series of sampling events. During the sampling events, a hand augered soil bore was advanced within the excavated area in an effort to determine the vertical extent of contamination. This sample location is identified by SP designation. In addition, hand augered soil bores were advanced along the outside edges of the excavated area in an effort to determine the horizontal extent of contamination. These sample locations are identified by HZ designation. During the advancement of the soil bores, soil samples were collected and field screened for the presence of chloride concentrations utilizing a Hach Quantab® chloride test kit.
