Vertex Project #: 22E-04170

Spill Closure Report: RDX Federal Com 17 #045H
Section 17, Township 26 South, Range 30 East
County: Eddy
API: 30-015-44408
Incident Report: nAPP2233351431

2022 Spill Assessment and Closure
December 2022

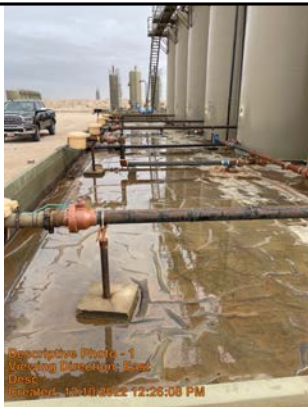
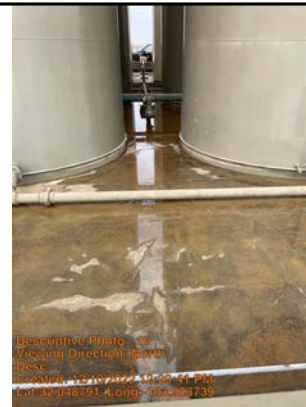
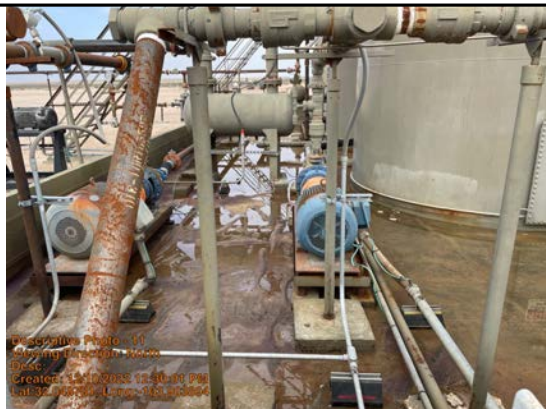
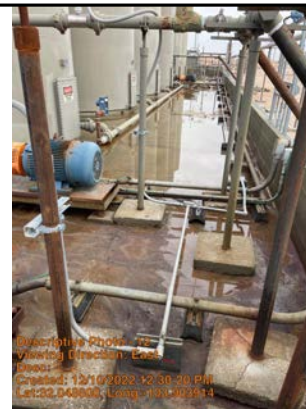
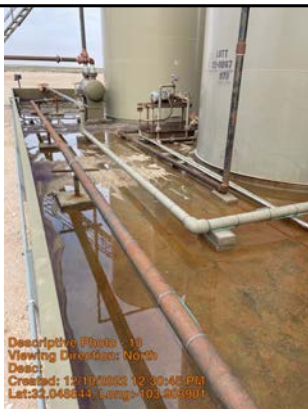
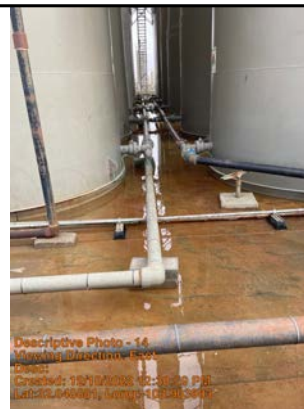
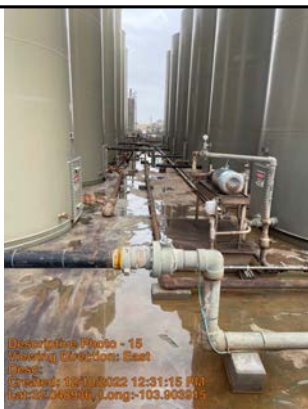
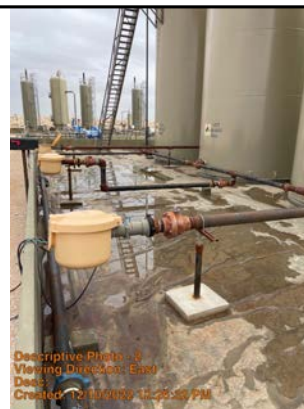
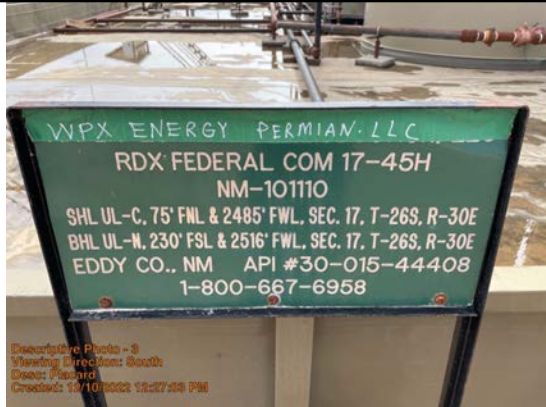
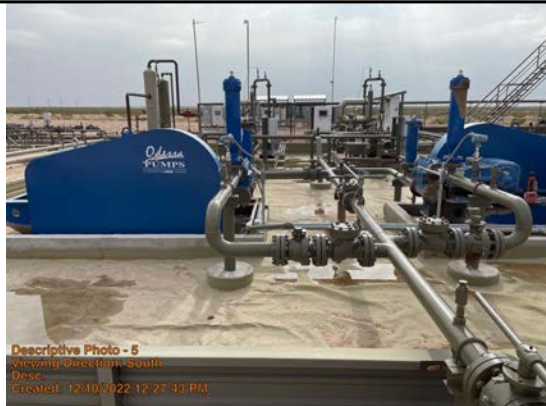
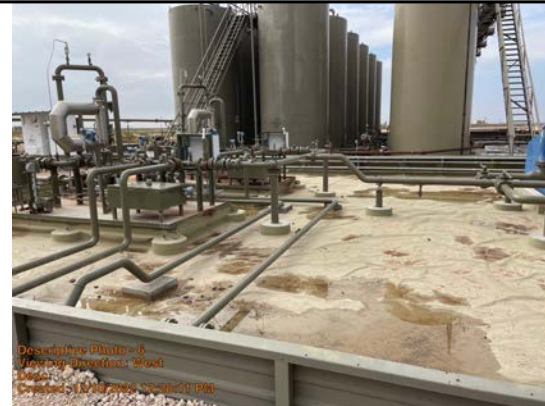
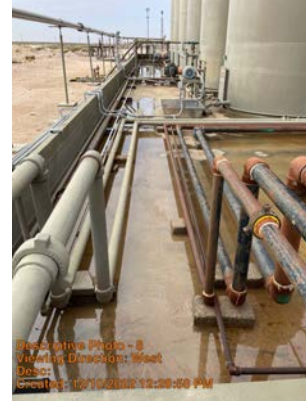
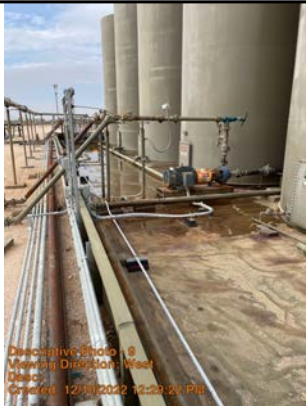
Site Photos

Notification that a liner inspection was scheduled to be completed was provided to the NMOCD on December 6, 2022 (Attachment 4). Visual observation of the liner was completed on all sides and the base of the containment, around equipment, and of all seams in the liner. As evidenced in the DFR (Attachment 2), liner integrity was confirmed.

Vertex recommends no remediation action to address the release at RDX. The secondary containment liner appeared to be intact and had the ability to contain the release, as shown in the inspection photographs included with the DFR (Attachment 2). There are no anticipated risks to human, ecological or hydrological receptors associated with the release site.
