Release Notification and Corrective Action

1RP-9-12-2850

REMEDIATION SUMMARY & SITE CLOSURE REQUEST

**PLAINS PIPELINE, LP
DUBLIN STATION LAUNCHER
Lea County, New Mexico
Unit Letter "G" (SW/NE), Section 12, Township 26 South, Range 36 East
Latitude 32.05795° North, Longitude 103.21766° West
Plains SRS #: 2012-193
NMOCD Reference #: 1RP-9-12-2850**

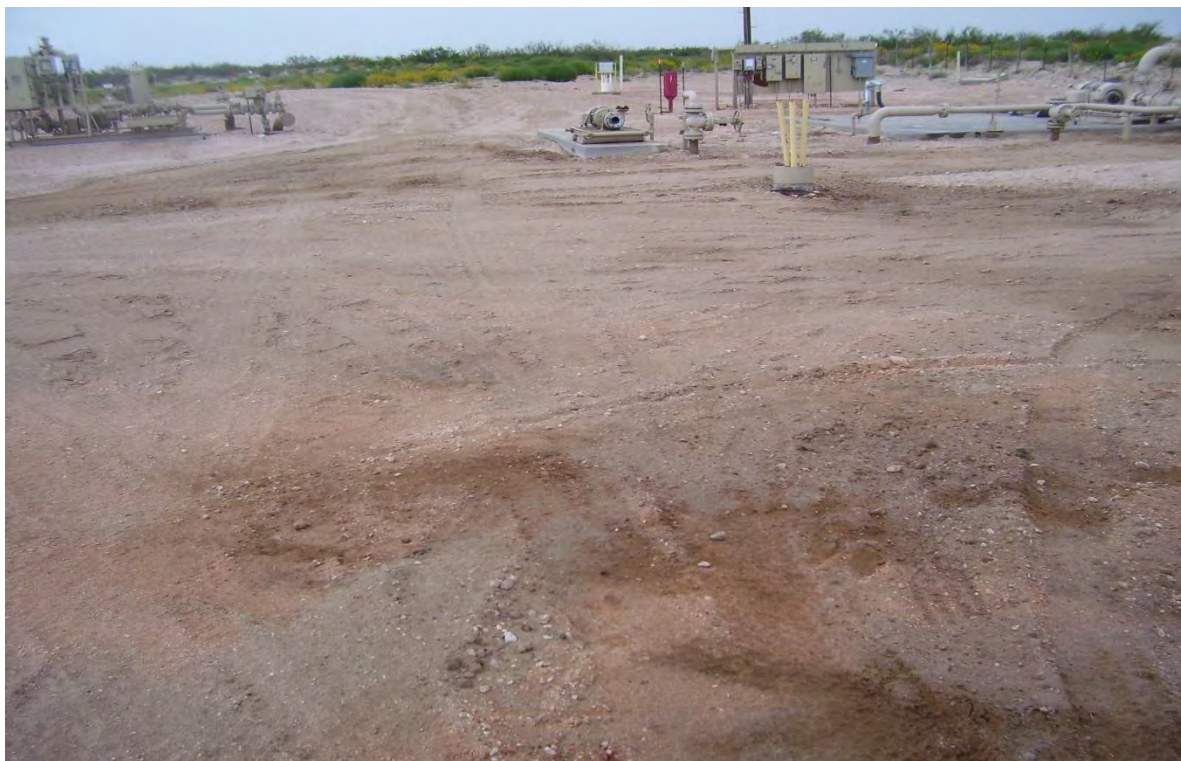
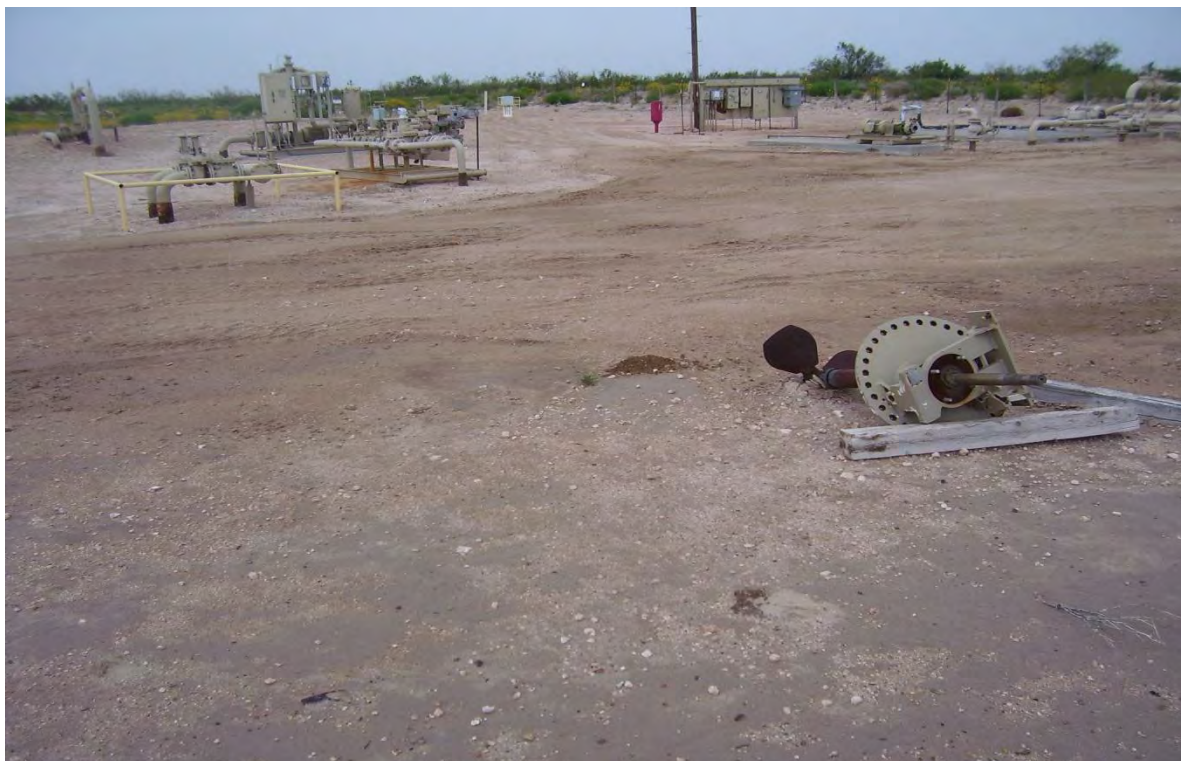
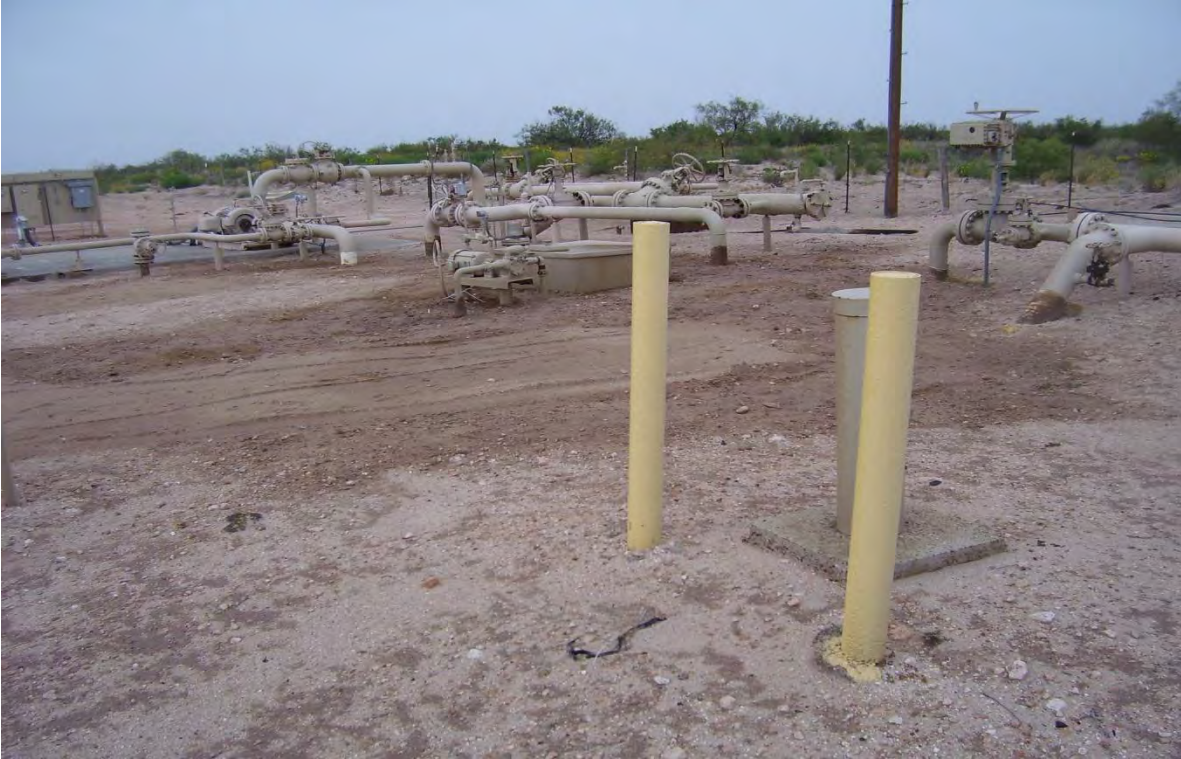
The released crude resulted in a surface stain that measured approximately 5' x 20'. The depth to groundwater in this area is approximately 210' below ground surface. The impacted area will be remediated per applicable NMOCD guidelines.

On September 21, 2012, Plains discovered a release had occurred at the Dublin Station Launcher to Jal Eight-inch (8") meter. During the launching of a pig, a drain valve on the barrel of the pig launcher failed to seat completely, resulting in a release of crude oil.

Dublin Station Launcher - Release Site

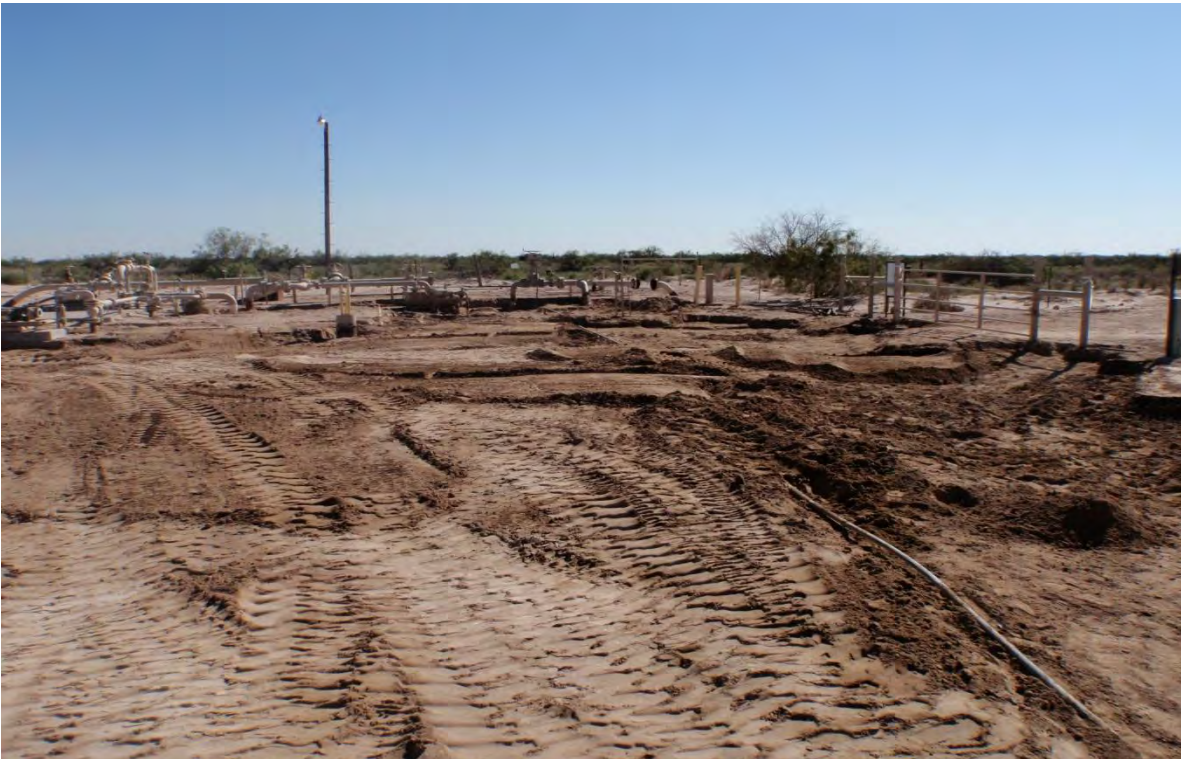
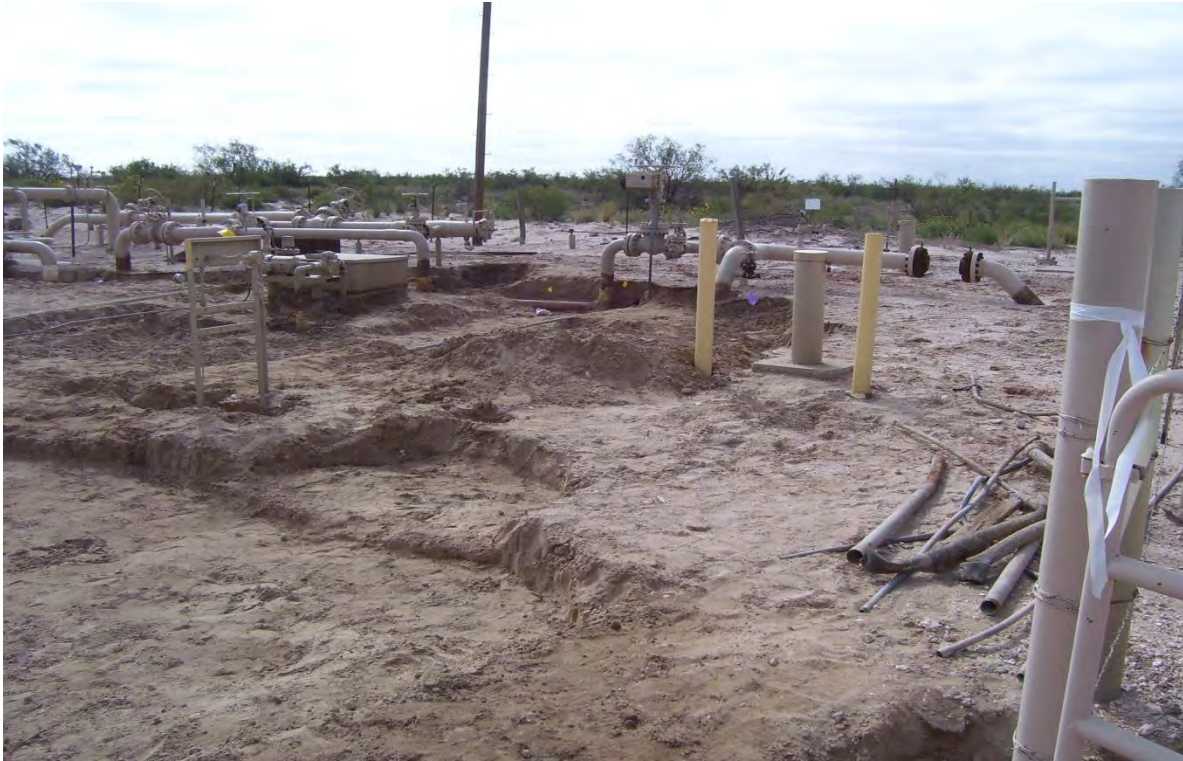
On October 3, 2012, following initial response activities, excavation of impacted soil commenced at the site. Olfactory and visual senses and Photo-Ionization Detector (PID) technology were used to determine the horizontal and vertical extent of impacted soil and to guide the excavation. From October 3 through October 5, 2012, impacted soil was excavated, aerated, and stockpiled on-site to facilitate bioremediation.

Dublin Station Launcher - Excavation

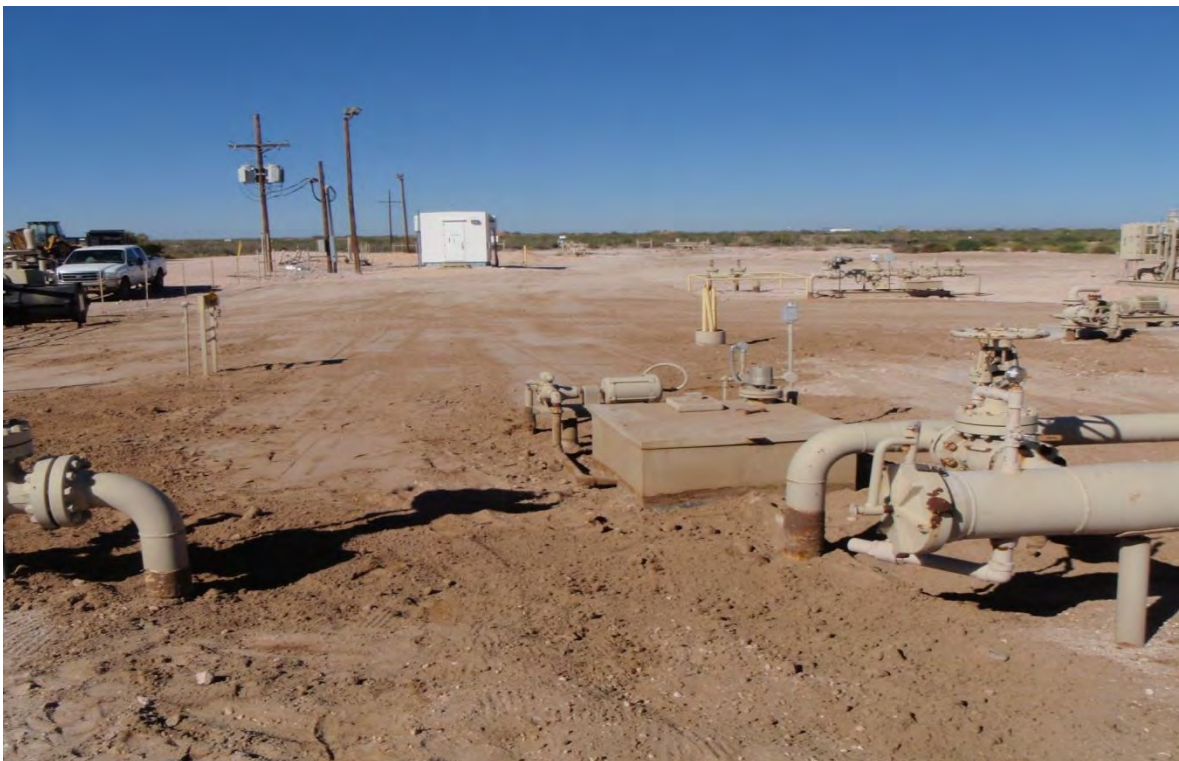
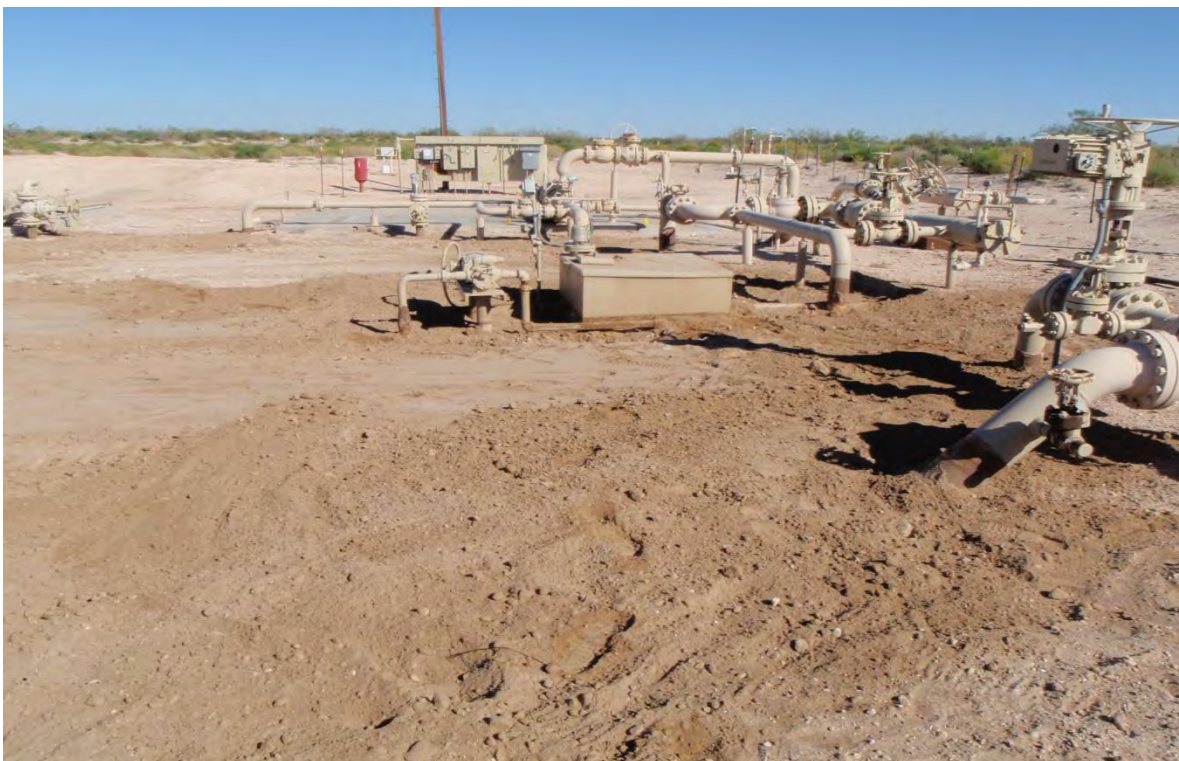
Dublin Station Launcher - Excavation, Following Backfill

Based on laboratory analytical results, and with NMOCD approval, on October 19, 2012, the excavation was backfilled, compacted, and contoured to fit the surrounding topography. Prior to backfilling, final dimensions of the excavation were approximately one hundred and twenty feet (120') in length, varying in width from approximately twenty-two feet (22') to approximately ninety feet (90'), and ranging in depth from approximately six inches (6") to approximately one and one-half feet (1.5') bgs.
