Release Notification and Corrective Action

REMEDIATION SUMMARY AND SITE CLOSURE REQUEST

**PLAINS PIPELINE, L.P.
James Ranch Unit 7-30 4-Inch (JRU 7-30 4")
Eddy County, New Mexico
Plains SRS # 2012-008
UNIT LTR "G" (SW/NE), Section 6, Township 23 South, Range 31 East
Latitude 32.3350° North, Longitude 103.8150° West
NMOCD Reference # 2RP-1007**

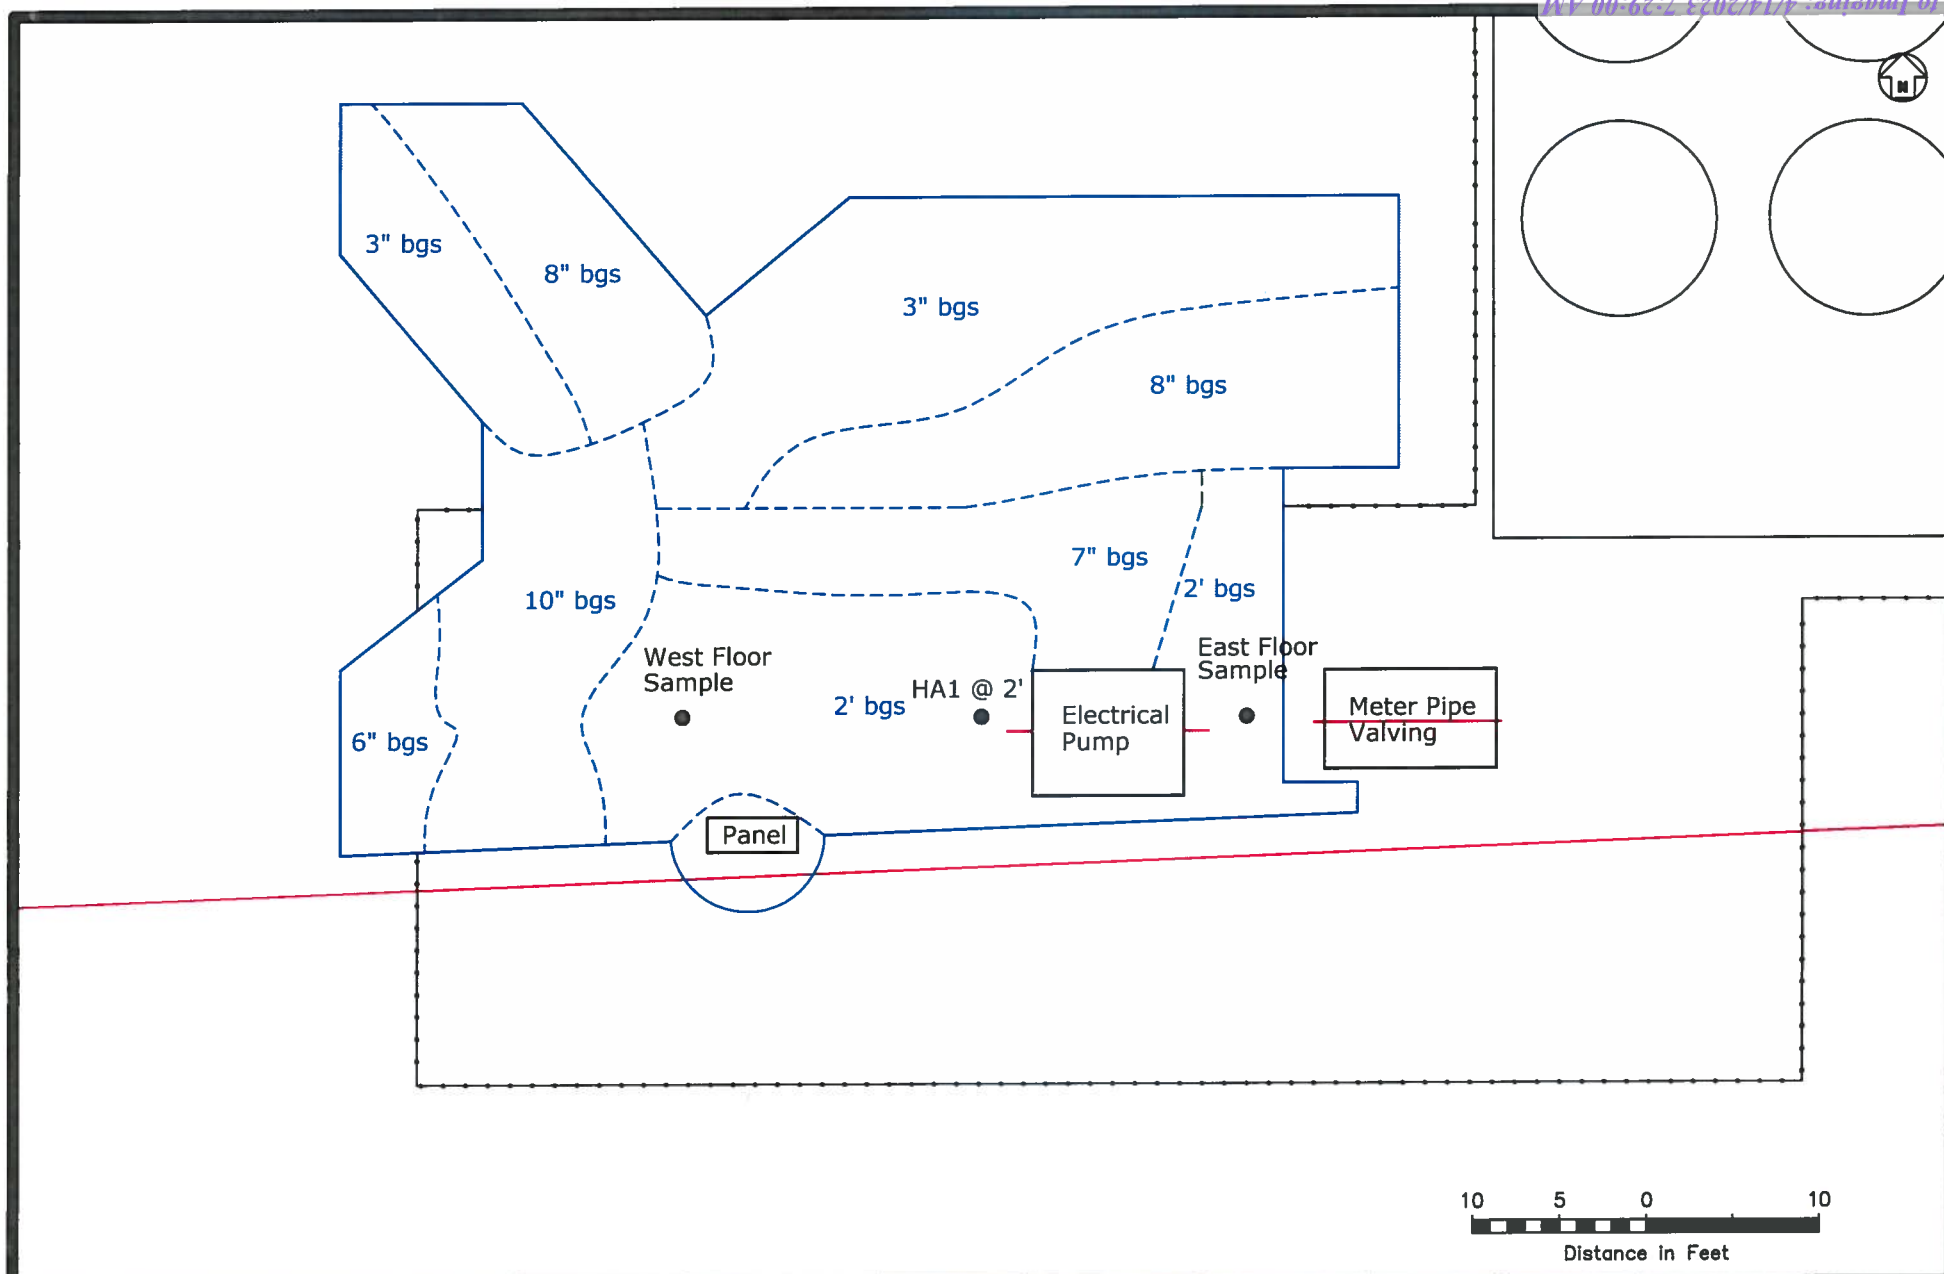
Figure 2
Site and Sample Location Map
Plains Pipeline, L.P.
James Ranch Unit 7-30 4-inch
Eddy County, New Mexico
SRS #: 2012-008
NMOCD Ref. #: 2RP-1007

On January 25, 2012, following initial response activities, excavation of the hydrocarbon impacted soil commenced at the site. Excavated soil was stockpiled on-site pending final disposition. A Photo-Ionization Detector (PID) was used to field-screen the horizontal and vertical extent of impacted soil and to guide the excavation.

On January 26, 2012, two (2) soil samples (East Floor and West Floor) were collected from the floor of the excavation at approximately two feet (2') bgs. The soil samples were submitted to Xenco Laboratories, Inc., of Odessa, Texas, for analysis of total petroleum hydrocarbon (TPH) concentrations in accordance with EPA Method SW-846 8015M. Soil sample East floor was also analyzed for concentrations of chloride in accordance with EPA Method 300.1. Table 1 summarizes the "Concentrations of Benzene, BTEX, TPH & Chloride in Soil". Laboratory analytical reports are provided as Appendix C.

On January 26, 2012, approximately forty-eight cubic yards (48 yd³) of impacted material was transported to Lea Station Landfarm, (Discharge Permit #GW-351) for remediation. Prior to backfilling, the final dimensions of the excavation were approximately fifty feet (50') in length, approximately forty-five feet (45') in width and ranged in depth from approximately three inches (3") bgs to two feet (2') bgs. Upon receiving laboratory analytical data from confirmation soil samples, the excavated area was backfilled with locally purchased, non-impacted material and compacted lifts. Areas affected by remediation activities were contoured to fit the needs of the well pad.

On May 22, 2012, one (1) confirmation soil sample (HA1 @ 2') was collected utilizing a hand auger at approximately two feet (2') bgs. The soil sample was submitted to the laboratory for analysis of BTEX and TPH concentrations in accordance with EPA Methods SW-846 8021b and SW-846 8015M, respectively. Laboratory analytical results indicated the concentration of benzene was less than the appropriate laboratory method detection limit (MDL). Analytical results indicated the concentration of total BTEX constituents was 17.2 mg/Kg. Analytical results indicated the concentration of TPH was 3,750 mg/Kg. Review of laboratory analytical results indicated benzene, total BTEX constituent and TPH concentrations were below the NMOCD regulatory remediation action levels established for the site.

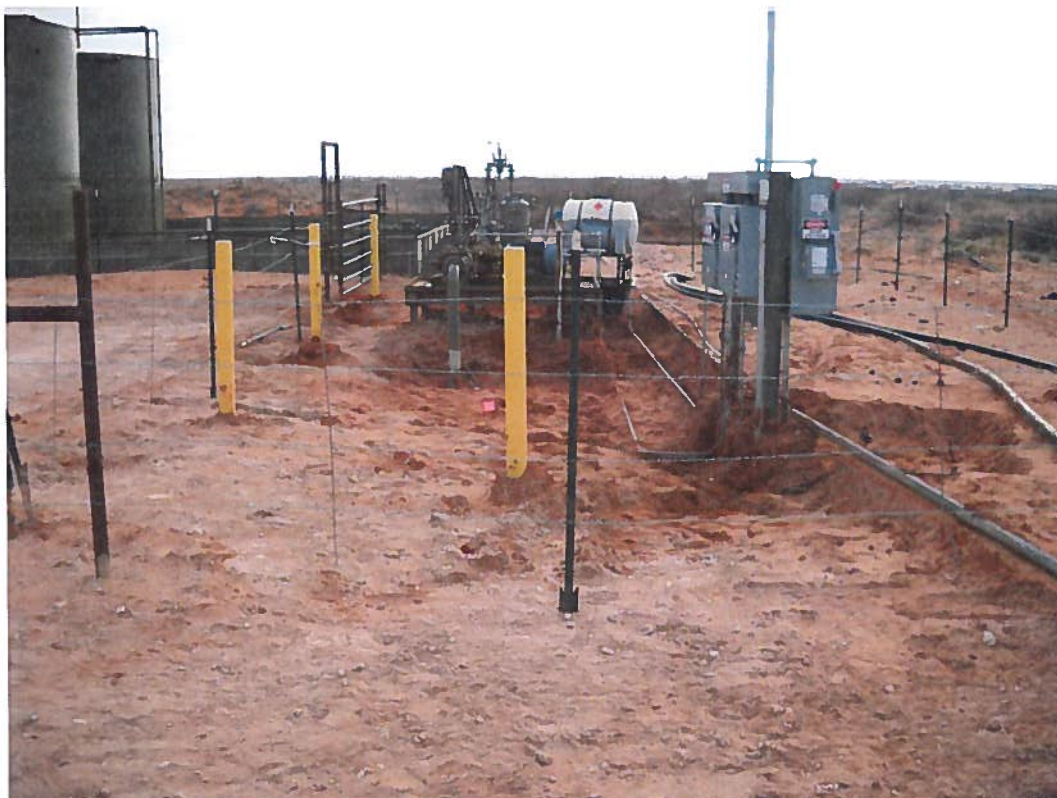
Excavation and Sample Locations at JRU 7-30 4" Release Site (Looking East)

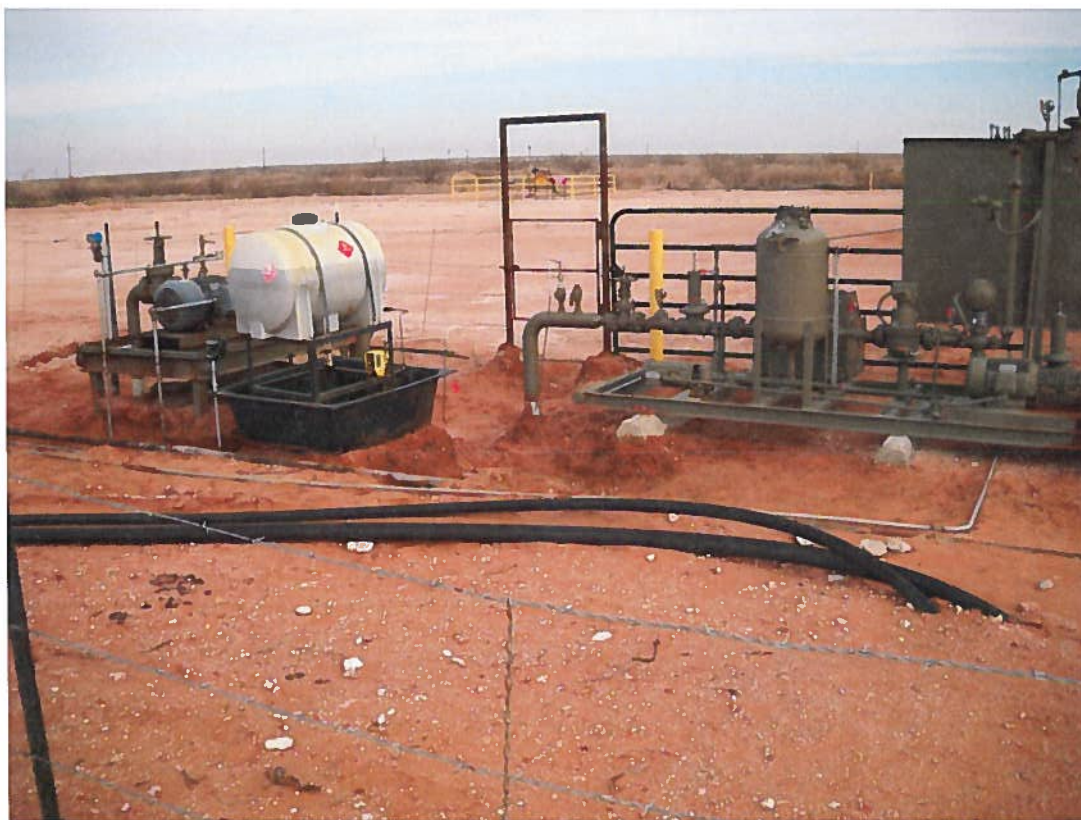
Excavation and Sample Locations at JRU 7-30 4" Release Site (Looking East)

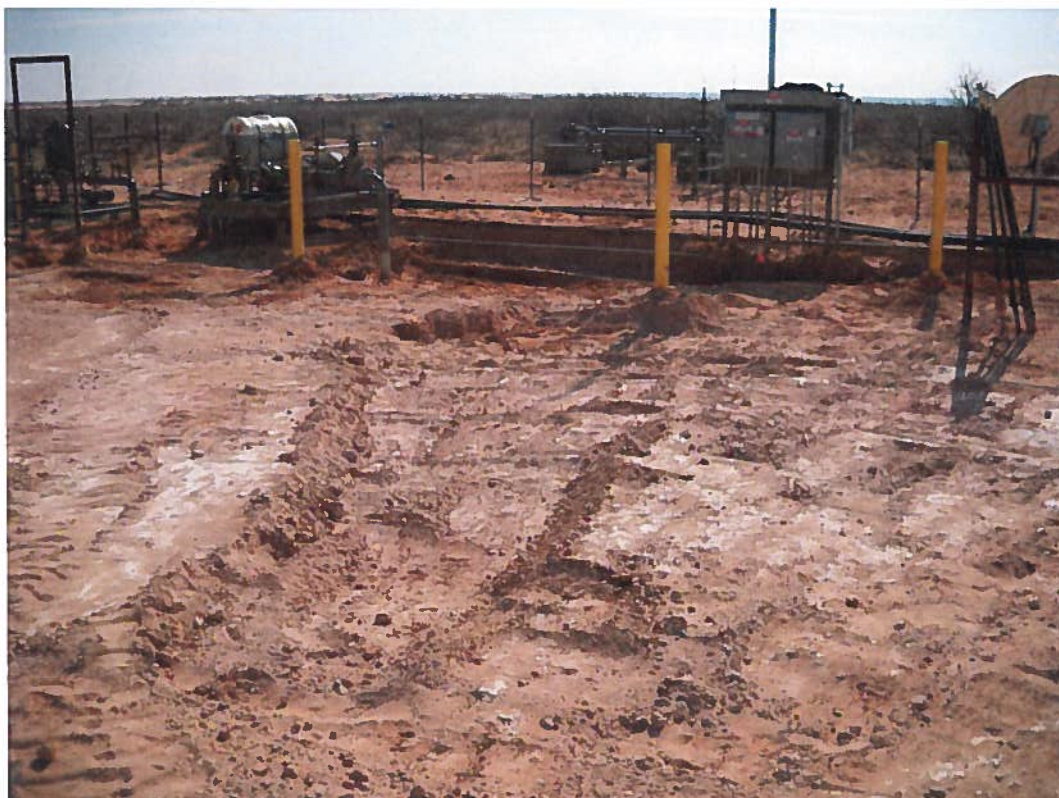
Excavation and Sample Locations at JRU 7-30 4" Release Site (Looking South)

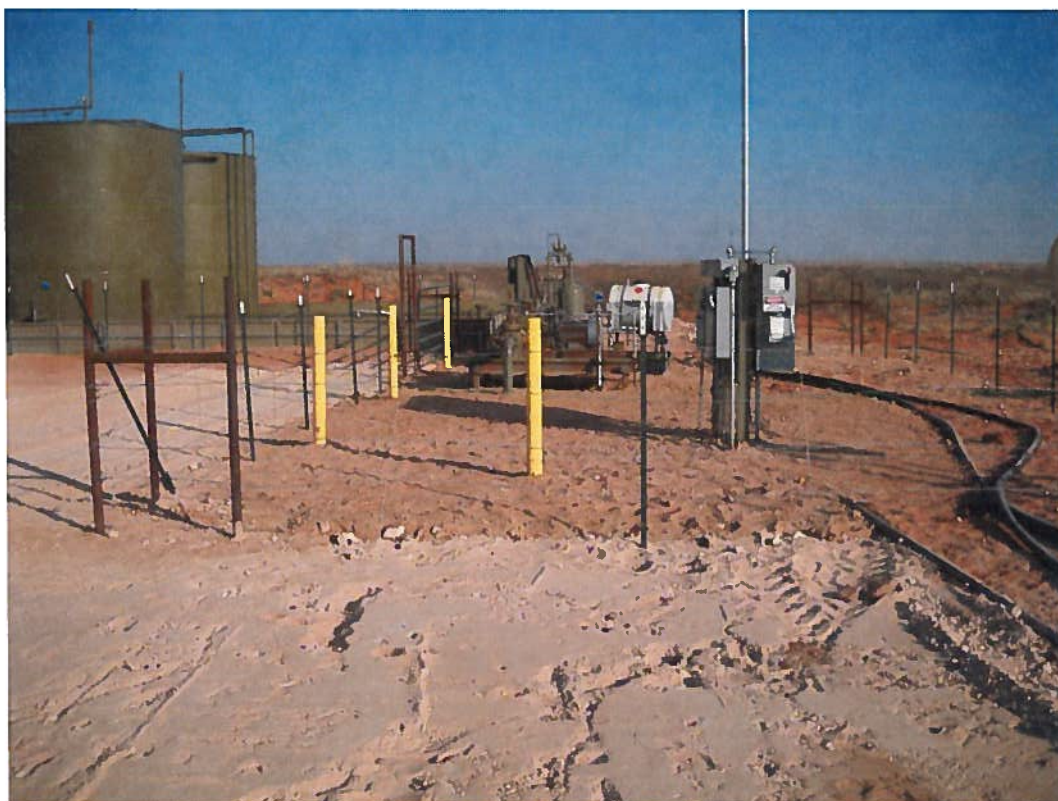
Backfill at the JRU 7-30 4" Release Site(Looking East)

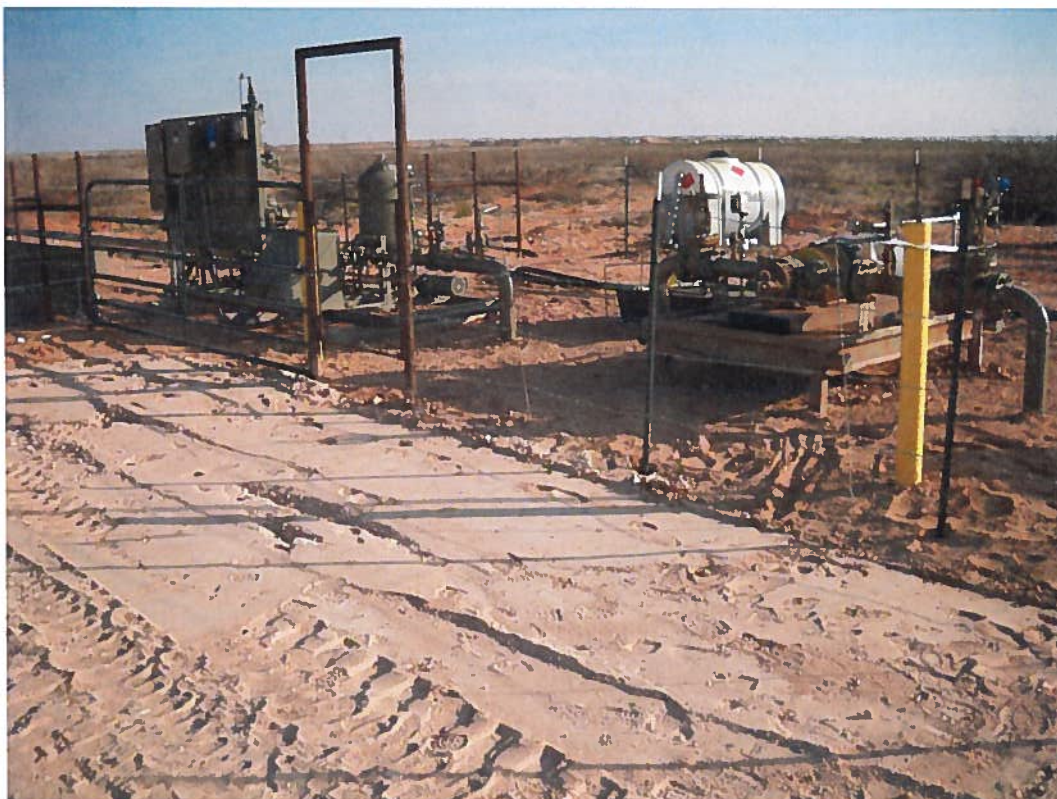
Backfill at the JRU 7-30 4" Release Site (Looking East)

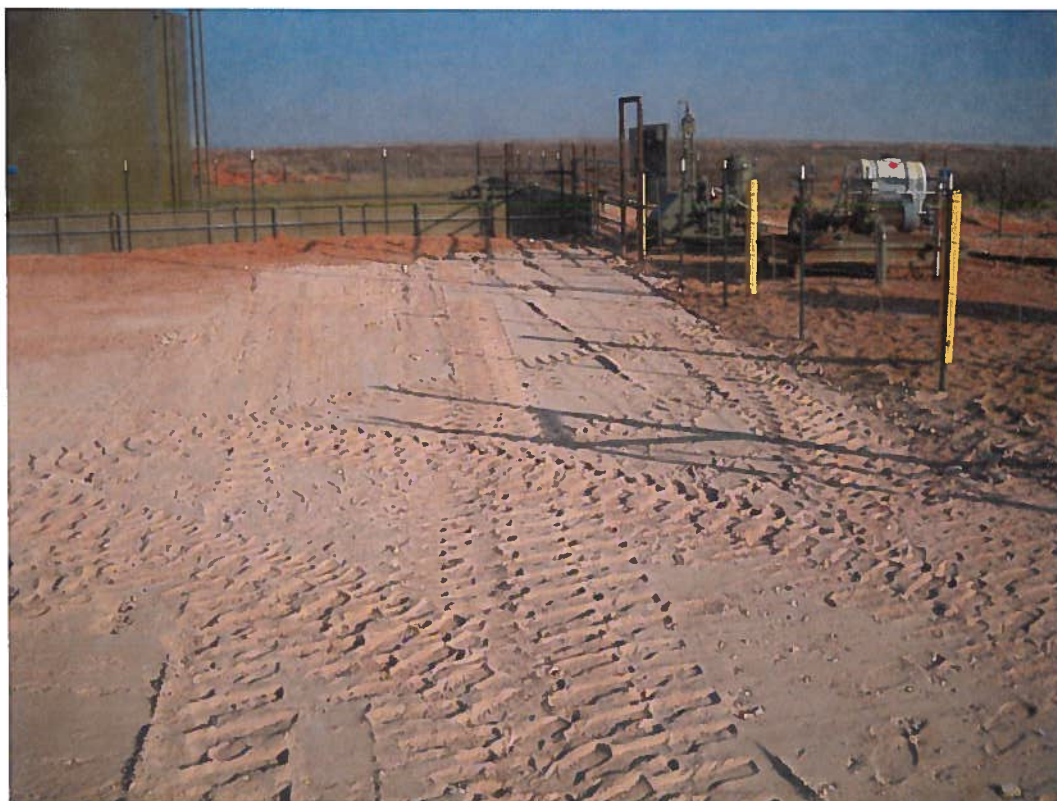
JRU 7-30 4" Release Site Post Remediation (Looking East)
